# 1Door4Care: CHEO Integrated Treatment Centre - Geotechnical Investigation Report (1Door4Care)

Children's Hospital of Eastern Ontario  
Campus, 401 and 407 Smyth Road,  
Ottawa, Ontario

Infrastructure Ontario Project # 182-OCTC

25 October 2022

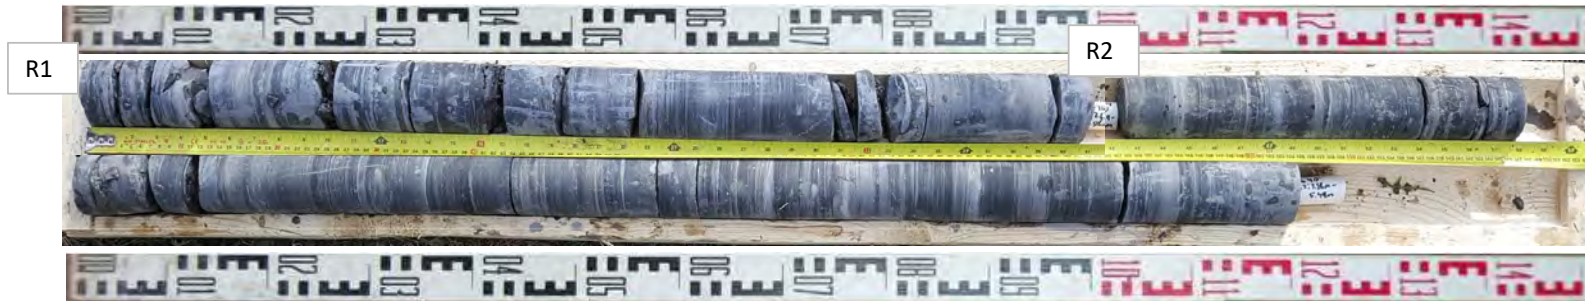
## Rock Core Photo Log MW4

R1 (RUN 1): 2.69 m - 3.86 m

R2 (RUN 2): 3.86 m - 5.49 m

The Total Core Recovery (TCR) achieved with the HQ size core bit ranged from approximately 64 to 100% and the Solid Core Recovery (SCR) ranged from 59 to 100 %. The Rock Quality Designation (RQD) ranged from 0 to 100% with the lower values of RQD observed near the surface of the rock and percentages generally increased with depth.

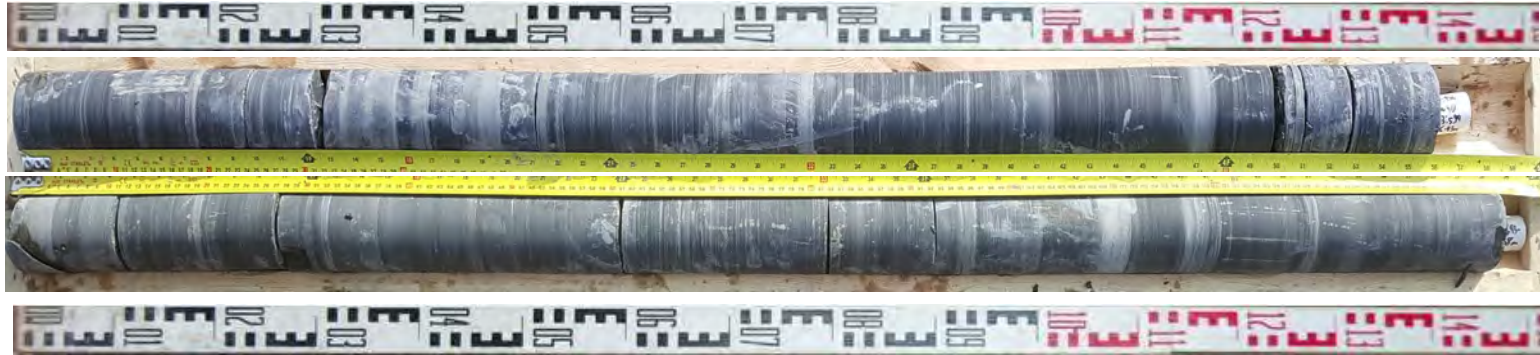
## Rock Core Photo Log MW4

R3 (RUN 3): 5.49 m - 6.93 m

R4 (RUN 4): 6.93 m - 8.38 m

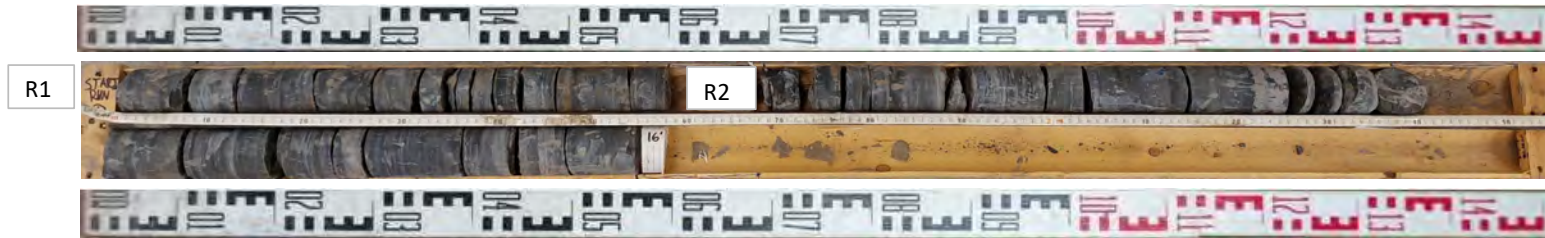
## Rock Core Photo Log MW9-22

R1 (RUN 1): 2.6 m - 3.3 m

R2 (RUN 2): 3.3 m - 4.9 m

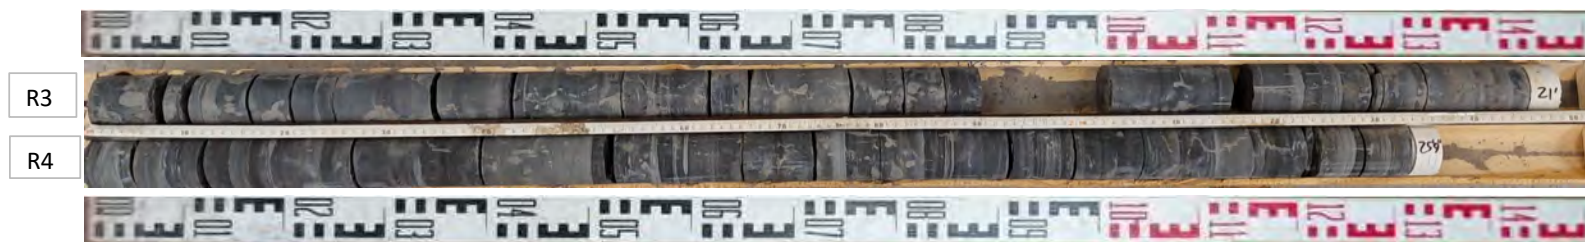
## Rock Core Photo Log MW9-22

R3 (RUN 3): 4.9 m - 6.4 m

R4 (RUN 4): 6.4 m - 7.9 m

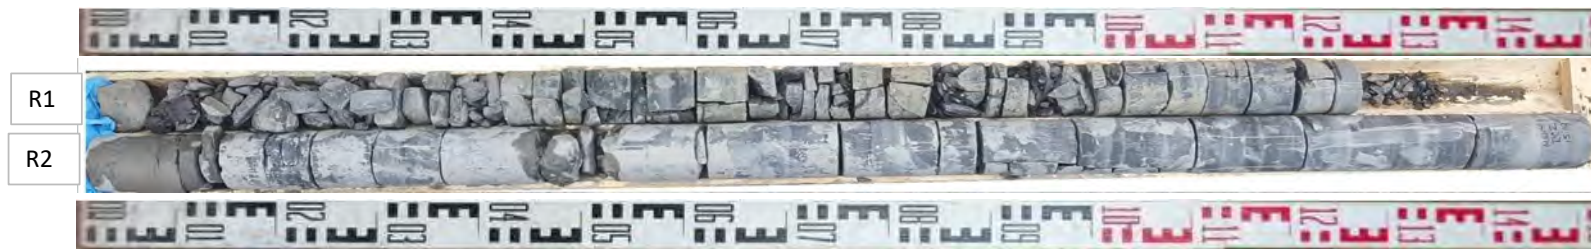
## Rock Core Photo Log MW14

R1 (RUN 1): 2.1 m - 3.4 m

R2 (RUN 2): 3.4 m - 4.8 m

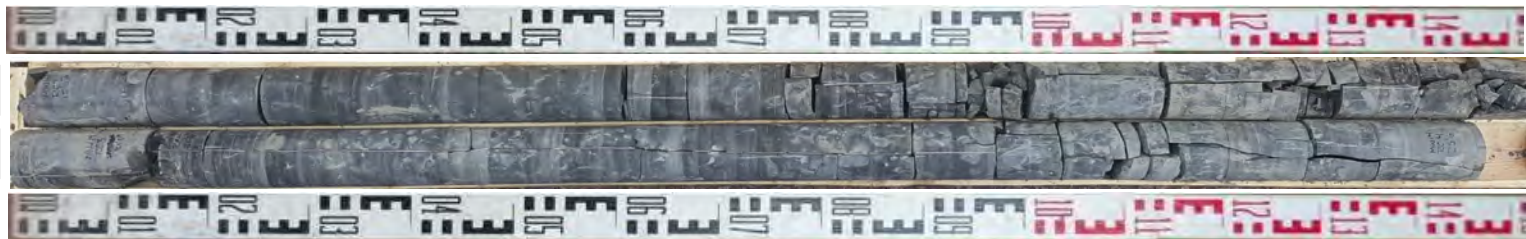
R3 (RUN 3): 4.8 m - 6.4 m

R4 (RUN 4): 6.4 m - 7.8 m

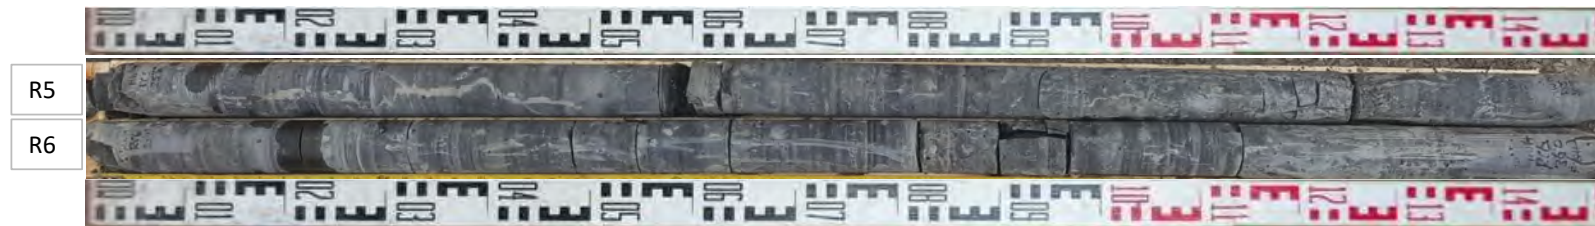
## Rock Core Photo Log MW14

R5 (RUN 5): 7.8 m - 9.4 m

R6 (RUN 6): 9.4 m - 11.0 m

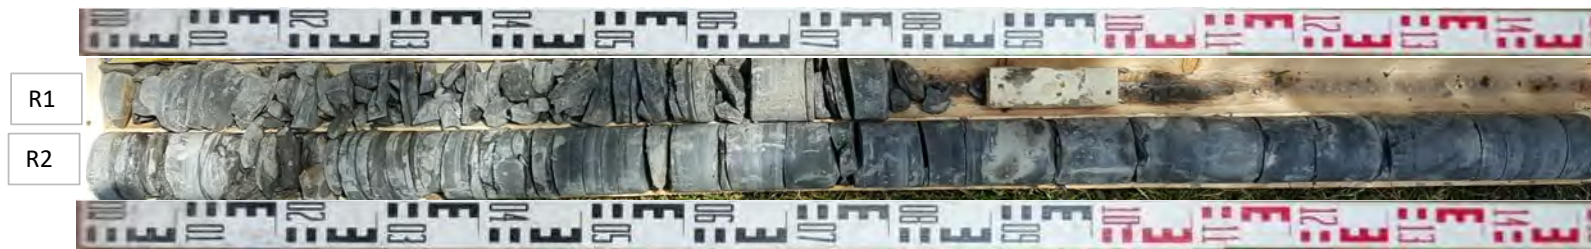
## Rock Core Photo Log BH21

R1 (RUN 1): 2.6 m - 3.3 m

R2 (RUN 2): 3.3 m - 4.8 m

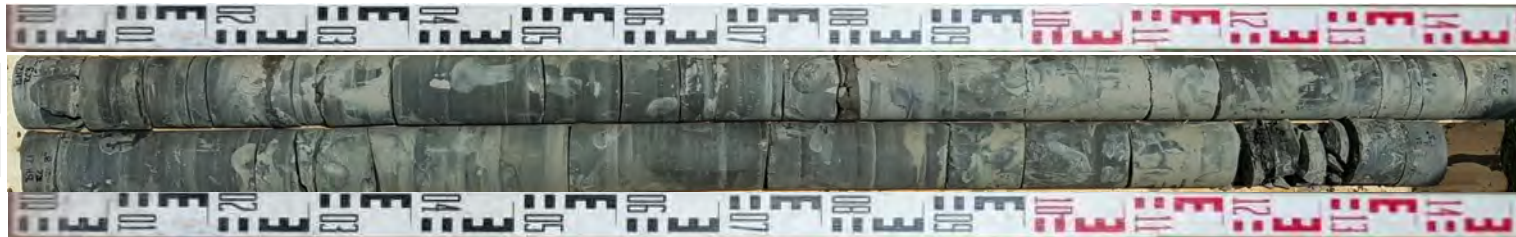
R3 (RUN 3): 4.8 m - 6.3 m

R4 (RUN 4): 6.3 m - 7.7 m

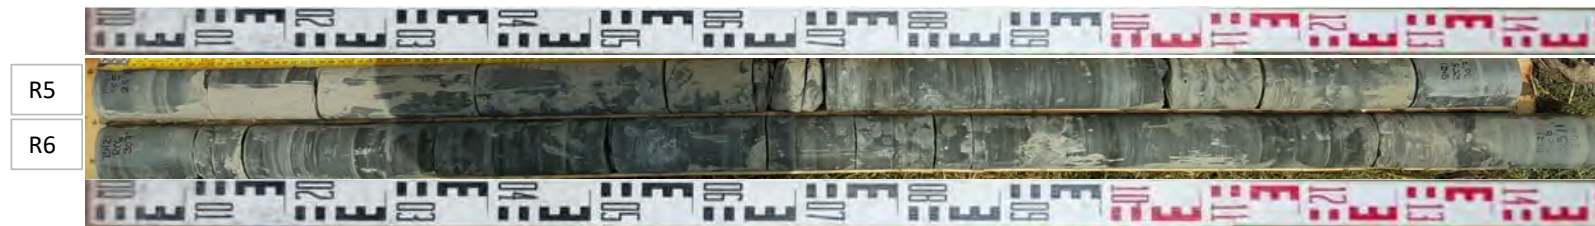
## Rock Core Photo Log BH21

R5 (RUN 5): 7.7 m - 9.3 m

R6 (RUN 6): 9.3 m - 11.0 m

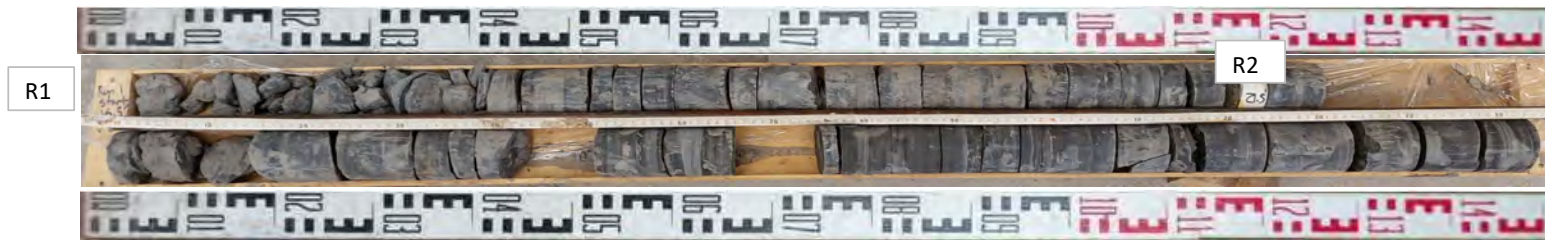
## Rock Core Photo Log MW23

R1 (RUN 1): 5.0 m - 6.5 m

R2 (RUN 2): 6.5 m - 8.1 m

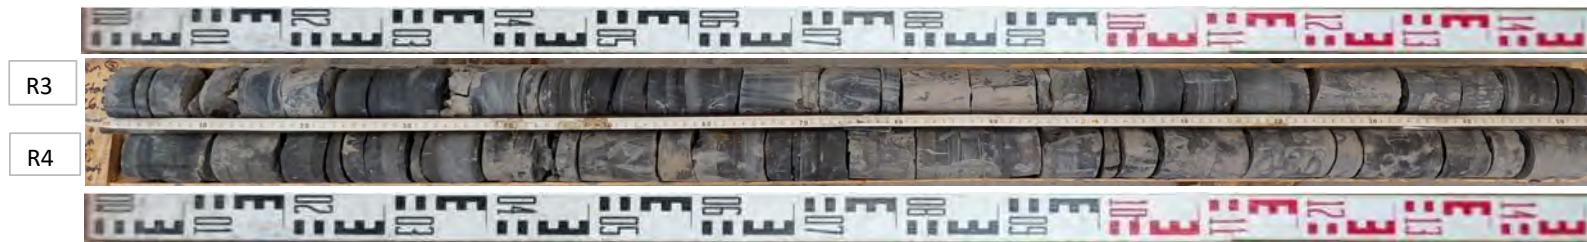
## Rock Core Photo Log MW23

R3 (RUN 3): 8.1 m - 9.6 m  
 R4 (RUN 4): 9.6 m - 11.1 m

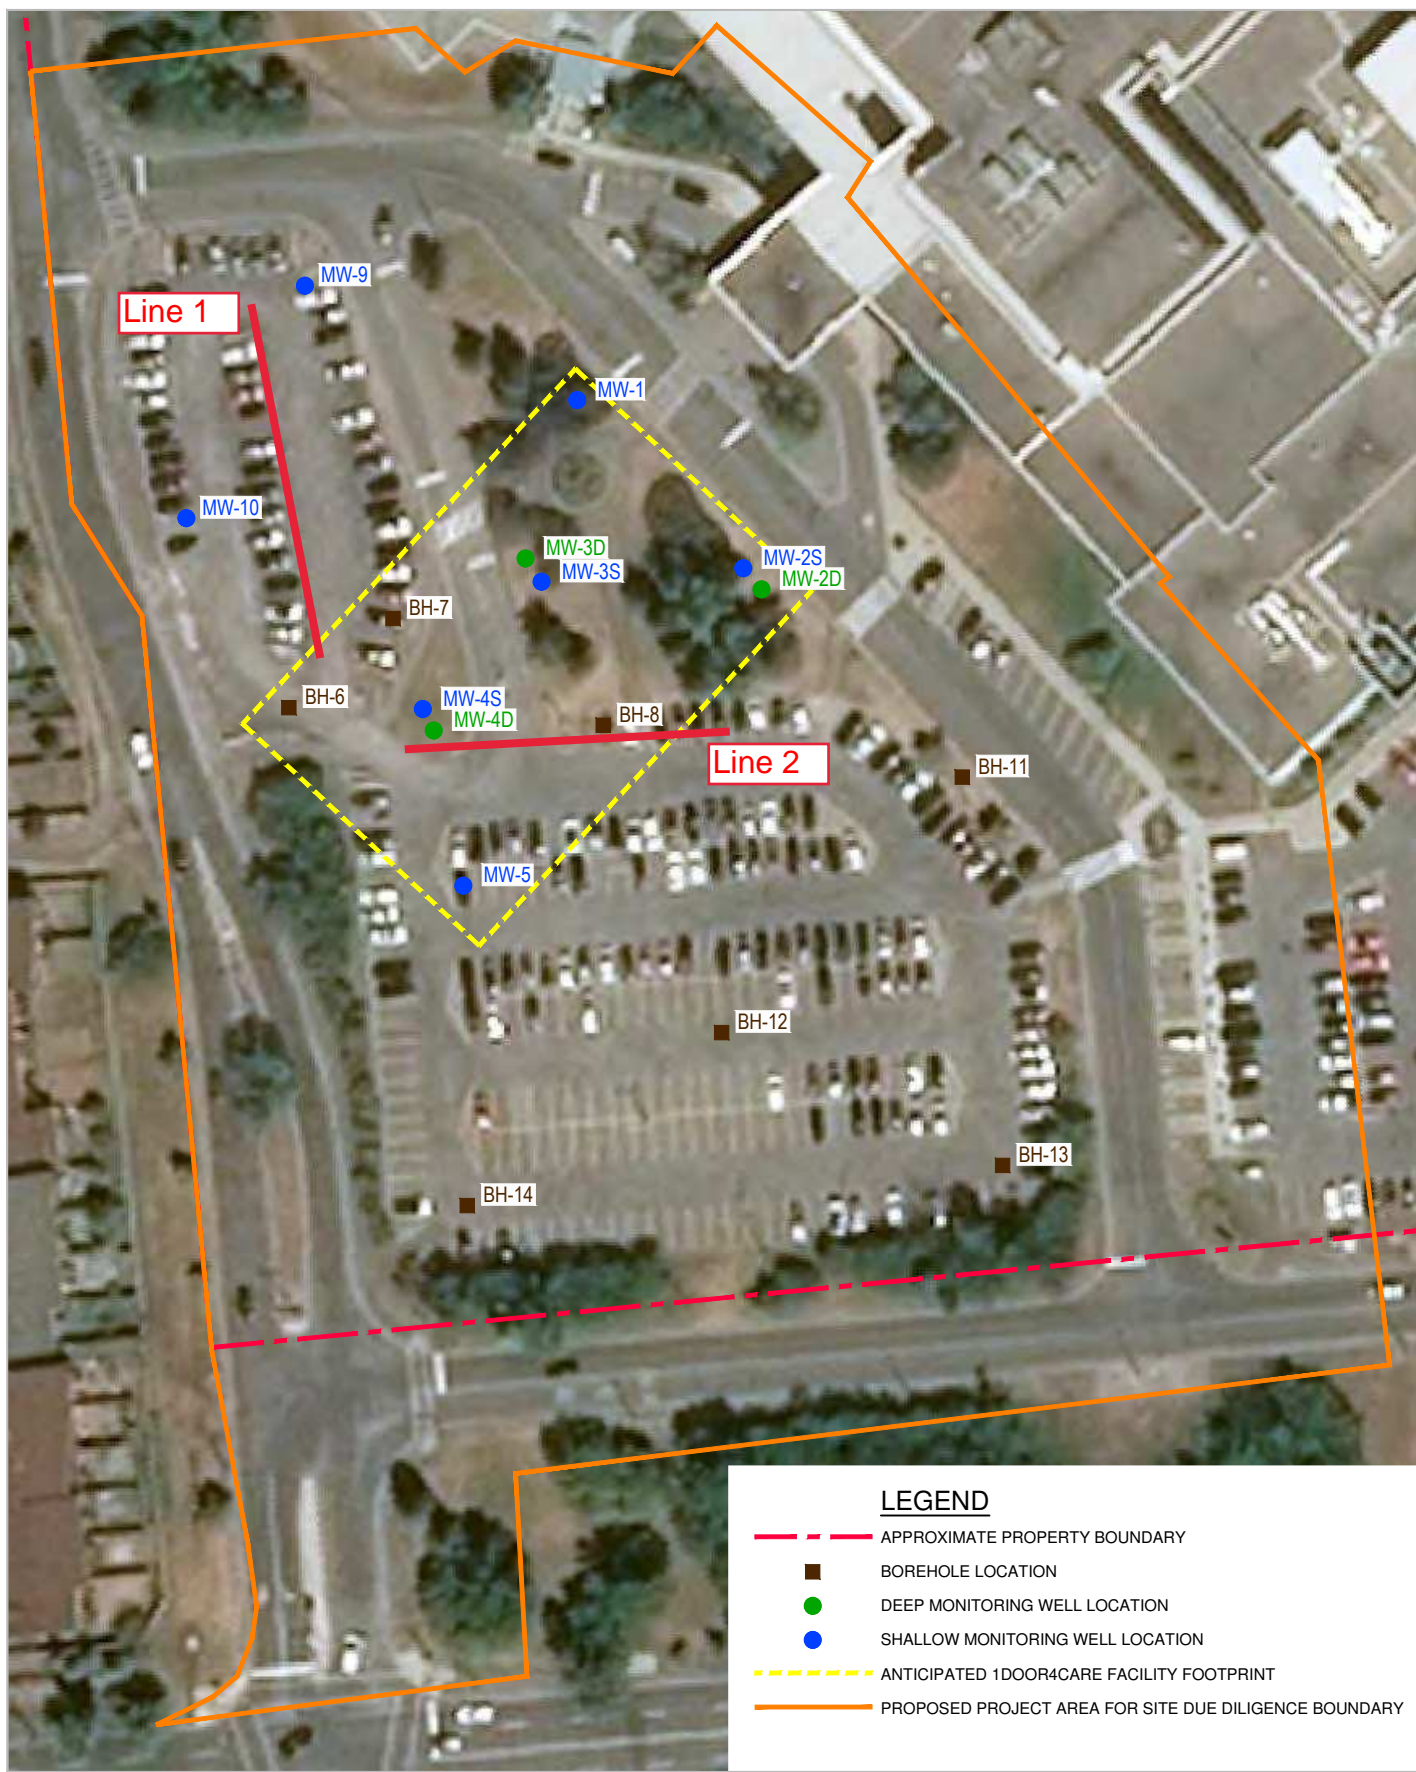
PROPOSED 1DOOR4CARE BUILDING  
CHILDREN'S HOSPITAL OF  
EASTERN ONTARIO CAMPUS  
401 SMYTH ROAD, OTTAWA, ONTARIO

**SITE PLAN AND  
INVESTIGATIVE LOCATIONS**

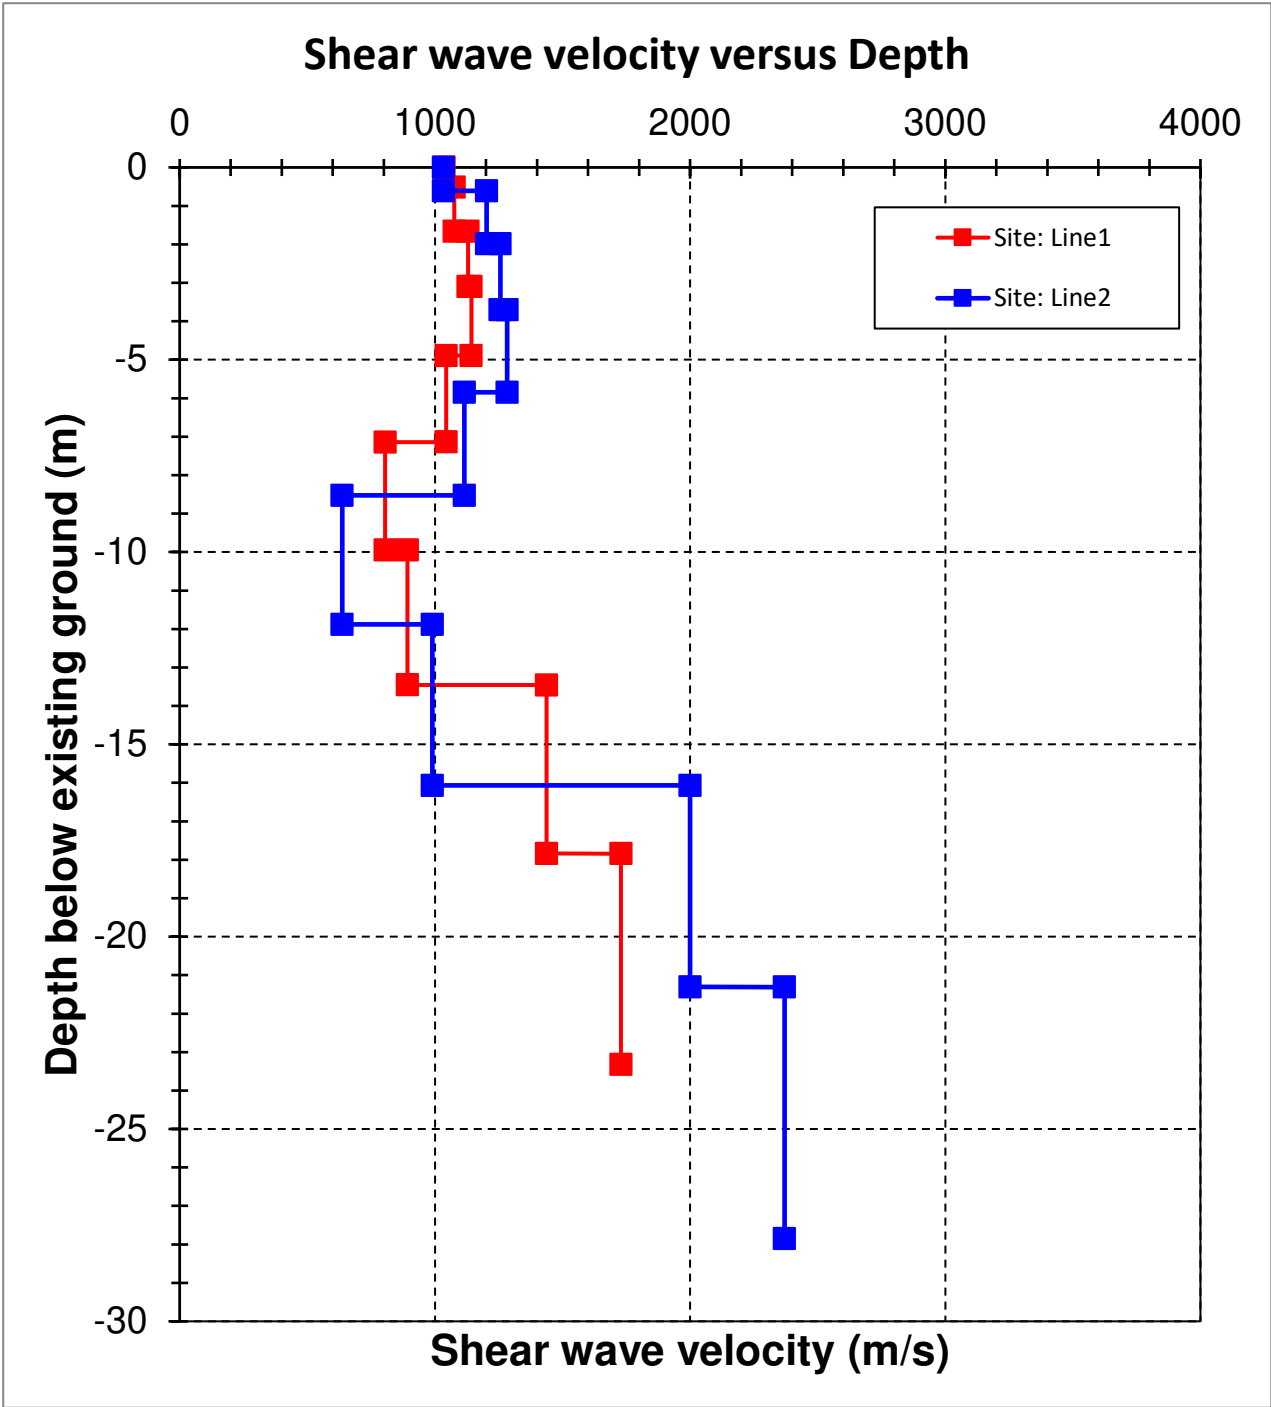
Infrastructure Ontario  
Proposed 1Door4Care Development  
Part of Childrens Hospital of Eastern Ontario Campus  
401 and 407 Smyth Road, Ottawa Ontario  
**SHEAR WAVE VELOCITY VS DEPTH**

In order to measure the ground shear wave velocity at the proposed building location and define the Site classification for seismic site response, a multi-channel analysis of surface waves (MASW) was carried out by GHD along two (2) select investigated lines within the Site. The purpose of the MASW survey was to assess the seismic site class in accordance with the Ontario Building Code (OBC 2012) by measuring the average shear wave velocity within the upper 30+ m of the soil/rock profile directly under the assumed founding level of the proposed building.

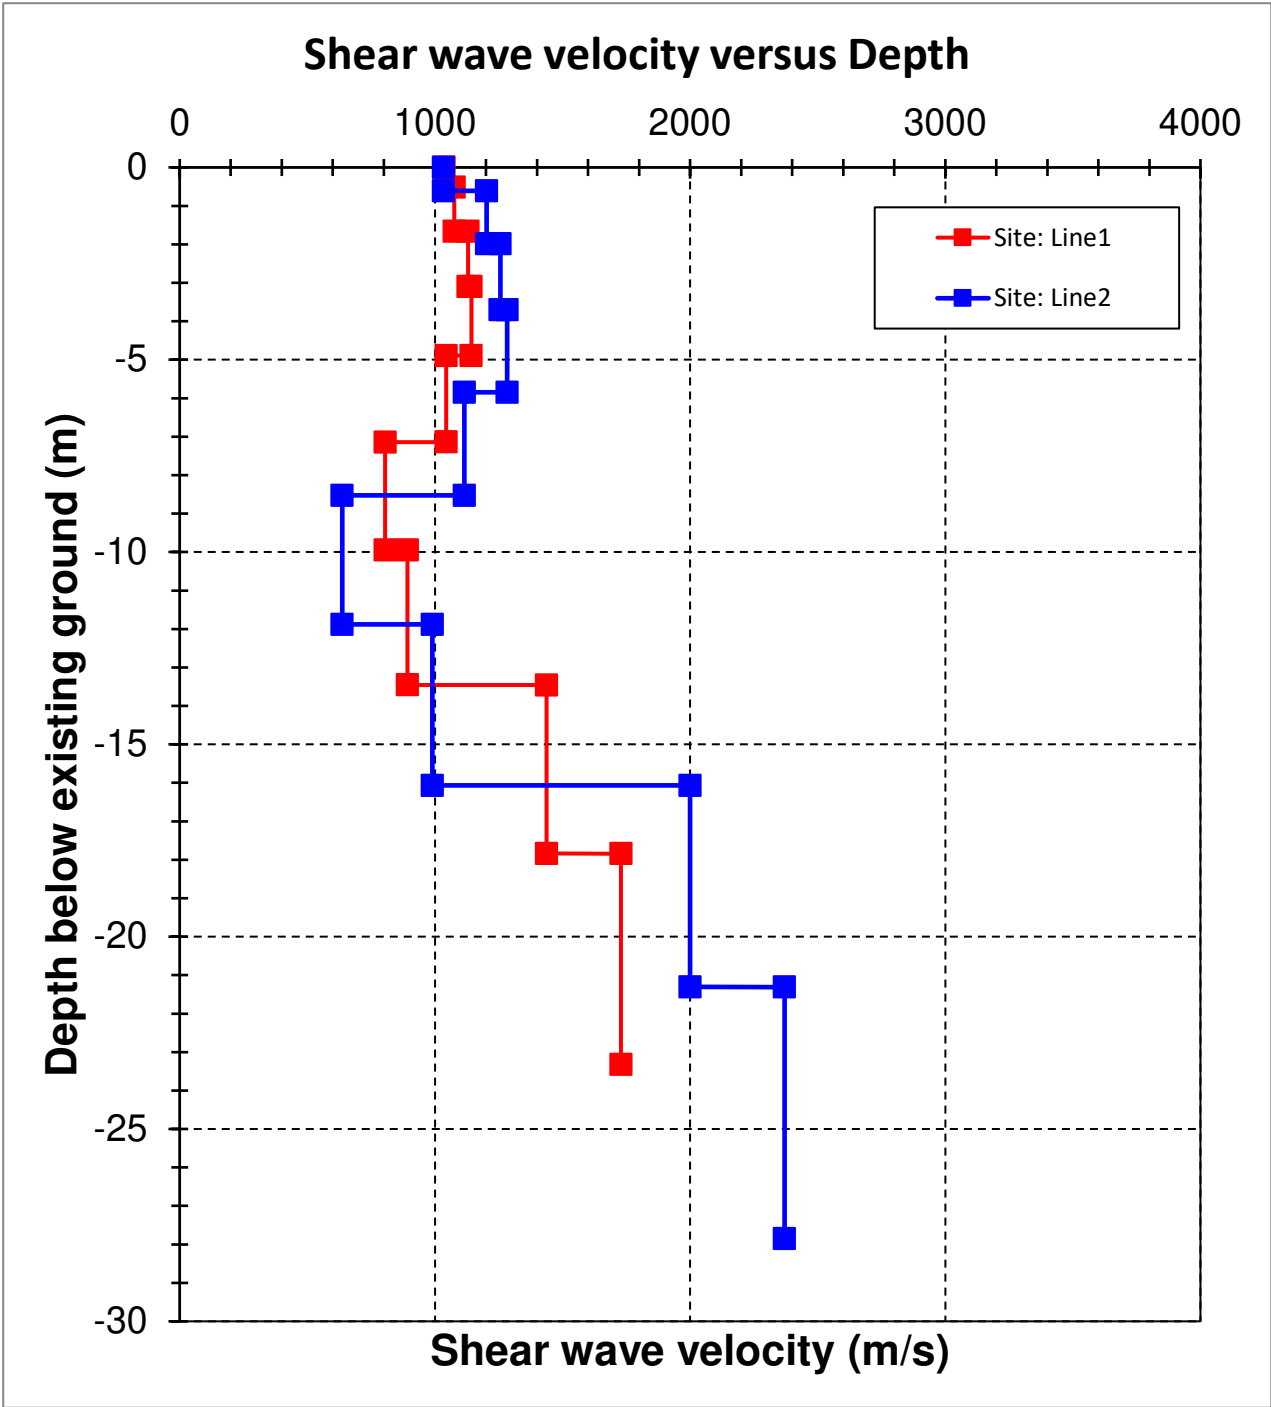
Infrastructure Ontario  
Proposed 1Door4Care Development  
Part of Childrens Hospital of Eastern Ontario Campus  
401 and 407 Smyth Road, Ottawa Ontario  
**SHEAR WAVE VELOCITY VS DEPTH**

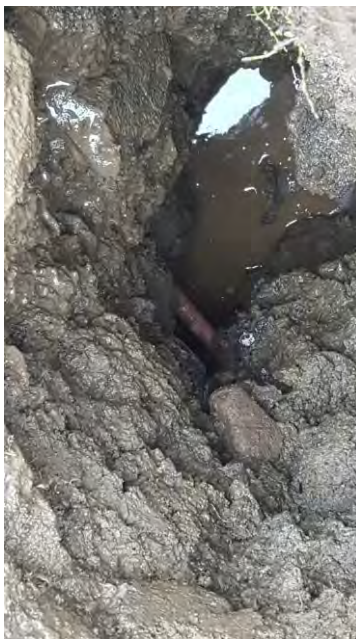
Photo 8: View of Test Pit TP4-20 water line

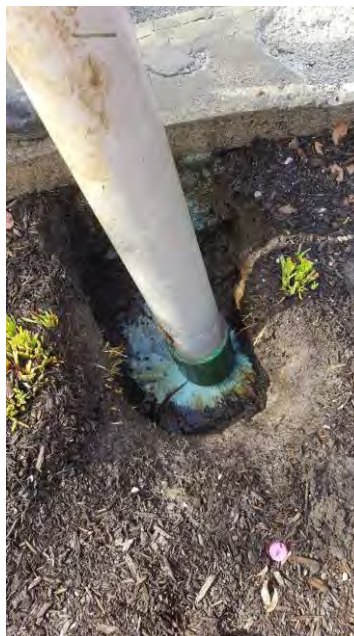
Photo 10: View of Test Pit TP5A-20 Concrete Surface facing West

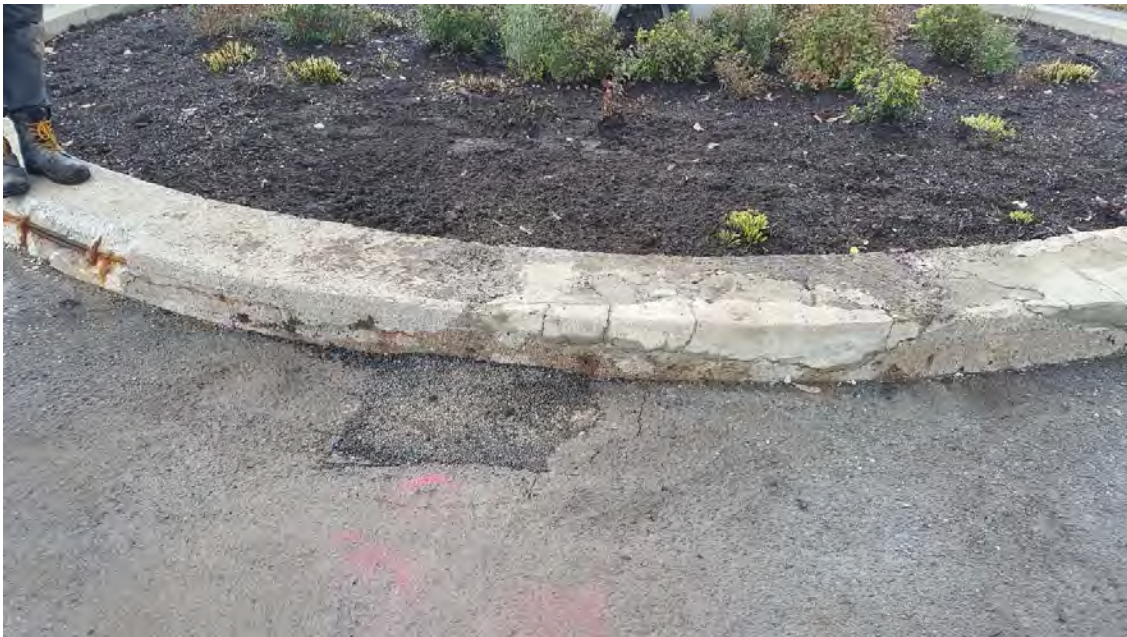
Photo 13: View of Test Pits TP5A-20 and TP5B-20 Surface Repair facing East

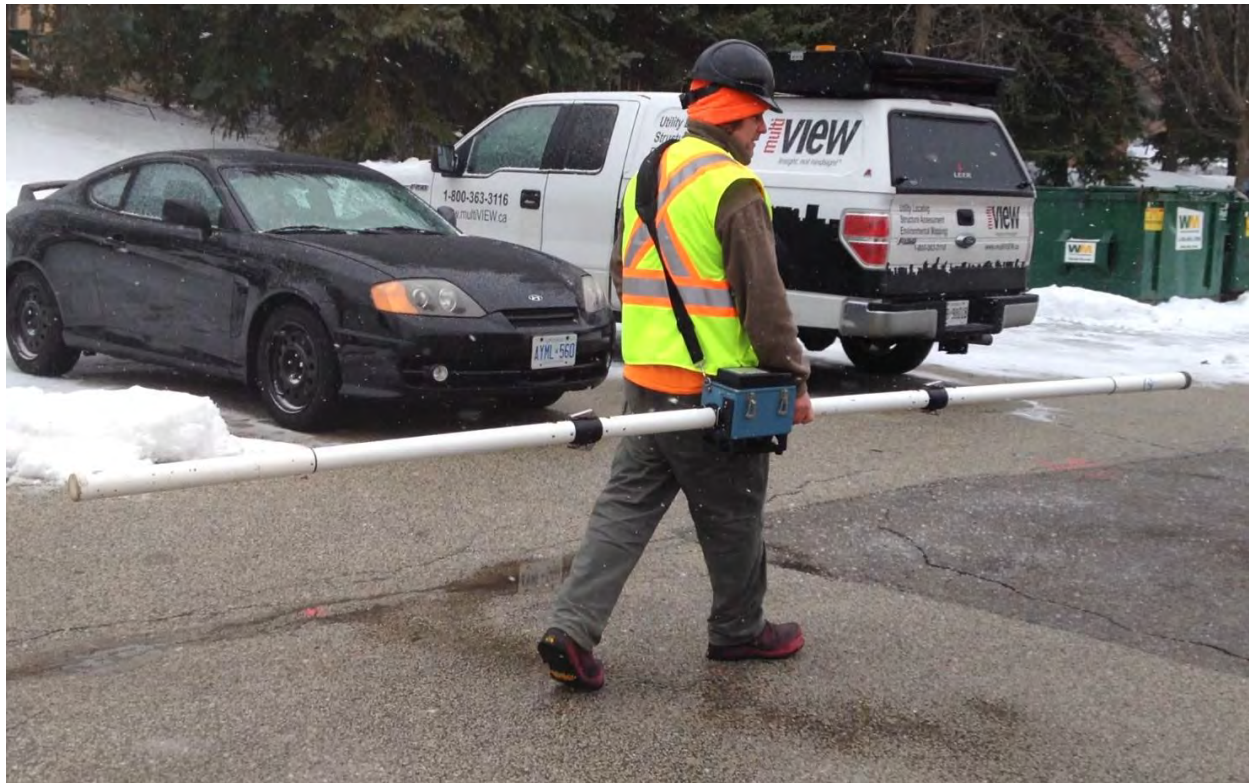
The measurement units of the system are “milli-Siemens per metre” (mS/m) for the Quadrature component and “parts per thousand” (ppt) for the In-phase component of the measured electromagnetic field. The electromagnetic data were acquired at approximate station spacing of 2 metres along lines spaced at 2 metres apart, excluding obstructed areas. GPS data were collected synchronously with the FDEM data using a receiver externally mounted on the EM31 logging system. Following the field survey, the GPS data were integrated with the FDEM data.

Figure 3-2: Typical FDEM Acquisition System Setup

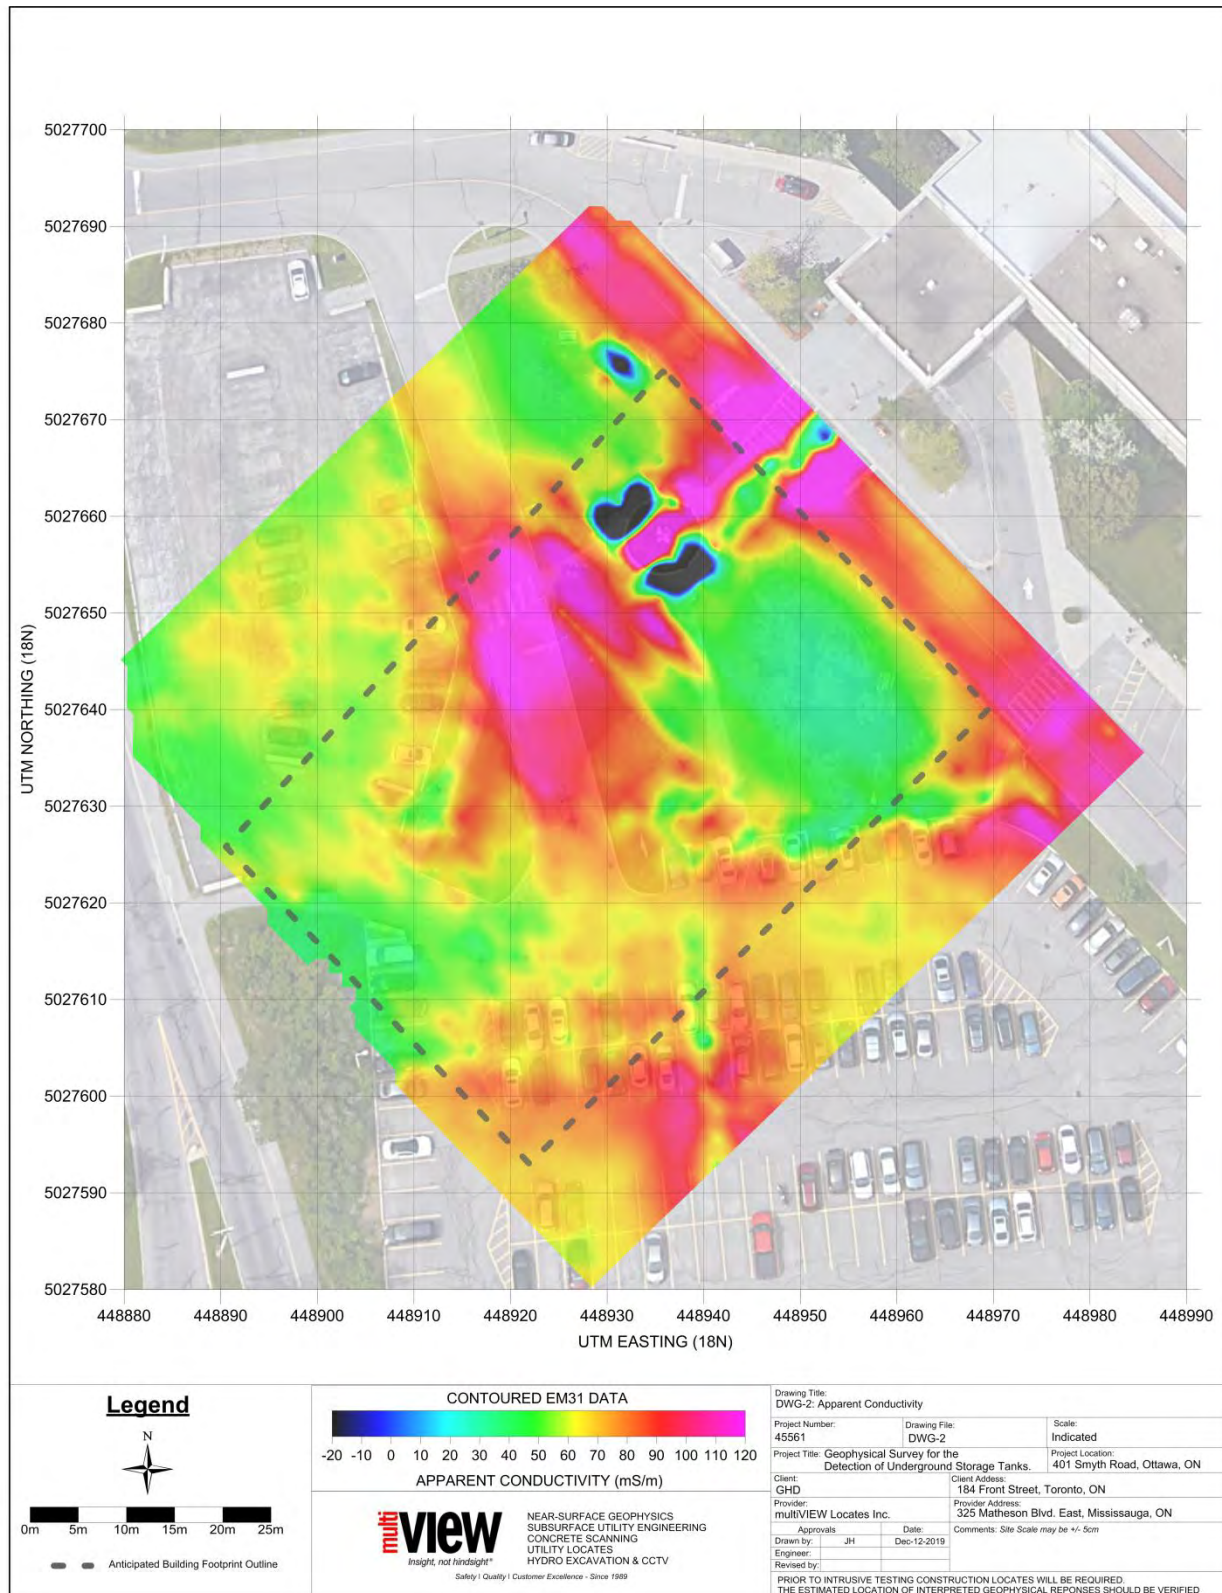
Figure 4-1: FDEM Apparent Conductivity

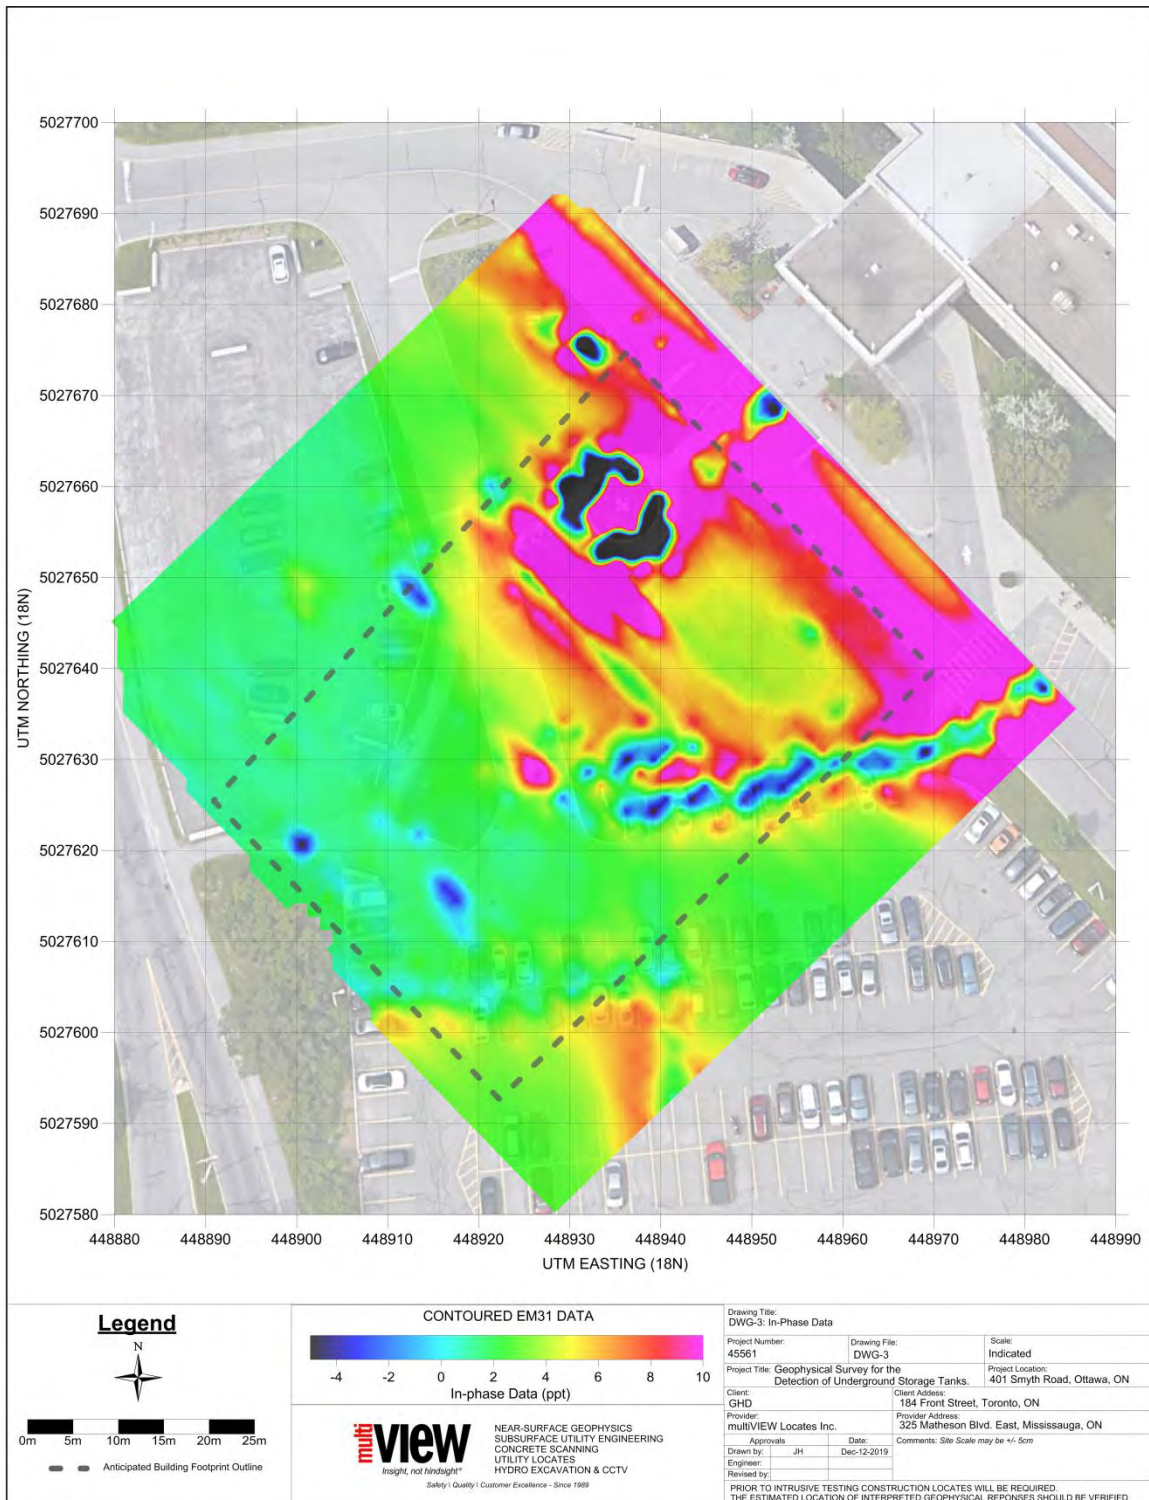
Figure 4-2: FDEM In-Phase Data

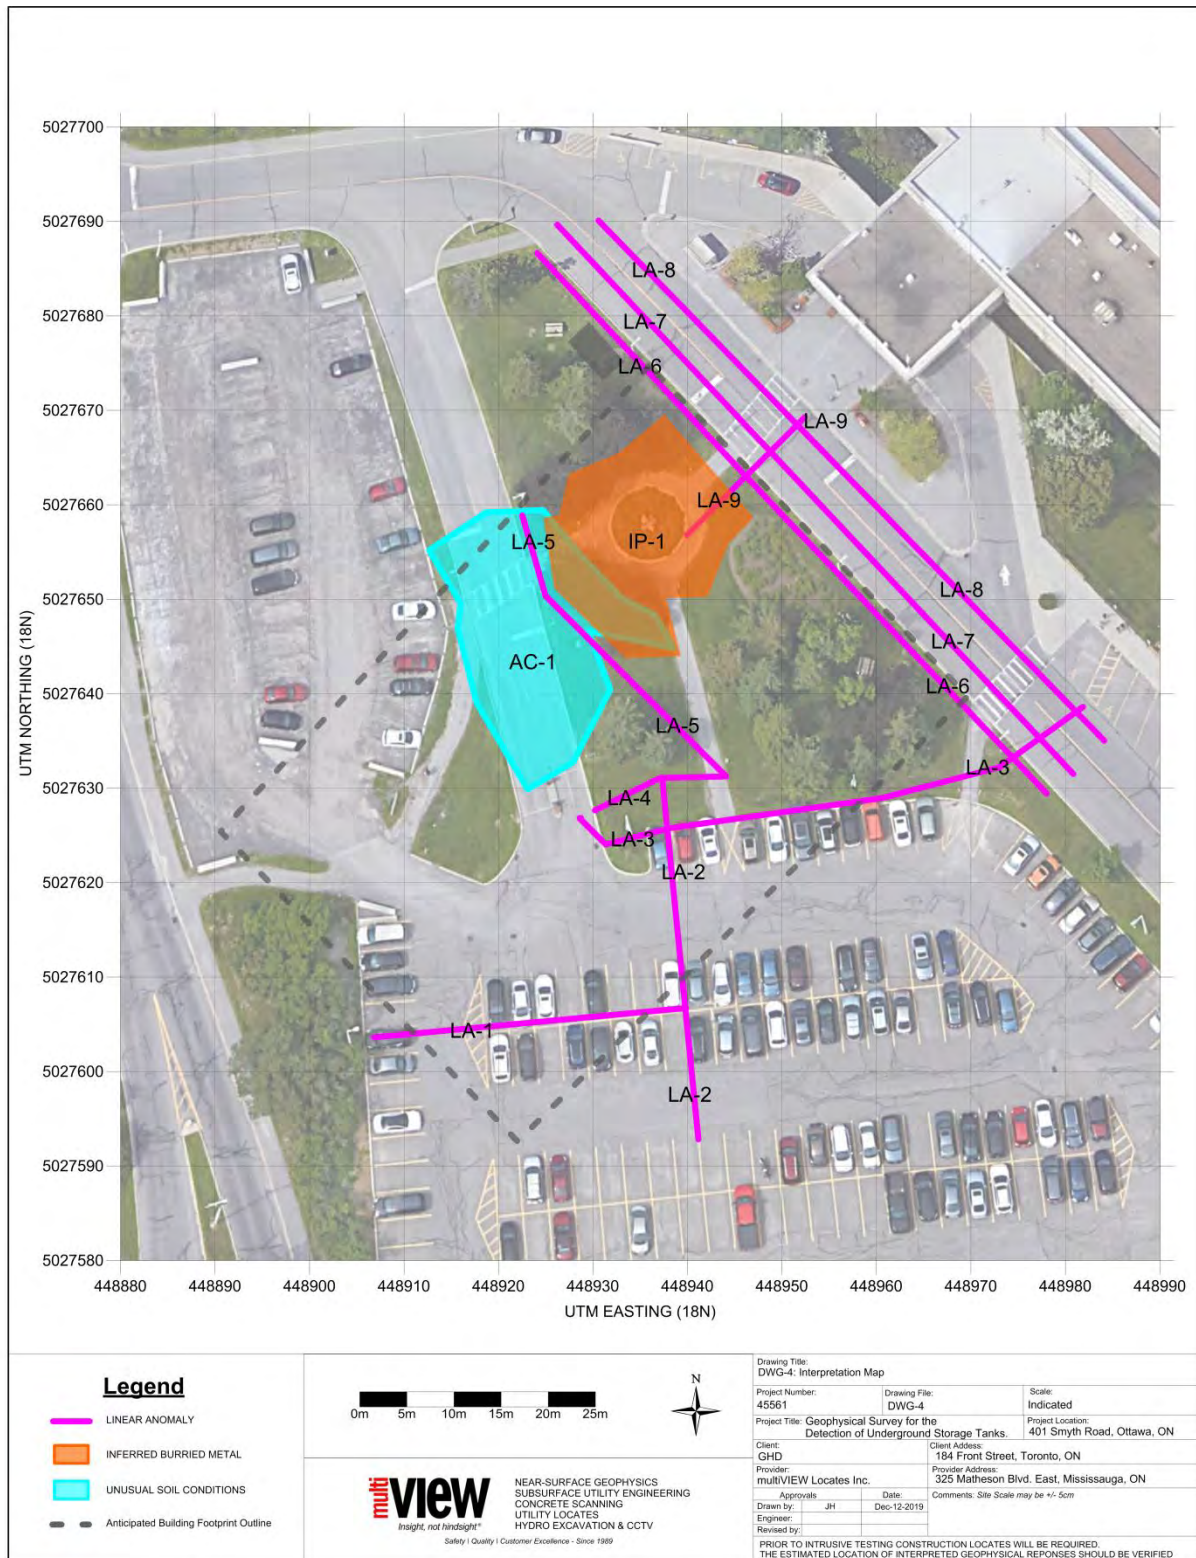
Figure 4-3: FDEM Interpretation Map

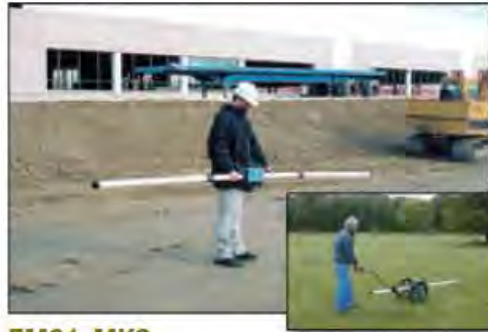
##### EM31-MK2

Using a patented electromagnetic inductive technique that allows measurement without any requirement for either electrodes or ground contact, the EM31-MK2 Ground Conductivity Meter maps soil materials, groundwater contaminants or any subsurface feature associated with changes in conductivity. With this inductive method, surveys can be conducted over any surface conditions, including those with high resistivity materials such as sand, gravel and asphalt.

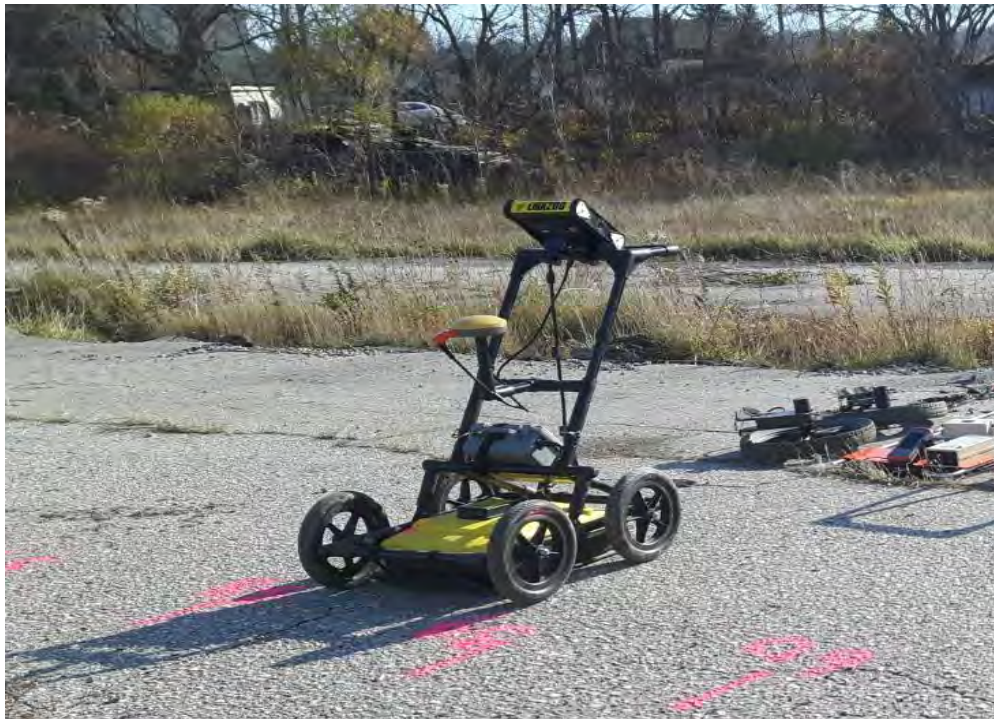
The GPR survey was completed using a Noggin 250MHz GPR system manufactured by Sensors & Software Inc. A general system configuration is shown in Figure 3. The GPR data were acquired with station spacing of 0.05m along the grid profiles established for the entire survey grid. Over the scanned area, the GPR profiling was run with parallel lines spaced at approximately 1 meter interval as shown in the geophysical line location map.

Figure 3: Typical GPR Acquisition System Setup

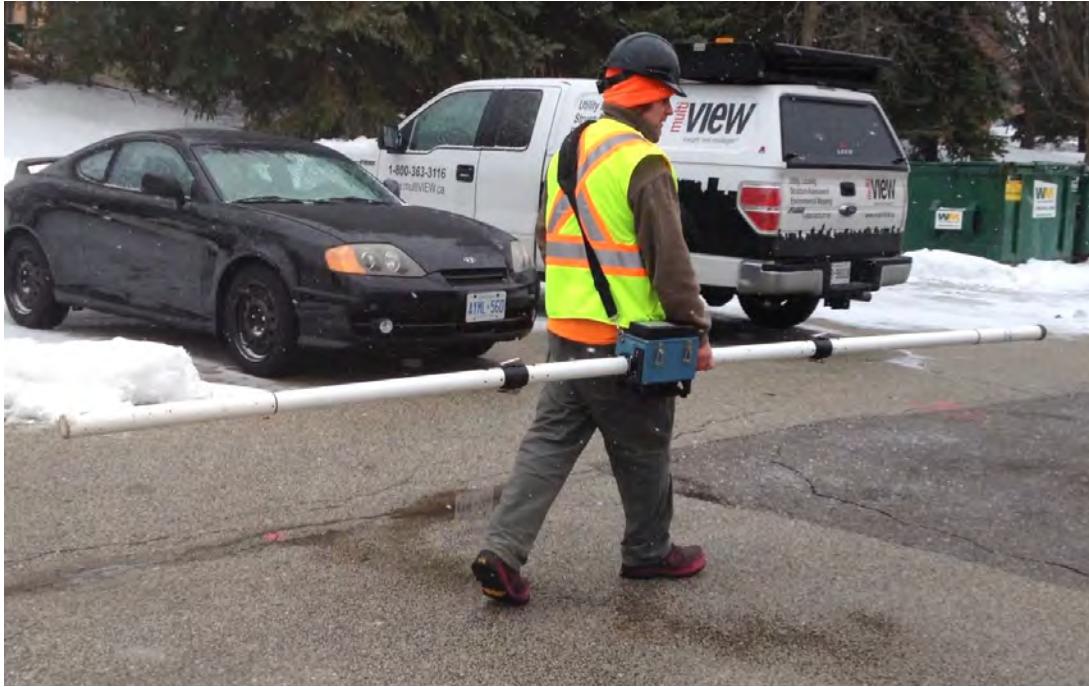
FDEM data acquisition was conducted across the entire project area using an EM31 system manufactured by Geonics Limited Ltd. The EM31 instrumentation provides data for indirect detection of buried metal objects and soil conductivity mapping to 3 to 6 meters depth using a horizontal coplanar coil configuration. A general system configuration is shown in Figure 4.

Figure 4: Photo Illustrating a Typical Frequency Domain EM31 Acquisition System Setup
