# 1Door4Care: CHEO Integrated Treatment Centre - Geotechnical Investigation Report (1Door4Care)

Children's Hospital of Eastern Ontario  
Campus, 401 and 407 Smyth Road,  
Ottawa, Ontario

Infrastructure Ontario Project # 182-OCTC

25 October 2022

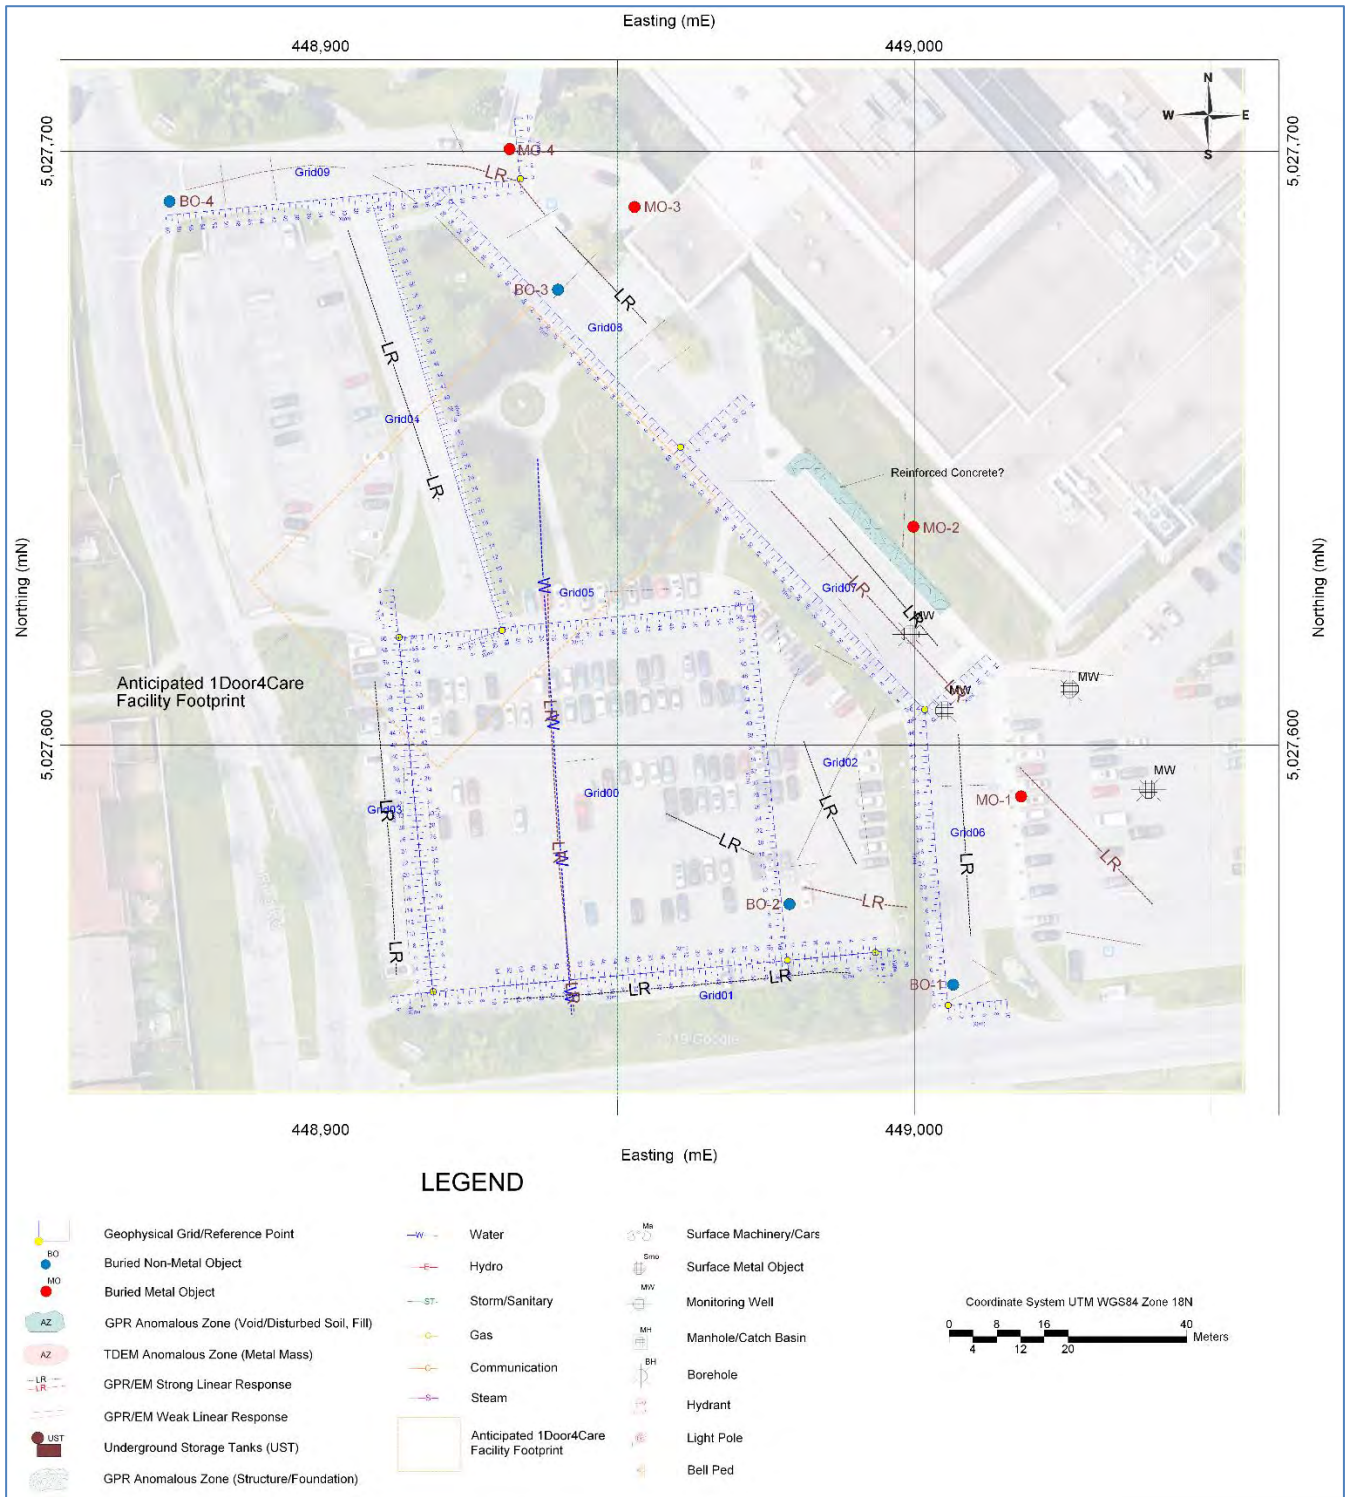
Figure 5: Geophysical Interpretation Plan Map

The following Table 1 summarises the interpreted underground buried features of relevance to the exploration program. The inferred location of the geophysical signatures was documented and transferred to digital drawings for referencing and assessment. For details on location of the responses refer to the geophysical interpretation maps, profiles and tables provided digitally.

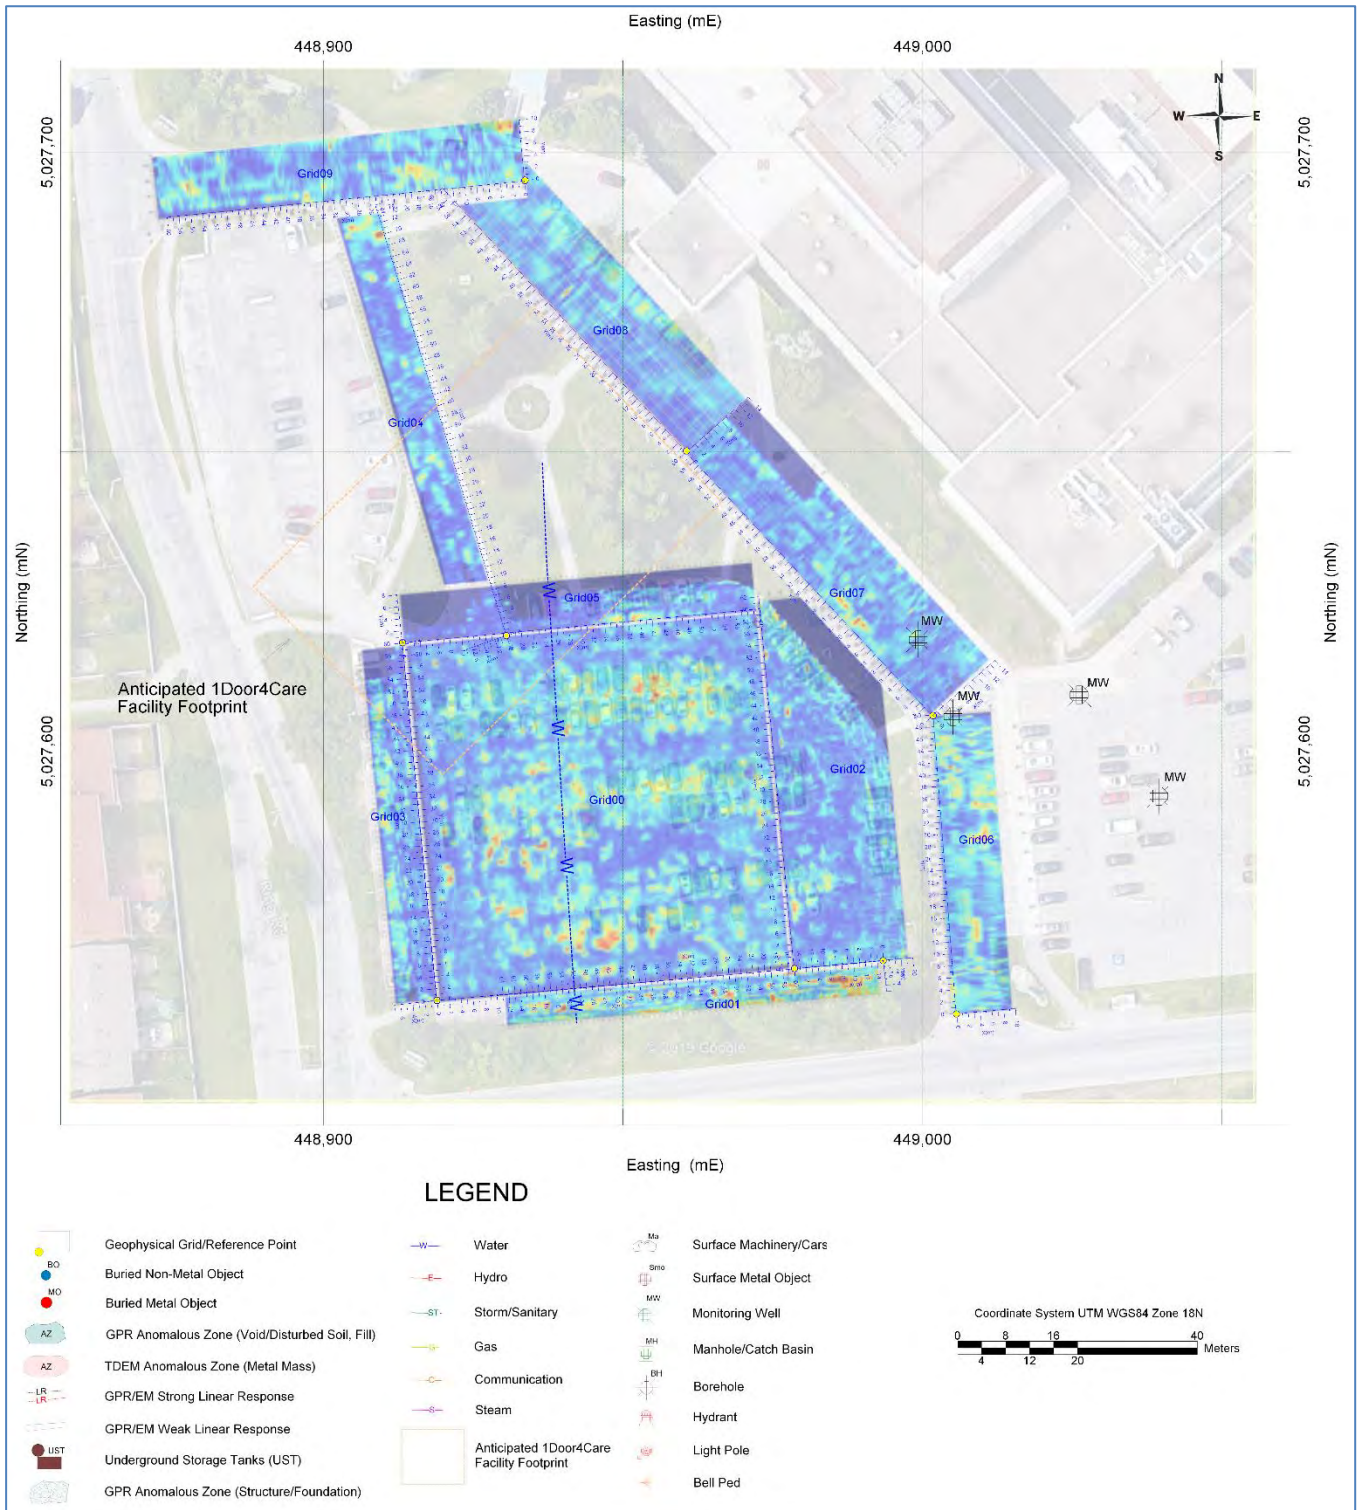
Figure 6: GPR Signal Amplitude at 50cm Depth

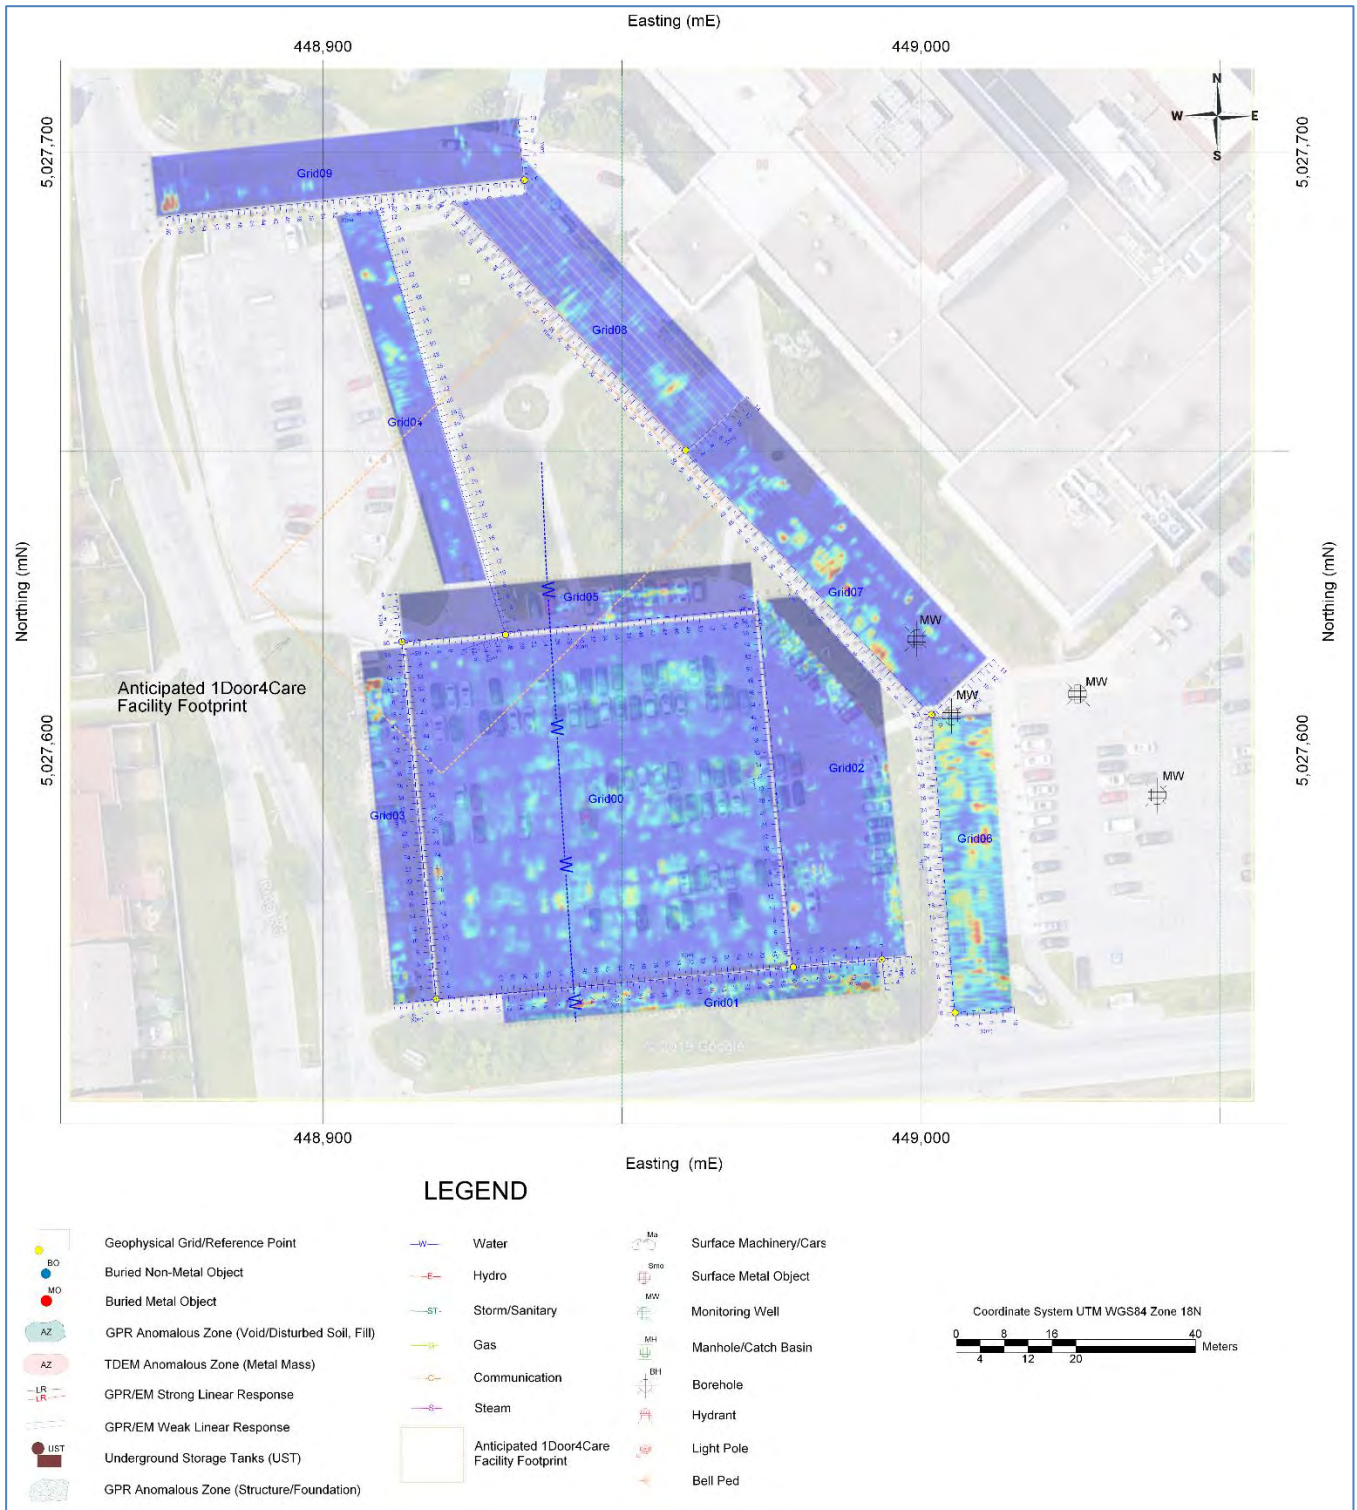
Figure 7: GPR Signal Amplitude at 100cm Depth

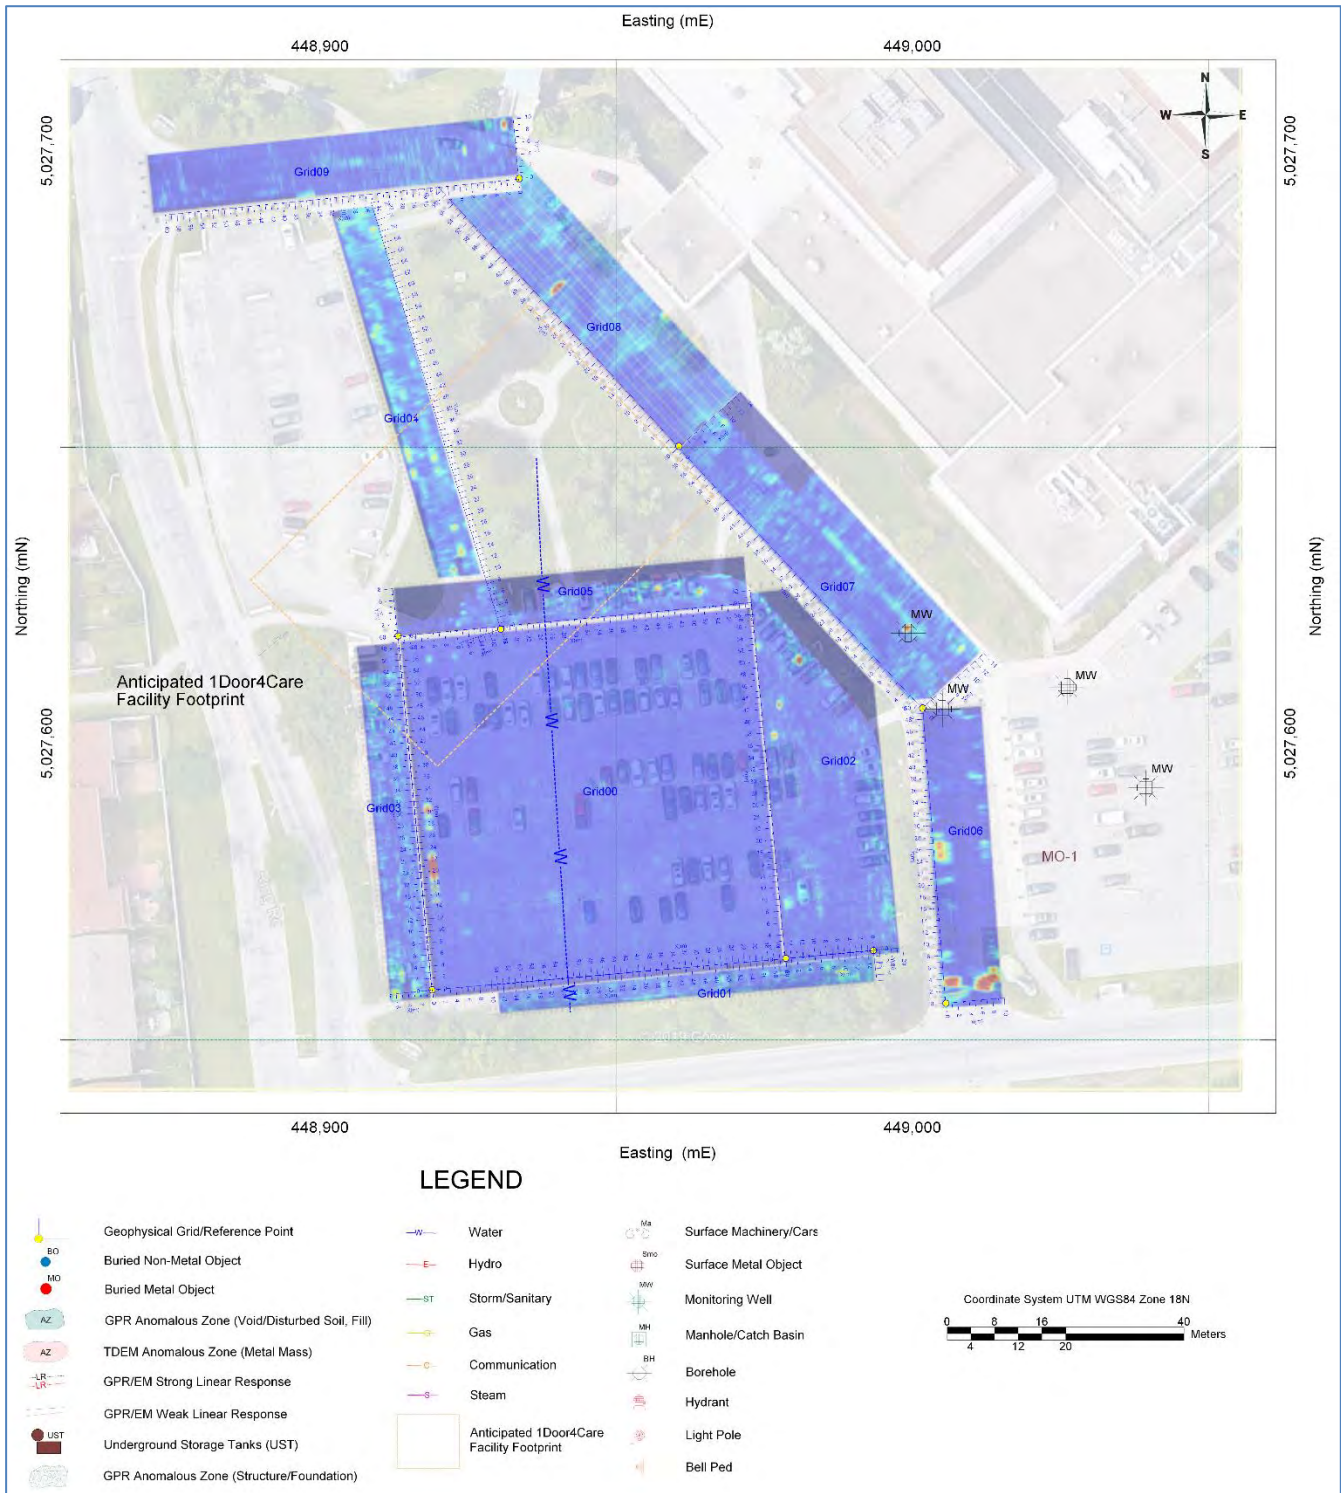
Figure 8: GPR Signal Amplitude at 150cm Depth

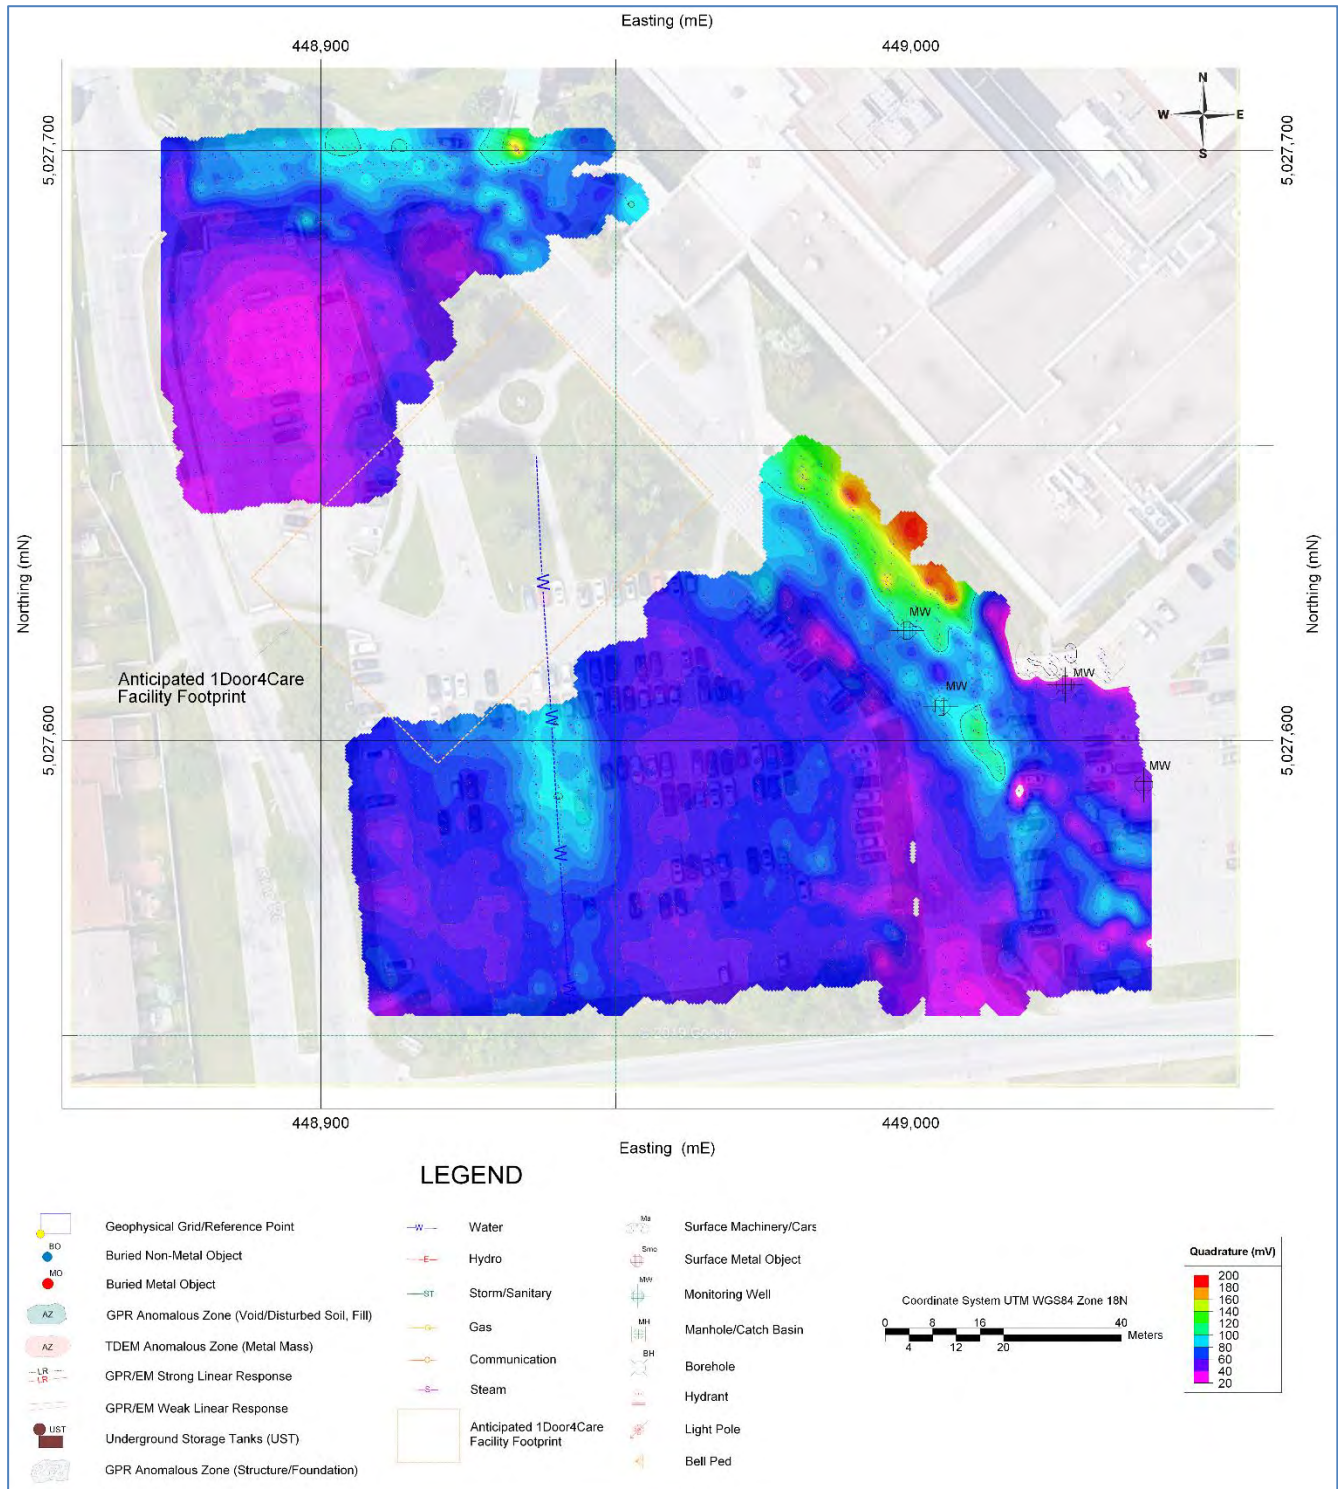
Figure 9: FDEM Quadrature Contour Grid Map

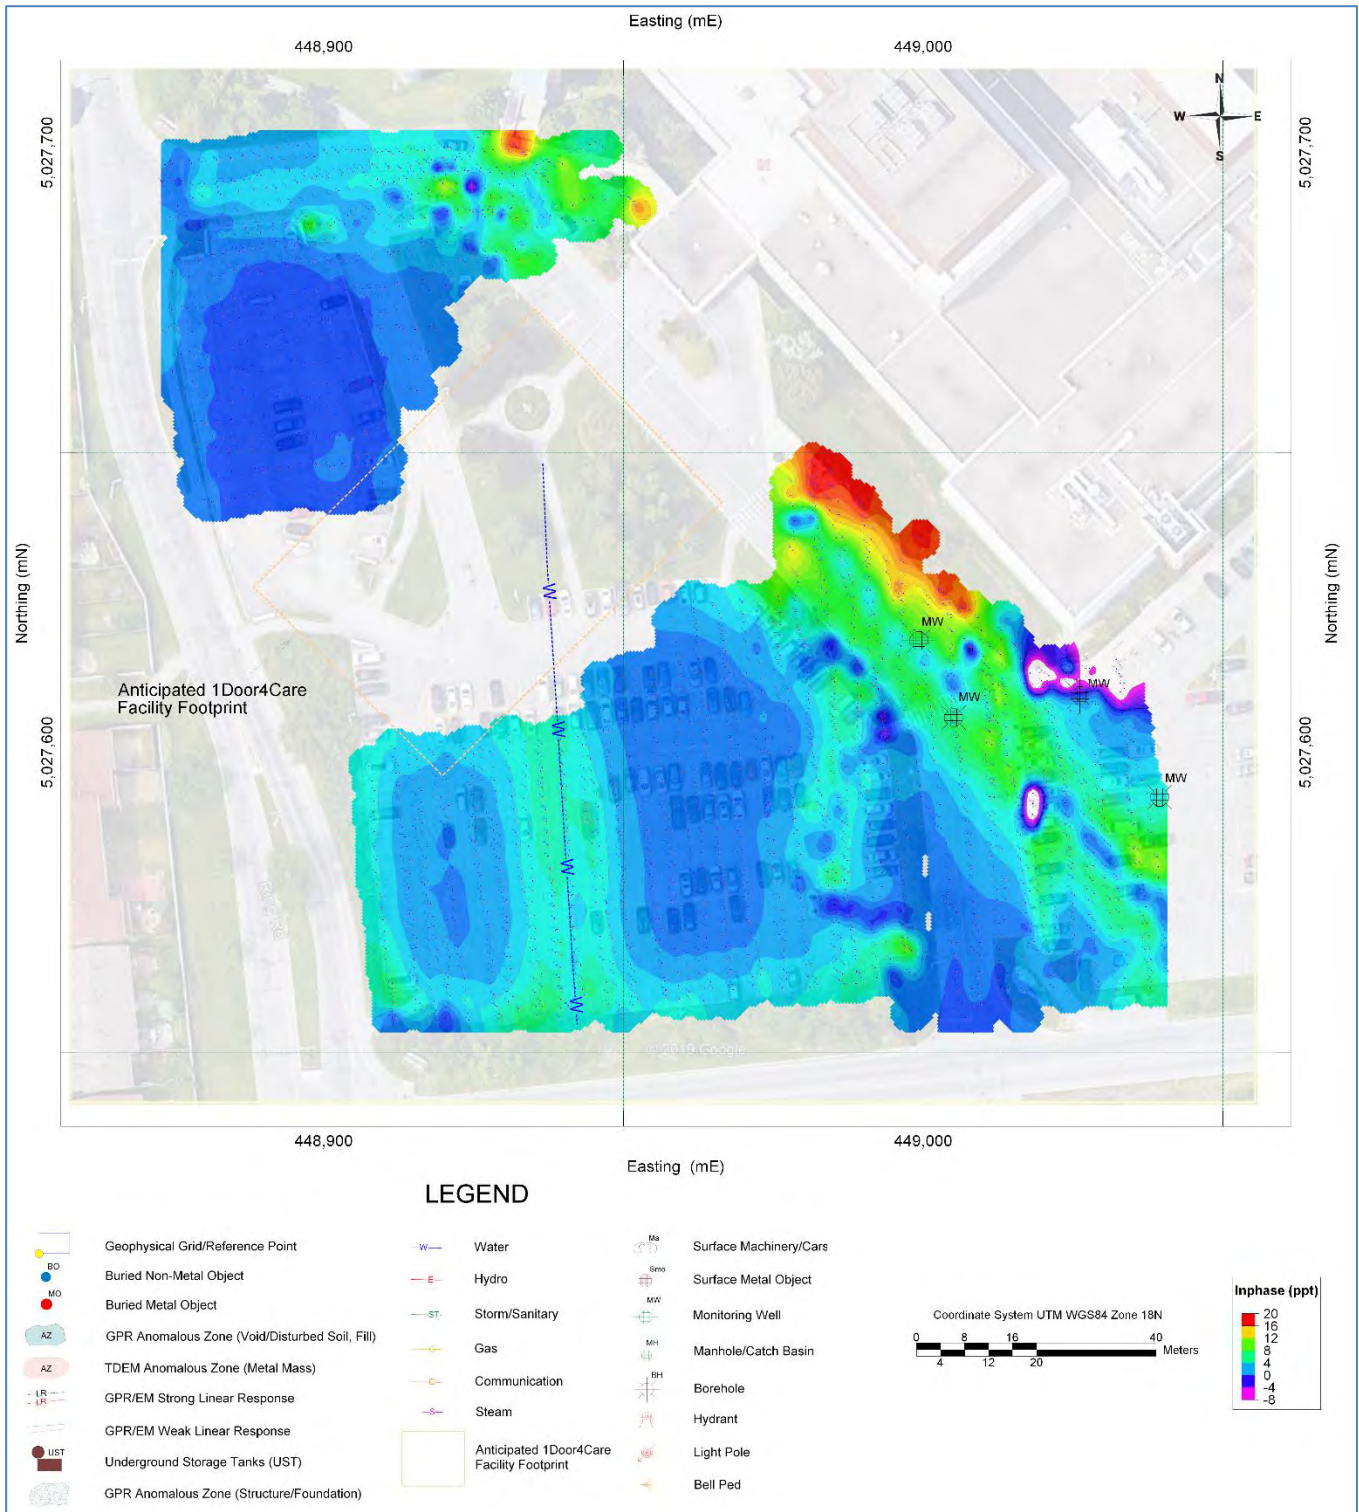
Figure 10: FDEM Inphase Contour Grid Map

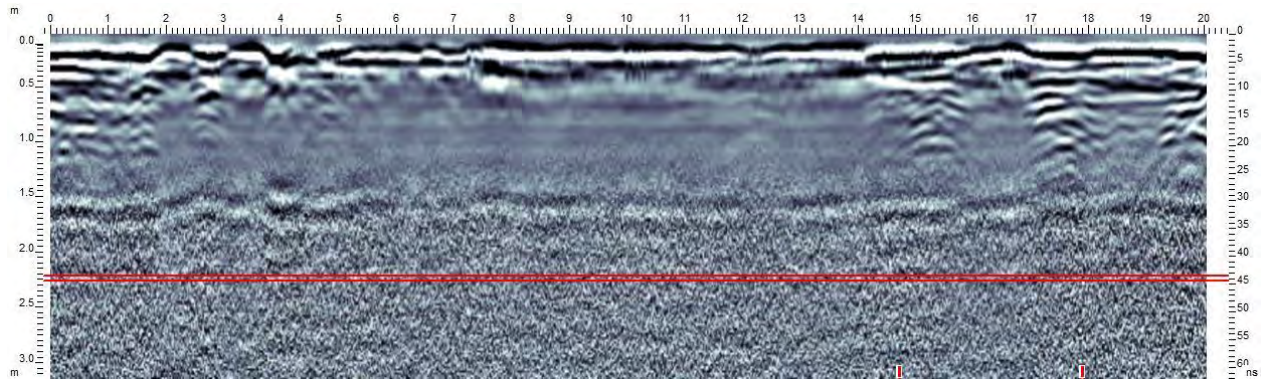
Figure 14: Example of GPR Profiles - Grid2 XLine34

GPR depth slice maps at 50cm, 100cm and 150cm depths are provided in Figure 6, Figure 7 and Figure 8 in order to illustrate the size and extent of the interpreted GPR features. Example of sections depicting the GPR responses along the survey profiles are provided in Figure 12 to Figure 23. FDEM Quadrature and Inphase amplitude contour grid maps are presented in Figure 9 and Figure 10.

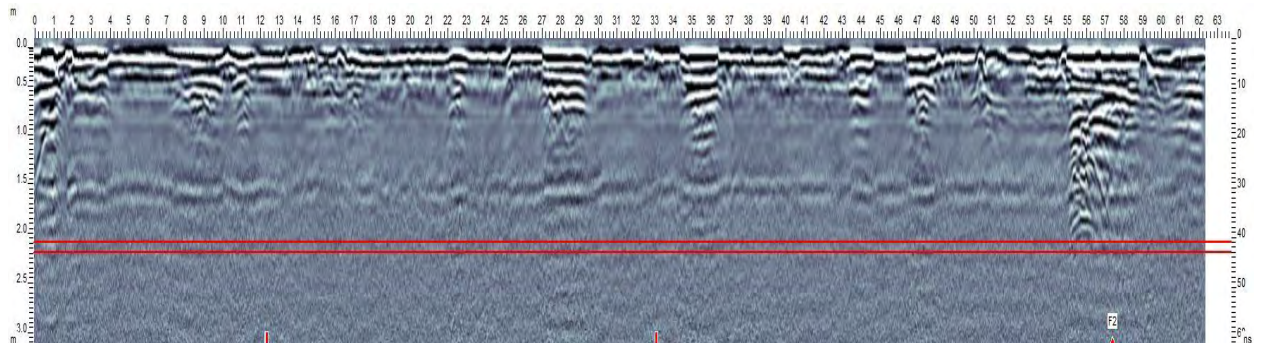
Figure 16: Example of GPR Profiles - Grid3 XLine2
