RE: 96 Bill Leathem Drive – Proposed Office / Warehouse Development Environmental Impact Study and Tree Conservation Report - Updated

96 BILL LEATHEM DRIVE – OFFICE / WAREHOUSE DEVELOPMENT ENVIRONMENTAL IMPACT STUDY and TREE CONSERVATION REPORT - UPDATE

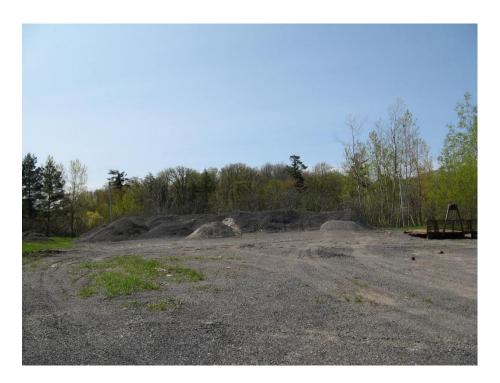
A hard packed gravel surface is on much of the site (Photo 1) and in other areas the topsoil appears to have been stripped. Gravel stockpiling is also present. This material is too coarse to be used by nesting swallows and other burrowing animals.

Cultural meadow habitat is present on former agricultural lands (Photo 1). Common ground flora includes orchard grass, June meadow grass, reed canary grass, awnless brome grass, wild carrot, common burdock, Canada thistle, common milkweed, wild parsnip, common dandelion, goldenrod, yellow rocket, white bedstraw, curled dock, white clover, red clover, and white-sweet clover. Red raspberry, staghorn sumac, and slender willows shrubs are scattered on the site. The only trees at least 10cm diameter at breast height (dbh) on the site are in the northeast corner. These planted street trees, a 20cm dbh hackberry (Tree 'A' on Map 1) and a 22cm dbh sugar maple (Tree 'B', Photo 2), to the south of Bill Leathem Drive appear to be on the site rather than the City owned road allowance and this is confirmed with the topographical survey. The hackberry appears to be in good condition, with extensive trunk damage on the south side of the base of the maple (Photo3). However, bud development and branching structure was good on the maple.

Photo 1 – Site looking south from just south of Bill Leathem Drive, with off-site trees north of the Clarke Bellinger Environmental Facility in the background

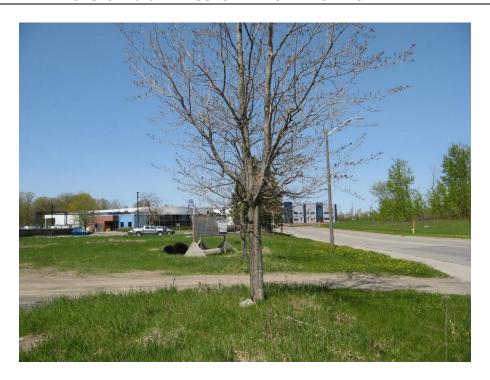
Photo 2 – Planted maple and hackberry (mostly hidden) trees along north edge of the site. View looking west from the northeast corner, with Bill Leathem Drive on the right

Due to the location and condition, it is not recommended that the planted sugar maple and hackberry (Trees 'A' and 'B') be retained. However, it is important that removal of these plantings be replaced with new plantings of native species. These plantings will provide a diversity of natural environment and aesthetic features and increase the extent of woody vegetation on the site. To provide a natural appearance, trees and shrubs should be planted in a random, cluster fashion rather than in a grid system. Potential native species to plant include nannyberry, elderberry and dogwood shrubs along with sugar maple, red maple, basswood, balsam fir, white cedar, red oak and white spruce trees. Sourcing native species from local seed sources is strongly recommended to ensure adaptability and longevity. Due to the clay soils, fast-growing trees located near buildings founded on cohesive soils that shrink on drying can result in long-term differential settlements of the structures. Tree varieties that may have the

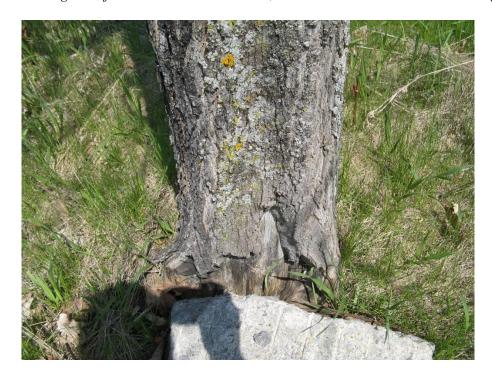
Photo 3 – Damage at base of maple in the above photo

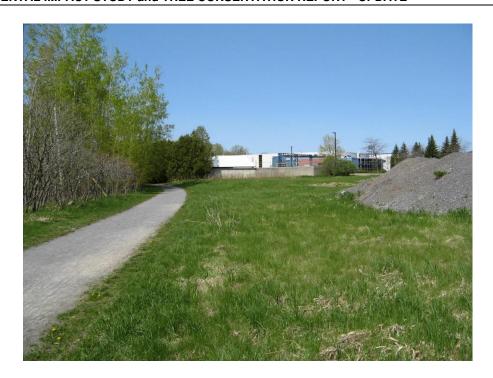
There are no other co-owned or adjacent trees with critical root zones extending onto the site. There are no critical root zones extending onto the south edge of the site as the stonedust three metre wide access road/pathway is immediately to the south of the site, to the north of the plantings on the north side of the Clarke Bellinger Environmental Facility (Photo 4). As a one-metre wide mowed area is to the south of the pathway and the maximum size of the outer trembling aspens are 18cm dbh, there is no potential for critical root zones to extend onto the site from south of the access road/pathway. Most of the outer plantings to the south of the site and pathway are staghorn sumac shrubs.

Photo 4 – South property line, with on-site gravel piles to the right and off-site stonedust access road/pathway and poplar and sumac plantings to the left. View looking west

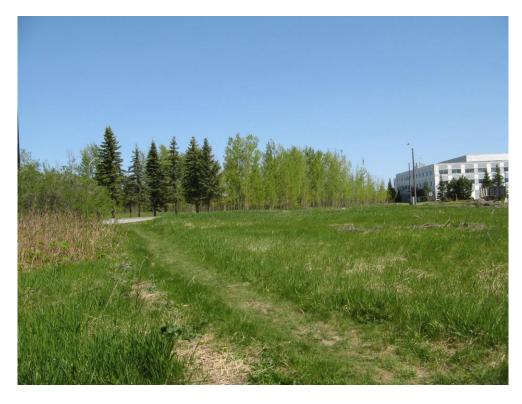
The centre line of a cedar hedge (Tree 'F') immediately to the west of the southwest corner of the site is one metre to the west of the site. Thus, the associated critical root zones of the larger 15cm dbh cedars would extend about 0.5 metres onto the site.

Photo 5 – The west property line and adjacent lands with view looking north from the southwest corner to the conifers to be retained

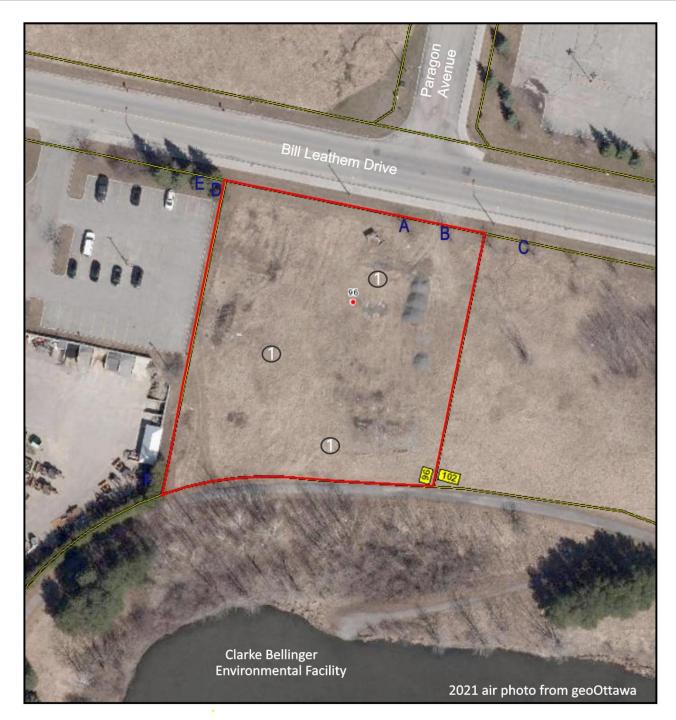
Map 1

As described above, the planted street trees along the south side of Bill Leathem Drive are on the site rather than the City owned road allowance. The next planted sugar maple (Tree 'C' on Map 1) in the row to the east is approximately 3.5 metres east of the east property line. As this tree is 18 cm dbh, its critical root zone does not extend onto the site. There are no trees in the City owned road allowance. A 26cm dbh white spruce (Tree 'D') is a co-owned tree in the northeast edge of the site (Photo 5). To the west, approximately two metres to the west of the northwest corner of the site is a 30cm dbh white spruce (Tree 'E'). The critical root zone of this conifer would extend approximately one metre onto the site.

EXISTING CONDITIONS

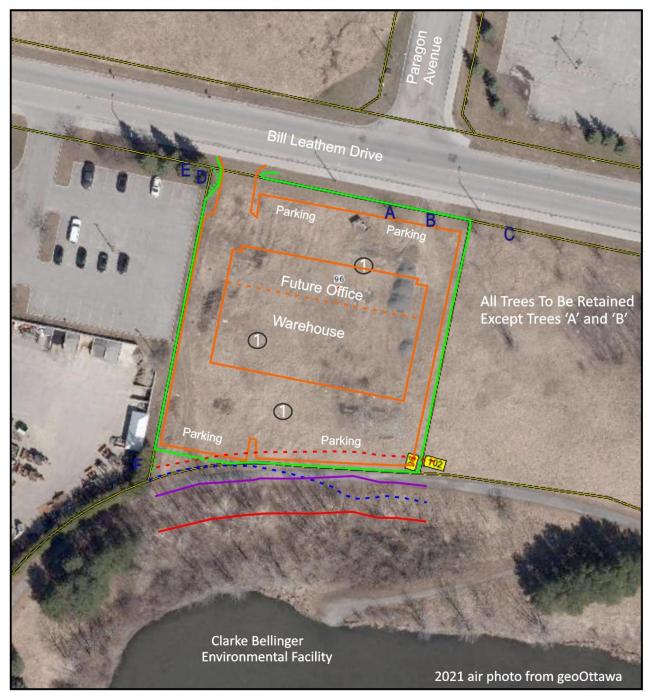
Map 2

The 30 metre setback from the top of bank also does not extend onto the site. As shown on Map 2, the 15 metre setback from the top of stable slope does extend slightly, between two and 4.5 metres onto the south edge of the site. The closest portion of the office/warehouse will be

There are no City-owned trees adjacent to the site. As shown on Map 2, in two locations the critical root zones of co-owned or adjacent trees extend onto the site (see dashed green lines on Map 2). These are Trees 'D' and 'E', the white spruce in the northwest corner and Tree 'F', the cedar hedge, adjacent to the southwest corner. The recommended location of the silt fencing to provide protection during construction has been modified, as shown with the solid green line on Map 2, to be outside of the critical root zones of these co-owned and adjacent trees. No impacts are anticipated on these trees provided the protective temporary fencing is properly installed and maintained.

FILE: 23 - 04 March 12, 2024 PROPOSED CONSERVED VEGETATION and SETBACKS

The silt fencing will assist in sediment and erosion control as well as protecting the adjacent trees to be retained and isolating the work area from wildlife. It is important that the fencing be properly installed and maintained. Signs, notices or posters are not to be attached to any tree. No grading, heavy machinery traffic, stockpiling of material, machinery maintenance and refueling or other activities that may cause soil compaction to occur within the critical root zones of the trees to be retained and protected. The root system, trunk or branches of the trees to be retained are to be protected and not damaged. If any roots of trees to be retained are exposed during site alterations, the roots shall be immediately reburied with soil or covered with filter cloth, burlap or woodchips and kept moist until the roots can be buried permanently. A covering of plastic should be used to retain moisture during an extended period when watering may not be possible. Any roots that must be cut are to be cut cleanly to facilitate healing and as far from the tree as possible. Exhaust fumes from all equipment during construction will not be directed towards the canopy of the retained trees.

All of the supports and bracing for the silt fencing should be placed outside of the protected area and should be installed in such a way as to minimize root damage. Also, since a desired effect of the temporary fencing is to prevent construction traffic from entering the trees' critical root zones, the silt fencing should be kept in place until all site servicing and construction has been completed.
