Subject: Review of the EIS for commercial development at 6165 Thunder

Road considering an updated site plan

Final Report

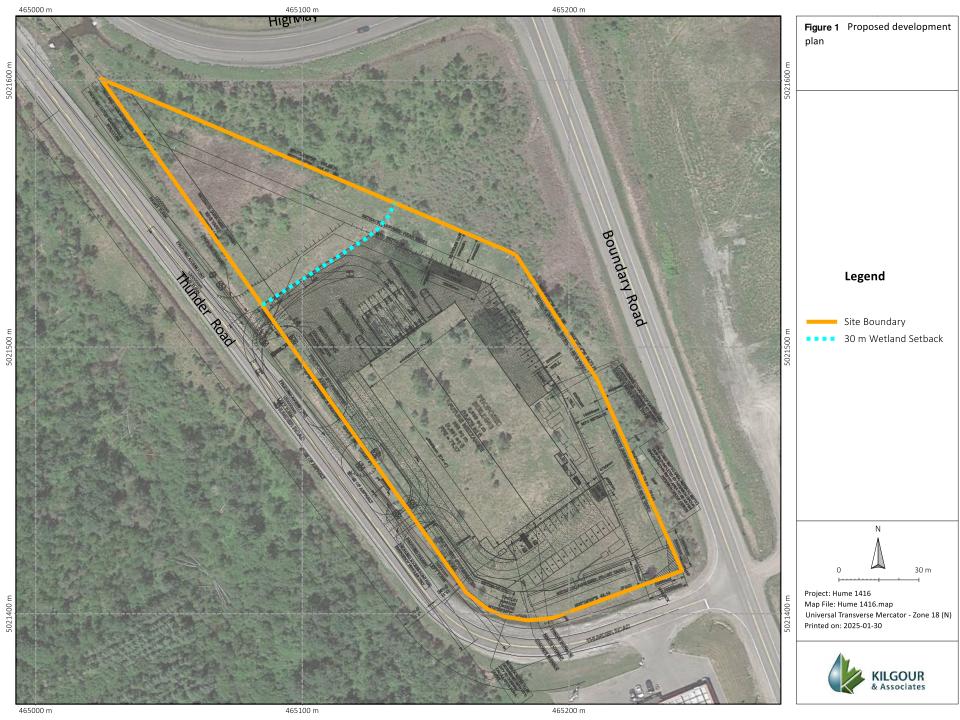
The updated site plan includes an increase to the proposed commercial building (3,686m²), with associated infrastructure (Figure 1). Proposed parking areas have been relocated to the east and south sides of the building, while the north portion of the development area comprises a truck loading area and an additional access point to Thunder Road. The loading area, which in the updated site plan is the closest point of development to the wetland areas, adheres to the agreed-upon 30 m setback from the wetlands (Figure 1). As such, there will still be no encroachment into wetland areas as a result of the revised development plan and no additional wetland permits or approvals are required as a result of the revisions to the site plan. Surface water mitigation measures provided in the EIS will be followed, thereby avoiding impacts to the wetlands as a result of the proposed development.

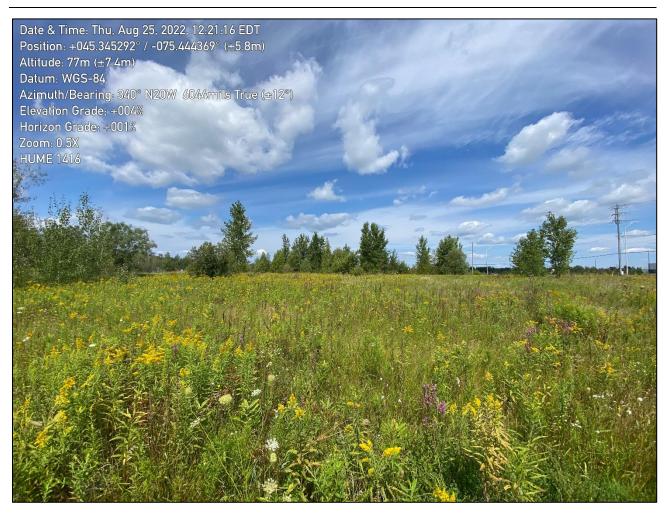
Figure 3 Goldenrod Forb Meadow (MEFM1-1) (Photo taken August 25, 2022)

A Goldenrod Forb Meadow type (MEFM1-1; Figure 3) comprises the majority of the Site. The meadow was forb and grass dominated with scattered trees and shrubs. The dominant trees and shrubs scattered within the meadow were Eastern Cottonwood (*Populus deltoides*), White Willow (*Salix alba*), and Sandbar Willow (*Salix exigua*), with White Birch (*Betula papyrifera*) and Alder Buckthorn (*Rhamnus frangula*). There was a cluster of trees in the centre of the meadow consisting of Trembling Aspen (*Populus tremuloides*), White Poplar (*Populus alba*), and Manitoba Maple (*Acer negundo*), with Staghorn Sumac (*Rhus typhina*) along the edge. The dominant forbs were Canada Goldenrod (*Solidago canadensis*) closely followed by Common Milkweed, with Purple Loosestrife (*Lythrum salicaria*; invasive species), Queen Anne's Lace (*Daucus carota*), Cow Vetch (*Vicia cracca*), and Bull Thistle (*Cirsium vulgare*; invasive species). The dominant grasses were Kentucky Bluegrass (*Poa pratensis*) and Perennial Ryegrass (*Lolium perenne*) with Reed Canary Grass (*Phalaris arundinacea*). There was Common Cattail in the roadside ditch along Thunder Road and scattered within the centre of the meadow were rock piles.

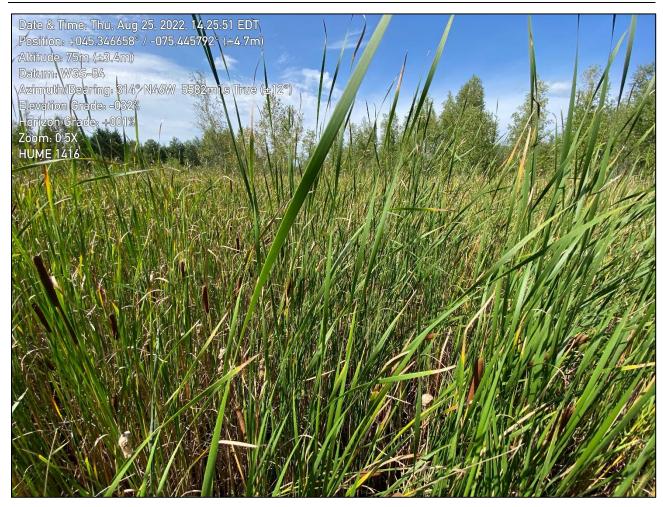
Figure 4 Cattail Mineral Shallow Marsh (MASM1-1) (Photo taken August 25, 2022)

A Cattail Mineral Shallow Marsh (MASM1-1; Figure 4) was located near the northwest end of the Site. It was dominated by Common Cattail and was relatively small (0.13 ha). The marsh had approximately 10-15 cm of standing water at the time of the site visit.

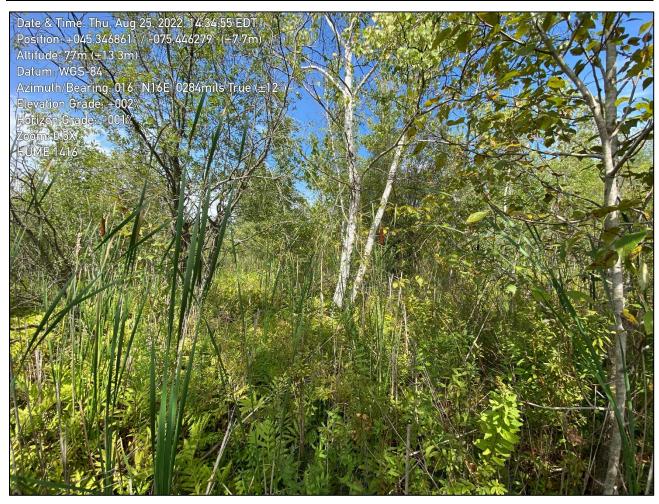
Figure 5 White Birch - Poplar Organic Deciduous Swamp (SWD03-1) (Photo taken August 25, 2022)

The deciduous swamp in the northwest corner of the Site was characterized as a White Birch – Poplar Organic Deciduous Swamp type (SWDO3-1; Figure 5). Only 0.05 ha of the swamp occurs on the Site, but it extends east off the Site. The canopy was relatively open and dominated by young White Birch, White Willow, and Balsam Poplar (*Populus balsamifera*), while the subcanopy had Sandbar Willow. Groundcover was characterized by Sensitive Fern (*Onoclea sensibilis*) and Common Cattail with Purple Loosestrife, Horsetail (*Equisetum spp.*), and stained leaf litter.

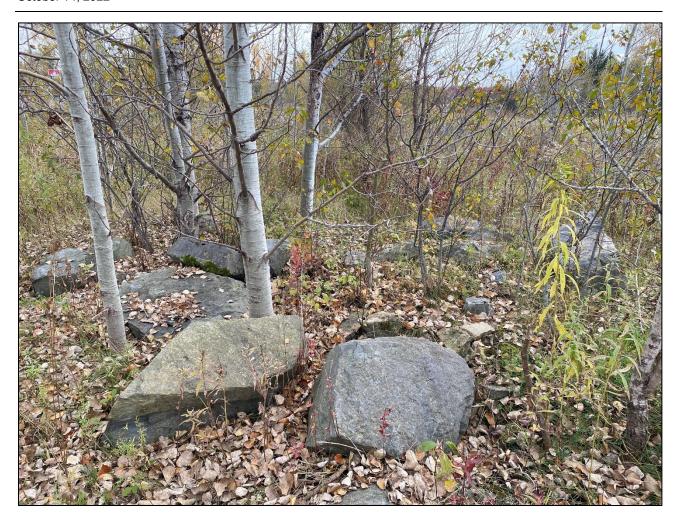
Scattered within the centre of the meadow (MEFM1-1) are rock piles and two mammal burrows that may meet the SWH criteria for reptile (snake) hibernacula (MNRF, 2015a). Confirmation of this potential SWH would require field studies confirming the presence of five or more individuals or individuals of two or more snake species within the rock feature(s) during the pre-hibernation and spring emergence periods (MNRF, 2015a).

Figure 6 Potential suitable snake hibernacula located within the development footprint.

Type of Significant Wildlife Habitat	Rationale and Mitigation
	case the rocks may not be deep enough in the ground to allow snakes access below the frost line (3.5 feet deep).
	Based on the client's current development plan many of the rock piles and mammal burrows on the Site will be removed as they fall within the project footprint. To limit potential impacts to snakes, it is recommended that initial earthworks be done between early May and/or early September when snakes are out of hibernation (MNRF, 2016; MNRF, 2018).
Turtle Nesting Areas (candidate)	Although there is no turtle overwintering habitat on the Site (as the cattail marsh is likely too shallow to support successful overwintering) there is suitable turtle nesting habitat. The meadow (MEFM1-1) adjacent to the marsh (MASM1-1) may provide suitable nesting habitat. However, it is unknown if turtles are using the feature in this way. It is recommended that initial site clearing take place between October and May to limit the potential for interactions with turtle nests.

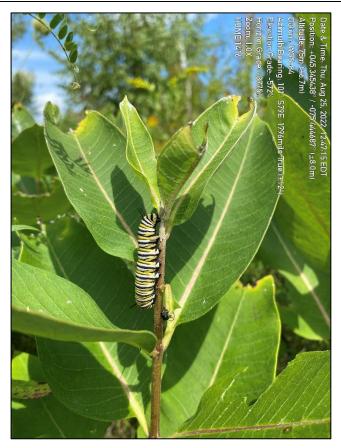
Incidental wildlife observations made during the site visits included Monarch (species of Special Concern). Adult Monarch butterflies were observed in the meadow (MEFM1-1) during three site visits (June 28, July 8, and August 25, 2022). A Monarch caterpillar (Figure 7) was observed in the meadow on Common Milkweed on August 25, 2022, indicating that they are breeding on the Site. Incidental bird observations are recorded in Table 2 above.

Figure 7 Monarch caterpillar on Common Milkweed in meadow (MEFM1-1).

Monarch was the only Species of Special Concern detected on the Site. A KAL biologist detected Monarch (adults and a caterpillar) in the meadow (MEFM1-1) during three site visits. The Site provides confirmed breeding habitat for Monarch. Although the following species were not observed during site visits, the meadow may also provide suitable breeding habitat for Grasshopper Sparrow and Common Nighthawk, while the swamp (SWDO3-1) may provide marginally suitable migratory stopover habitat for Rusty Blackbird.

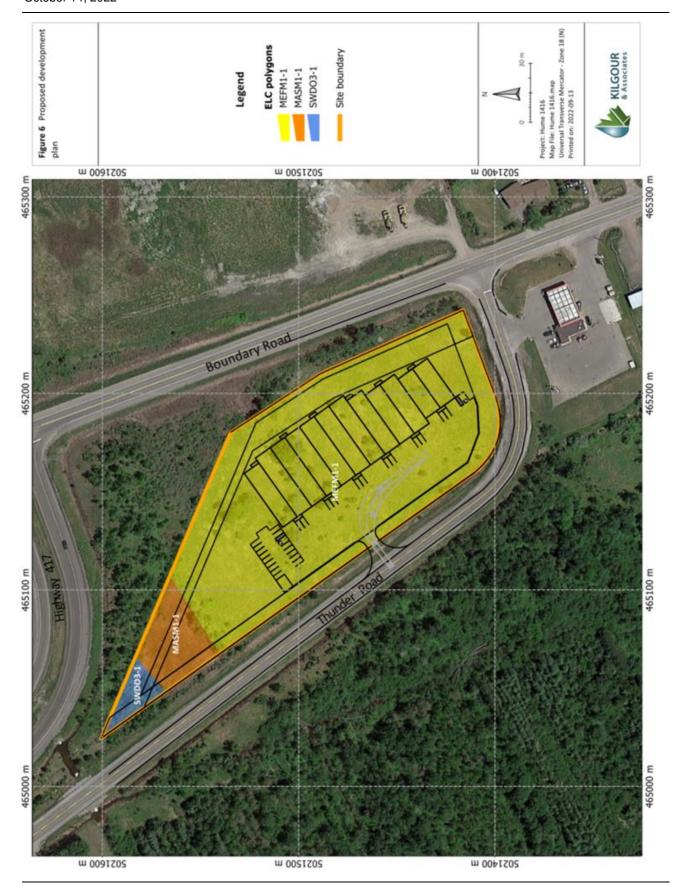
The proposed development would comprise an 11 m tall, 3,623 m² commercial building and associated infrastructure (e.g., parking area and landscaping) (Figure 8). The client's preliminary site plan depicts 6 m of landscaping along Thunder Road. This landscaping would intersect the wetlands in the northwestern portion of the Site. However, KAL recommends that landscaping end a minimum of 5 m before the wetland boundary begins to minimize impact to the Cattail Mineral Shallow Marsh (MASM1-1) and the Poplar Organic Deciduous Swamp (SWDO3-1) in the northwestern portion of the Site. Encroaching on the wetlands should be avoided. The parking area, which is the closest point of development to the wetlands, will be situated 43 m southeast of the marsh. Since the watercourse is approximately 20 m northwest of the Site it will be approximately 63 m from of the proposed development.

The proposed development is 14.6 m from the northeast property boundary, which coincides with an unevaluated wetland (ELC unit SWTM3-6). The unevaluated wetland northeast of the Site should not be impacted by development actives. The preliminary site plan depicts a 10 m setback from the northeastern property boundary.

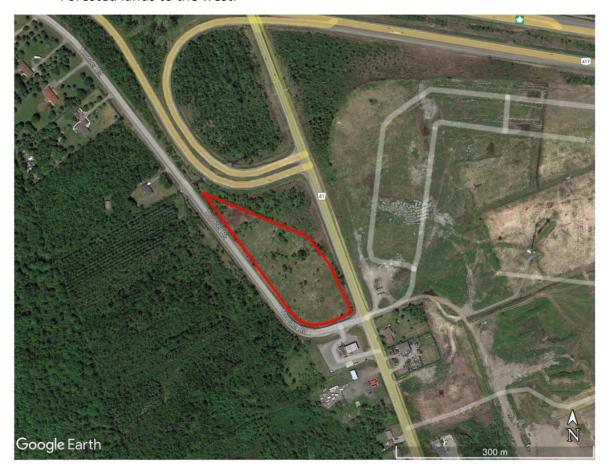
- Wetlands to the north;
- Commercial areas to the east;
- Commercial and forested lands to the south; and
- Forested lands to the west.

Figure 1 Location and existing conditions of the site

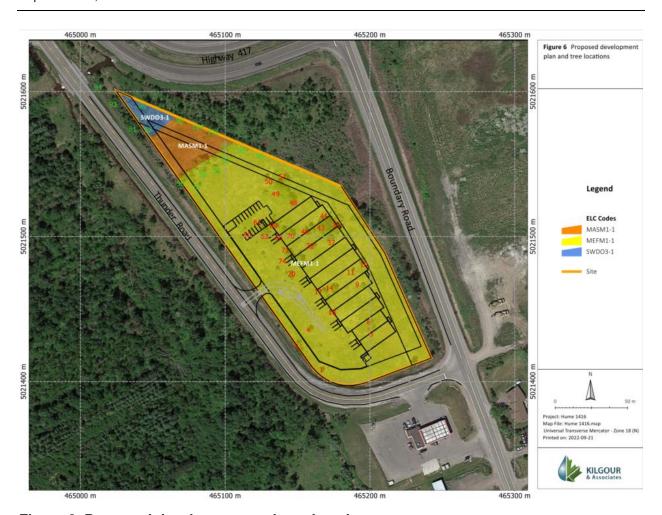
The proposed development would comprise an 11 m tall, 3,623 m² commercial building and associated infrastructure (e.g., parking area and landscaping) (Figure 6). Construction of this building will entail alterations to the southeast portion of the Site, which will necessitate the removal of 69 trees in this area (Appendix A). All other trees on the Site will be retained.

Figure 2 Proposed development and tree locations
