Phase I - Environmental Site Assessment

2475 Regina Street
Ottawa, Ontario

Windmill Development Group Ltd.

Report: PE5366-1

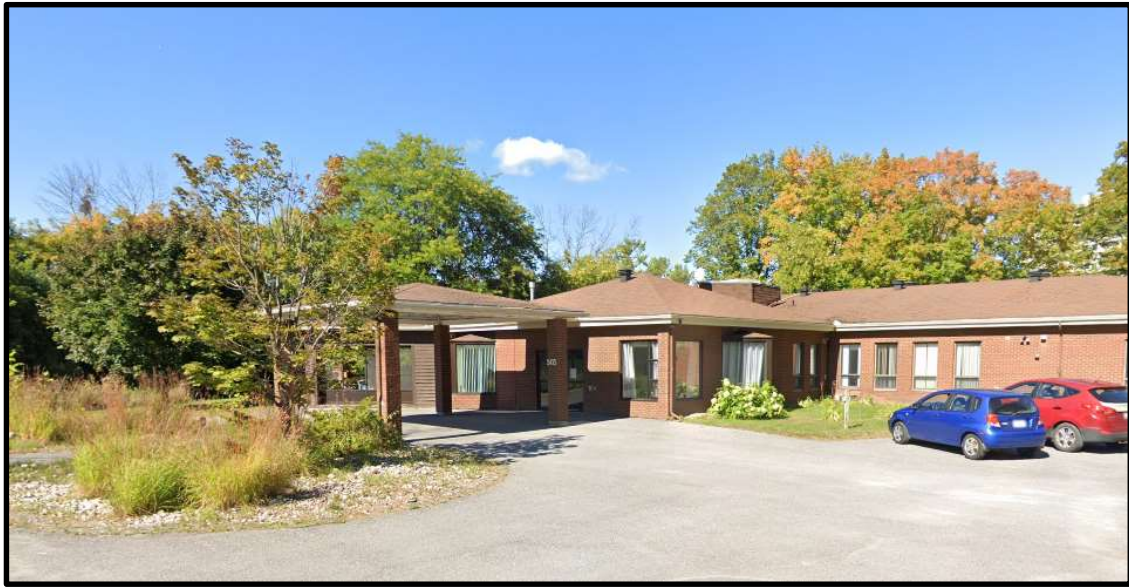
Photograph 1: View of long-term care home looking northeast.

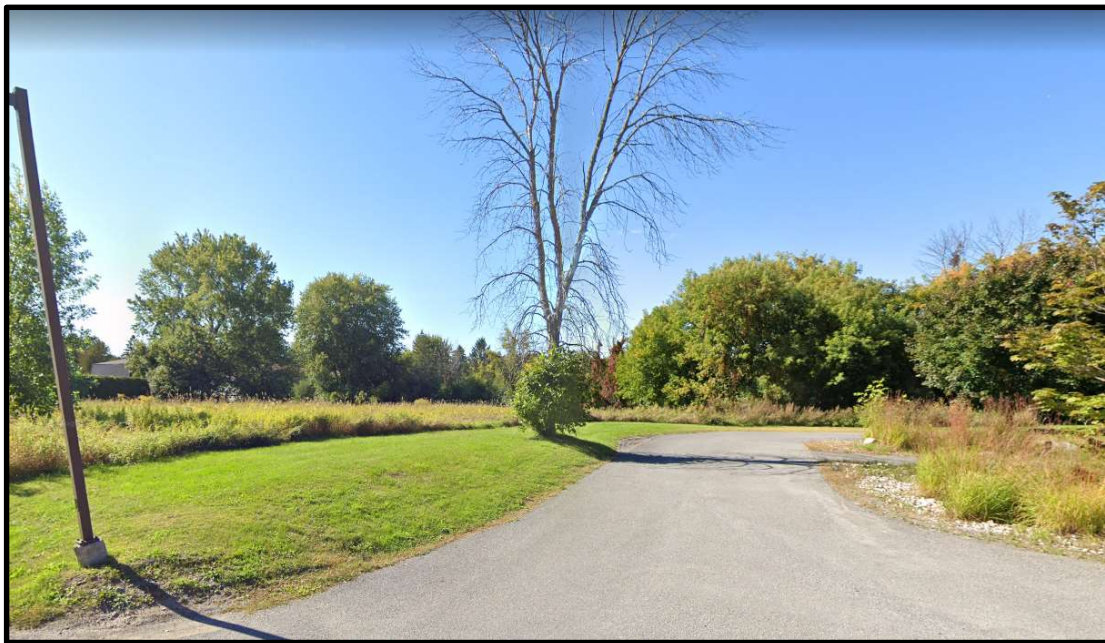
Photograph 2: View of Phase I – Property looking northwest.
