# 1412 Stittsville Main Street

## PHASE TWO ENVIRONMENTAL SITE ASSESSMENT

Elite Living Properties

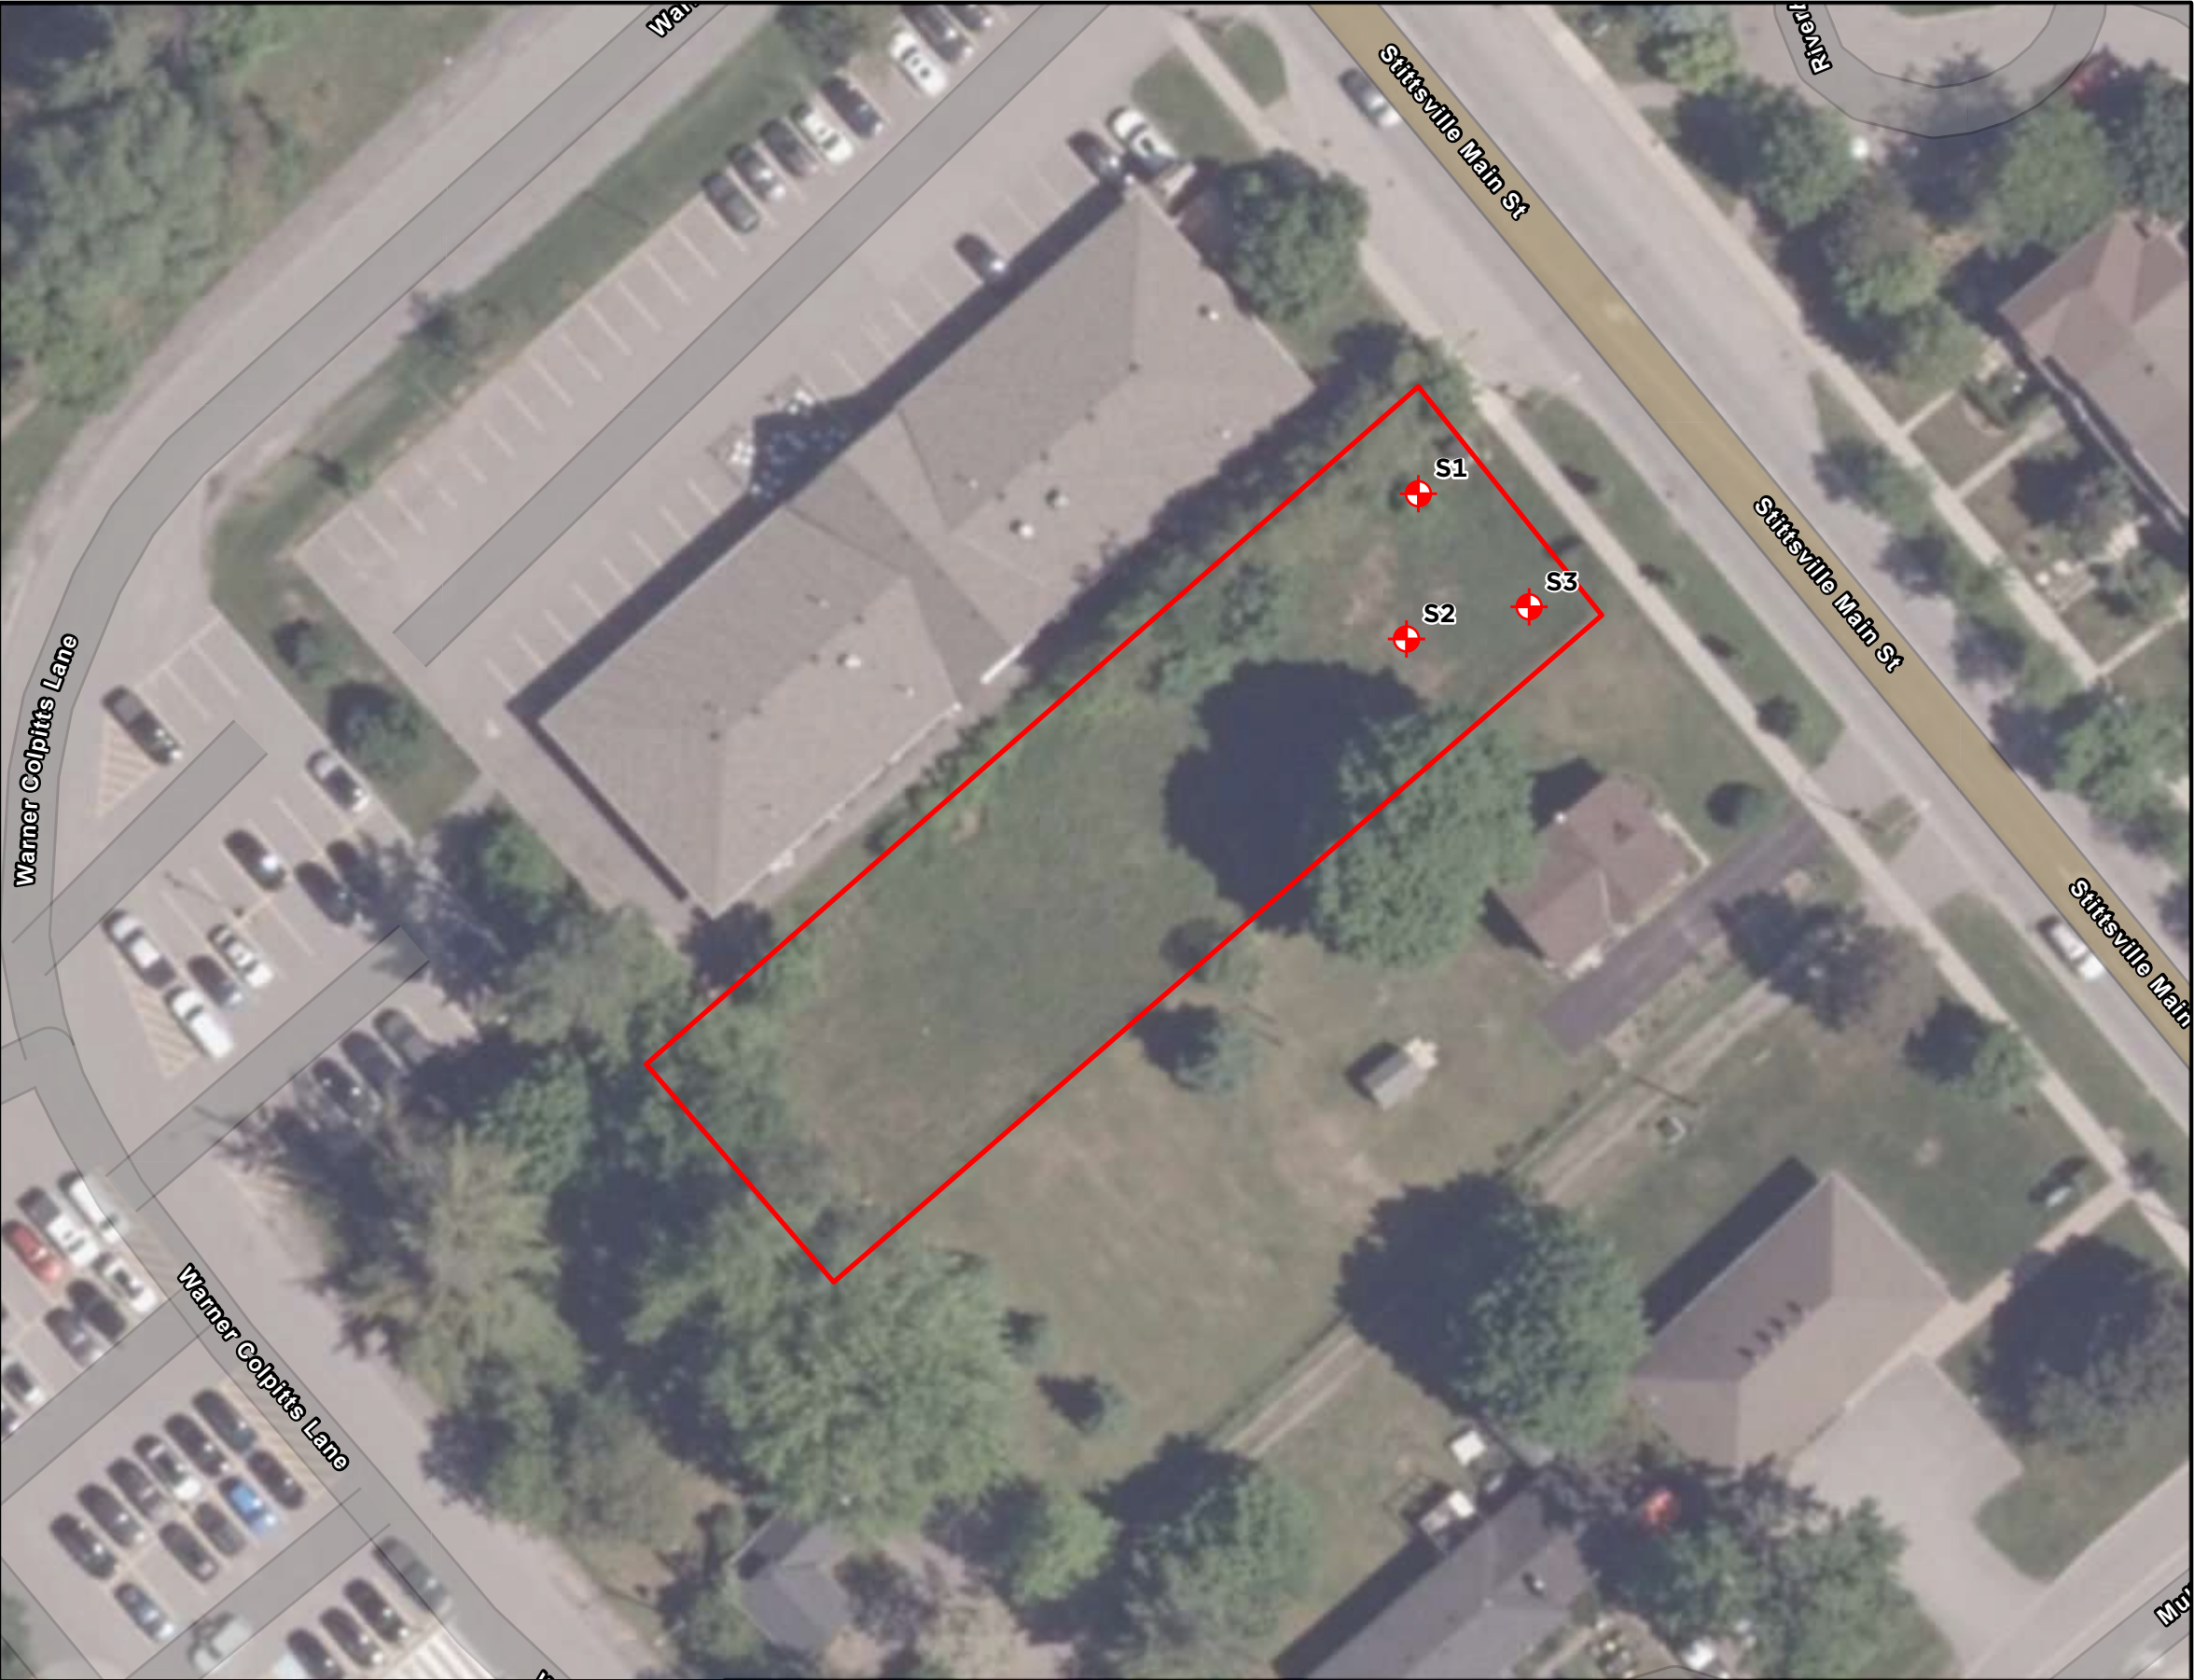
| | | 1412 STITTSVILLE MAIN STREET, OTTAWA<br>PHASE TWO ENVIRONMENTAL ASSESSMENT<br>TEST PIT LOCATION PLAN | | | DWG. No.<br><b>FIG-4</b> |

TEST PITS

- Three (3) hand dug test pits were advanced by Tatham on February 26, 2025. Soils samples were collected below the topsoil within the identified fill material. The soil samples were obtained at a depth of 0.3 – 0.6 m bgs.
