Phase One Environmental Site Assessment

1412 Stittsville Main Street Ottawa, Ontario

LRL File No.: 240811 February 5, 2025

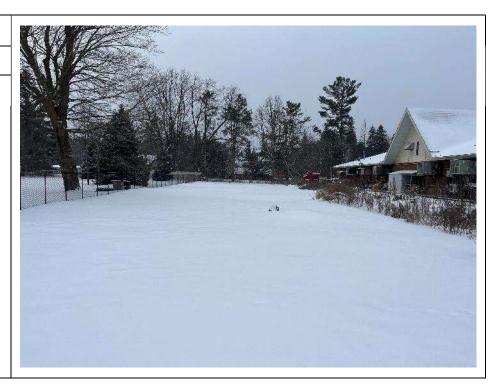
From east facing west across entirety of the Site.

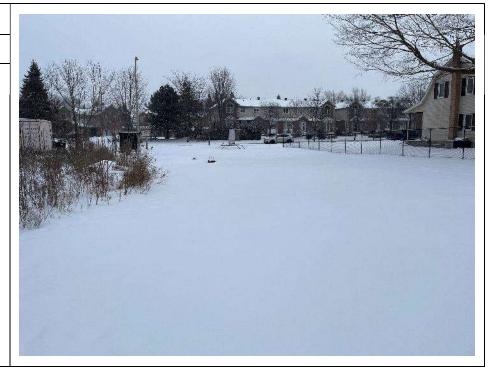
Photograph No. 2

From west facing east across entirety of the Site.

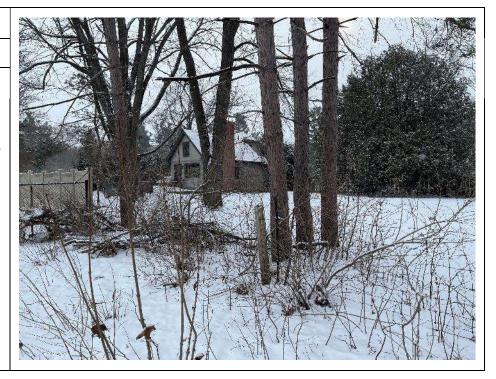
Western extent of the Site facing west towards Commercial – personal care facility. Overgrown vegetation present along western extent of the Site.

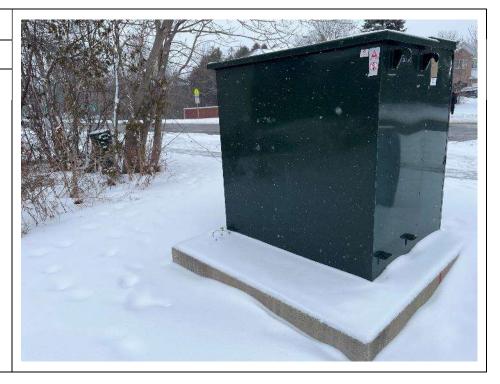
Photograph No. 4

Two (2) dumpsters were observed in the property to the north, which are assumed to collect wastes for the commercial operations. Two (2) smaller containers, and one (1) drum were also observed along the rear of the adjacent property used to store spent cooking oils. They were in good condition with no evidence of spills, leaks or overfilling.
	South of the Site is a single-family residence. The property to the east of the Site, following Stittsville Main Street is also developed with residential structures, although they are mush denser and more comparable to an urban setting.
	No evidence of potential contaminating activities was observed in the vicinity of the Site.
	Exhaust stacks, likely from the kitchen operations, were observed on the roof of the adjacent property to the north.
Utilities	A pad mounted transformer was observed along northeastern extent of the Site. The manufacturing date of the transformer, based on the corresponding manufacturer plate, is found to be June 2015.

Pad mounted generator – dated 2015.

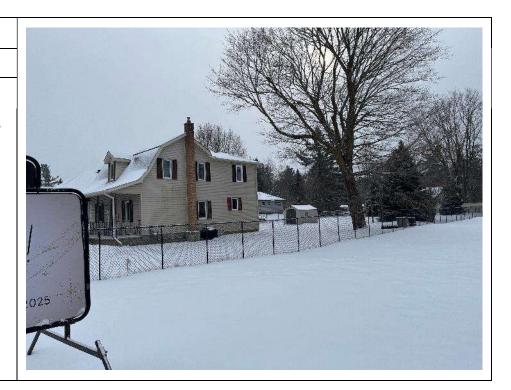
Photograph No. 6

From west facing east along the northern extent of the Site.
Adjacent property
Commercial development visible in photograph.

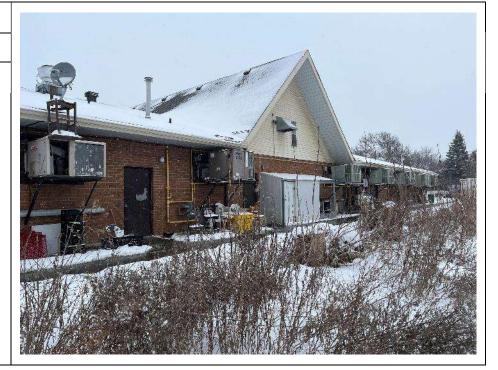
Facing east of the Site. Stittsville Main Street followed by Residential development.

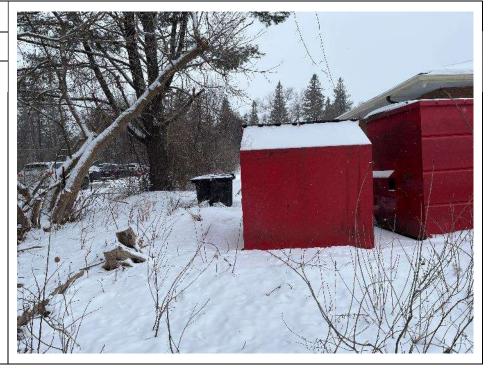
Photograph No. 10

Waste collection dumpsters and used cooking oil collection container observed on the adjacent property to the north.

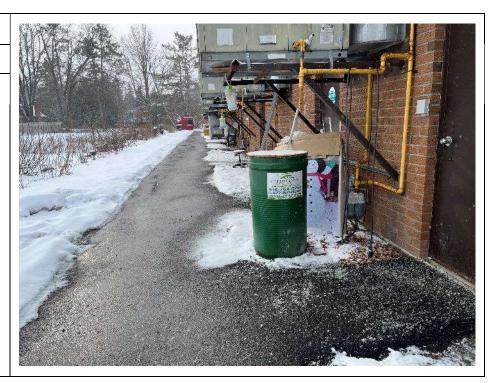
From east facing west along the southern extent of the adjacent property to the north. Food cooking oil drum present in the photograph.
