## **Phase II – Environmental Site Assessment**

Part of 155 Dun Skipper Drive  
Ottawa, Ontario

**Report: PE6616-2**  
**October 25, 2024**

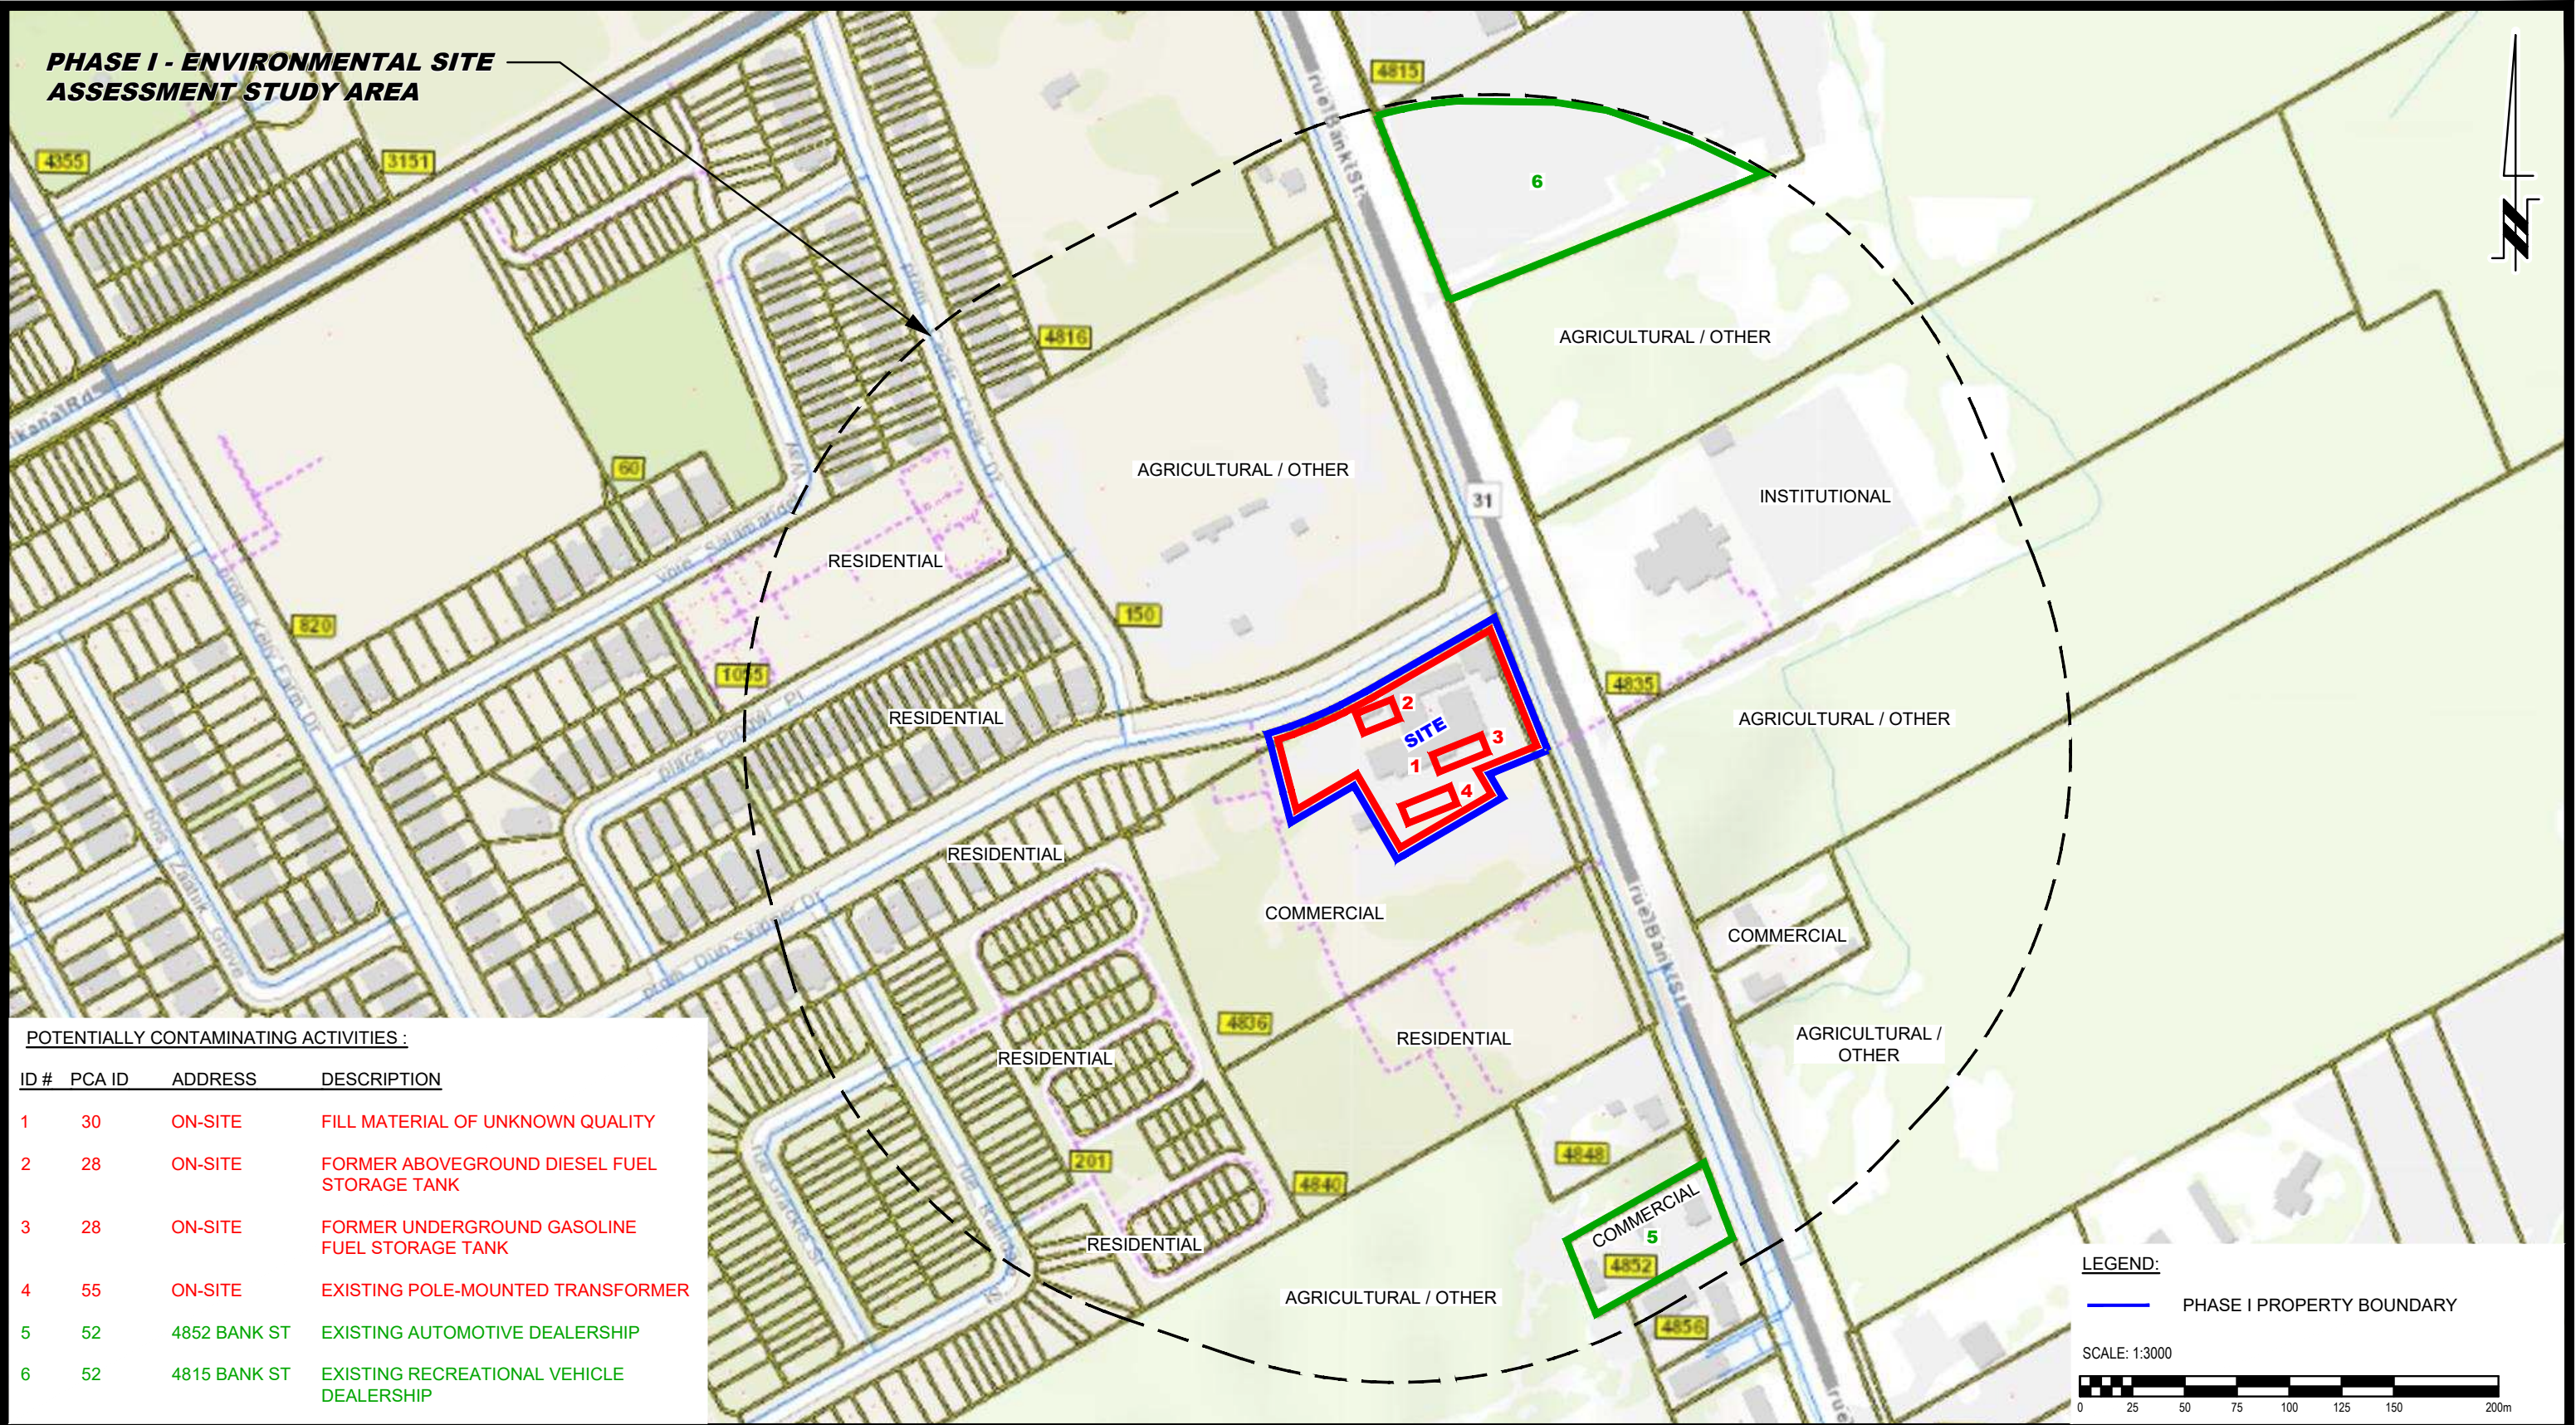
Title: **SURROUNDING LAND USE PLAN**

POTENTIALLY CONTAMINATING ACTIVITIES :

ID #	PCA ID	ADDRESS	DESCRIPTION
1	30	ON-SITE	FILL MATERIAL OF UNKNOWN QUALITY
2	28	ON-SITE	FORMER ABOVEGROUND DIESEL FUEL STORAGE TANK
3	28	ON-SITE	FORMER UNDERGROUND GASOLINE FUEL STORAGE TANK
4	55	ON-SITE	EXISTING POLE-MOUNTED TRANSFORMER
5	52	4852 BANK ST	EXISTING AUTOMOTIVE DEALERSHIP
6	52	4815 BANK ST	EXISTING RECREATIONAL VEHICLE DEALERSHIP

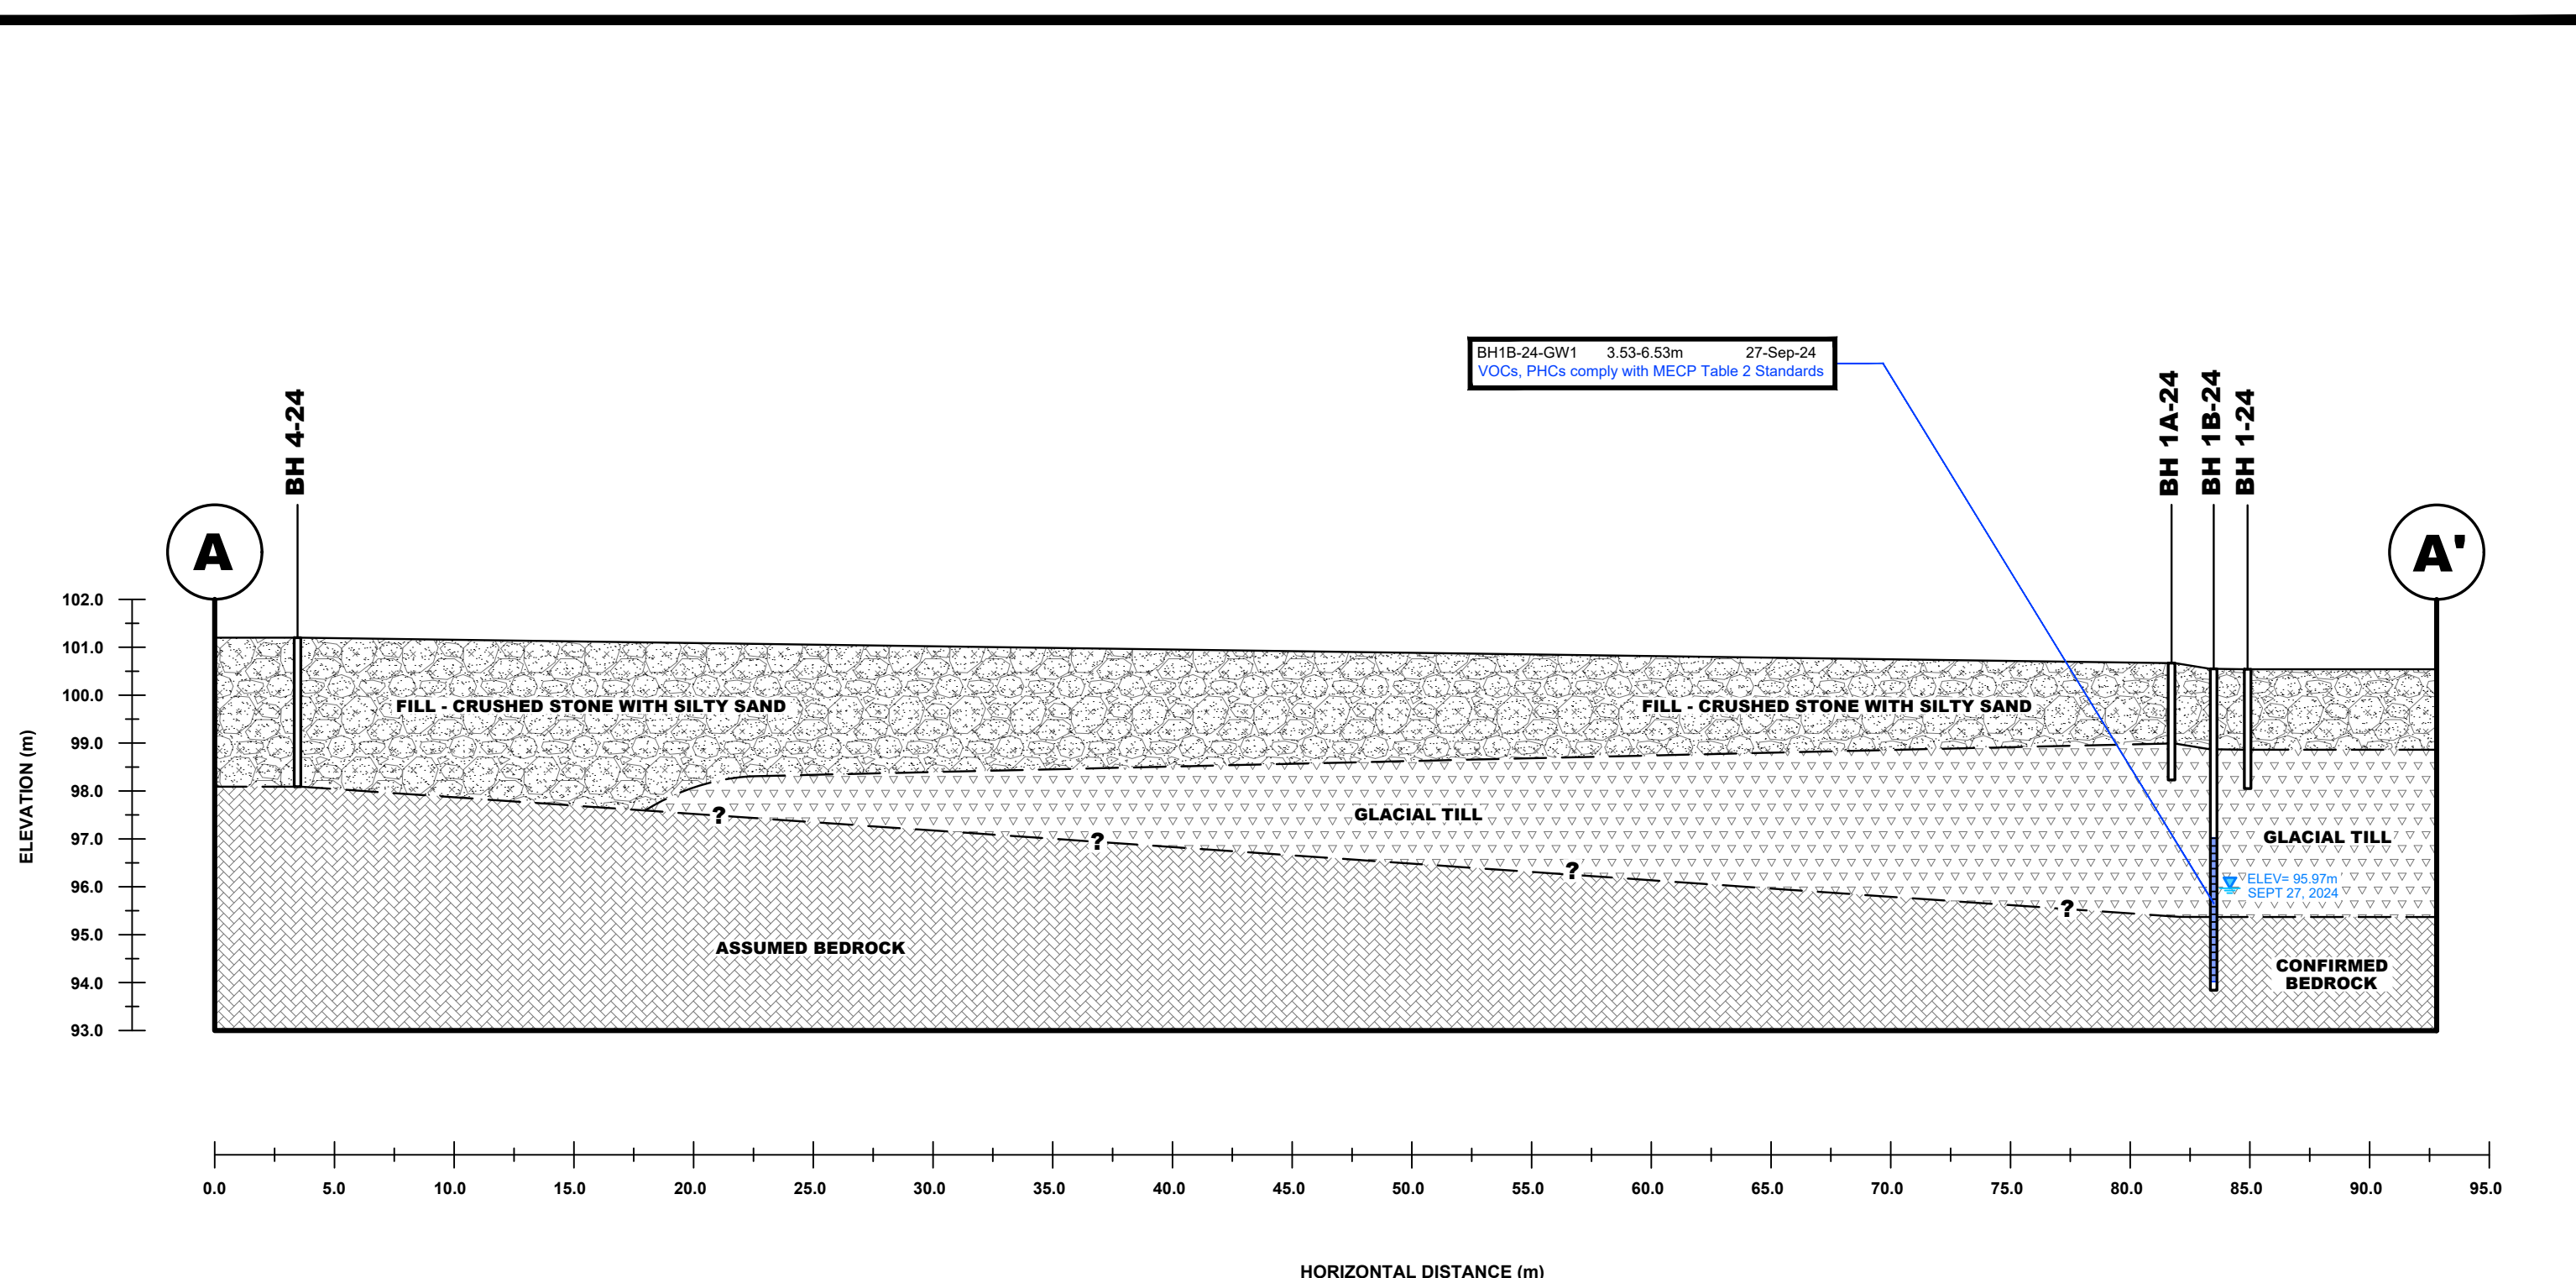
**DRAWING PE6616-6A – CROSS SECTION A-A' – GROUNDWATER**

GROUNDWATER RESULT COMPLIES WITH THE MECP TABLE 2 STANDARDS

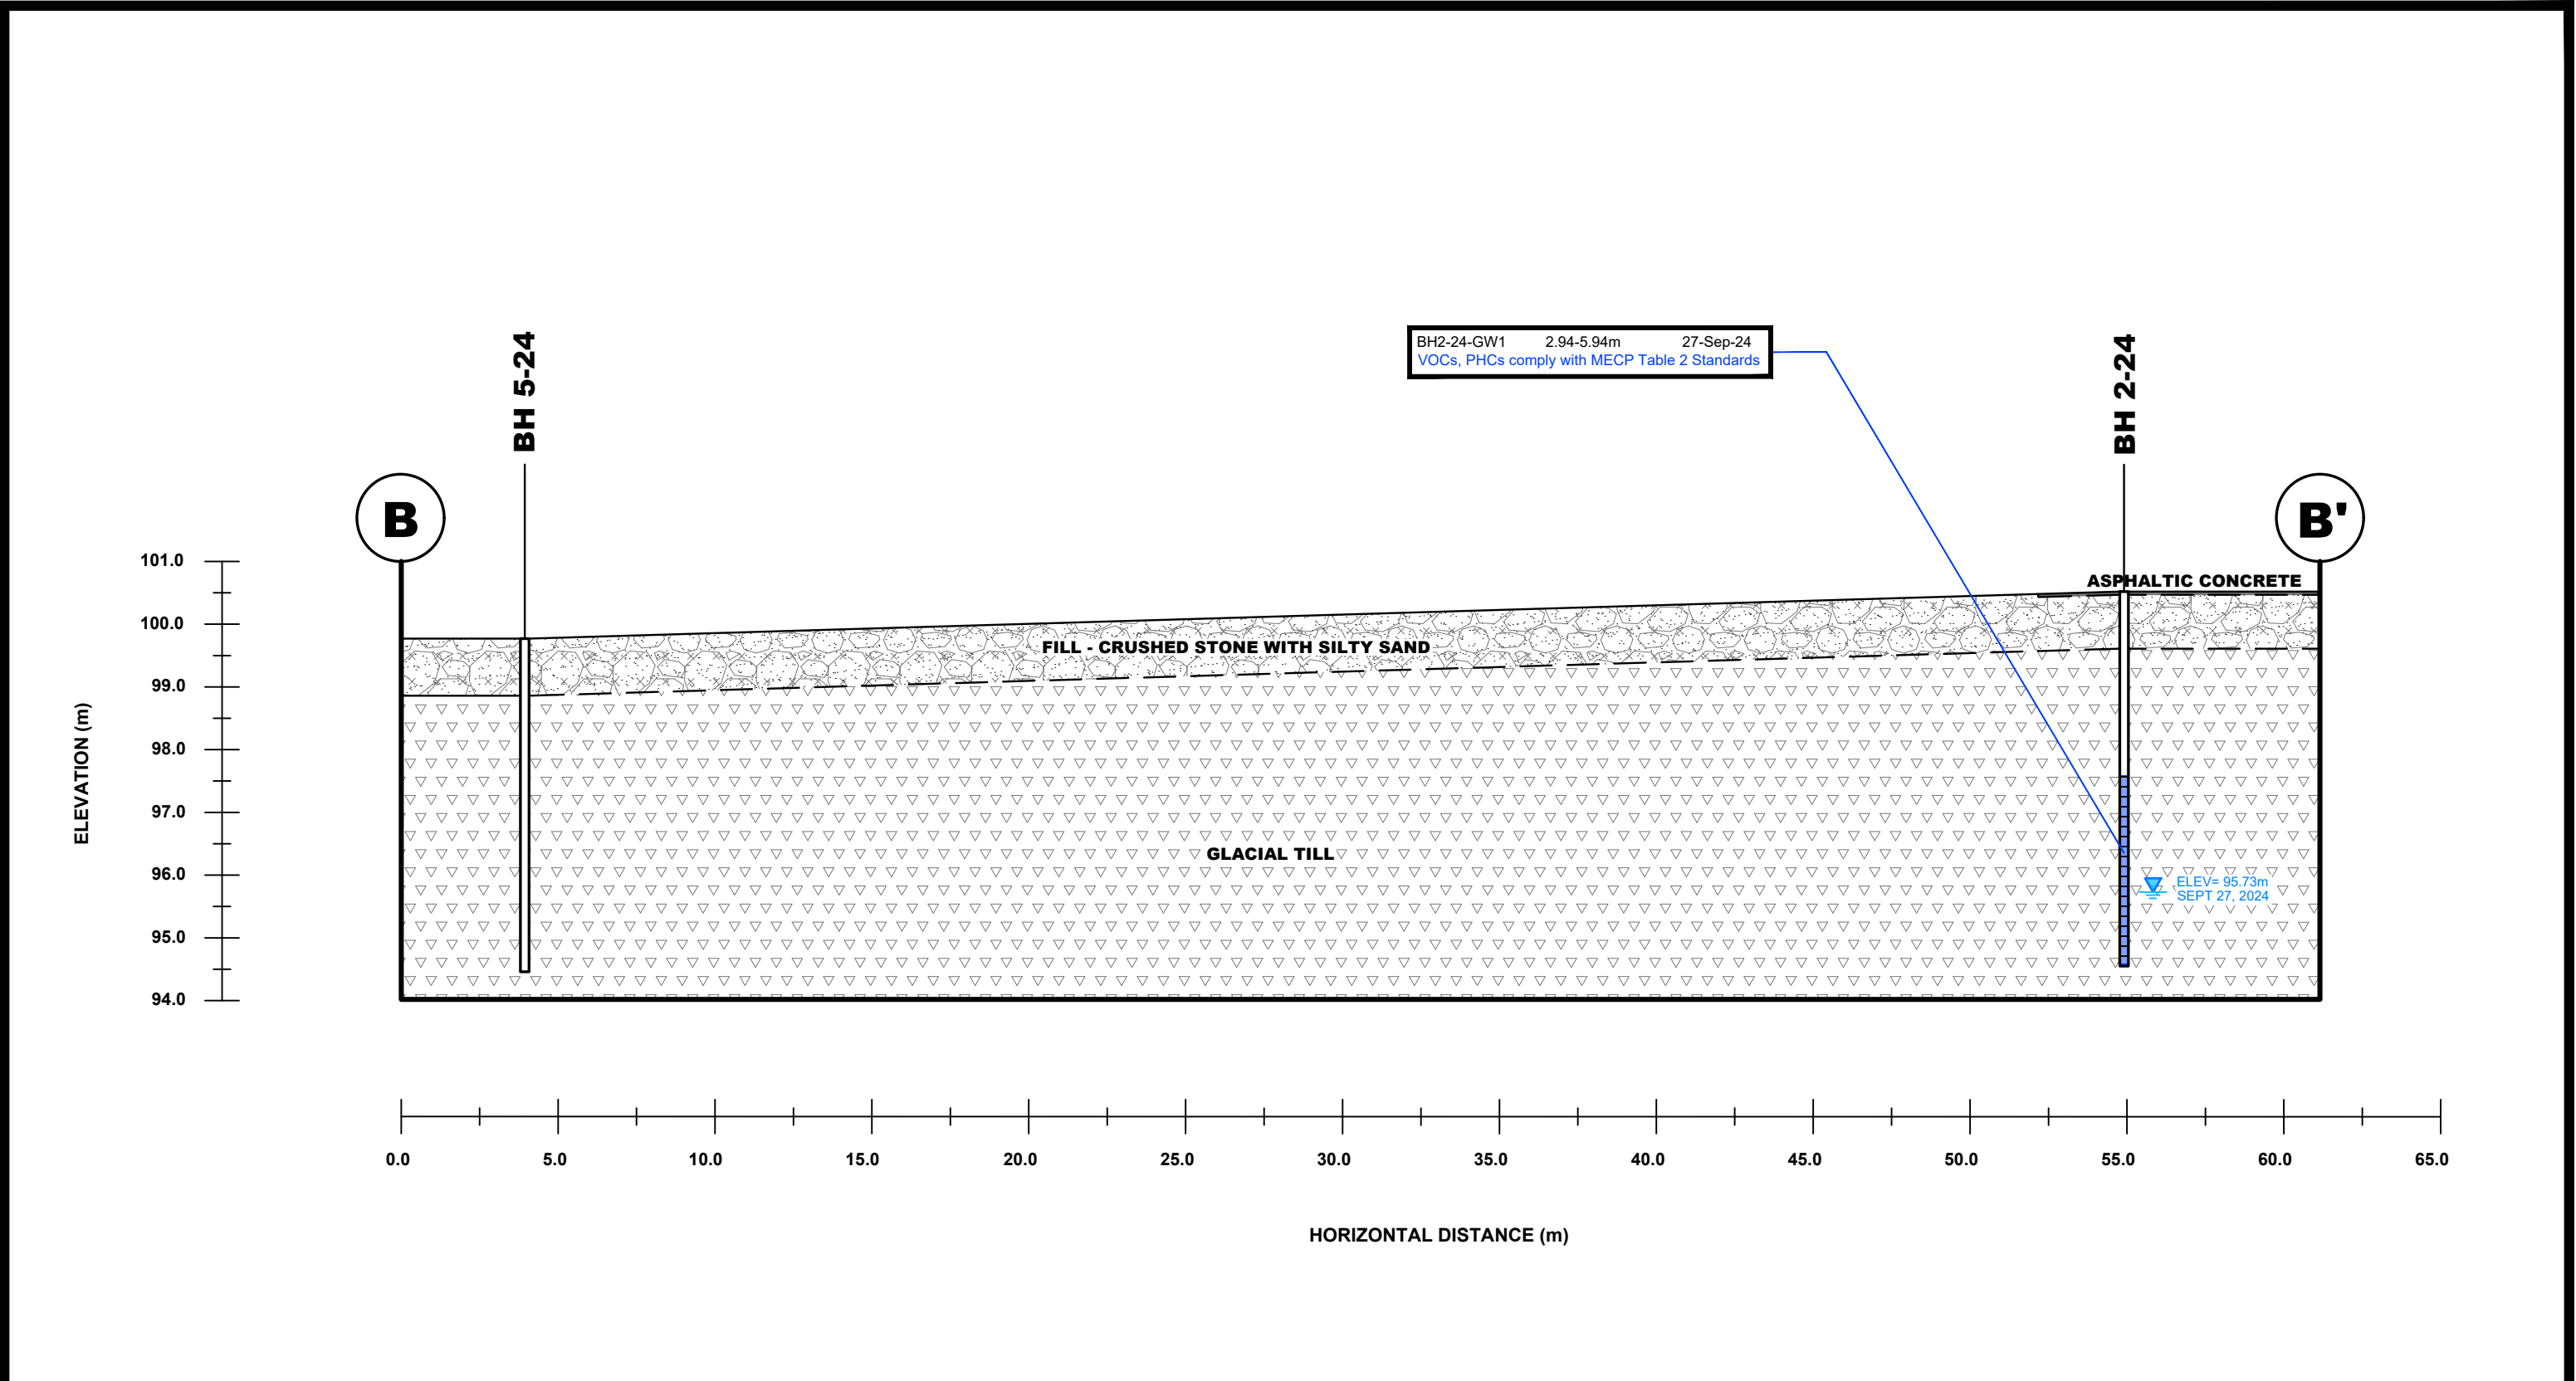
**DRAWING PE6616-6B – CROSS SECTION B-B' – GROUNDWATER**

GROUNDWATER RESULT COMPLIES WITH THE MECP TABLE 2 STANDARDS

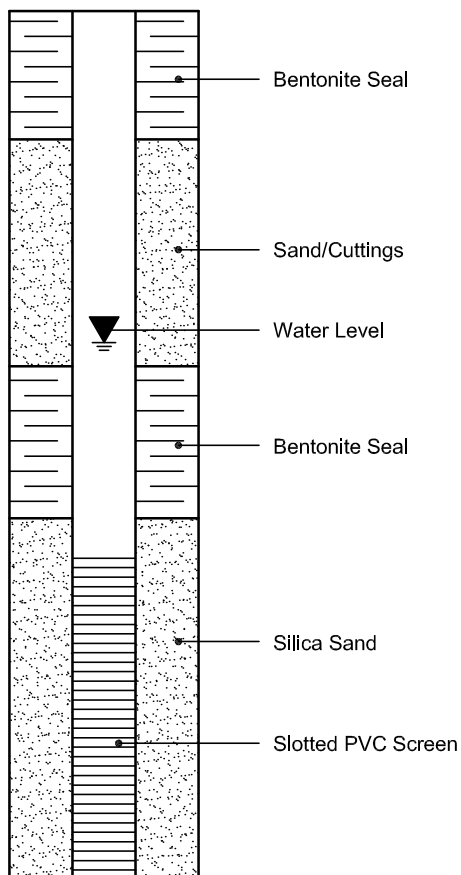
#### MONITORING WELL CONSTRUCTION

Upon completion, the groundwater monitoring wells were developed using a dedicated inertial lift pump, with a minimum of three well volumes being removed from the wells at the time of installation. The wells were developed until the appearance of the water was noted to have stabilized. In addition, the ground surface elevations of each borehole were subsequently surveyed with respect to a known geodetic elevation.
