Phase One Environmental Site Assessment

214-224 Somerset Street East
Ottawa, Ontario

Prepared for:
Ottawa Community Housing
Corporation

June 21, 2023

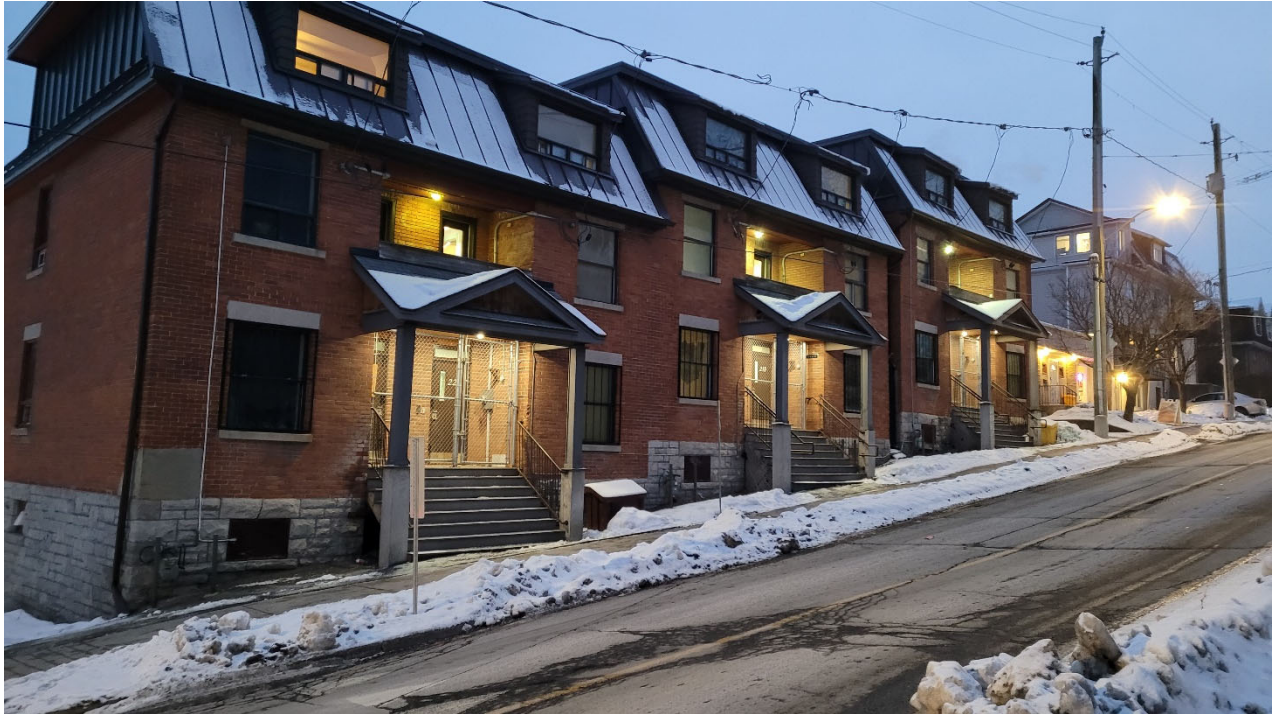
Photograph 1: View of the front of the Phase One Property, looking south from the north side of Somerset Street East; view shows the 3 present-day residential buildings at the Site.

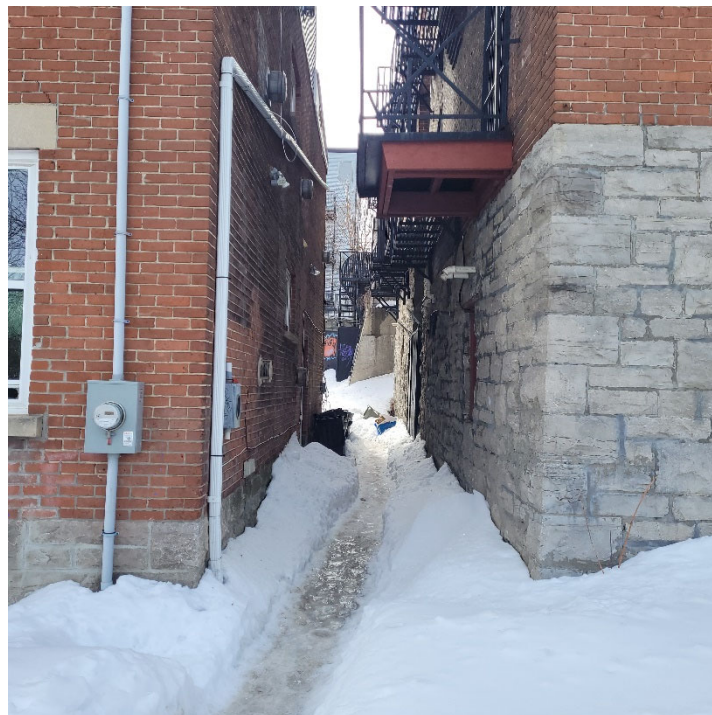
Photograph 2: View of the south portion of the Phase One Property looking west; view shows the (snow covered) asphalt pedestrian pathway shared between the Property and adjacent property to the south.

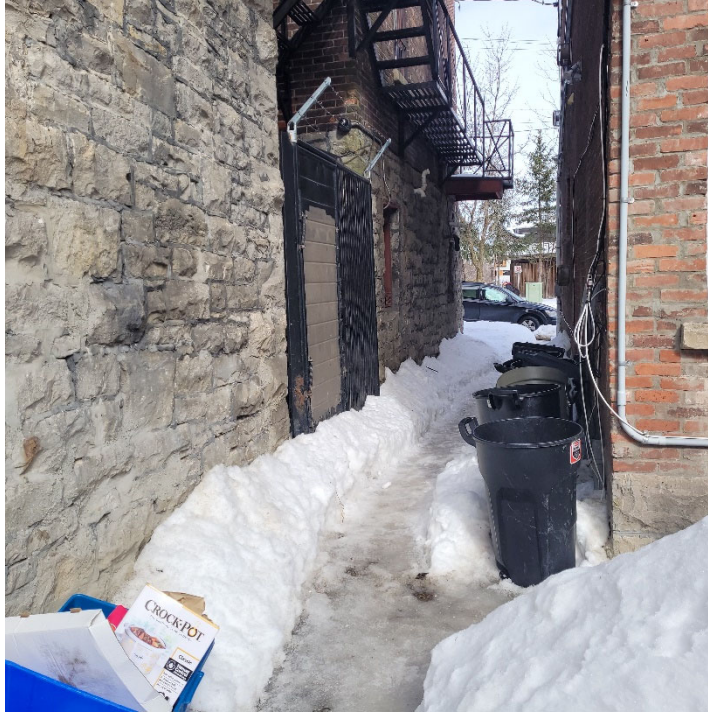
Photograph 3: View of the south portion of the Phase One Property looking east; view shows the (snow covered) asphalt pedestrian pathway shared between the Property and adjacent property to the south.

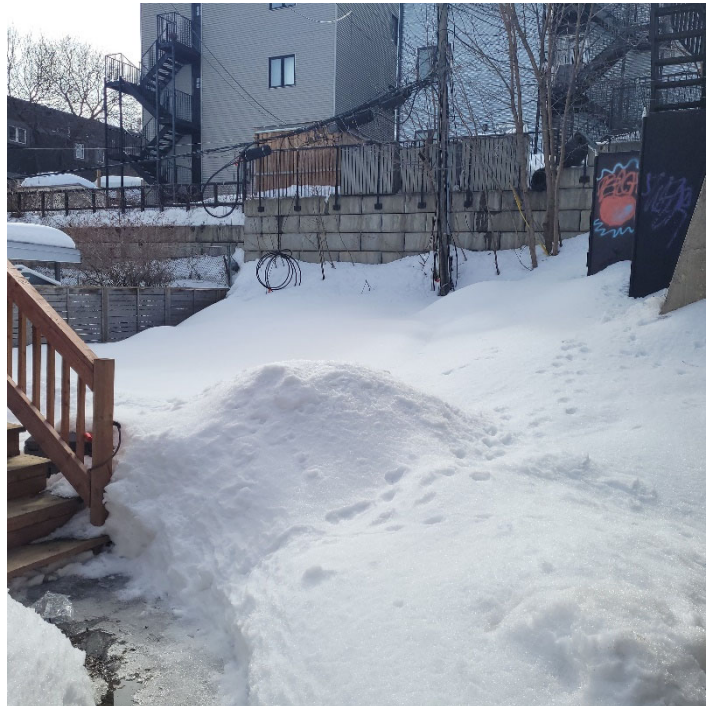
Photograph 4: View of the southwest (snow-covered) portion of the Phase One Property looking southwest. View shows retaining walls constructed on adjacent properties.

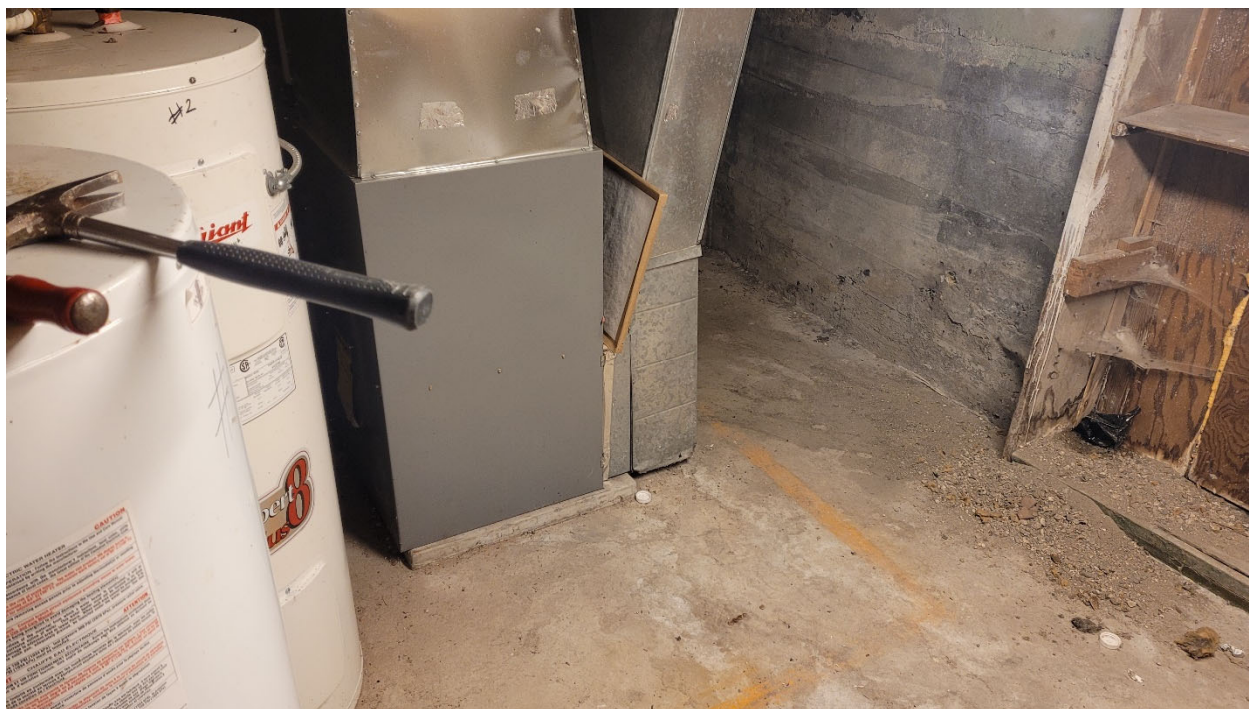
The residential units throughout the buildings are heated by (6) natural gas fired furnaces, present in each of the mechanical rooms (2 per building); there were supplemental baseboard heaters observed in some of the units and mechanical spaces. There were no details regarding former heating and cooling systems, including historical fuel sources for buildings at the Phase One Property.

Photograph 5: View of the natural gas fired equipment, flooring and foundations in one of the buildings' mechanical rooms.

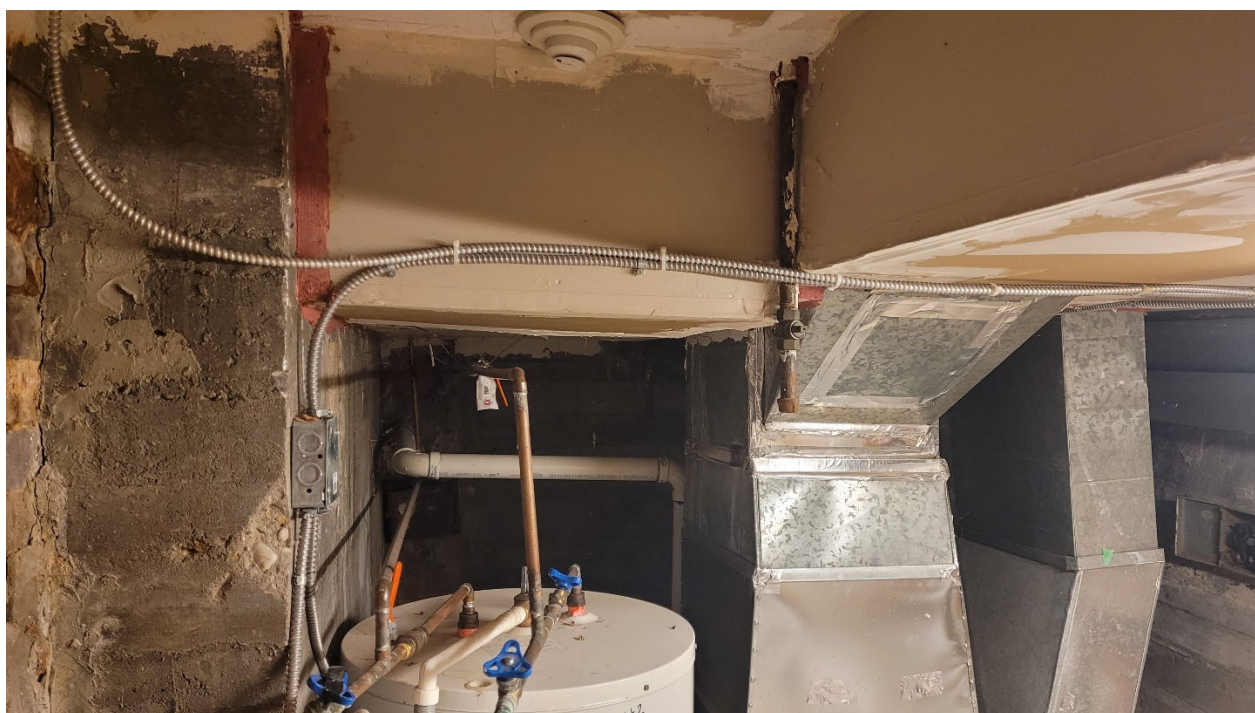
Photograph 6: View of the natural gas fired equipment, ceilings and foundation walls in one of the buildings' mechanical rooms. Note that recent drywalling around the mechanical room ceilings prevented observation of potential former heating oil supply lines.
