**Roger Grenon  
Greely Car Wash**

**Phase I Environmental Site Assessment  
1386 Greely Lane  
Greely, Ontario**

**ER1015**

**January 24, 2023**

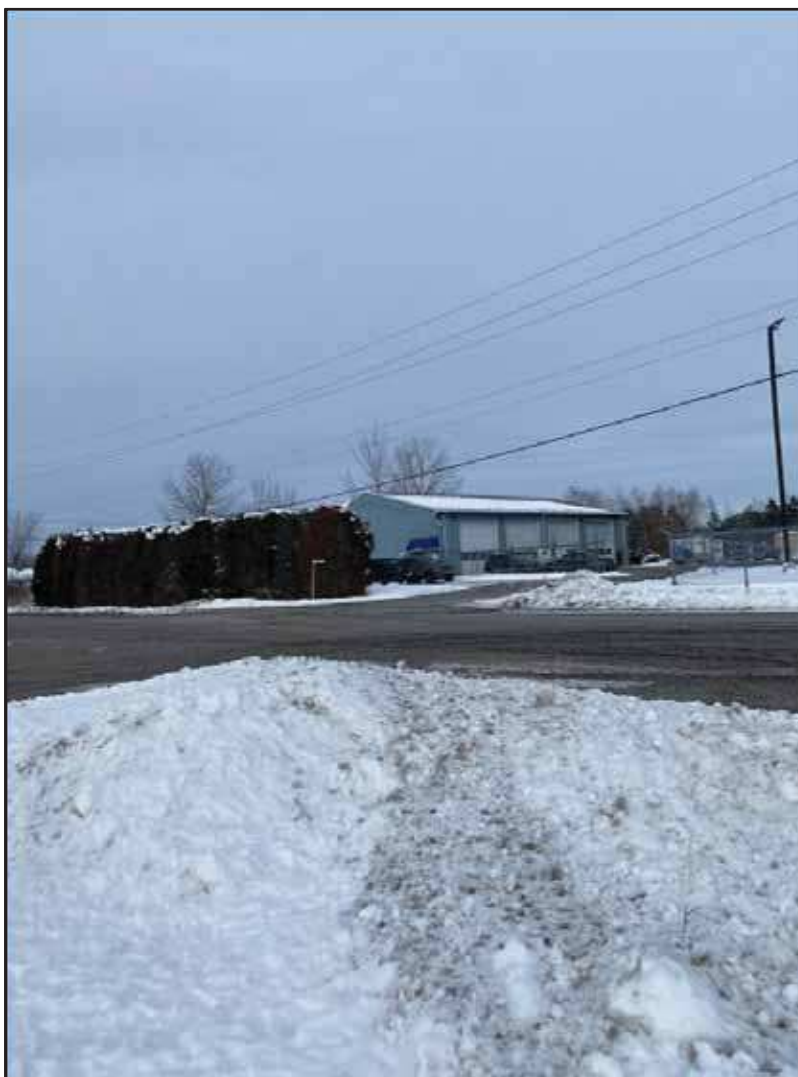
CM3 observed above ground fuel storage tanks (ASTs) at the properties to the east and west of the subject property at 1387 Greely Lane and 6906 McKeown Drive. Equipment and/or vehicle storage was observed on the properties immediately adjacent to the north and west of the subject property.

**Photograph 3:** Looking north at the adjacent property used for a commercial fuel delivery fleet at 1387 Greely Lane.

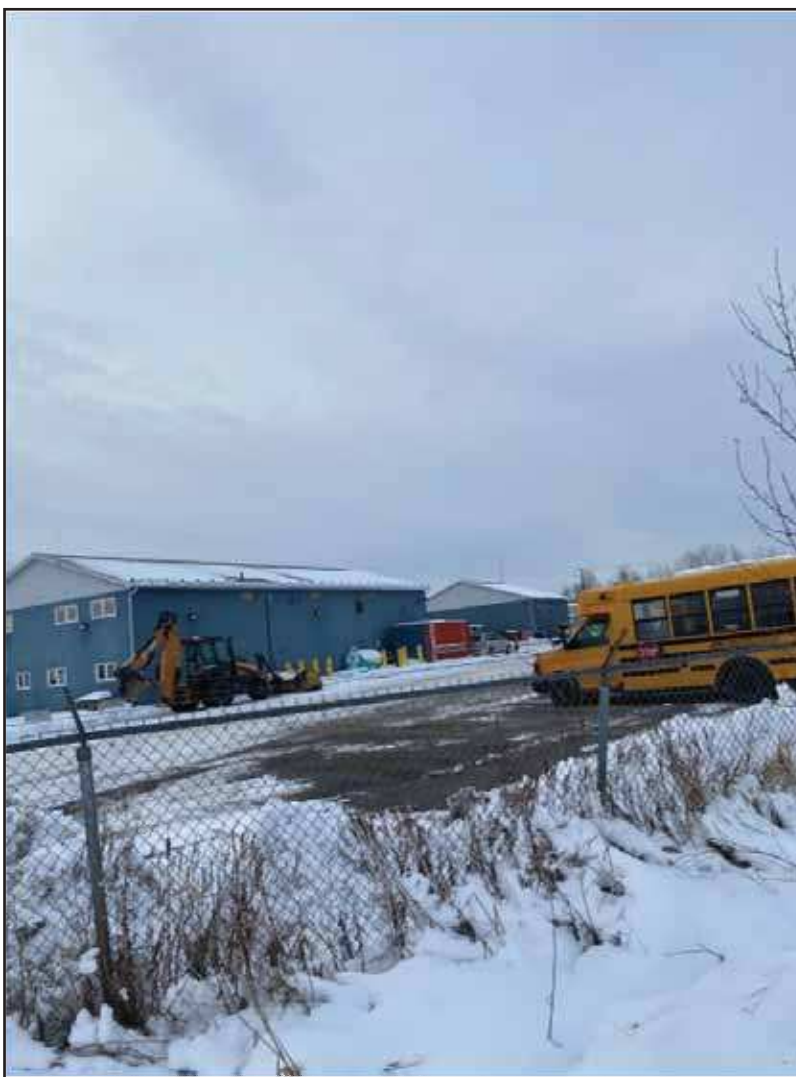
**Photograph 4:** Looking south-west at the adjacent property used for a commercial bus fleet.

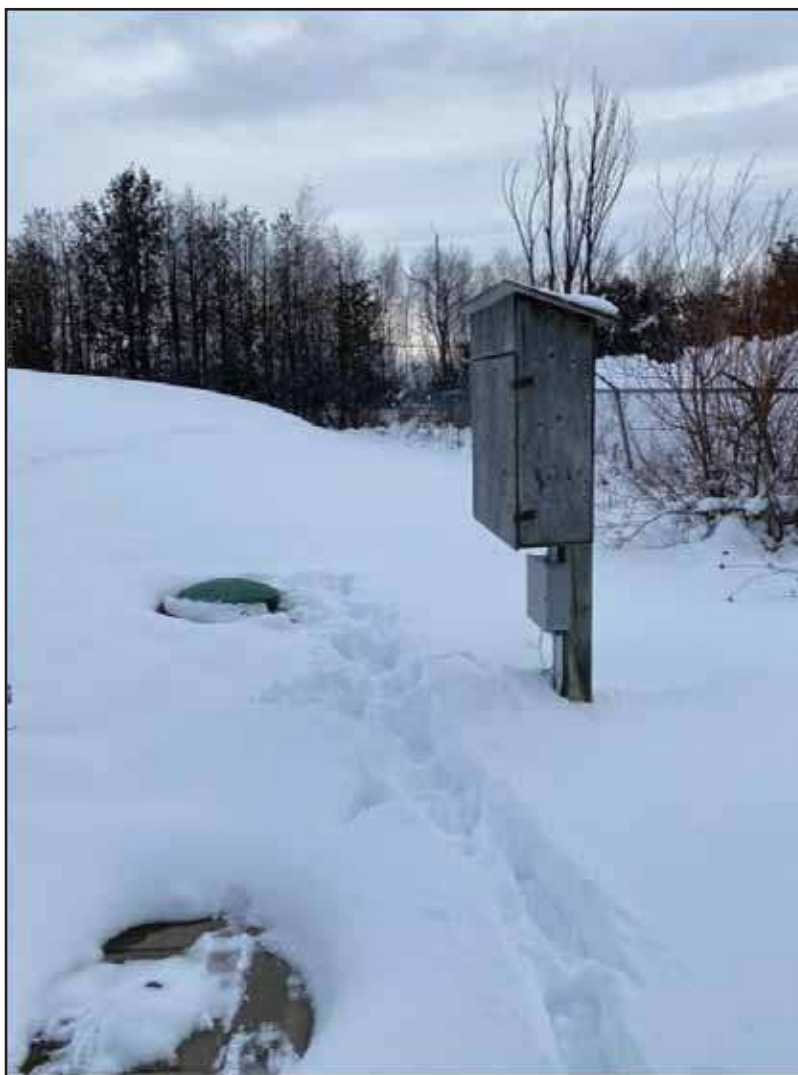
**Photograph 5:** View of access hatches and electrical systems associated with the septic system located on the south property boundary.

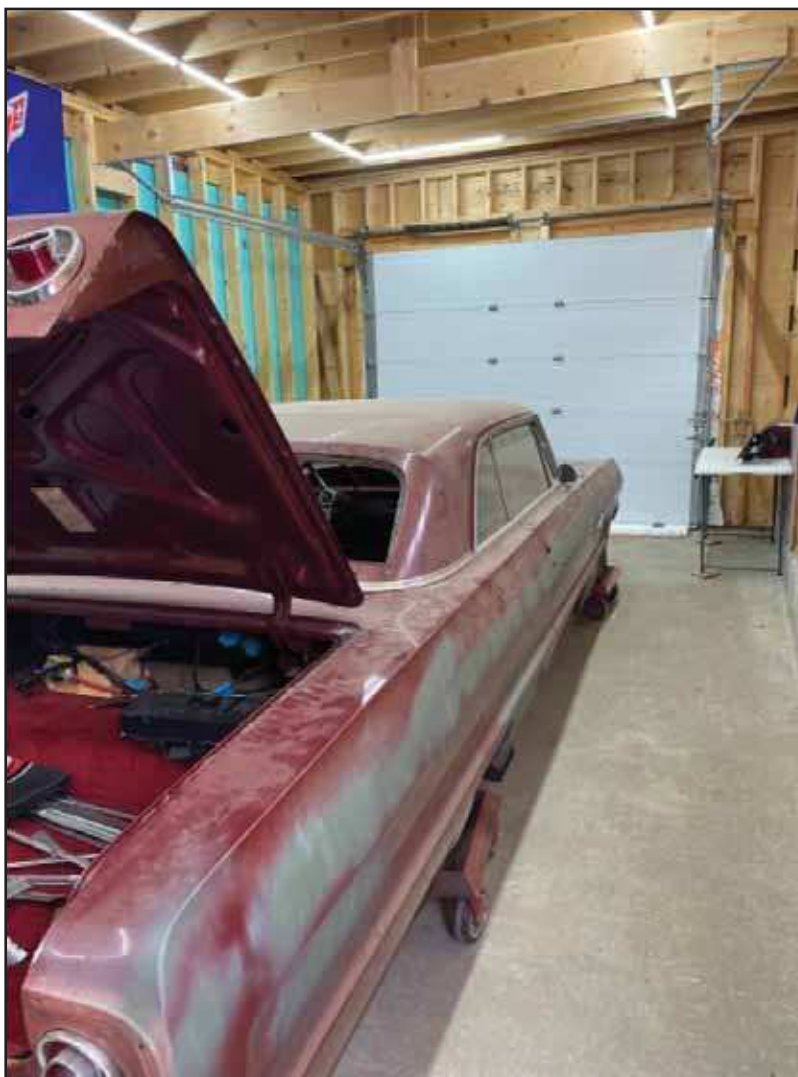
**Photograph 8:** Interior view of the addition on the car wash building. A vehicle is pictured. A channel drain is located under the vehicle.

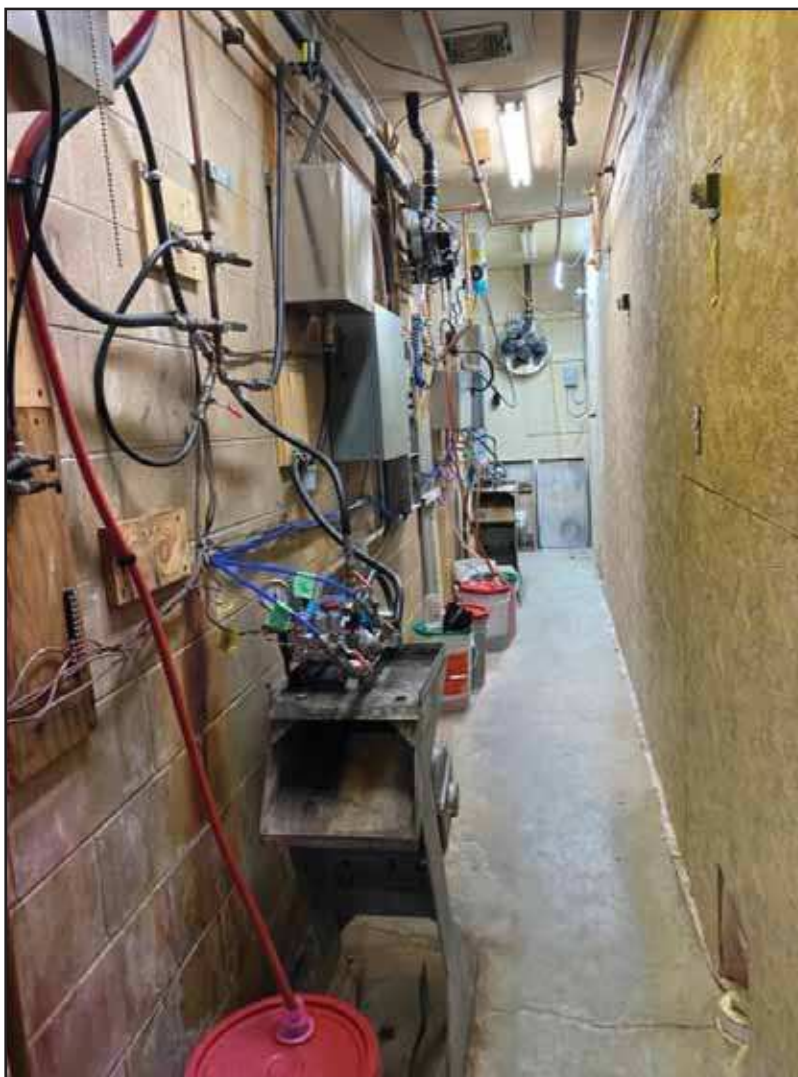
**Photograph 10:** Interior view of the car wash. Mechanical systems for the car wash are pictured.

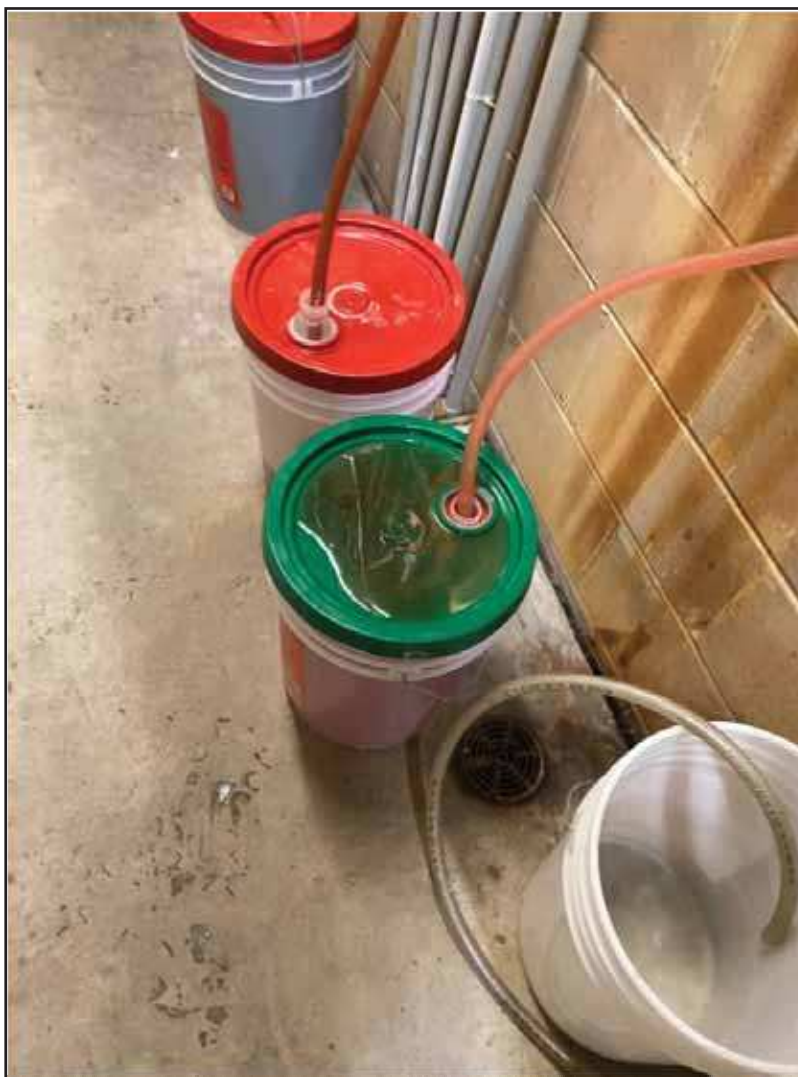
Floor drains were observed in the car wash bays. It was reported that the floor drains are used to collect the wash water and discharge to the septic holding tank southwest of the building. Two additional floor drains were observed on the north interior side of the car wash. Minor staining relating to mud from vehicles and cleaning agents were observed around the floor drains.

**Photograph 11:** View of concentrated cleaning liquids for the car wash. A floor drain is pictured.

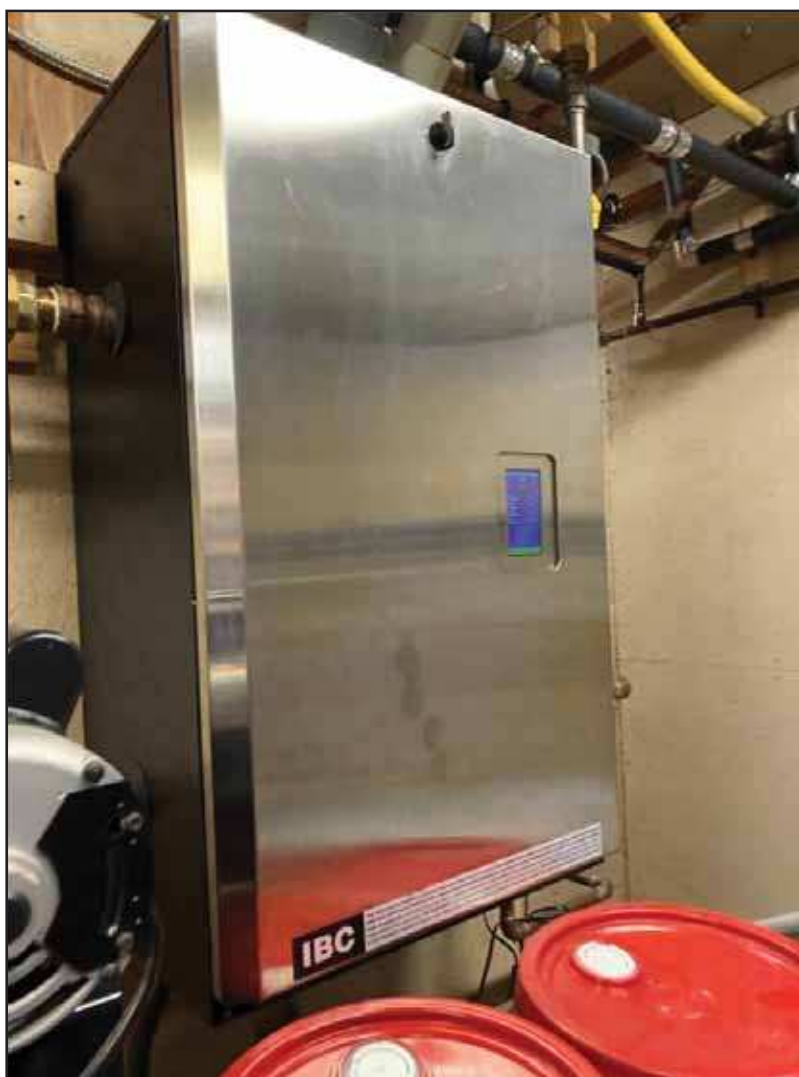
The car wash building is heated by a natural gas boiler and in-floor radiant heating. The addition and vehicle storage building were not heated. The on-site buildings were not air conditioned.

**Photograph 13:** View of car wash heating system.

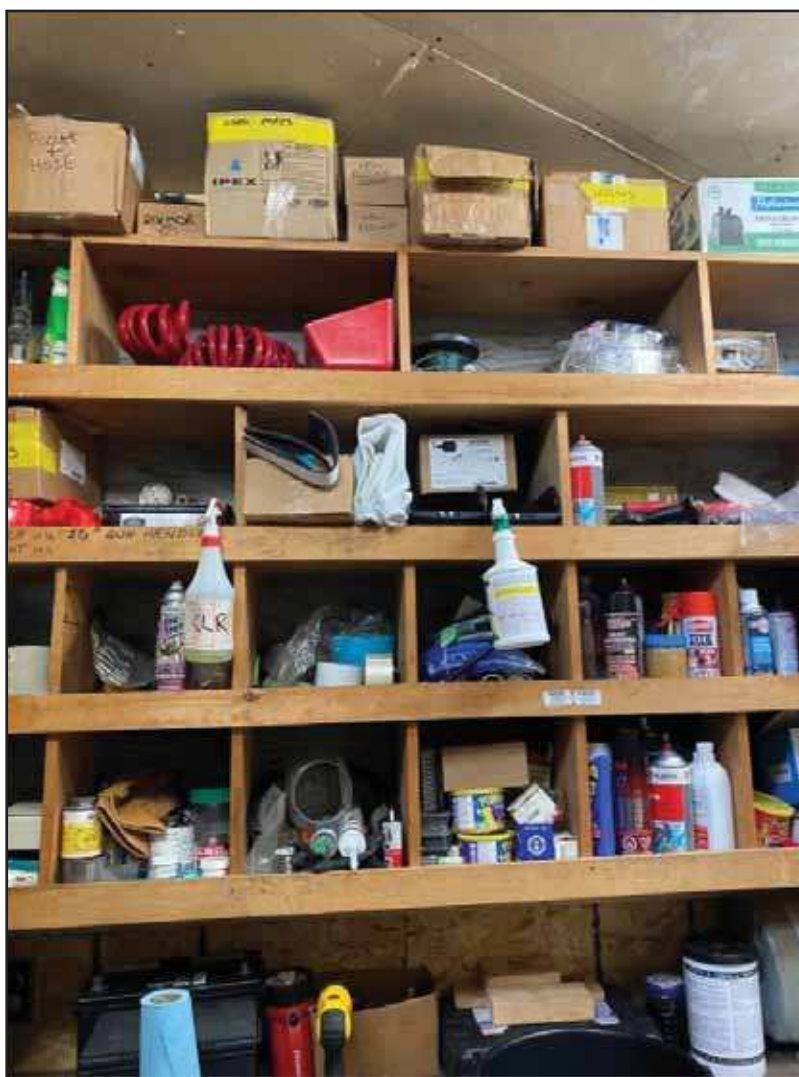
All containers observed on-site were labeled. Containers of unidentified substances were not observed at the subject property.

**Photograph 15:** View of various cleaning supplies, paint, oils, lubricants, etc.

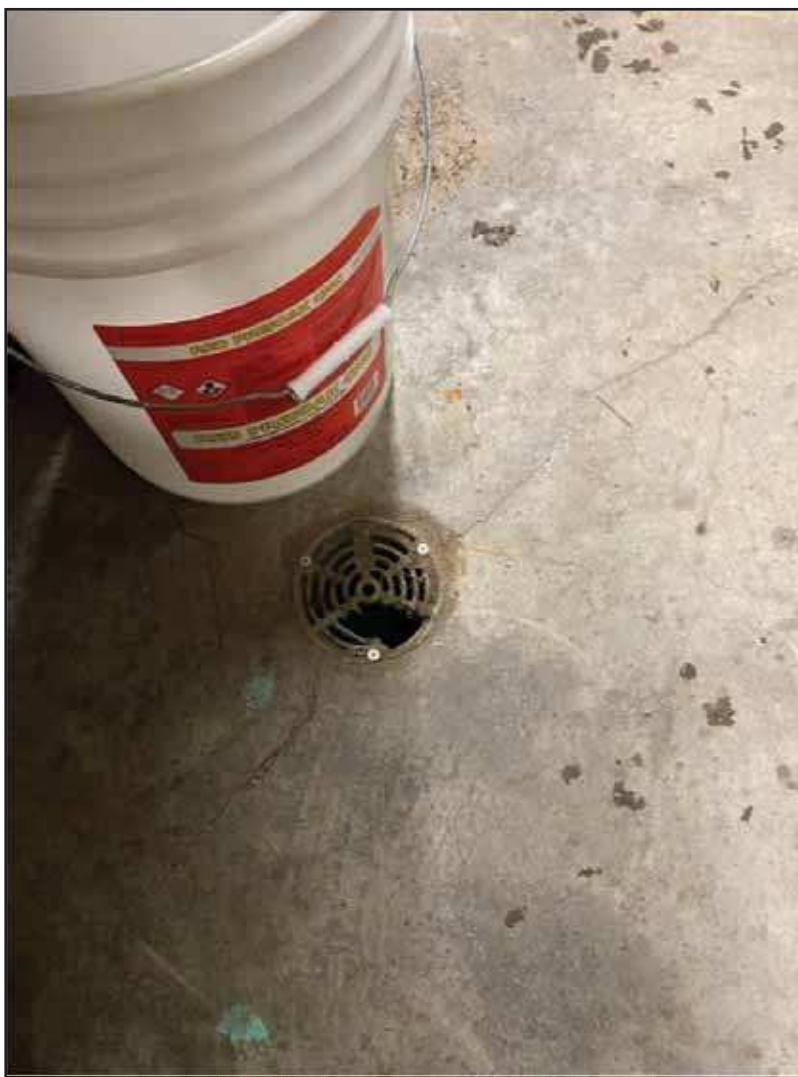
**Photograph 16:** View of floor drain near the entrance to the car wash.
