Phase One Environmental Site Assessment - 2405 and 2419 Mer Bleue Road, Ottawa, Ontario

Prepared for:
Conseil des écoles publiques de l'Est de l'Ontario

Cambium Reference: 20361-003

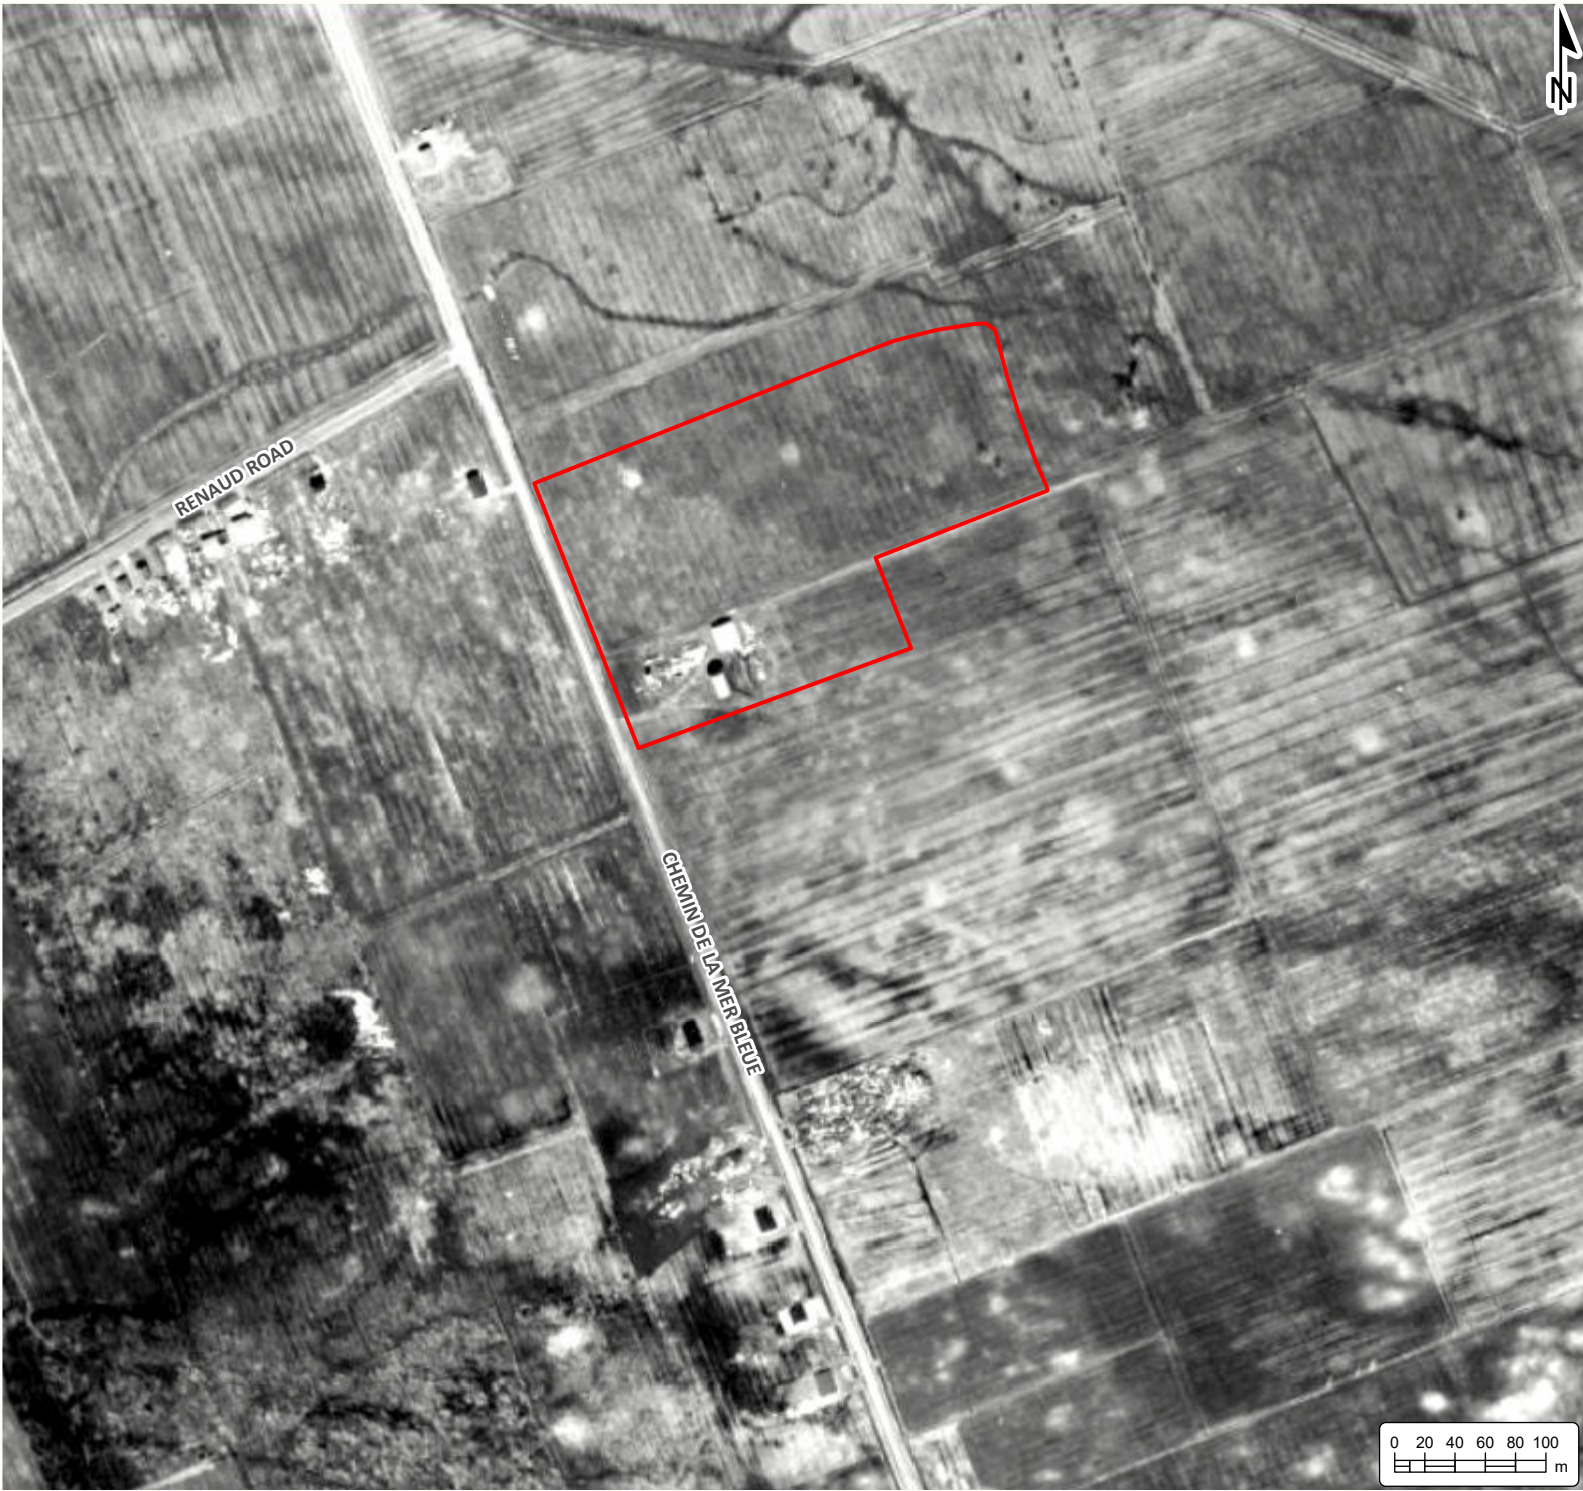
Project No.: 20361-003	Date: April 2025
Scale: 1:2,500	Rev.: NAD 1983 UTM Zone 18N
Created by: TLC	Checked by: KF
Figure: 4

As required by O.Reg. 153/04, all on-site PCAs contributed to an APEC. There were no PCAs identified in the surrounding area. Refer to Table 3 in Section 7.4.6 for APEC details and Figure 4 for APEC locations.

All on-site PCAs contributed to an APEC. Refer to Table 3 for APEC details and Figure 4 for APEC locations.

**CONCEPTUAL SITE MODEL
PHASE ONE SITE PLAN**

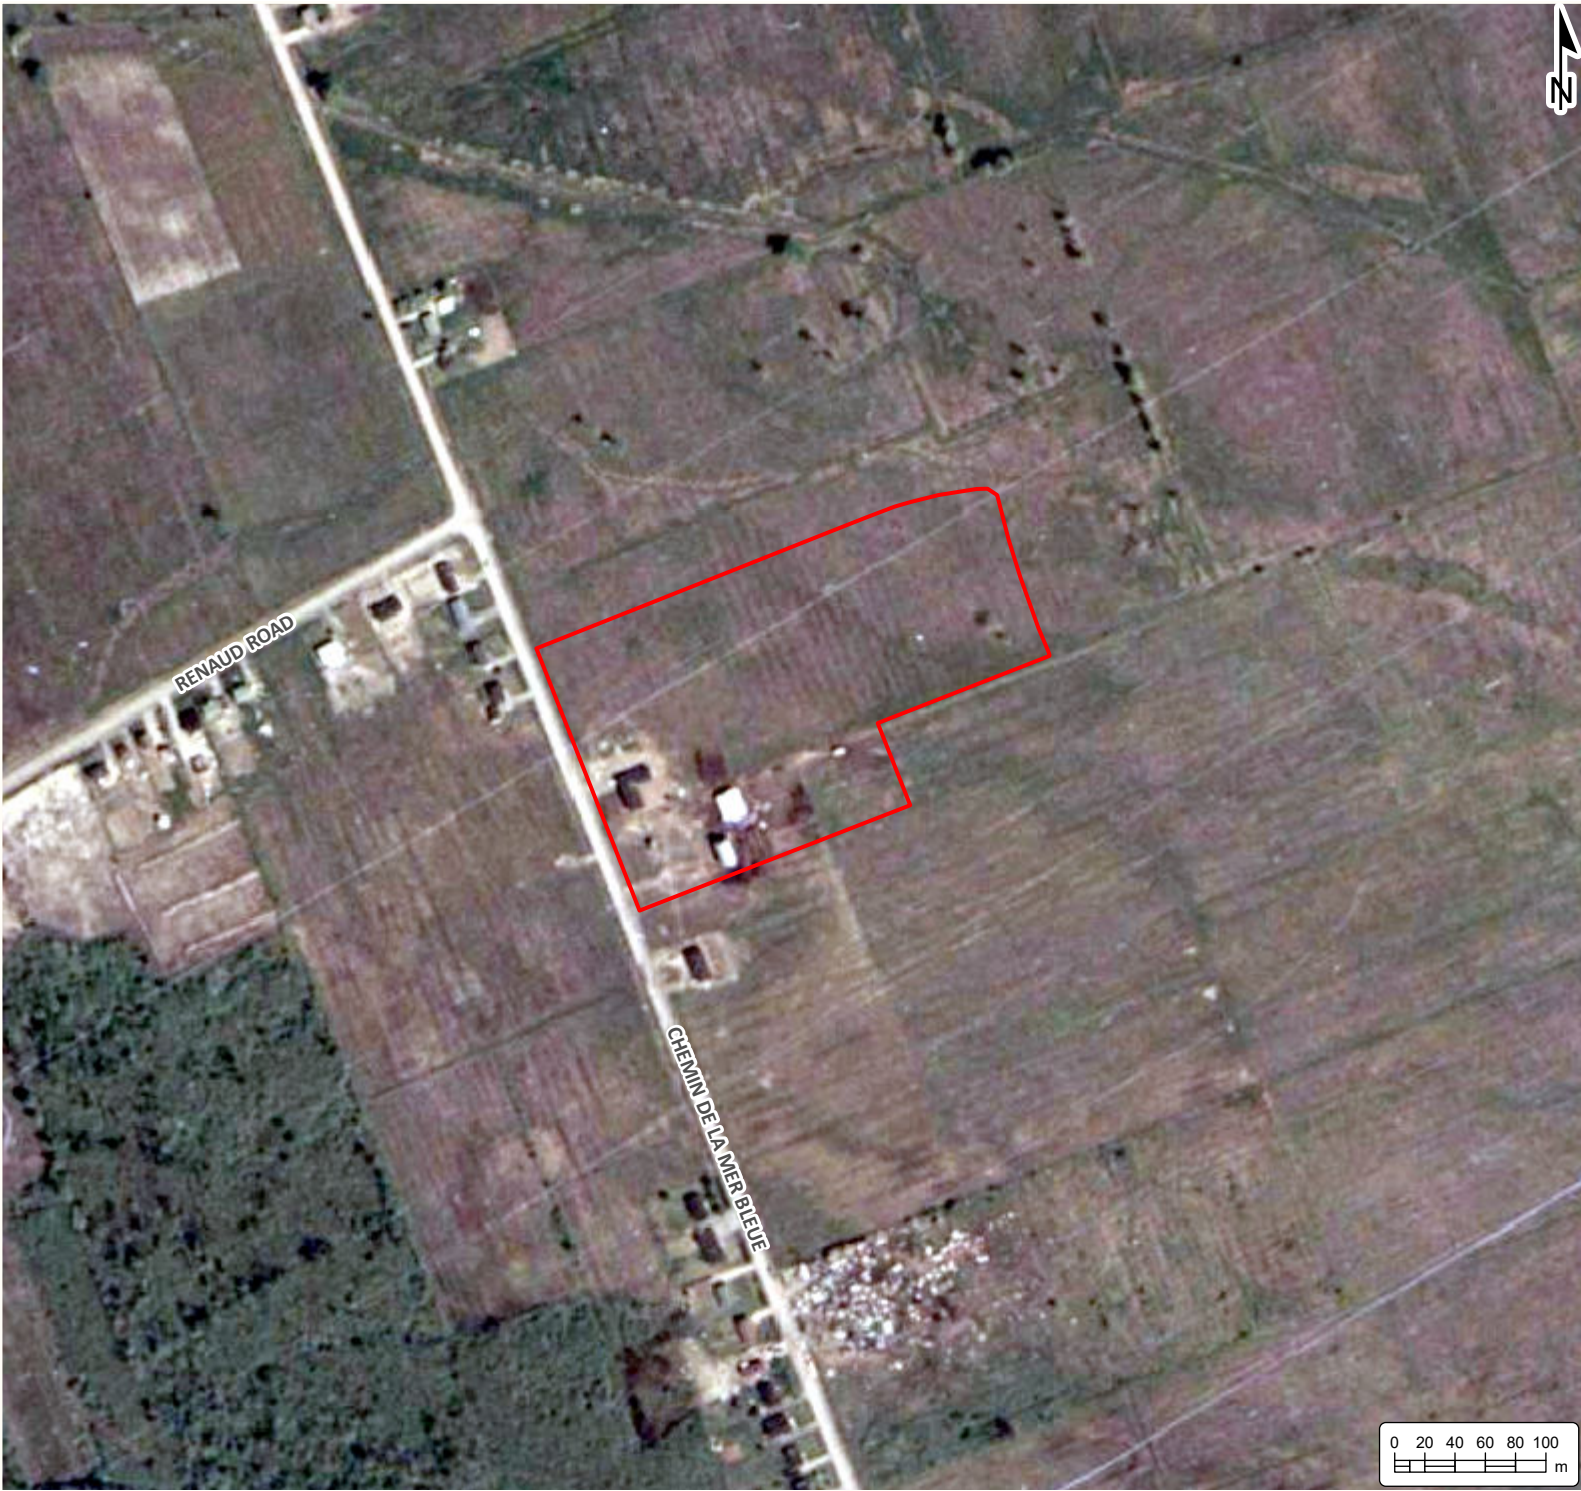
Project No.: 20361-003		Date: April 2025	
Scale: 1:5,000		Rev.: NAD 1983 UTM Zone 18N	
Created by: TLC	Checked by: KF	Figure: 5

1965 AERIAL IMAGERY

Aerial photographs dated 1965, 1976, 1984, 1991, 2002, 2014 and 2023 were reviewed to identify the first developed use of the Site and subsequent on-site activities, buildings, structures, PCAs, and APECs, as per Schedule D, paragraph 9, of O.Reg. 153/04. Detailed observations are provided in Appendix G. The aerial photographs are provided as Figure 5 to Figure 9.

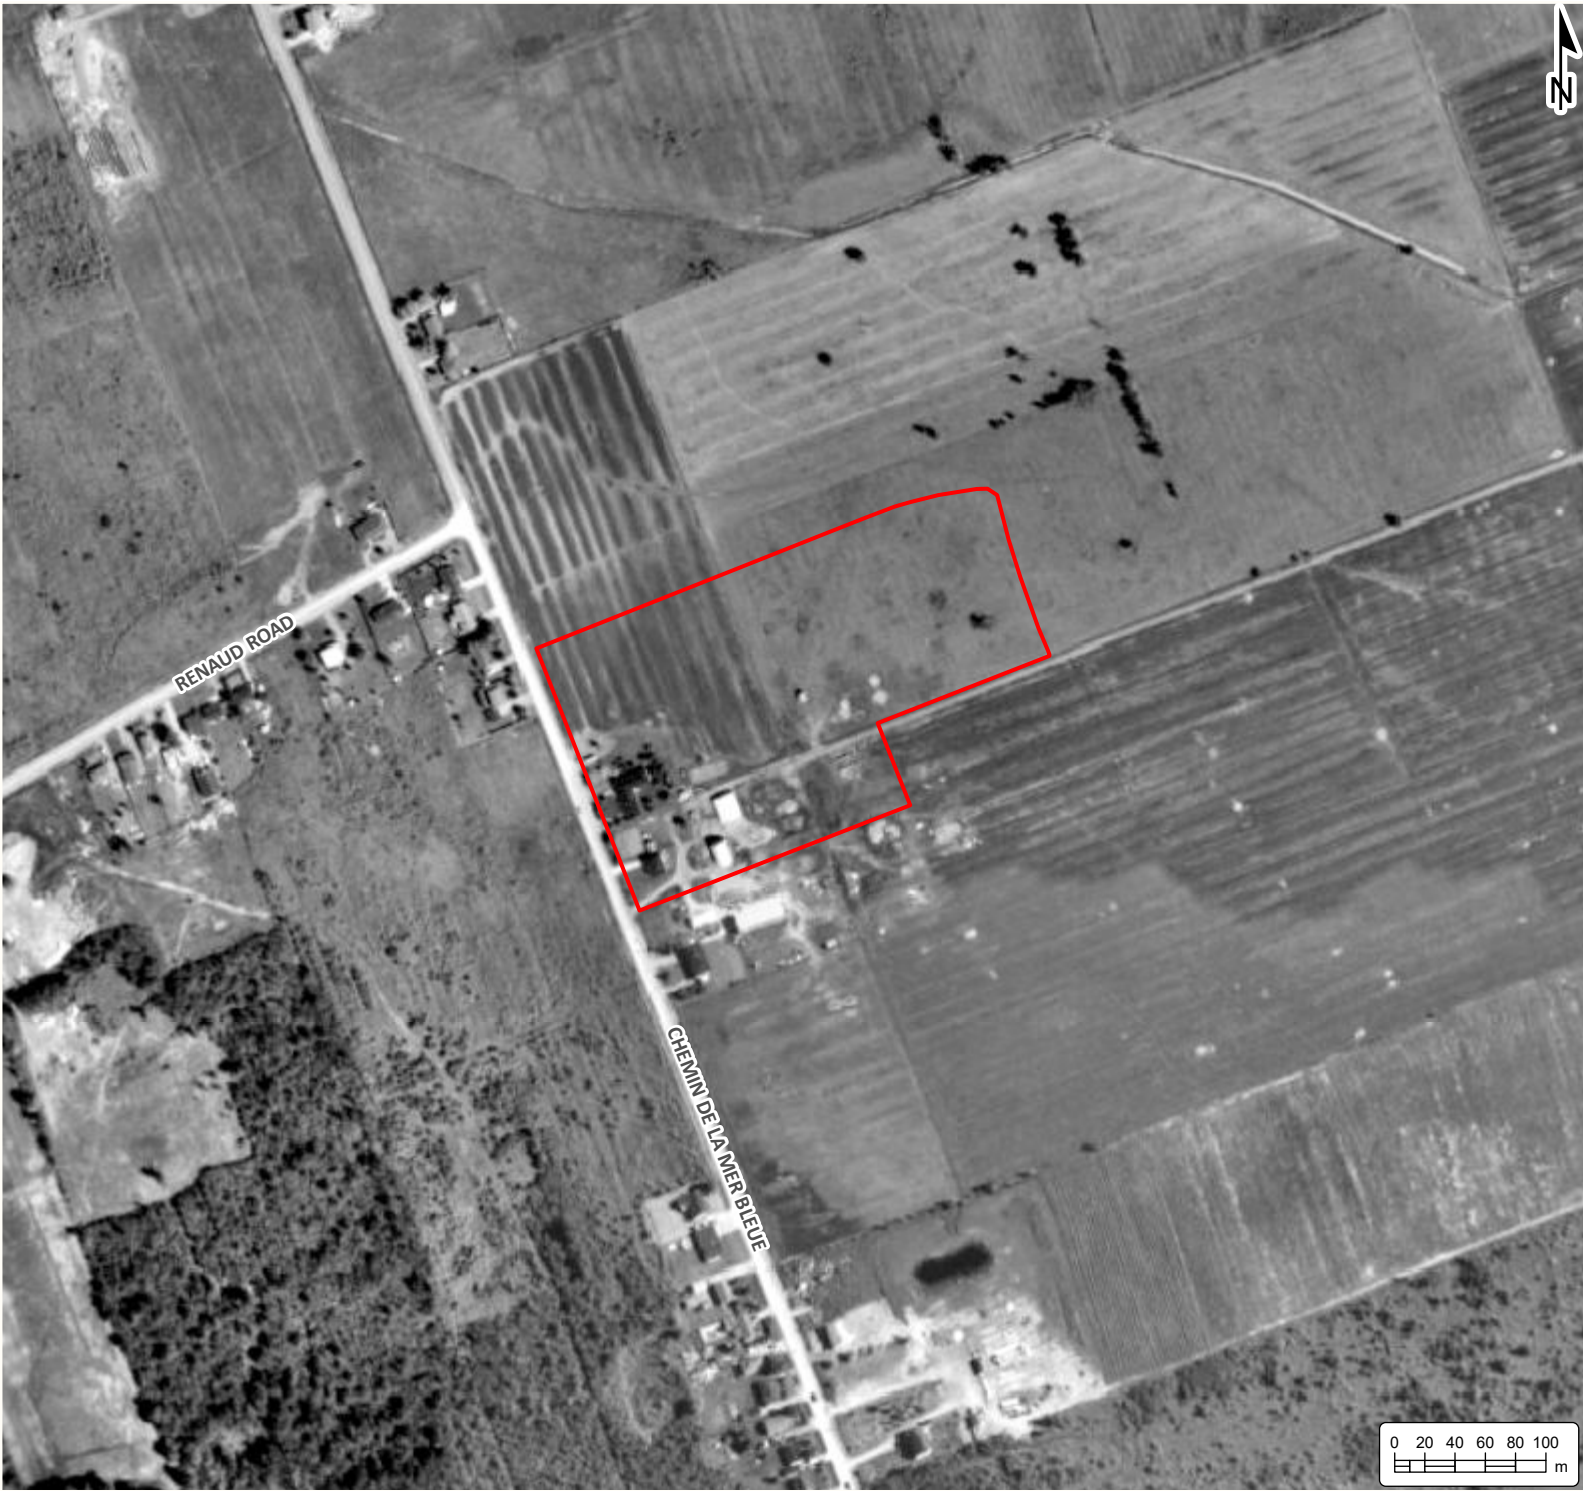
Project No.:	Date: April 2025	
20361-003	Rev.:	
Scale:	Projection:	
1:5,000	NAD 1983 UTM Zone 18N	
Created by:	Checked by:	Figure:
TLC	KF	7

1987 AERIAL IMAGERY

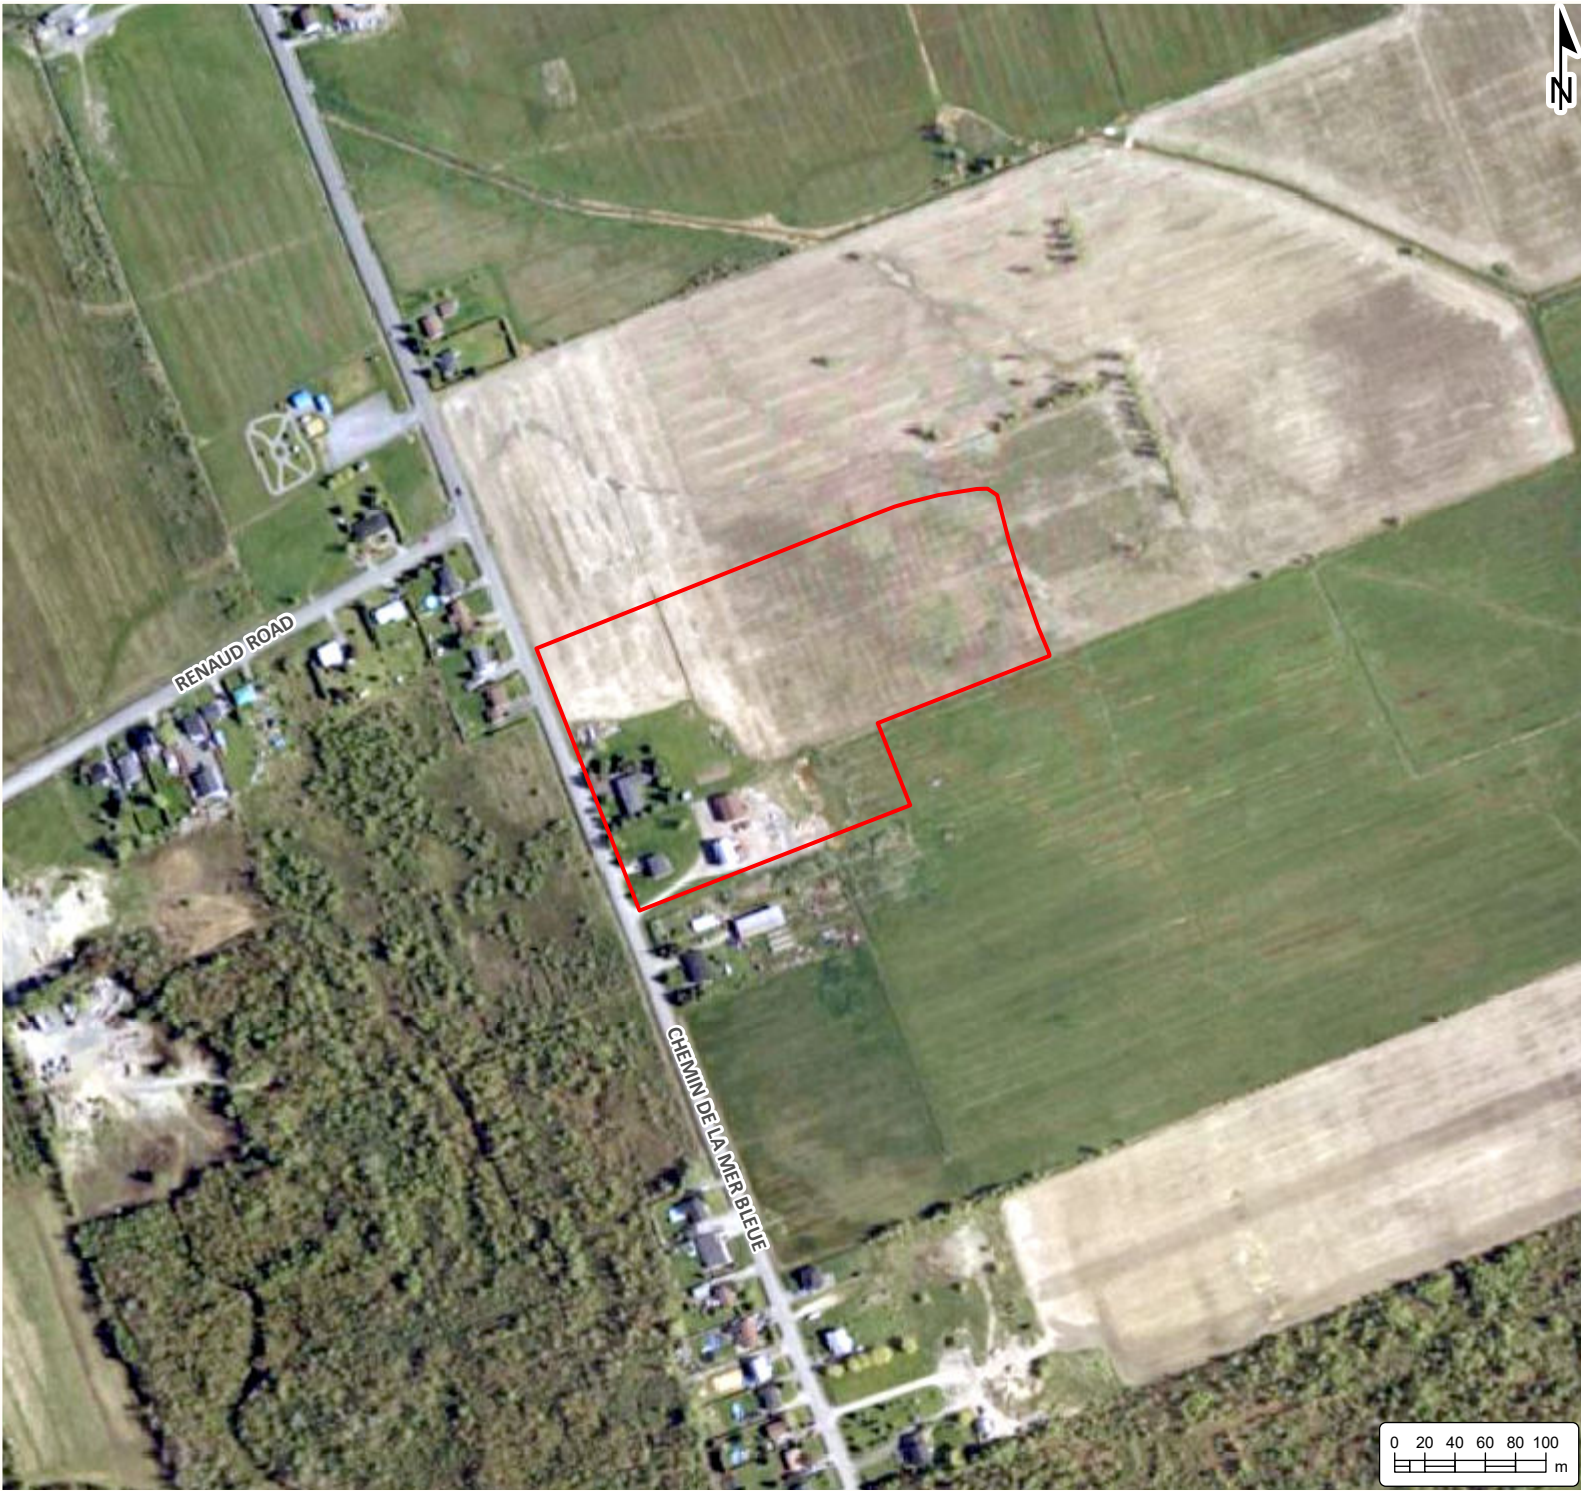
Project No.: 20361-003		Date: April 2025	
Scale: 1:5,000		Projection: NAD 1983 UTM Zone 18N	
Created by: TLC	Checked by: KF	Figure: 8

1991 AERIAL IMAGERY

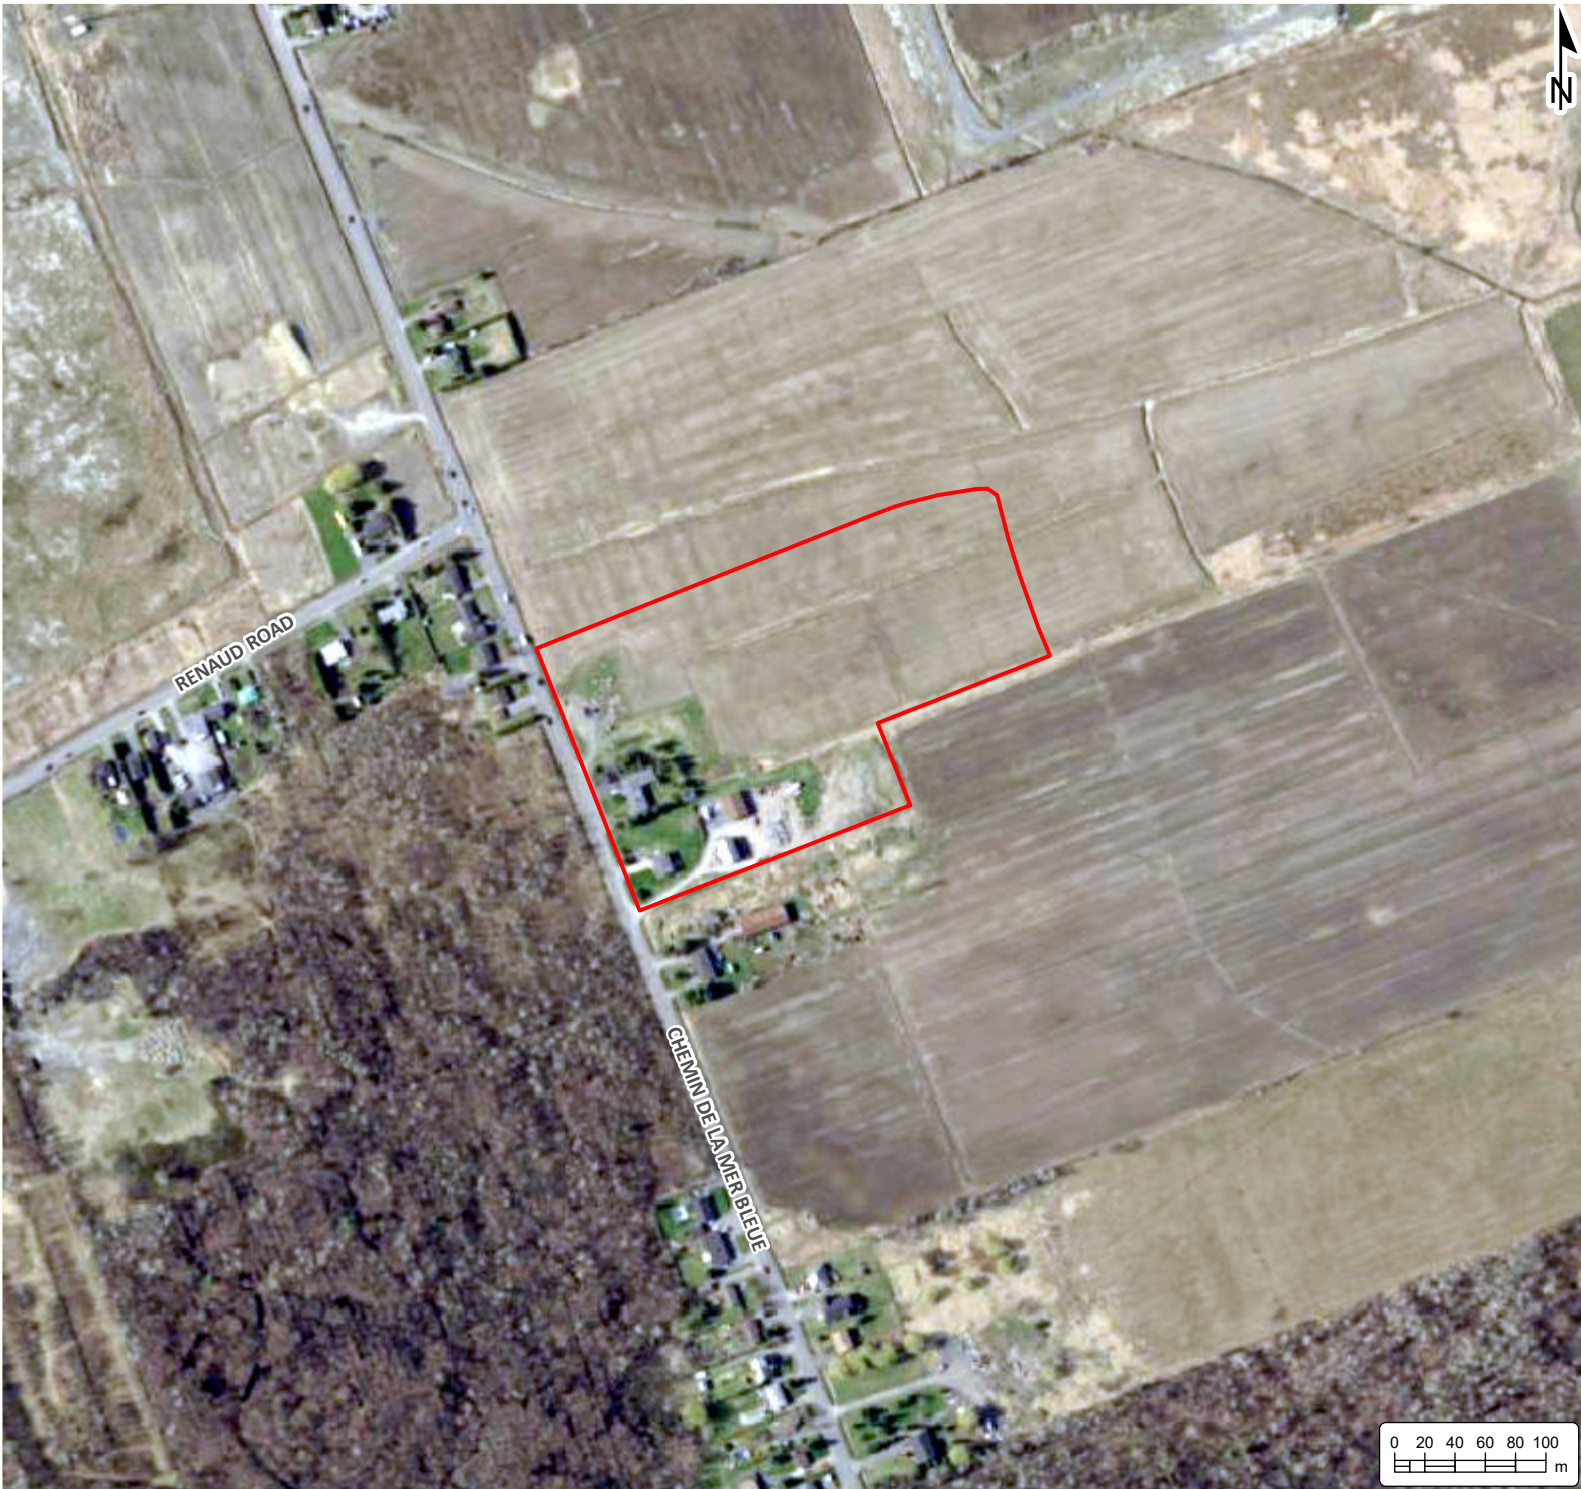
Project No.: 20361-003		Date: April 2025	
Scale: 1:5,000		Projection: NAD 1983 UTM Zone 18N	
Created by: TLC	Checked by: KF	Figure: 9

2002 AERIAL IMAGERY

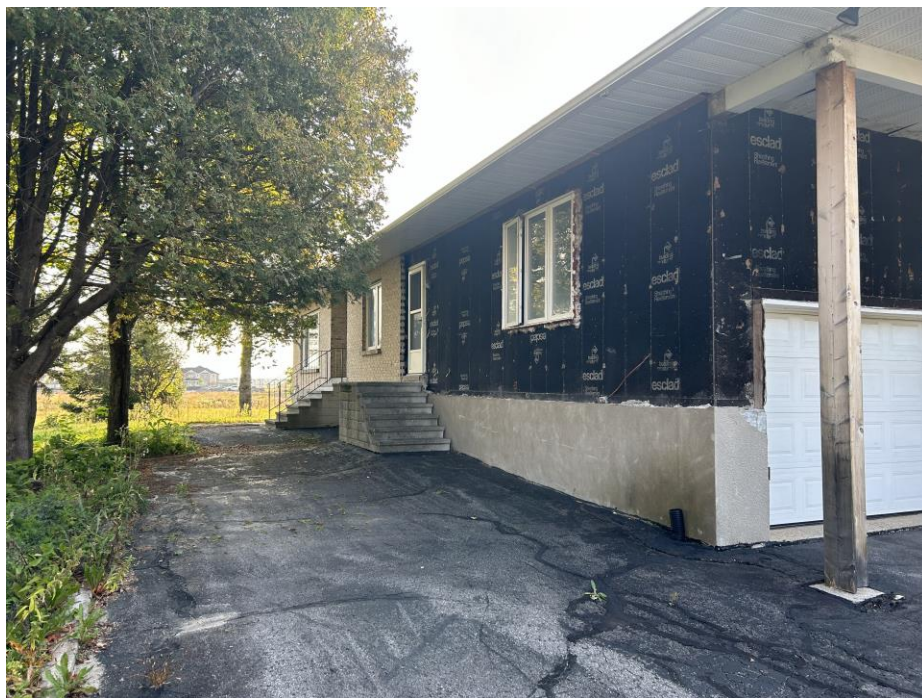
Photo 1 North portion of the Site Building, September 13, 2024.

Heating within the building was observed as natural gas-fired heating, and the cooling system was observed as an electric AC unit.

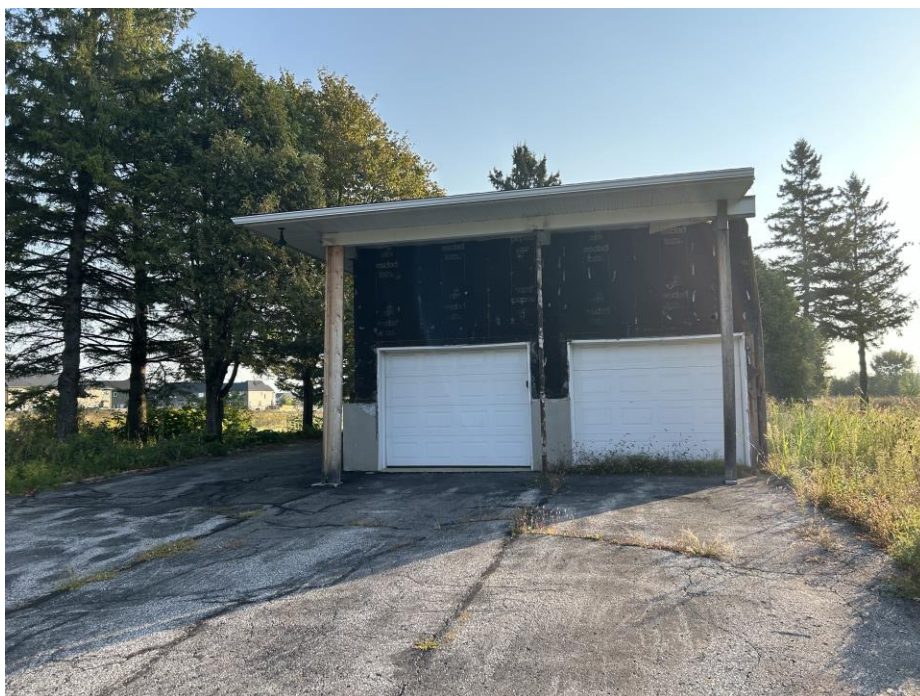
Photo 2 West portion of the Site Building, September 13, 2024.

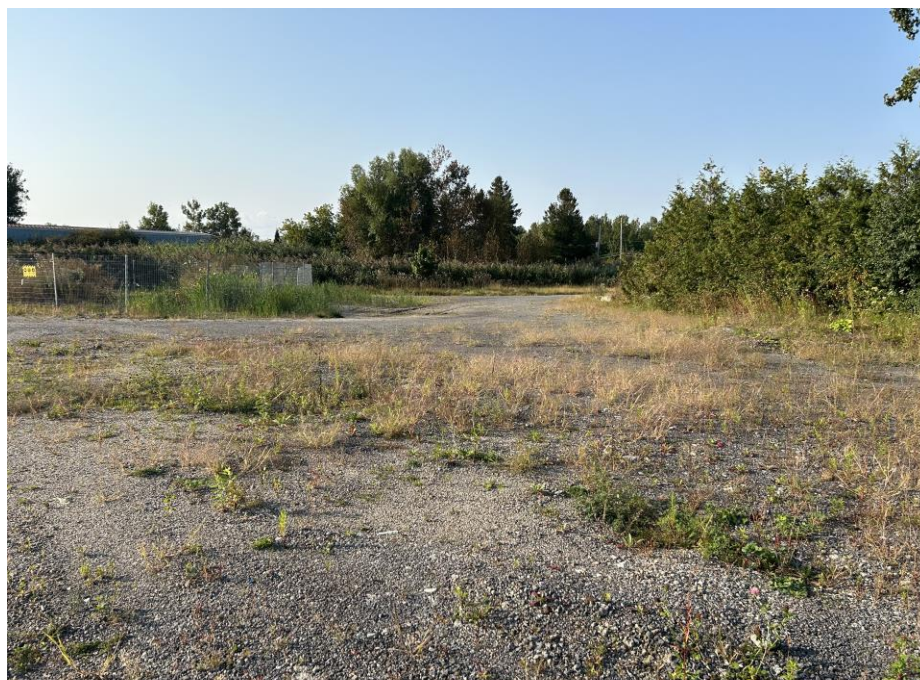
Photo 4 South portion of the Site, September 13, 2024.

- Gravel cover was observed on south portion of the Site.
- Asphalt/pavement driveways were observed in the west-central and southwest portions of the Site.
- Grass cover was observed on the north portion of the Site.
- Mature trees were observed along the west property boundaries.

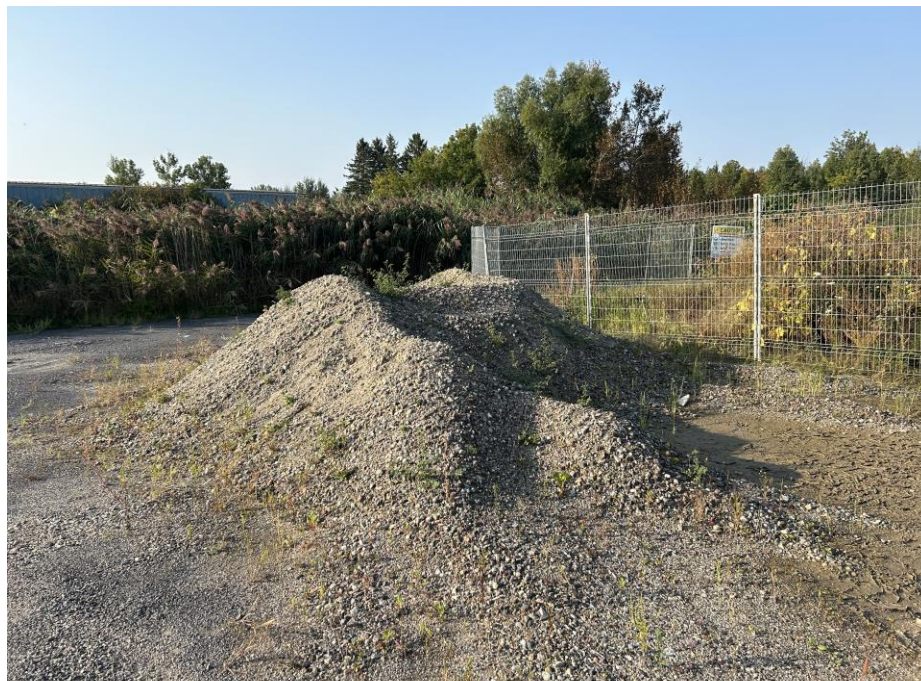
Photo 5 Clean fill material pile (i.e., gravel) located on the south portion of the Site, September 13, 2024.

As noted in Section 4.1.5, fill material was noted during previous investigations at the Site to a maximum depth of about 1.37 mbgs. Therefore, it is anticipated fill material of unknown quality is present on the south portion of the Site and is a PCA that contributes to an APEC.
