Subject : **Phase II Environmental Site Assessment (ESA)**
Property located at 1660 Merivale Road, Nepean, Ottawa, ON
Reference Number: HARN1660P2

PHASE II ENVIRONMENTAL SITE ASSESSMENT

Property located at
1660 Merivale Road,
Nepean, Ottawa, Ontario.

Reference Number:
HARN1660P2

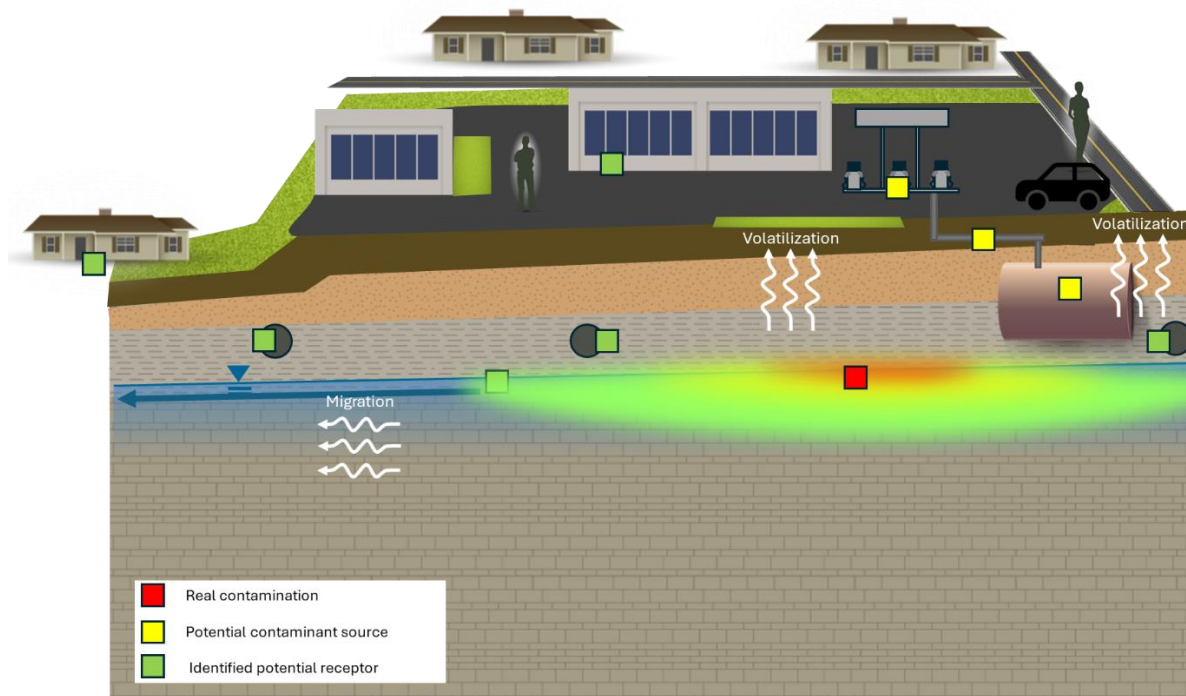
Considering these results, the following image schematically presents the real and potential contamination sources on site.

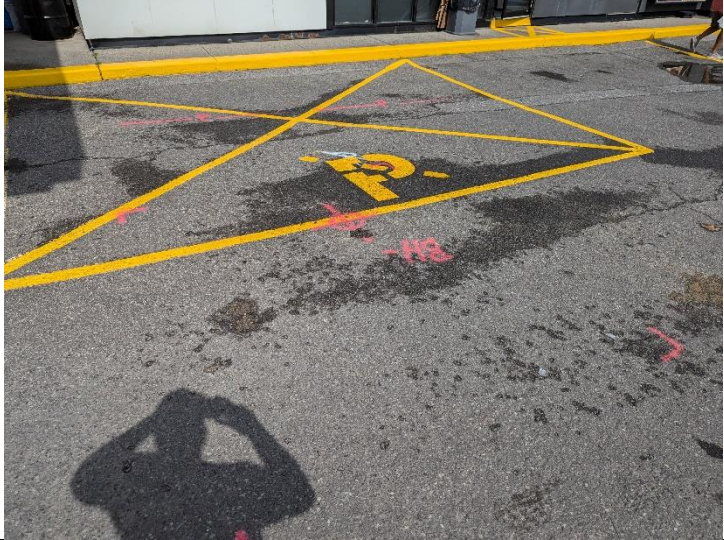
<p>Photo 5 : BH-05</p>	<p>Photo 6 : BH-06</p>

<p>Description : View of BH-05 at the location of a former mechanical garage, southwest of the pump islands.</p>	<p>Description : View of the realization of borehole BH-06 at the location of a former pump island, southeast of the actual ones.</p>
<p>Photo 7 : BH-07</p>	<p>Photo 8 : BH-08</p>

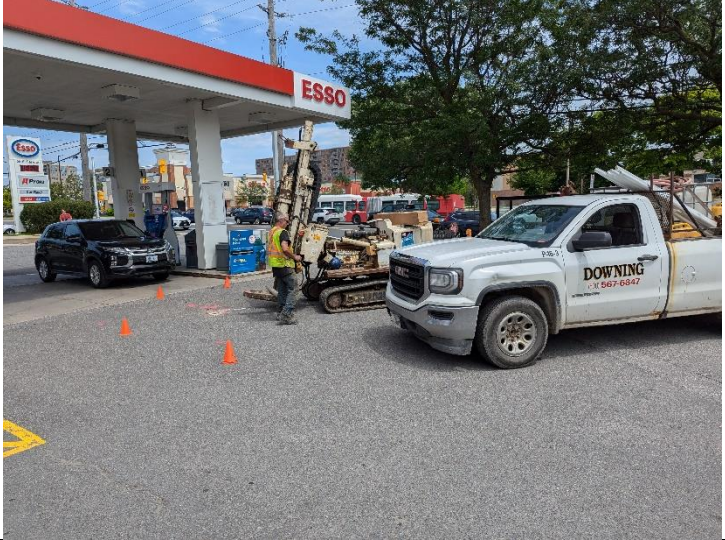
As mentioned in Section 5.3, soil samples were screened on site for visual and olfactory impacts, and VOC field measurements were conducted. Petroleum odors were detected in boreholes BH-04, located west of the pump islands, and BH-06, located southeast of the pump islands. VOC concentrations up to 84 ppm were measured in BH-06, just above the bedrock refusal. No significant values were observed in the other boreholes.

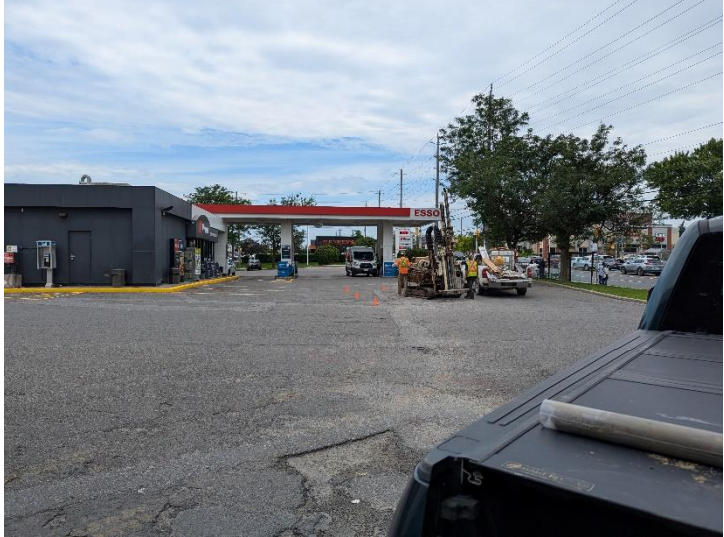
<p>Description : View of the realization of borehole BH-07, located southeast of the pump islands and south of borehole 23F01.</p>	<p>Description : View of BH-08 located south of the carwash.</p>

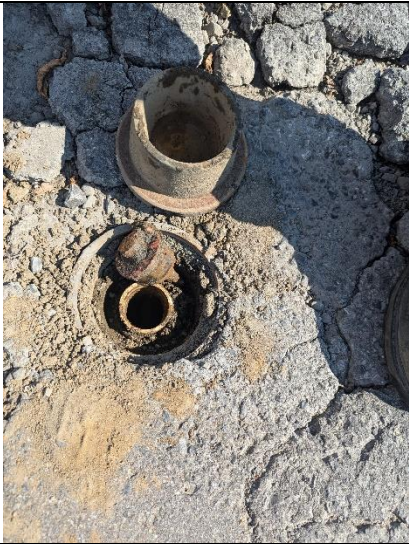
<p>Photo 9 : TH1</p>	<p>Photo 10 : TH2</p>

A visual inspection of the wells installed on site during previous studies was conducted on July 8, 2024. It was noted that some wells had the cap removed (TH6) and/or were partially filled with sediments due to a poor surface sealing (TH1, TH2, TH4, TH5, TH6). One well had the cap blocked (MW1-22).

<p>Description : View of the state of well TH1.</p>	<p>Description : View of the state of well TH2.</p>
<p>Photo 11 : TH4</p>	<p>Photo 12 : TH6</p>

It should be noted that no groundwater samples were taken from wells considered in poor condition, and some of these wells had historically non-compliant groundwater concentrations (> Table 3 standards). These wells should be replaced to ensure a complete and accurate TSSA groundwater monitoring program.

Additionally, groundwater contamination is present both on and off the site according to previous reports. It is recommended to continue the annual groundwater monitoring program with the TSSA using both existing and new wells. The damaged wells should be replaced to ensure a complete and accurate TSSA groundwater monitoring program. New wells should be constructed to intercept the groundwater interface to effectively capture LNAPL, if applicable.

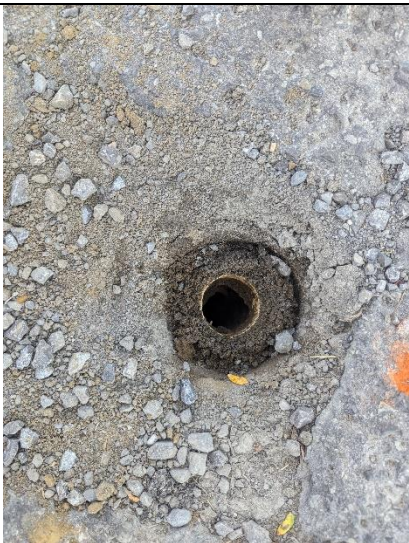
<p>Description : View of the state of well TH4.</p>	<p>Description : View of the state of well TH6.</p>
