PHASE ONE ENVIRONMENTAL SITE ASSESSMENT

5580 Manotick Main Street
Ottawa, ON
K4M 1E2

Project No. B040007

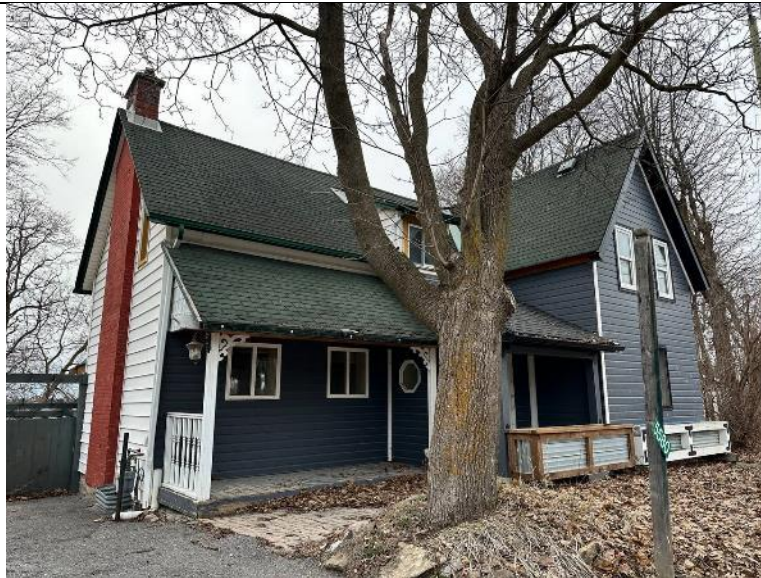
The above photograph of the front of the residential property facing Manotick Main Street shows a fuel storage tank vent pipe sticking out of the asphalt paved area on the south side of the residential building. This suggests that a fuel tank was used in the past for heating. This is an area of potential concern due to potential spills related to fuel transfer or malfunctions. No fuel tank was observed in the crawl space or basement of the residential building. This photograph was taken in the west direction.

A vent pipe was observed by Blastek on the south side of the building during the Site inspection, suggesting the presence of current or former USTs. No USTs were found during the inspection. The presence of former or current USTs was not reported by the Site representative.

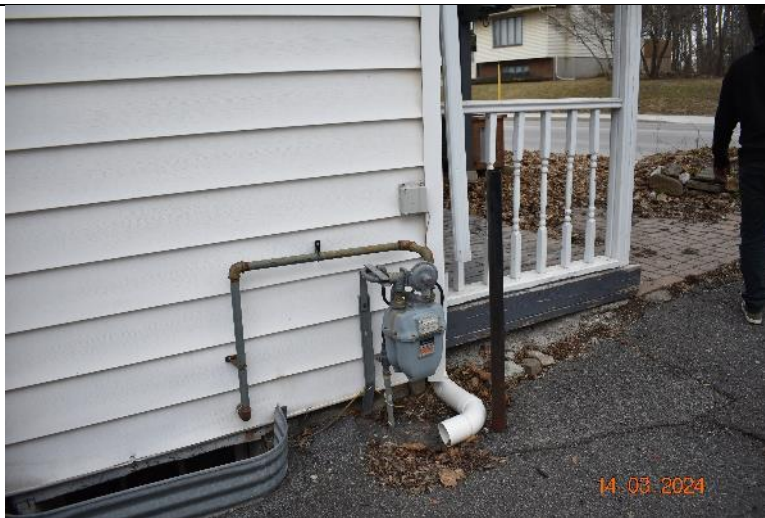
The above photograph illustrates the fuel storage tank vent on the south side of the residential building in closer detail. This photograph was taken in the north direction.

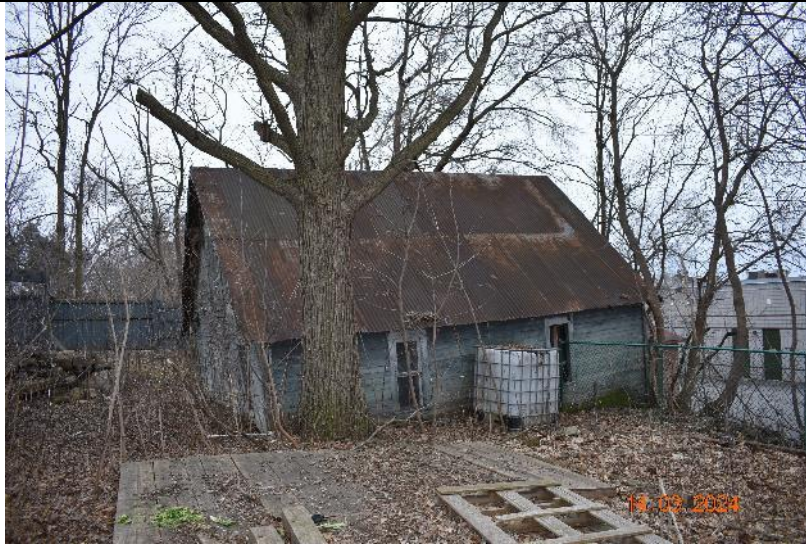
The above photograph shows the barn in the backyard of the Property, which is an area of potential environmental concern. During the interview with the Property Owner, the Property Owner stated that he was unaware of the past uses and activities that were conducted in the barn. The white tote on the north side of the barn contributes to this area of potential environmental concern. It suggest that chemicals could have been stored on the Property. This photograph was taken in the south direction.

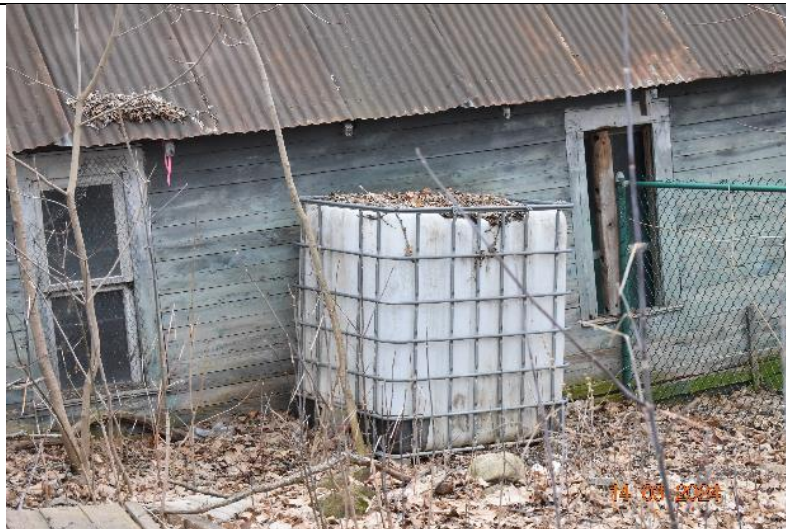
The above photograph illustrates the white tote on the north side of the barn in closer detail. This photograph was taken in the south direction.

A tote was observed on the north side of the barn in the west portion of the Property during the Site inspection, suggesting the use and storage of chemicals. The current Property owner is not aware of the past uses of the tote and has not reported any chemical use or storage on the Property. No domestic cleaning products were observed within the Property during the Site inspection.

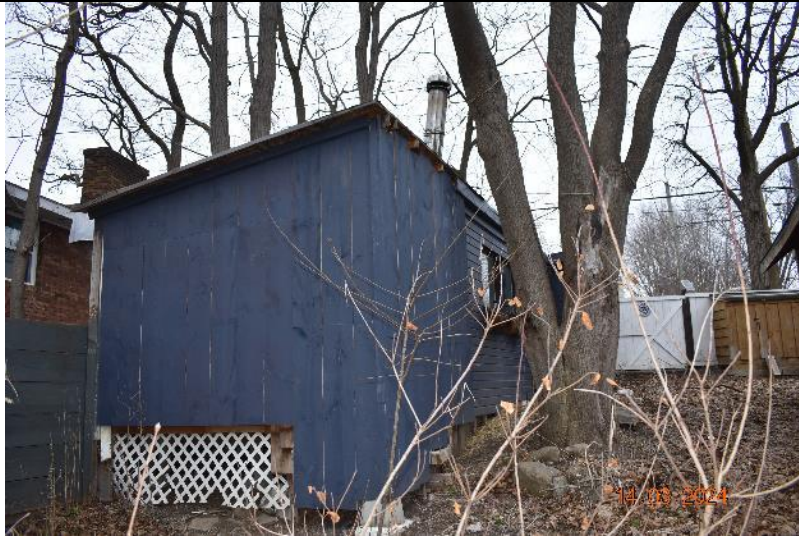
The above photograph illustrates the blue workshop on the north side of the residential property. This photograph was taken in the northeast direction.

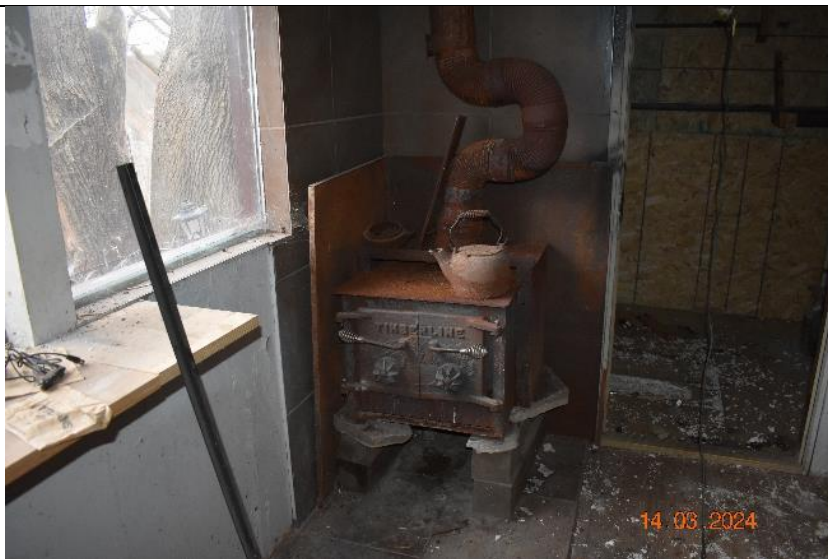
The above photograph shows the chimney and wood burning oven in the southwest corner of the workshop. The Property Owner was not aware of the date of the chimney; however, it seems old. This photograph was taken in the west direction.

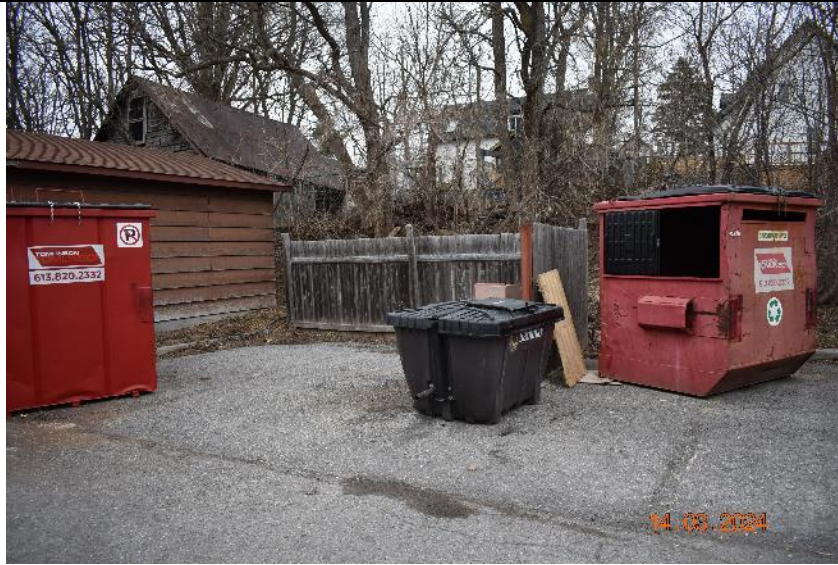
The above photograph was taken from the commercial building adjacent to the west of the Property. It illustrates the back of the Property as well as a black grease and fat storage bin located behind the Property. Oil stains can be seen on the asphalt leading to the bin, suggesting oil spills. This photograph was taken in the northeast direction.

No significant oil or chemical staining was noted on the surfaces of the concrete slab floors, or on finished or landscaped surfaces exterior to the Site building. Oil staining was observed on the asphalt near the grease and fat storage bin to the west of the Site, suggesting the spillage of oil. No monitoring wells, distressed vegetation or abnormal odours, suggesting the presence of significant chemical or petroleum spills or releases, were noted at the time of the Site inspection.

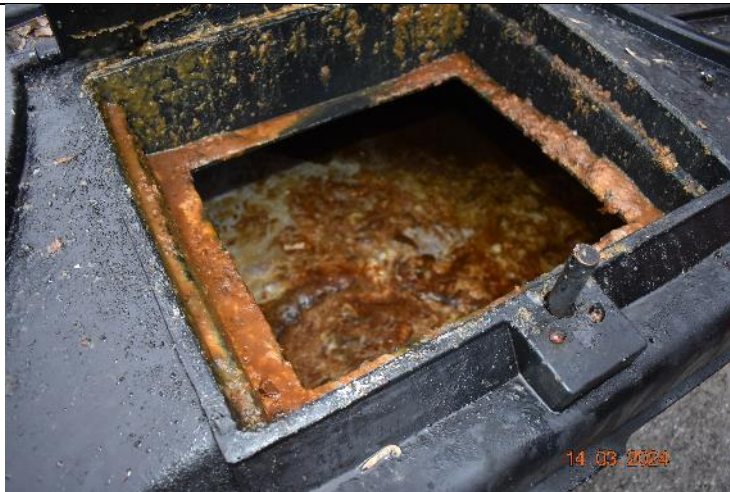
The above photograph illustrates the contents of the black bin located on the commercial property to the west of the Property. Grease, fat and oil were found inside as well as on top of the bin. The fats found inside the bin probably originated from the Pearl House Dining Lounge, a restaurant located directly southwest of the Property, at 1160 Beaverwood Road. The restaurant is shown in the photograph below. This photograph was taken in the north direction.

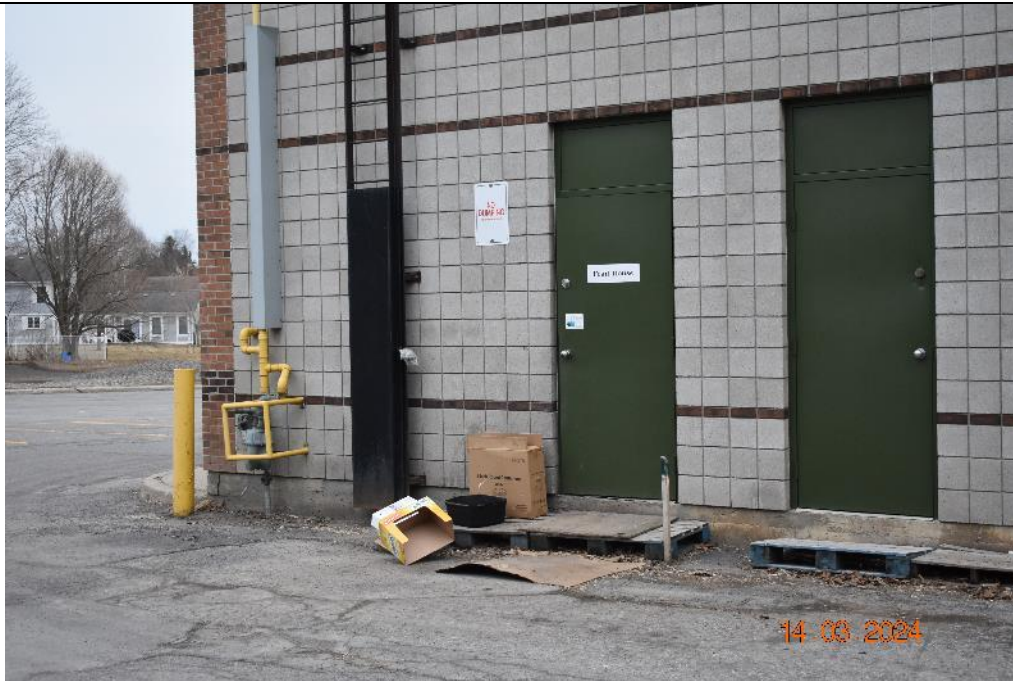
The above photograph shows the back of the Pearl House Dining Lounge restaurant located at 1160 Beaverwood Road. This photograph was taken in the southwest direction.
