**Phase I  
Environmental Site Assessment  
3955 Kelly Farm Drive  
Ottawa, Ontario**

March 10, 2021  
Project: 100441.001 – V02

**Re: Phase I ESA**  
**3955 Kelly Farm Drive**  
**Ottawa, Ontario**

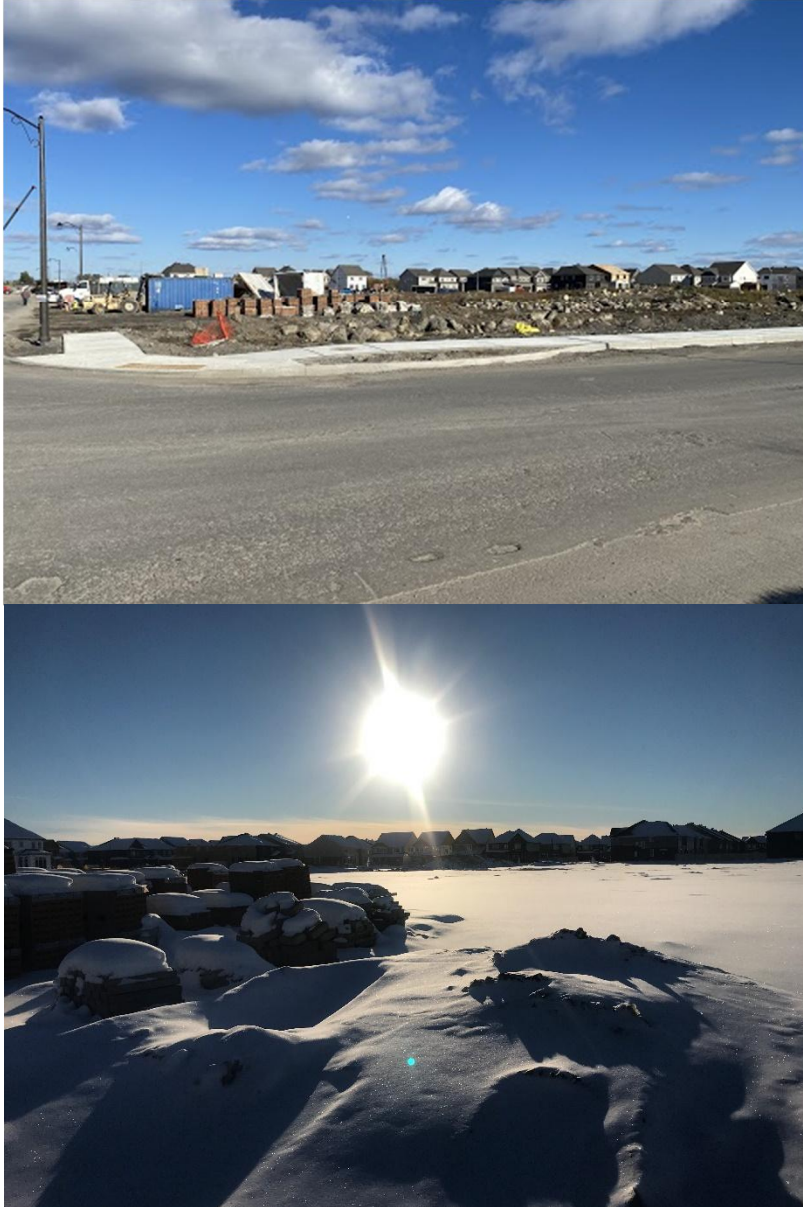
Photograph I1

Southeast – Overview of the subject property (Fall and Winter).

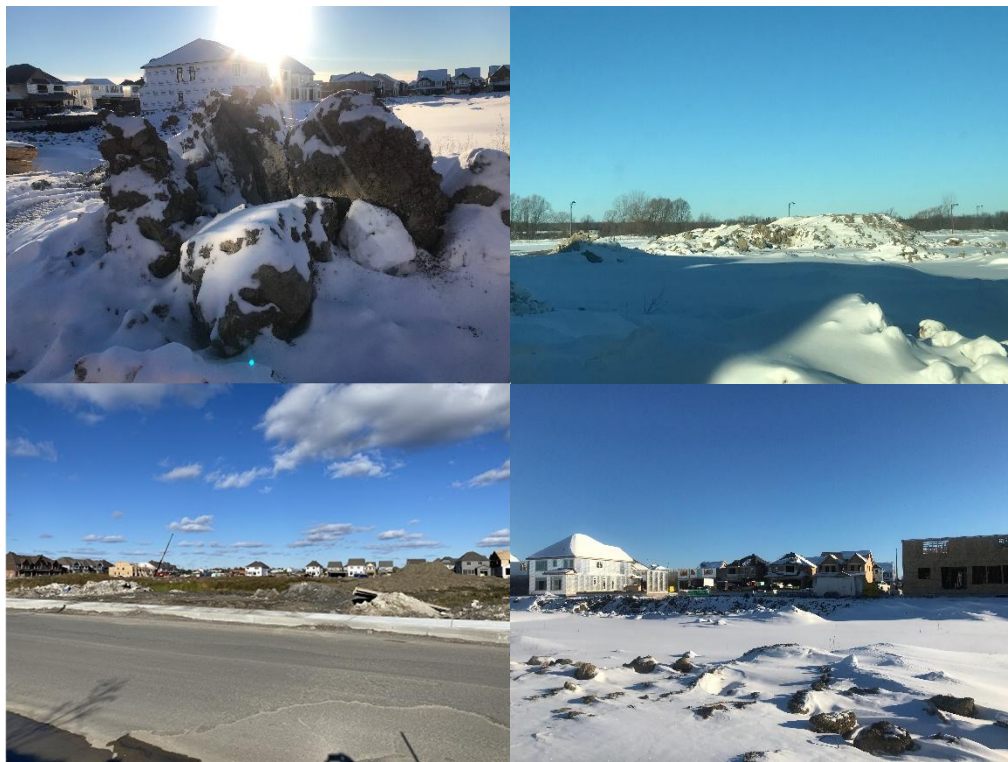
Photograph I2

Fill materials were observed on the subject property during the site reconnaissance. However fill material is anticipated to be present on the subject property based on historical aerial photographs reviewed for the subject property.

Moving Clockwise: Southeast, Northwest, Southwest and, Northeast  
– Fill Material identified on the subject site.

The completion of a Phase II ESA is recommended to investigate soil and groundwater quality within the APECs on the subject property.

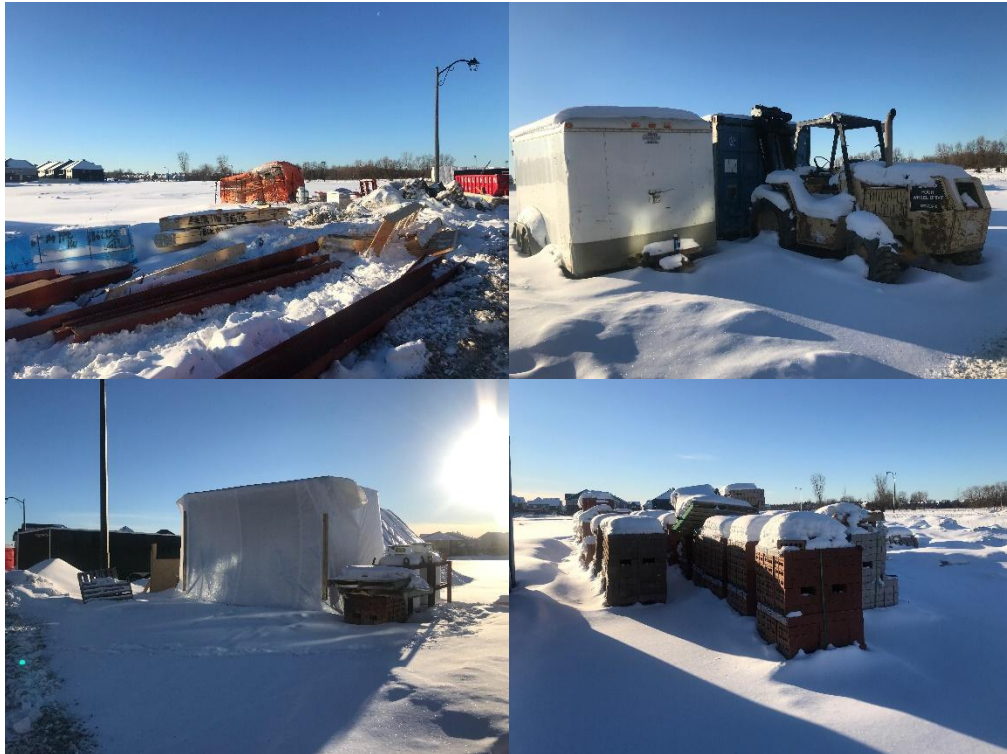
Photograph H3

Moving Clockwise: Southeast, Southwest, Southeast, and Northeast  
– Construction debris identified on the subject site.

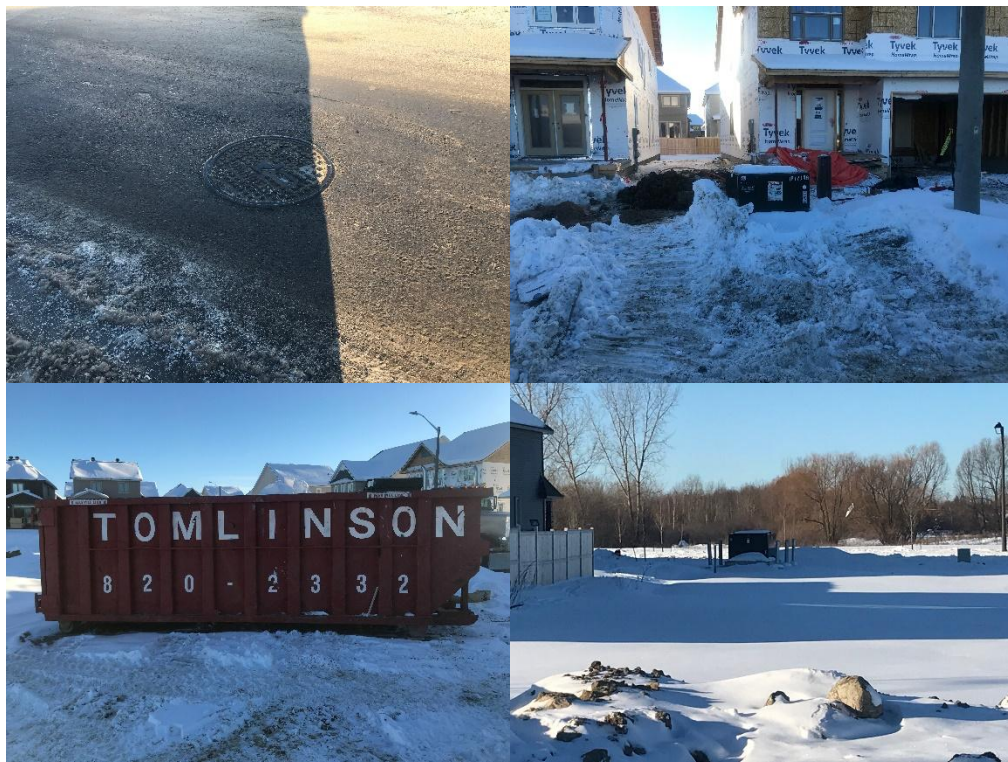
Photograph H4

Pad mounted transformers were identified on the subject property and within the study area at the time of site reconnaissance. The transformers appeared to be in good condition, however indications of leaking could not be commented on due to the presence of snow cover.

Moving Clockwise: Northwest, Southeast, Southwest, and Northeast, – Manholes, adjacent construction site, pad mounted transformer, and waste bin at the subject property and in the study area.
