Muncaster
Environmental
Planning Inc.

RE: 145 Walgreen Road
Scoped Environmental Impact Study

I have completed a scoped Environmental Impact Study (EIS) for the proposed redevelopment of an existing truck yard at 145 Walgreen Road in the northwest portion of Stittsville in the rural/urban expansion area of the City of Ottawa. The site is on the south side of Walgreen Road, about 100 metres east of the south terminus of Westbrook Road. For the purposes of this report, Walgreen Road is considered to be in an east-west orientation.

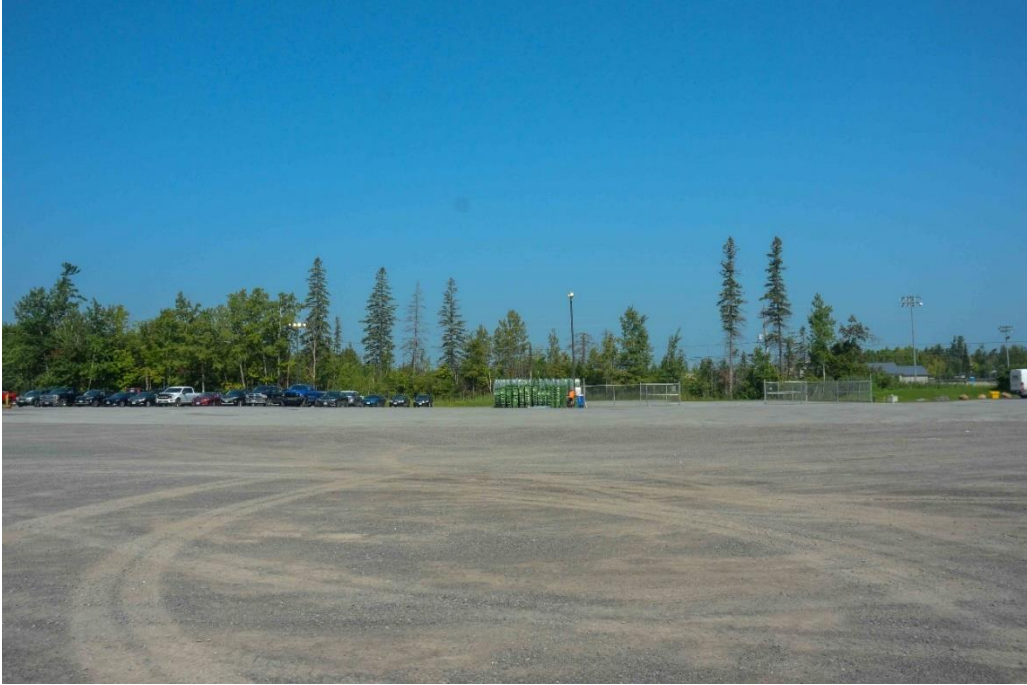
Another mixed hedgerow is along the north portion of the site. This hedgerow is intermittent and contains generally smaller trees (Photo 1). Red oak, Scot's pine, white spruce, bur oak, trembling aspen, balsam poplar, white birch, green ash, and basswood are representative of the tree species in the north hedgerow, with the largest aspens up to 30cm dbh. Some of the poplars and the two white spruce in the east portion of the north hedgerow showed decreased leaf-out.

Photo 1 – Typical existing conditions of the site. This example is looking north towards the intermittent mixed hedgerow and Walgreen Road, from the south edge of the compound

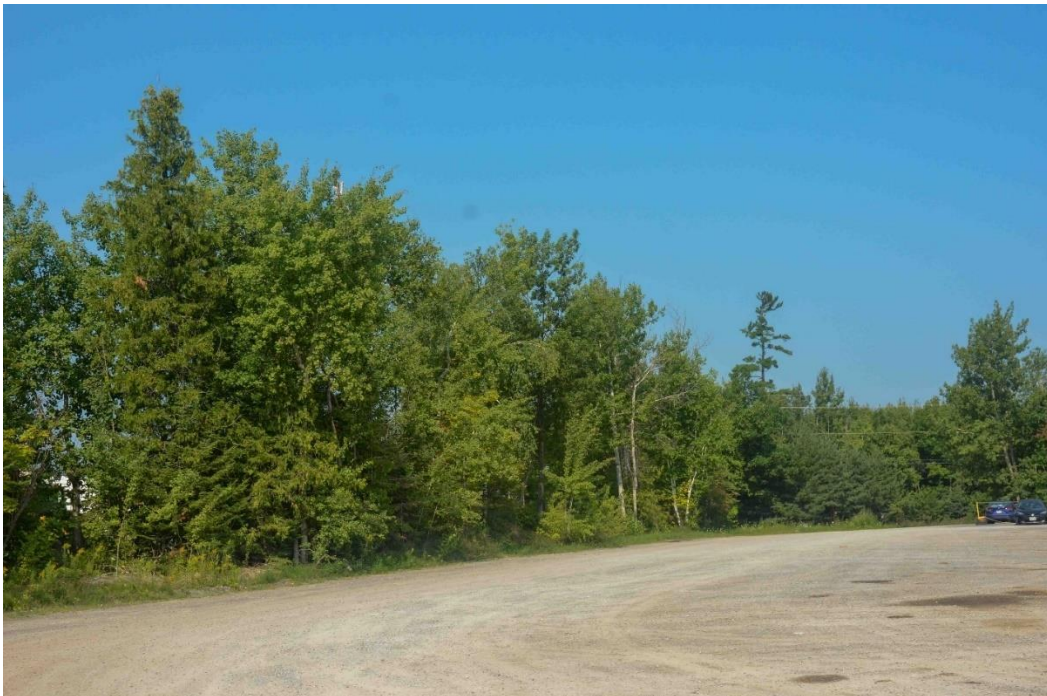
The site is generally level, with a very gentle slope to the north. The site is dominated by compacted gravel (Photos 1 and 2). Ditches are mapped on the geoOttawa layer in the south portion of the site within the 12 metres easement. A roadside channel is mapped along the north side of Walgreen Road, with a north-south channel approximately 35 metres to the east of the site. These channels flow into the wetland to the southeast of the site. Standing water with limited flow was observed in these channels on August 13th. The channels may support intermittent direct fish habitat for forage fish extending north from the wetland marsh during higher flow periods, and the flows in the channels would indirectly contribute to the fish habitat in the downstream wetland marsh.

Photo 2 – West portion of the site, looking northwest to the hedgerows along the site periphery

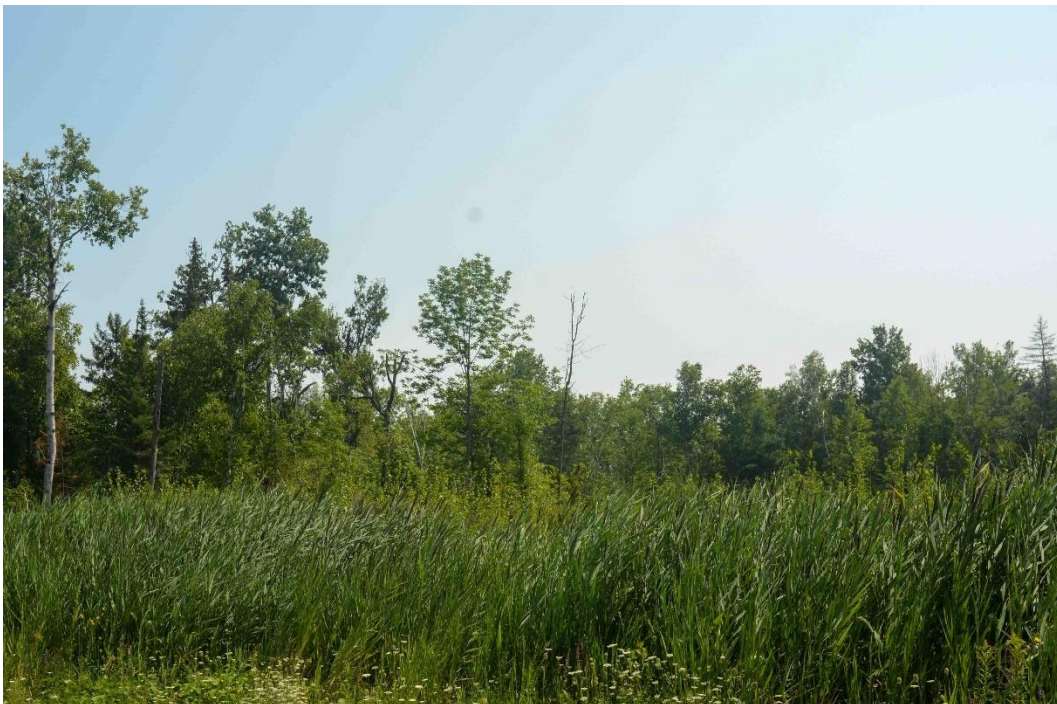
Pockets of standing water were noted among the common reed in the 12 metre easement along the south portion of the site. No flow was observed and the water depth was less than 5cm. Other than vegetation, no potential aquatic habitat features such as coarse substrate, woody debris, a defined low flow channel, or undercut banks were observed among the common reed and cattails and there was no defined channel connection to the north-south channel to the east. No potential fish habitat is considered present in the 12 metre easement along the south portion of the site.

Common reed (*Phragmites*) is dominant in the 12 metre easement along the south portion of the site (Photo 4). Purple loosestrife, reed canary grass, bugleweed, broad-leaved cattail, narrow-leaved goldenrod, and glossy buckthorn shrubs were also observed in the easement, along with regenerating white elm, poplar, and white elm stems.

*Photo 4 – Common reed in the 12 metre easement along the south portion of the site.
View looking south to remaining trees to the south of the site*

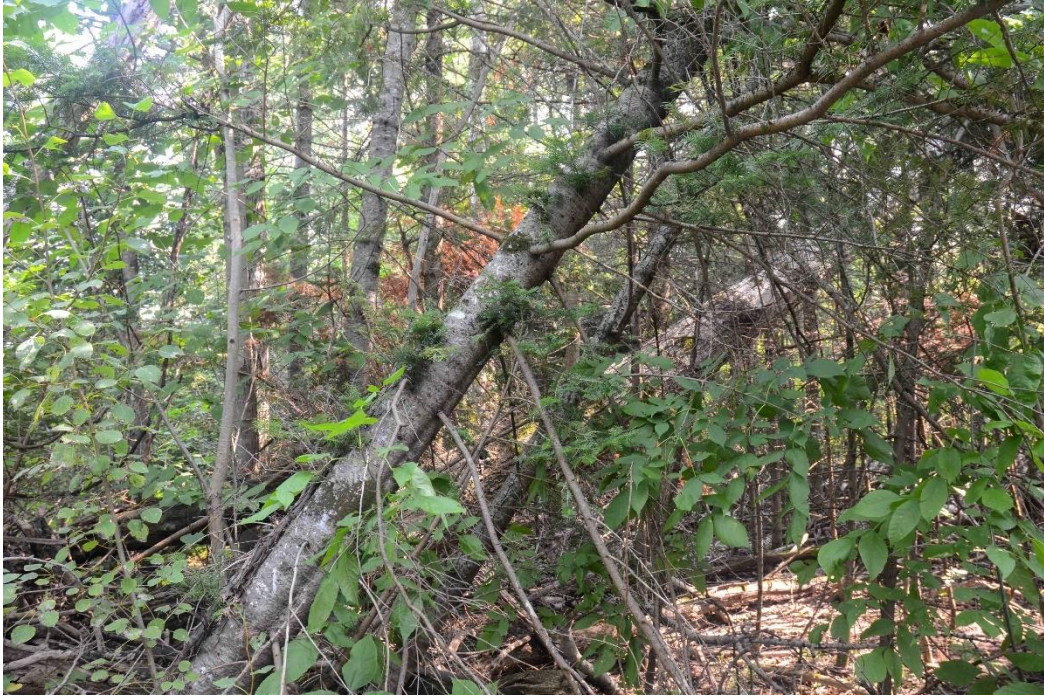
The majority of trees within 100 metres of the south site boundary have been removed by the adjacent owner. A width of approximately 35 metres of trees remains adjacent to the southeast corner of the site. The remaining outer trees are young trembling aspen, large-toothed aspen, white spruce, and balsam fir up to 20cm dbh. Larger trees are further south, with for example a 32cm dbh trembling aspen about eight metres south of the property line. Red oak and white cedar are also present in the upland mixed forest. Wind damage is extensive in the remnant forest (Photo 5). Regenerating poplar, white ash, white cedar, and balsam fir stems are in the understory, along with glossy buckthorn shrubs. Ground flora in the adjacent upland mixed forest included poison ivy, wild grape, thicket creeper, and Canada mayflower. No wetland habitat was observed within thirty metres to the south of the site.

Photo 5 – The remaining trees immediately to the southeast site boundary are generally young with windthrow extensive. View looking east
