Trail Road BESS Station and Transmission Line Tree Conservation Report

October 30, 2025

Hatch Project #375035

Appendix B: Site Layout Figure

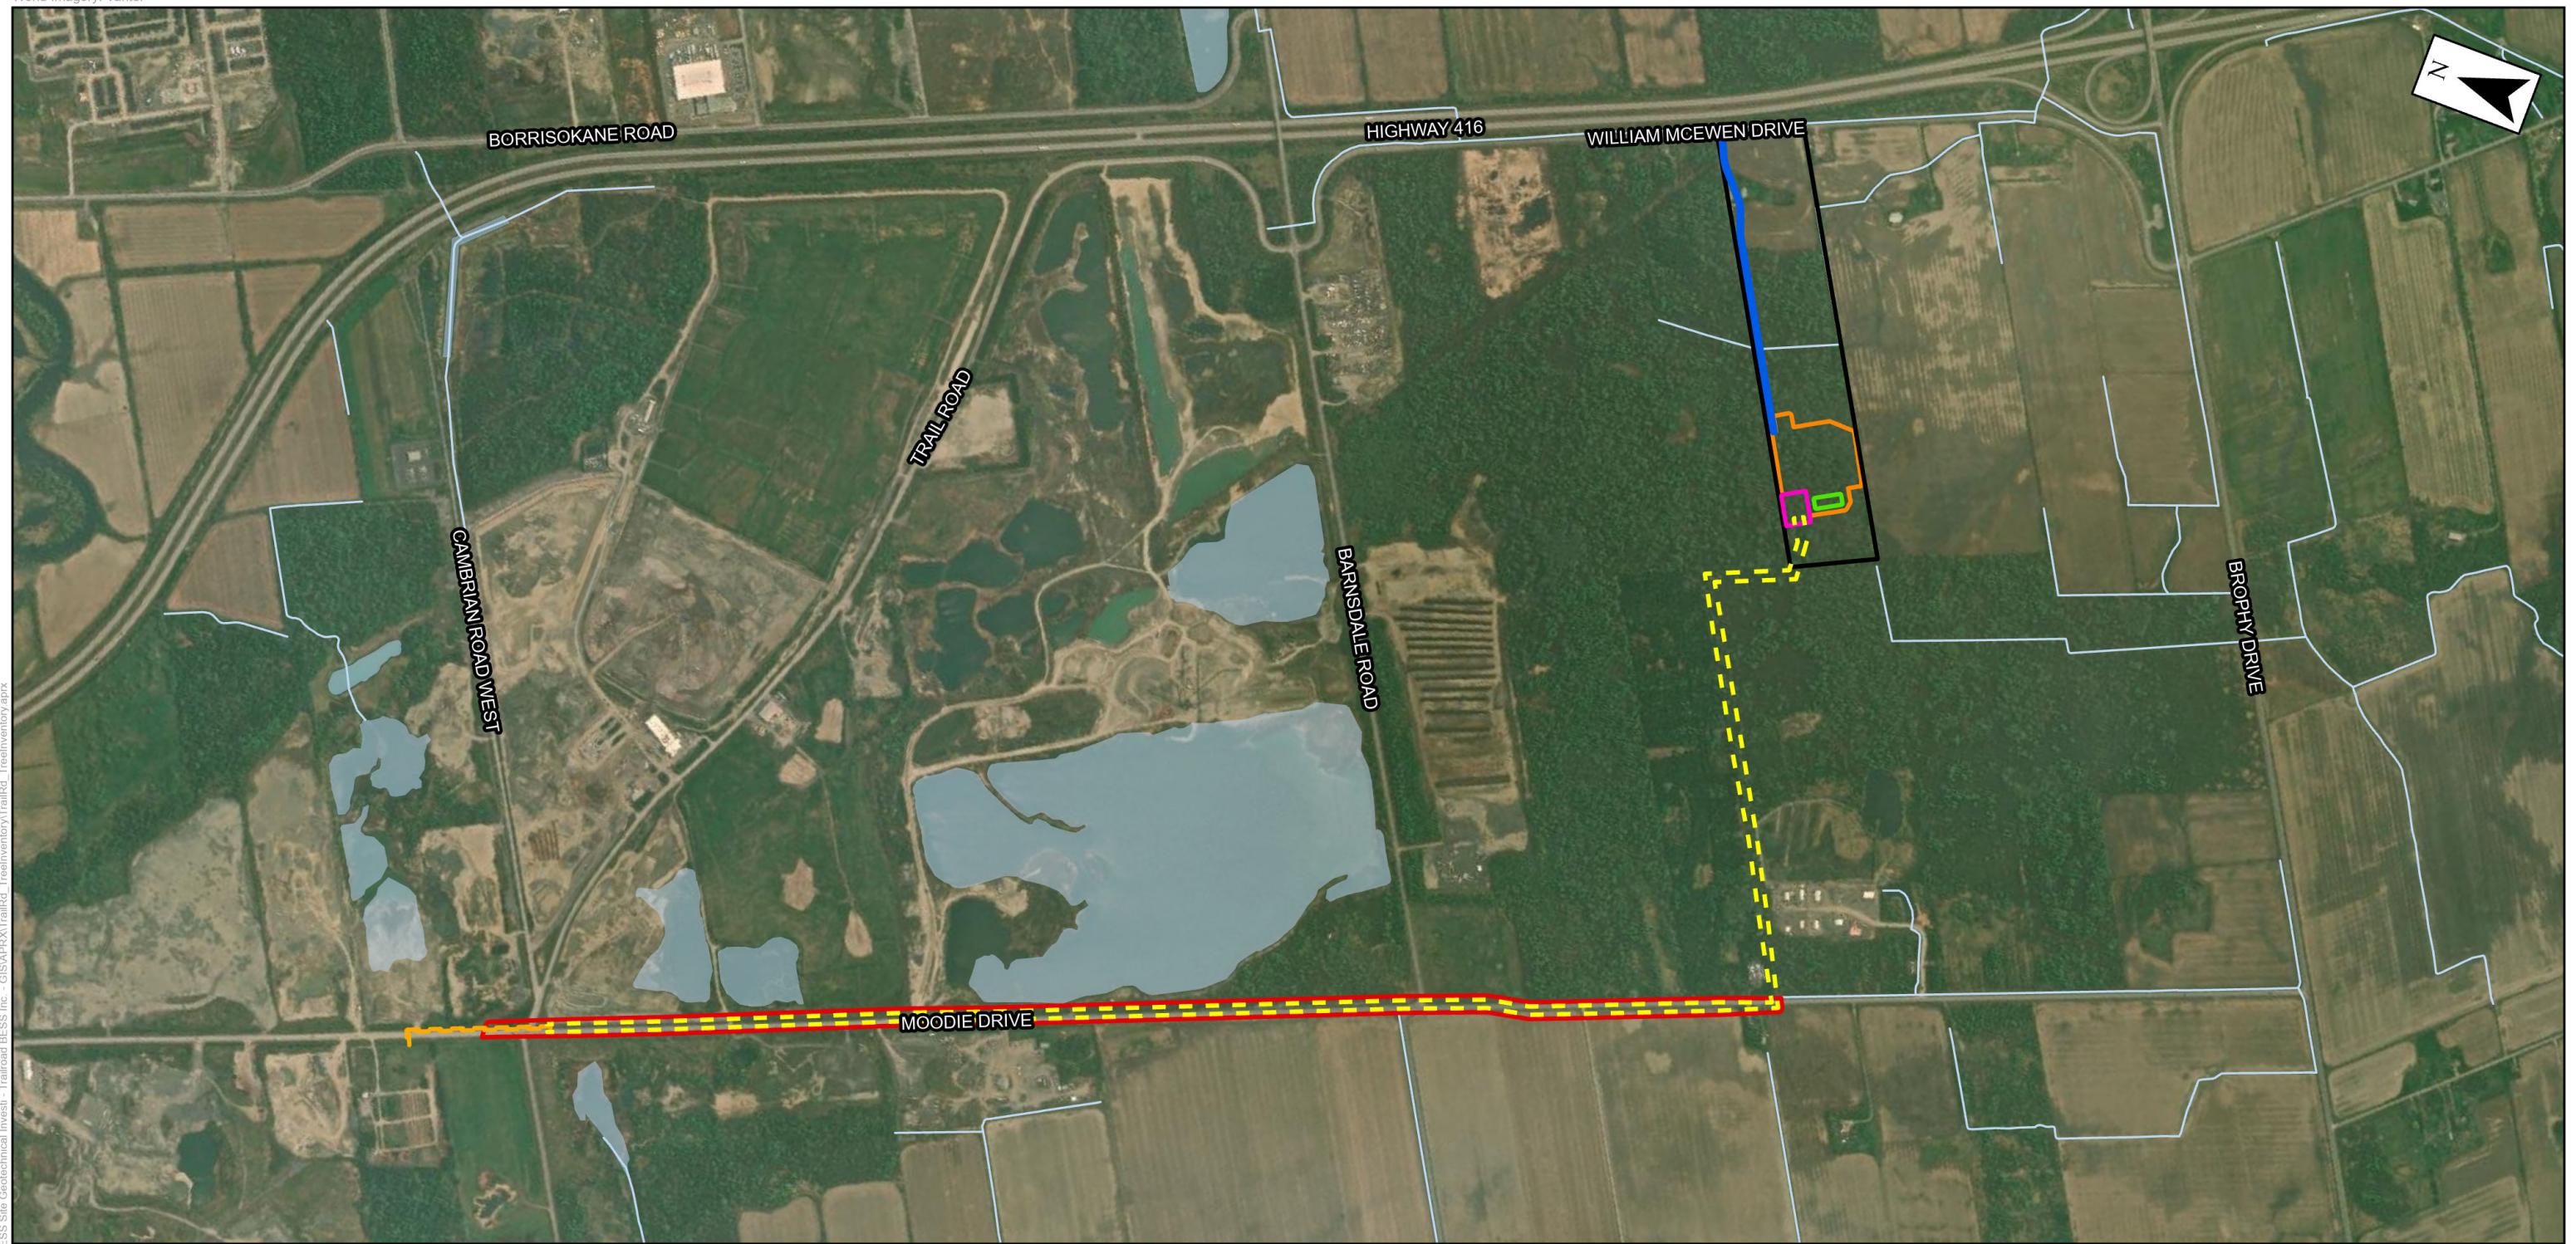
- Underground Transmission Line Corridor
- Tree Survey Study Area (10m Buffer)
- BESS Area
- Property Line
- Proposed Access Road
- Stormwater Pond
- Substation Area
- Watercourse (RVCA)
- Waterbody (RVCA)

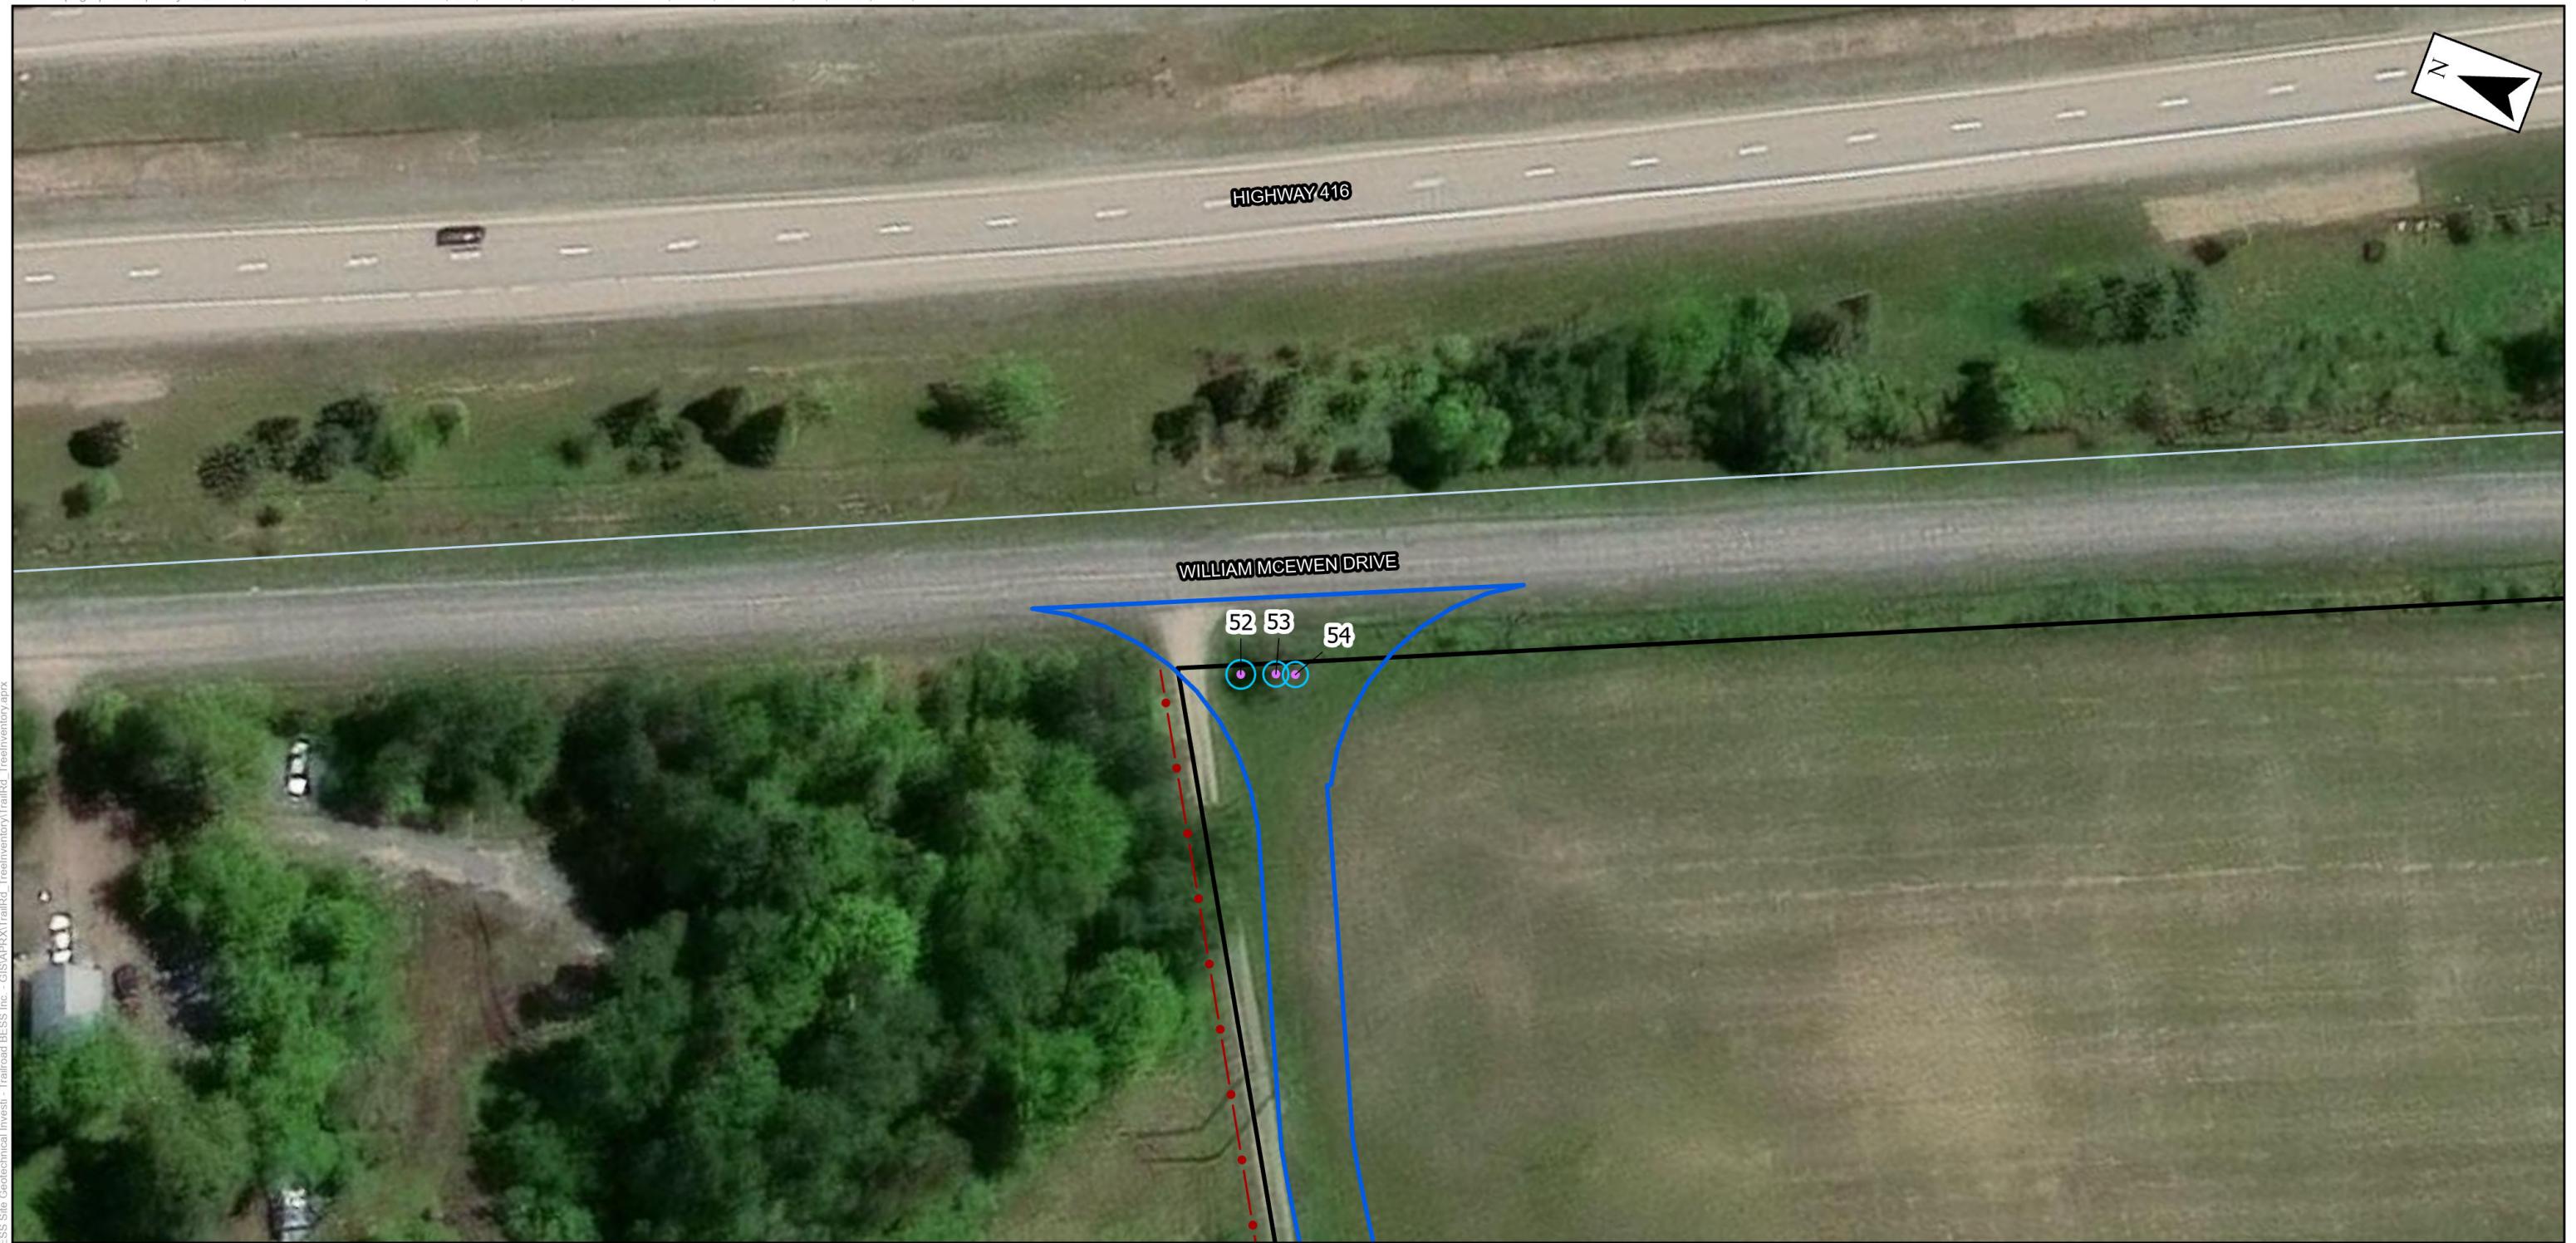
Appendix C: Tree Removal, Injury and Retention Figure

- Tree to be Removed
- Tree Protection Fence (TPF)
- Watercourse (RVCA)
- Property Line
- Proposed Access Road
- Critical Root Zone (CRZ)

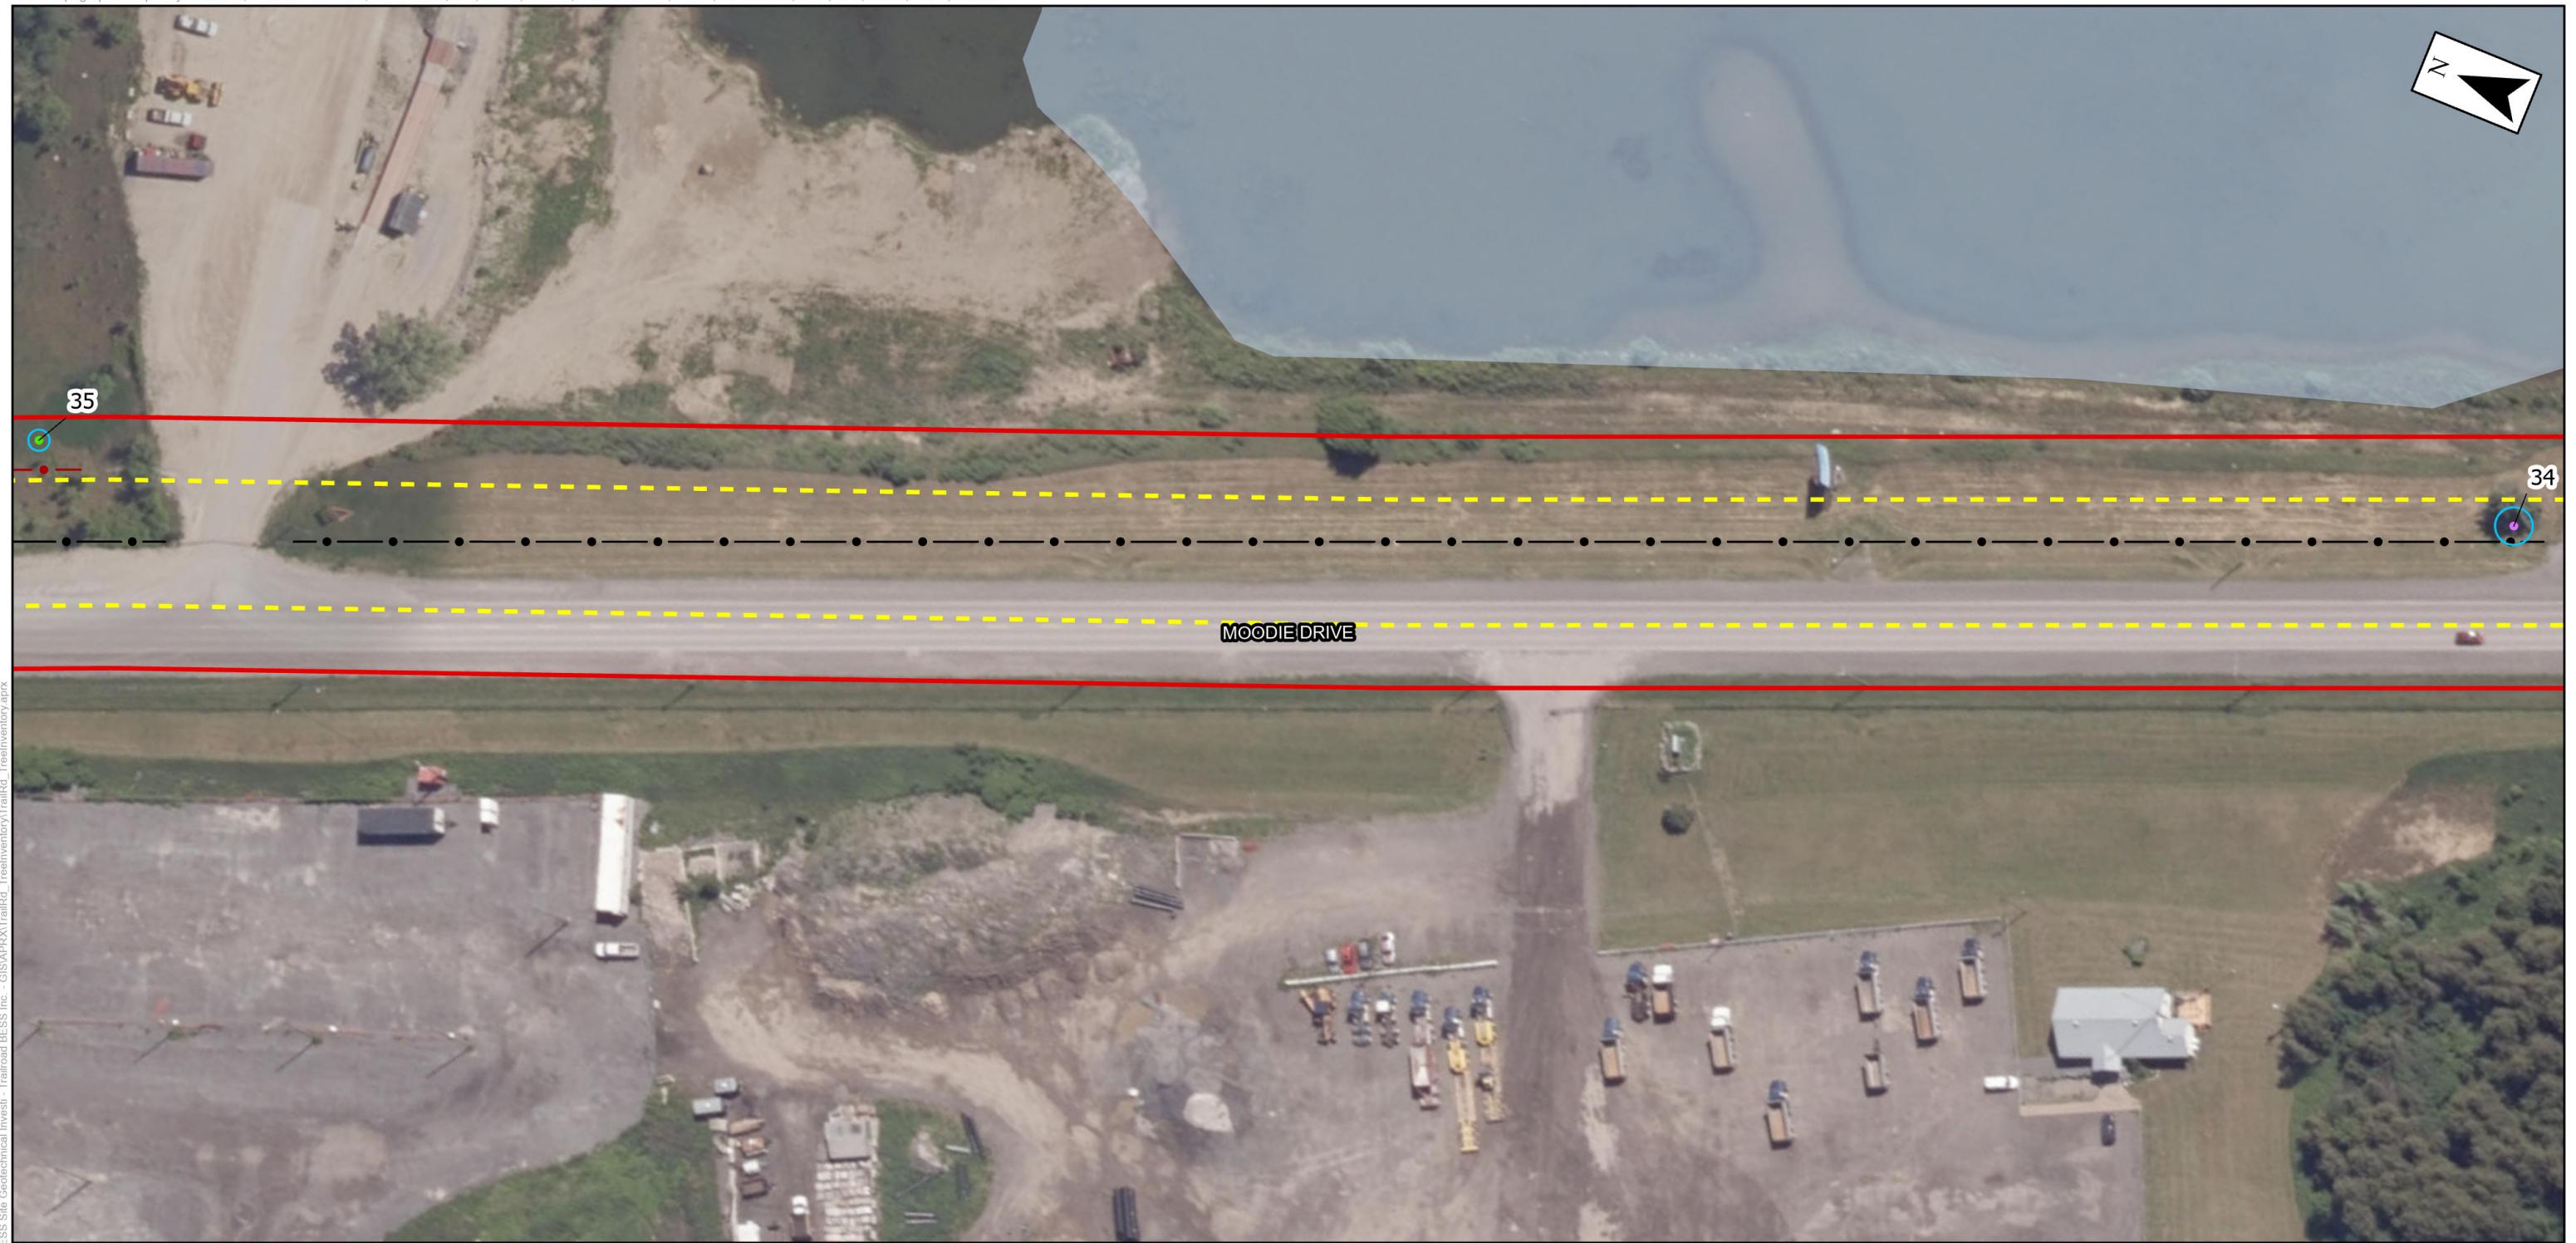
- Tree to be Removed
- Tree to be Preserved
- Existing Fenceline
- Tree Protection Fence (TPF)
- Waterbody (RVCA)
- Critical Root Zone (CRZ)
- Transmission Line Corridor
- Tree Survey Study Area (10m Buffer)
