Report

Trail Road Battery Energy Storage System (BESS)  
Fluvial Geomorphology Assessment

H375035-0000-2B0-066-0001

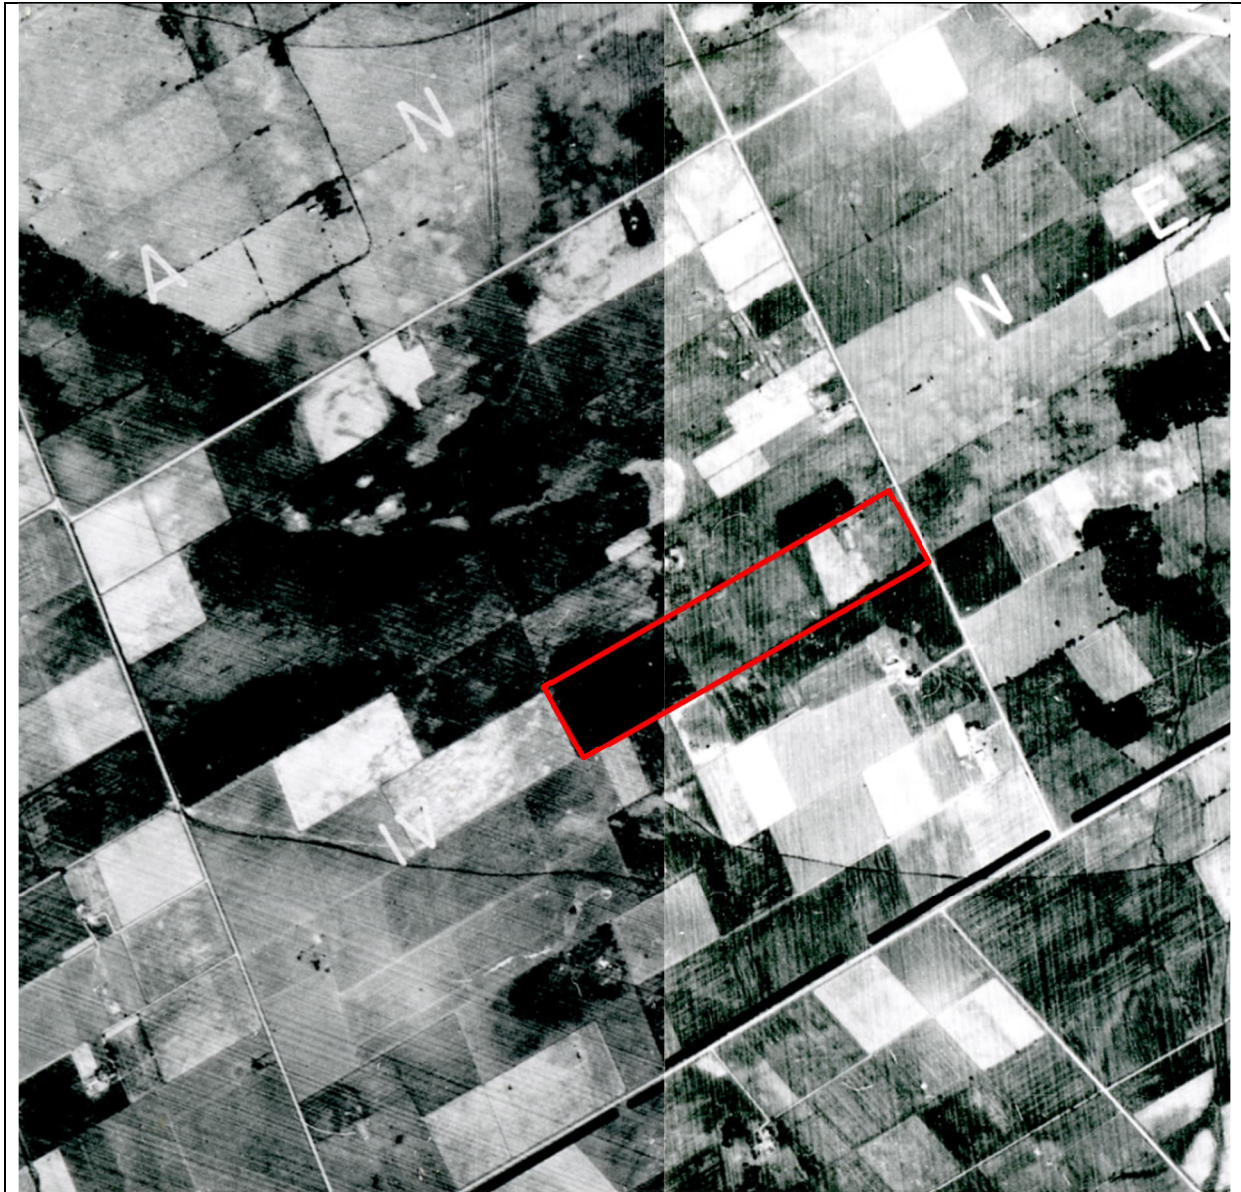
**Year:** 1954

**Red Boundary:** Site Limits

Between 2002 and 2004, the watercourse is present in good condition, with no observable changes compared to the 1954 aerial photography. The surrounding land use appears unchanged.
