Report

Trail Road Battery Energy Storage System (BESS)  
Fluvial Geomorphology Assessment

H375035-0000-2B0-066-0001

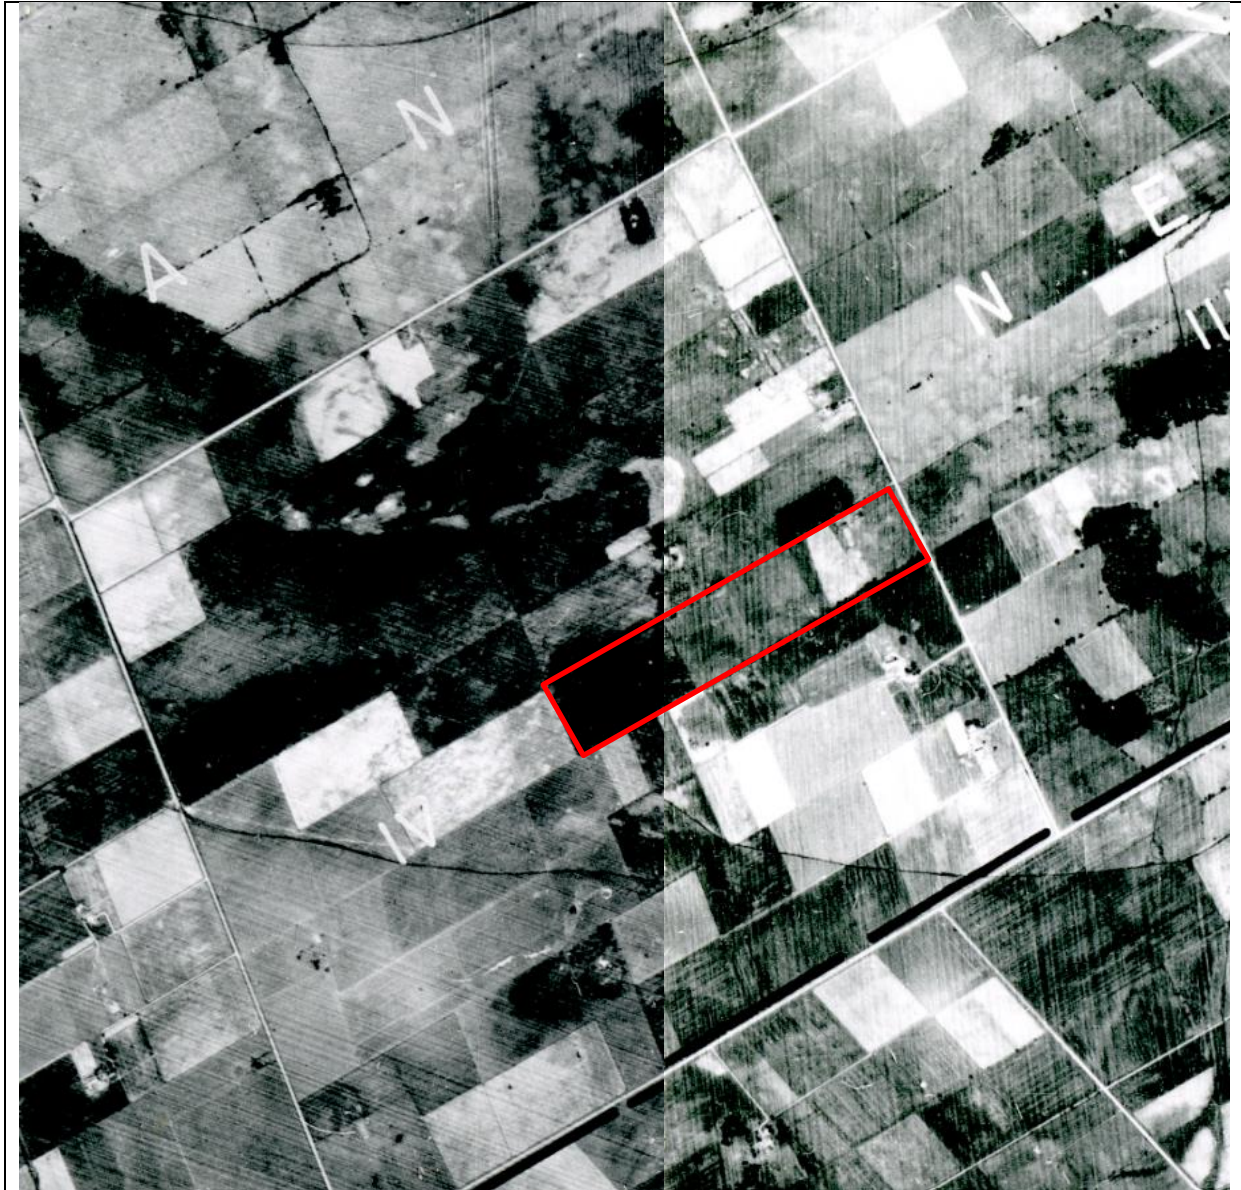
**Year:** 1954

Between 2002 and 2004, the watercourse is present in good condition, with no observable changes compared to the 1954 aerial photography. The surrounding land use appears unchanged.
