# VUZE Construction

1015 Tweddle Road

## TREE CONSERVATION REPORT

CIMA+ file number: Z0018492  
18 November 2025 - Review 002

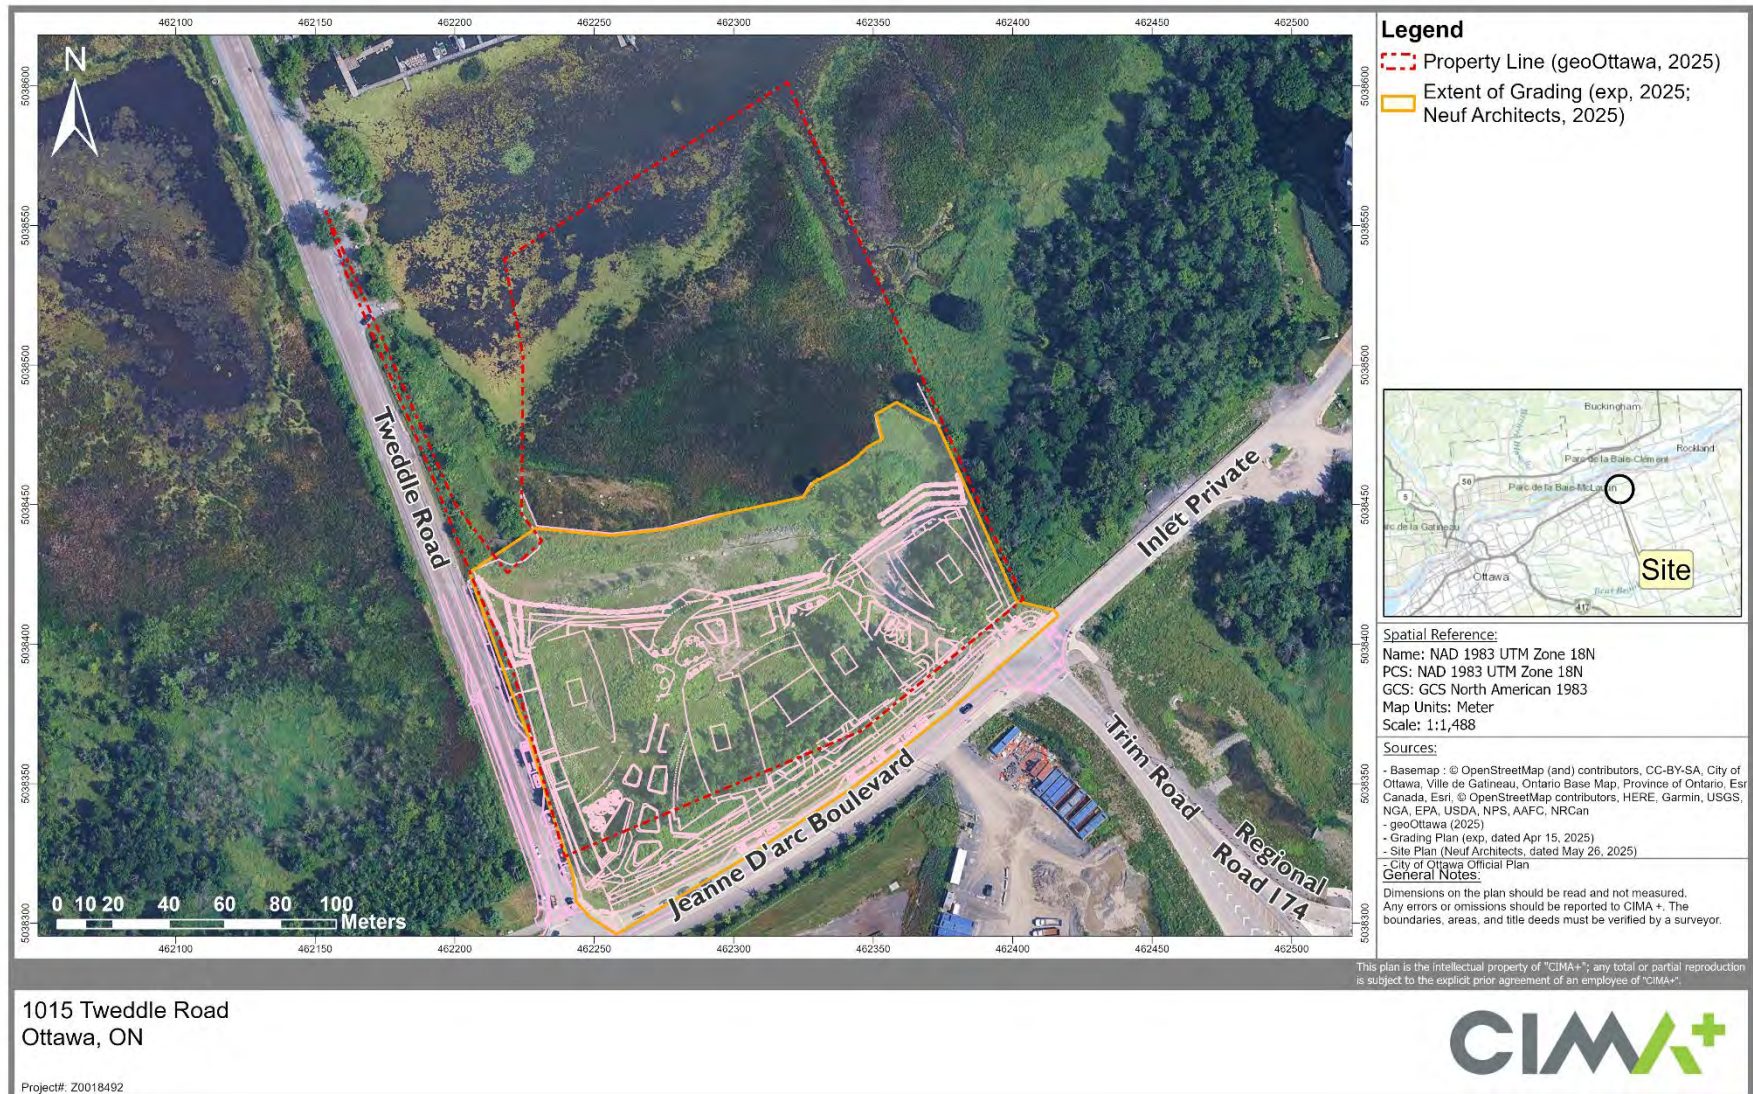
Figure 1: Property Location and Proposed Works

VUZE Construction, hereafter referred to as the proponent, intends to develop the property at 1015 Tweddle Road (the “Property”), situated at the northeast corner of the intersection at Tweddle Road and Jeanne d’Arc Boulevard North. As of 2022, Bowfin merged its services with CIMA+ who has taken over the mandate of updating this Tree Conservation Report (TCR) as per the City of Ottawa’s Tree Conservation Report Guidelines (2021).

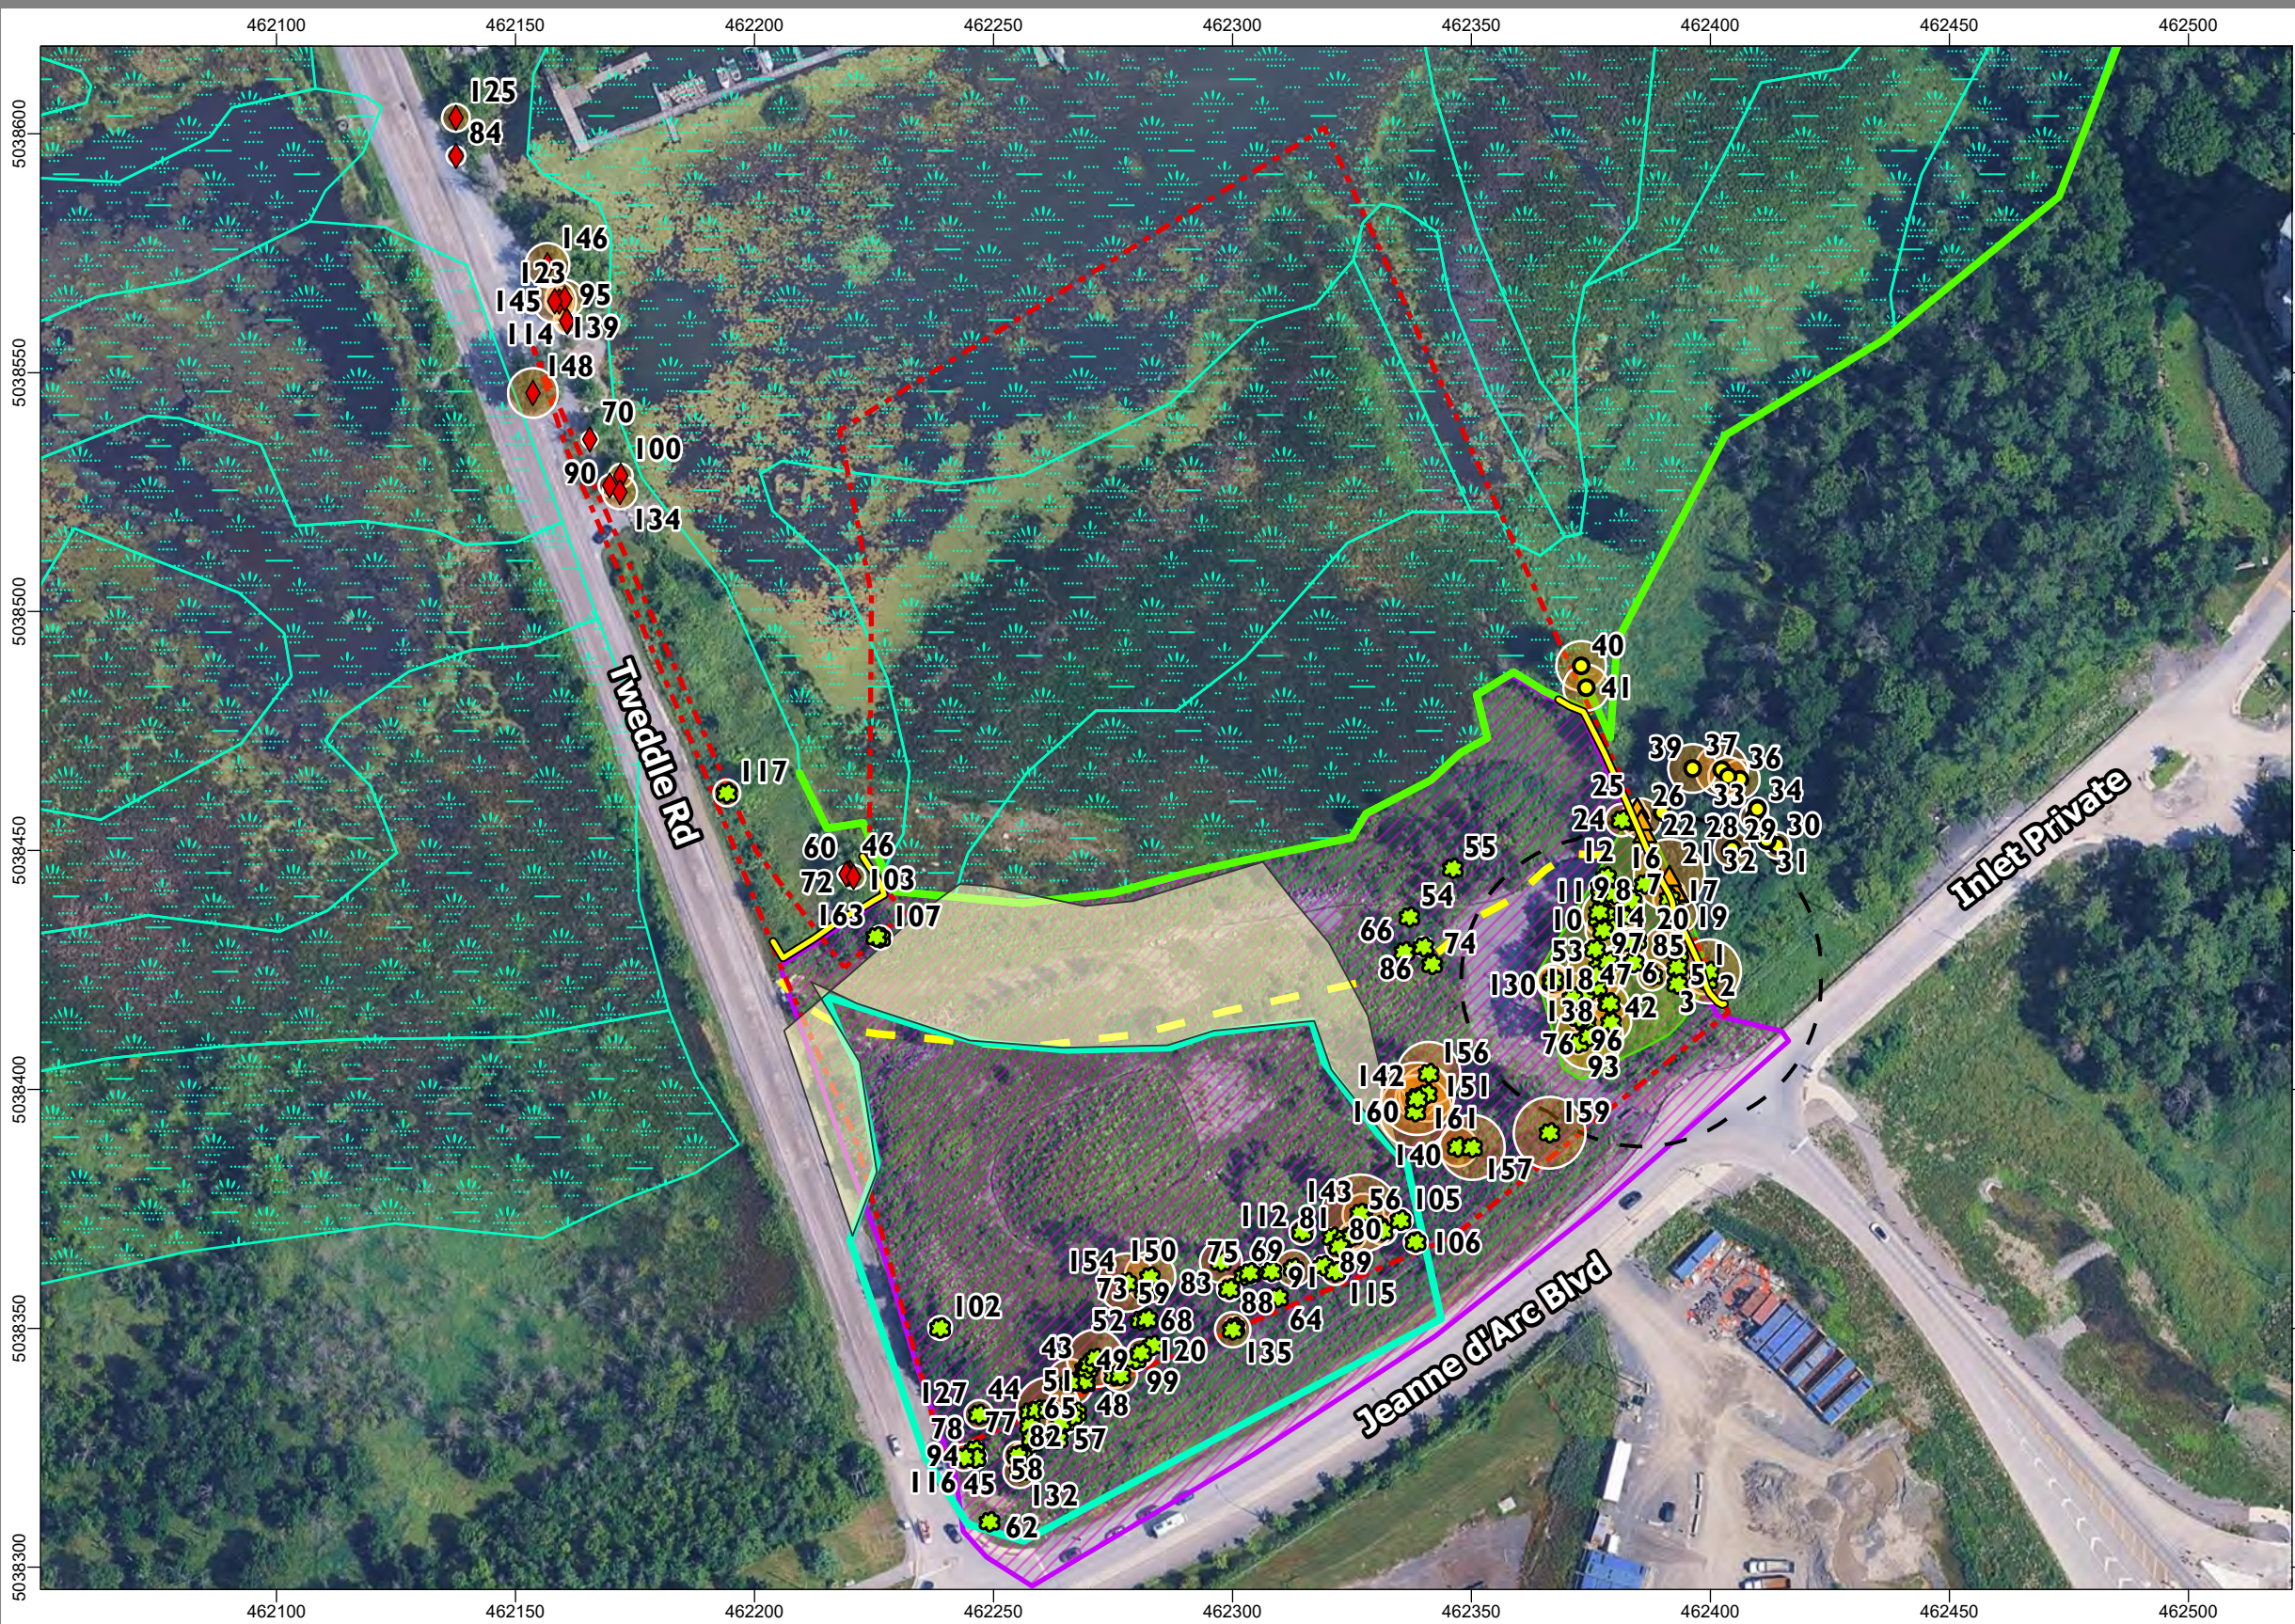
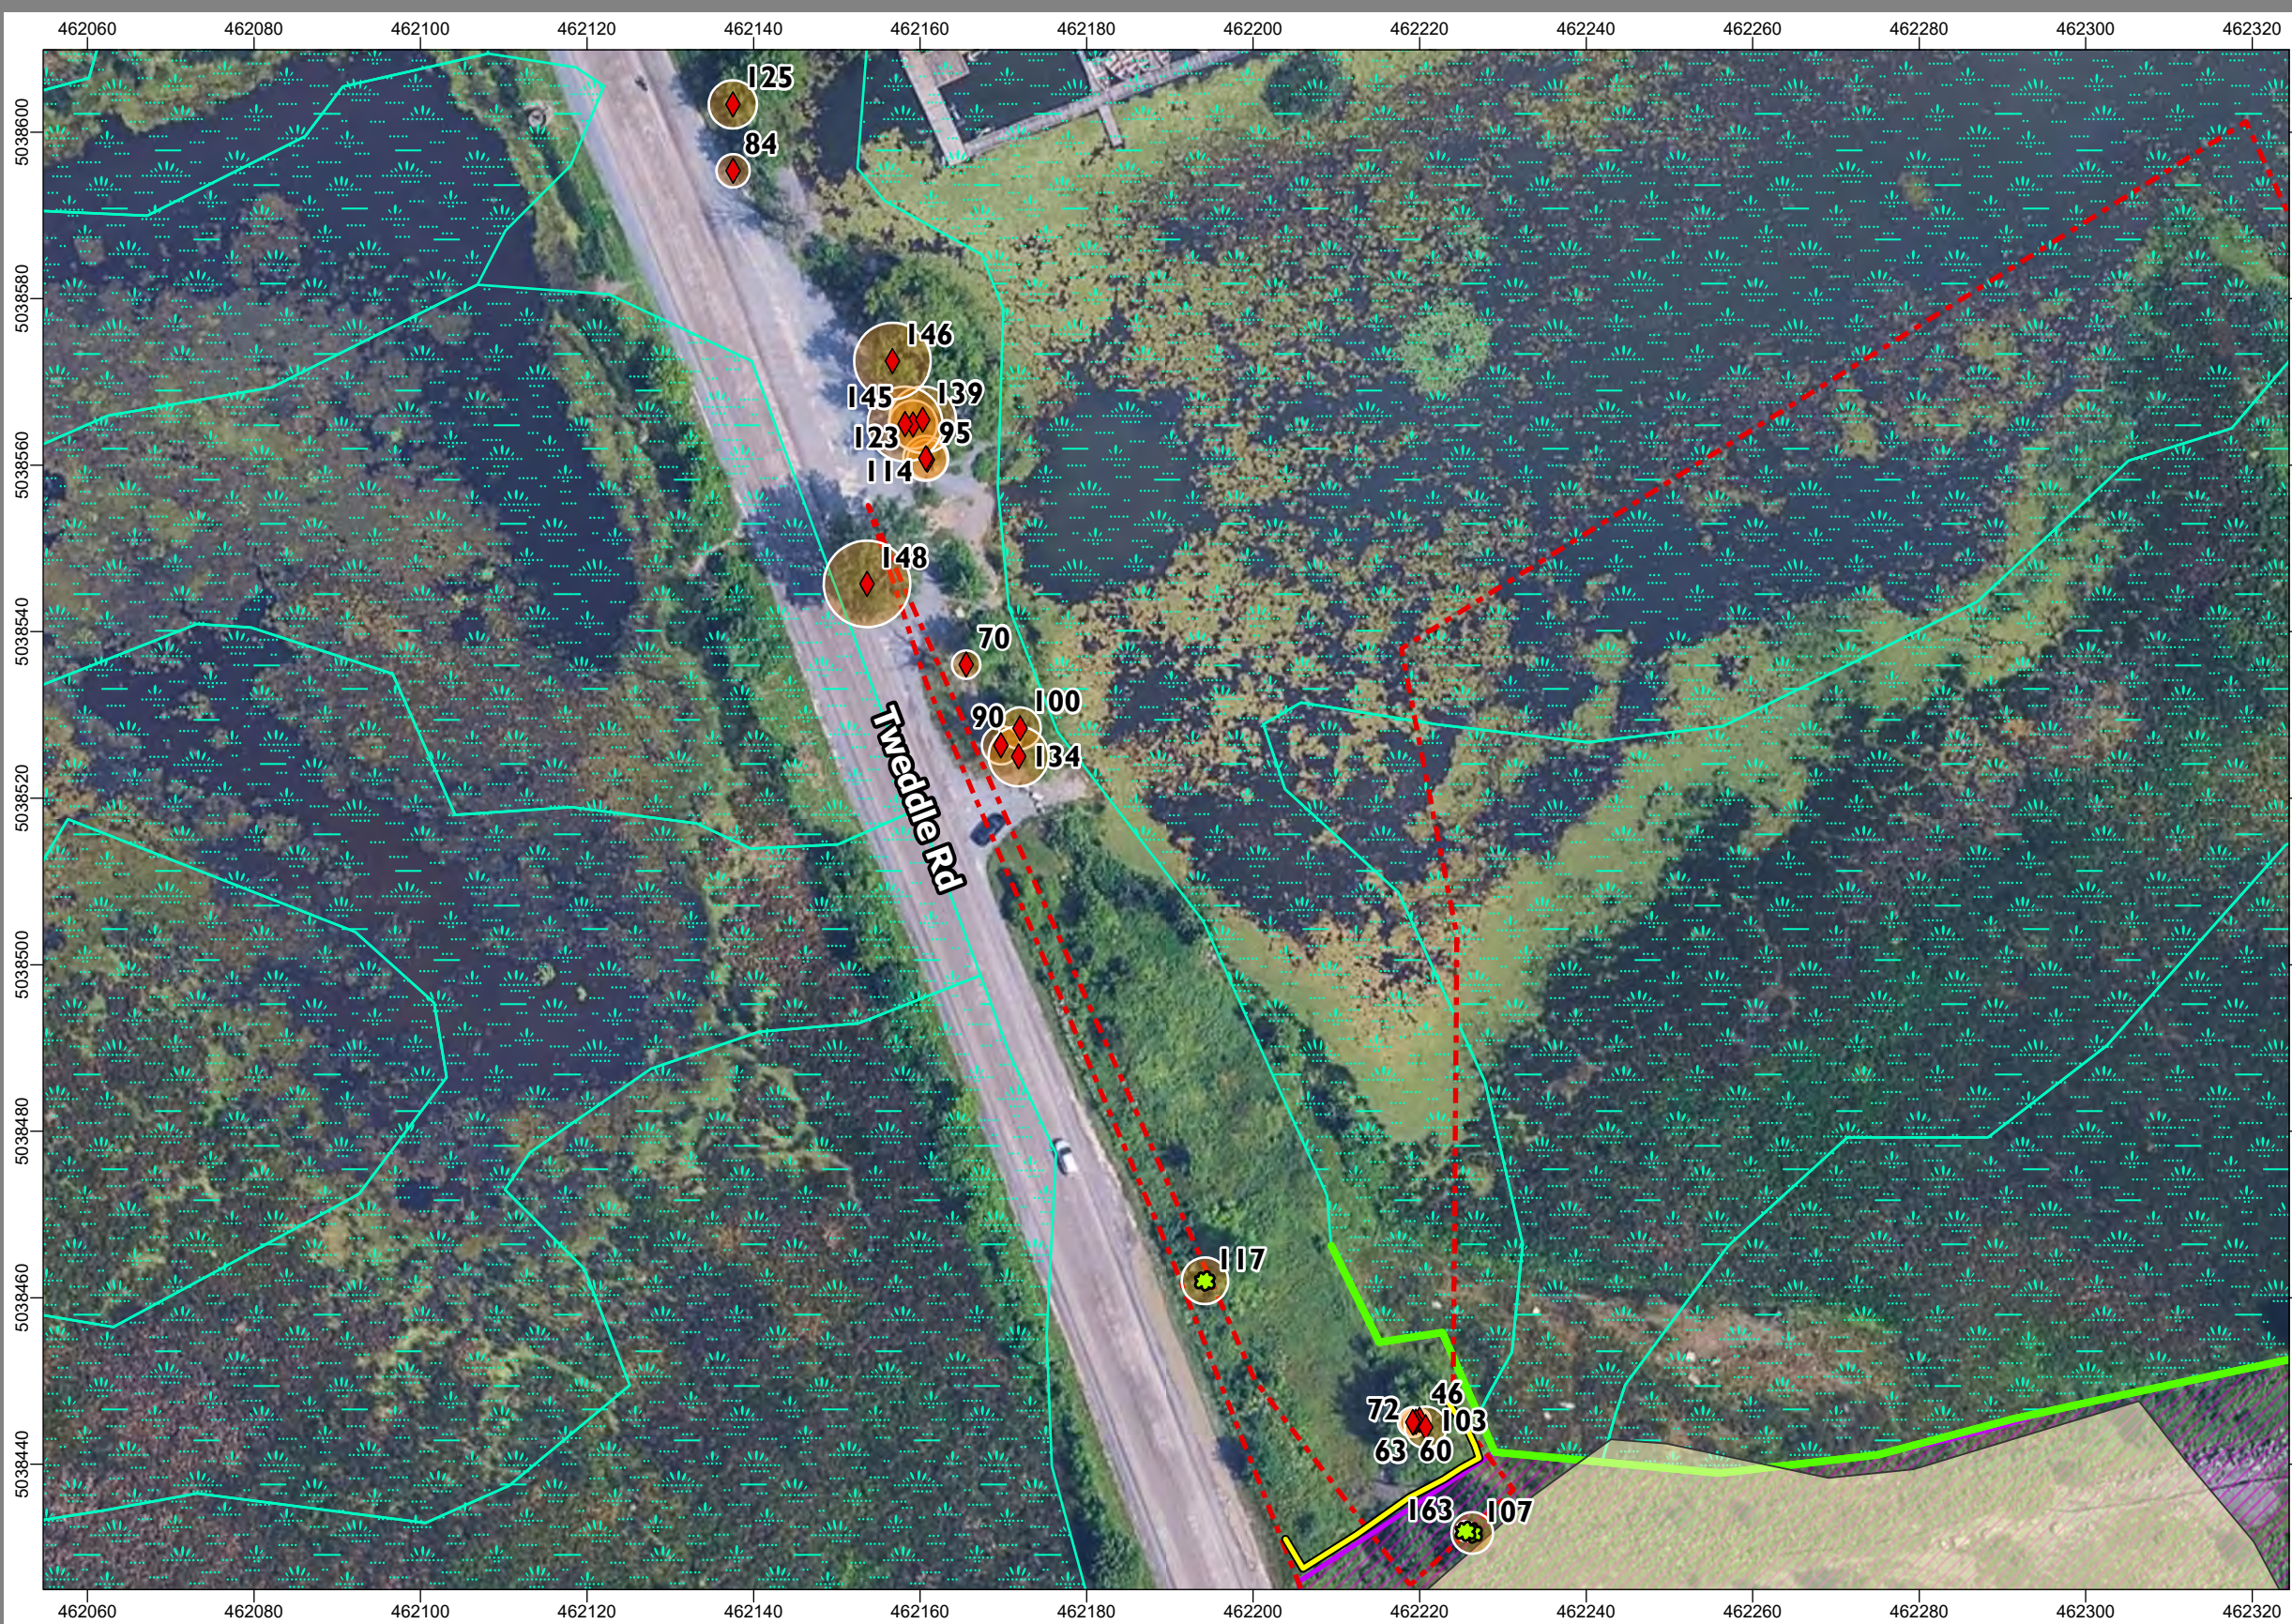
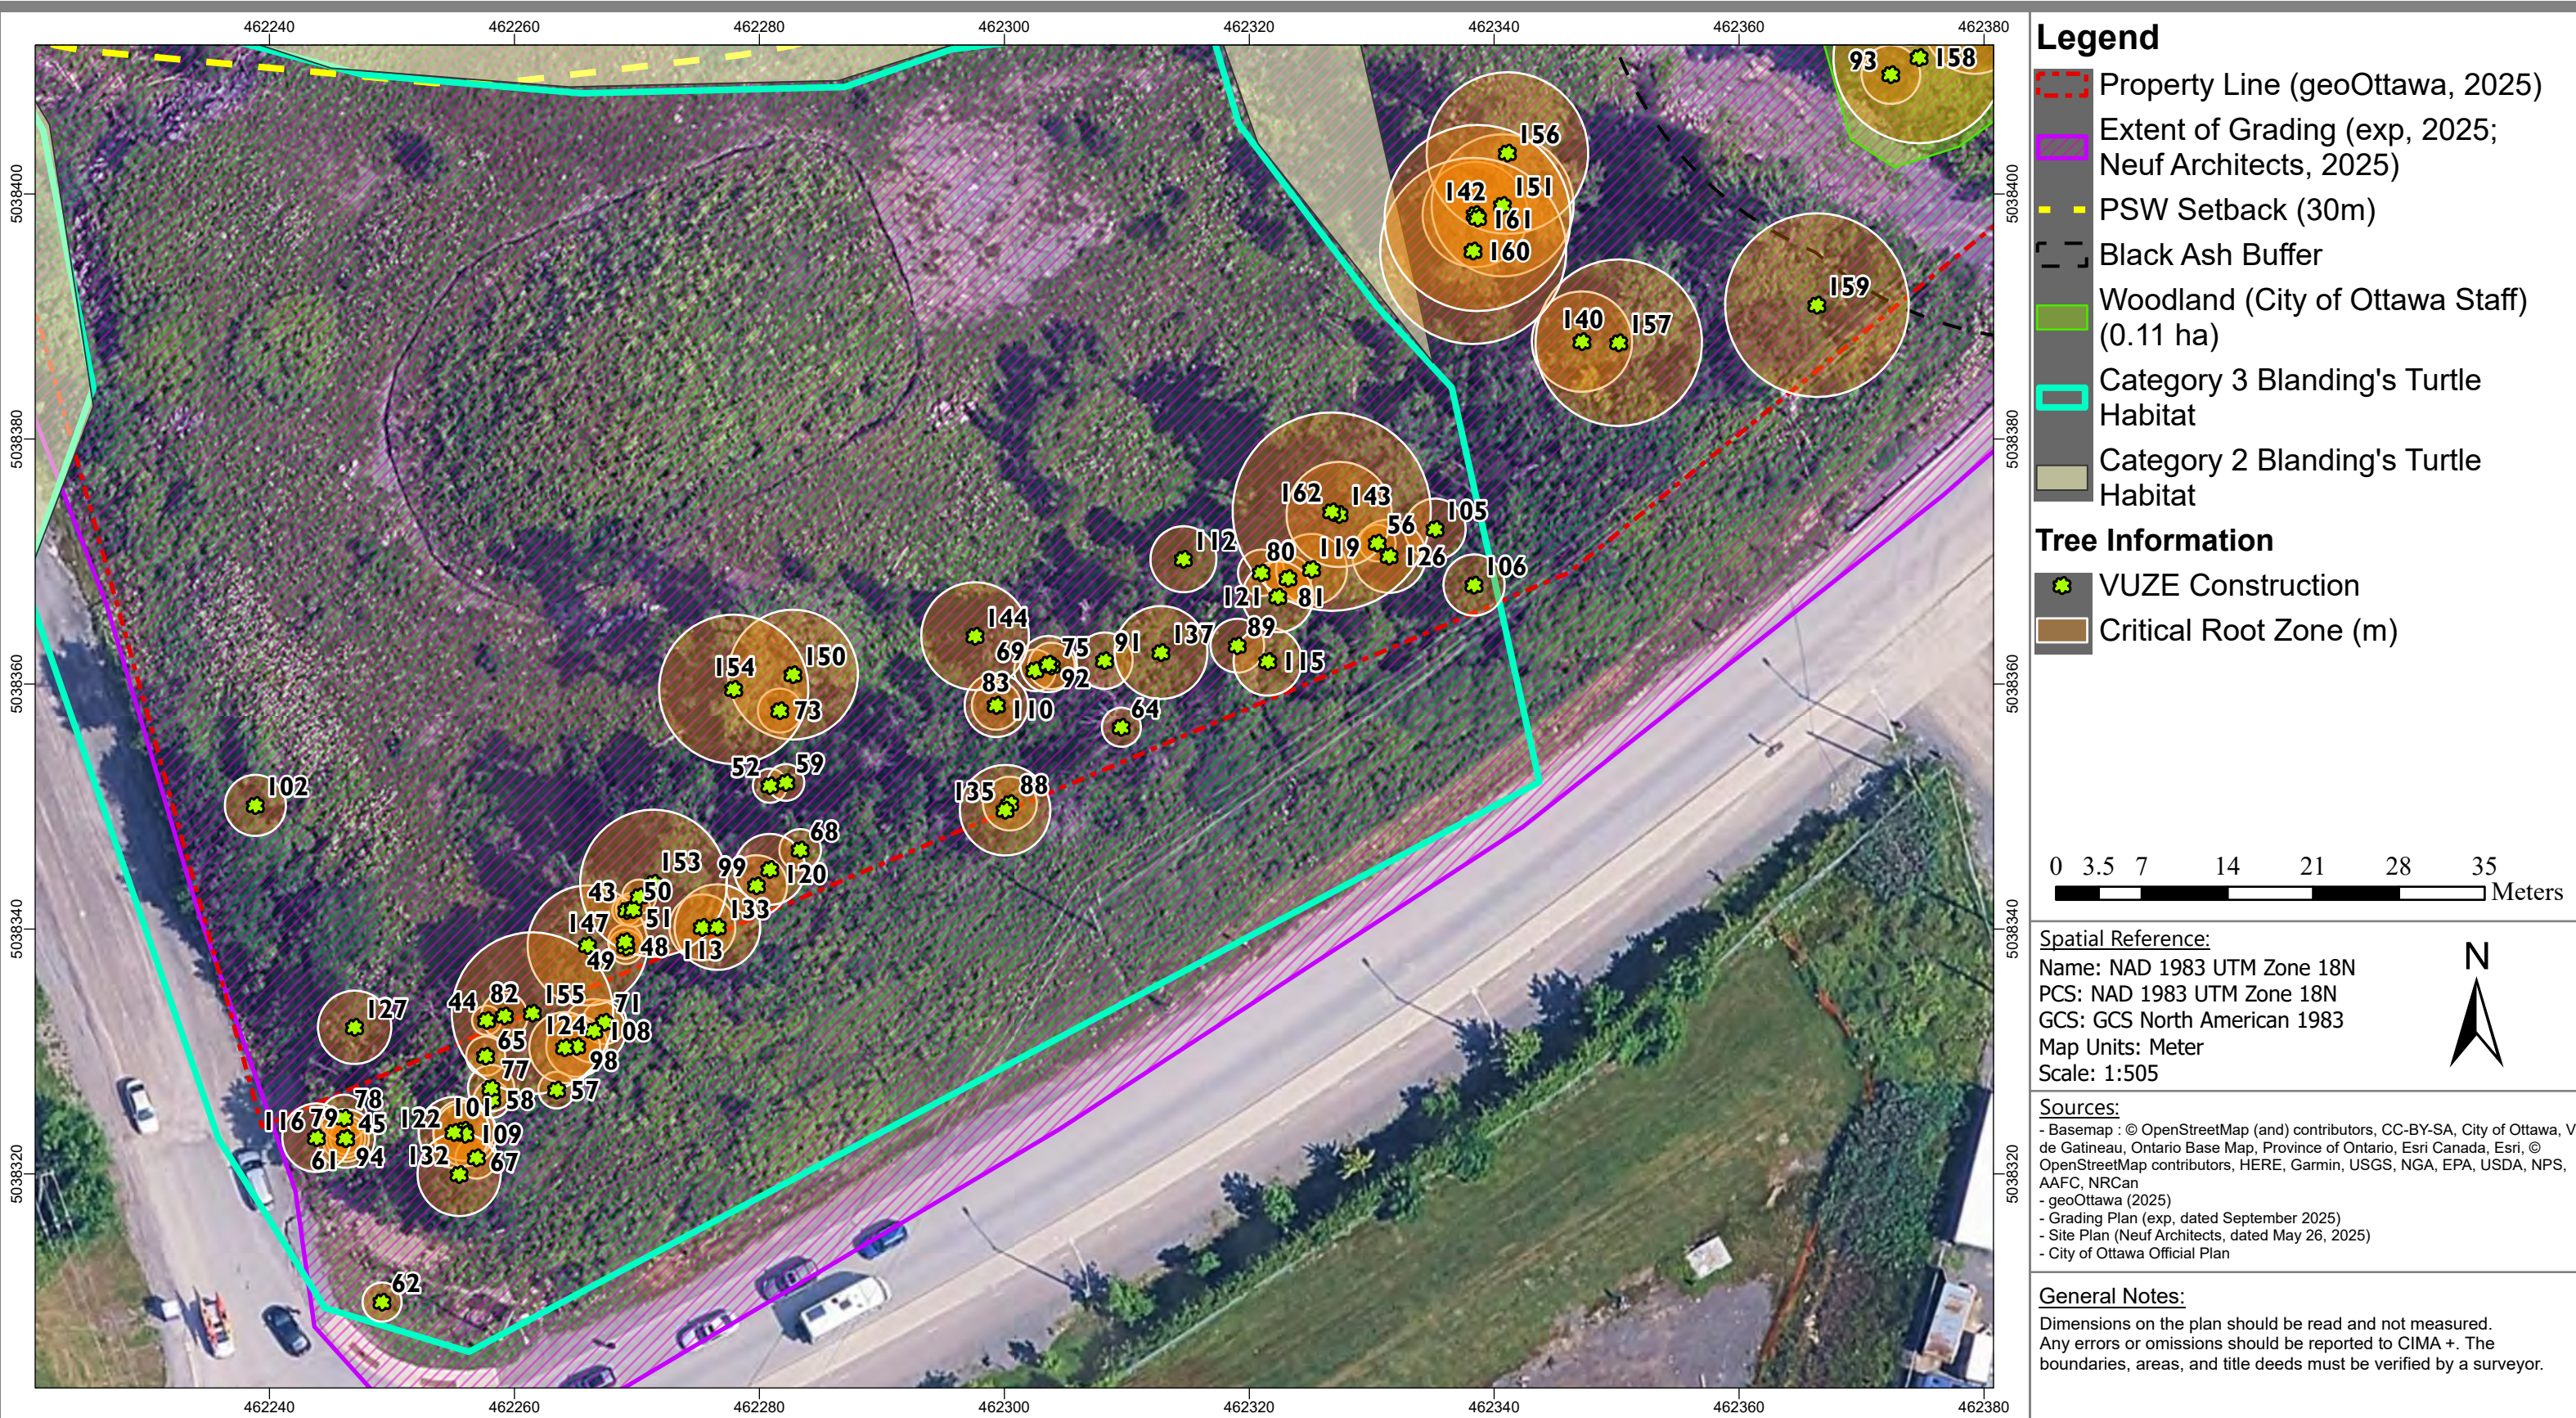
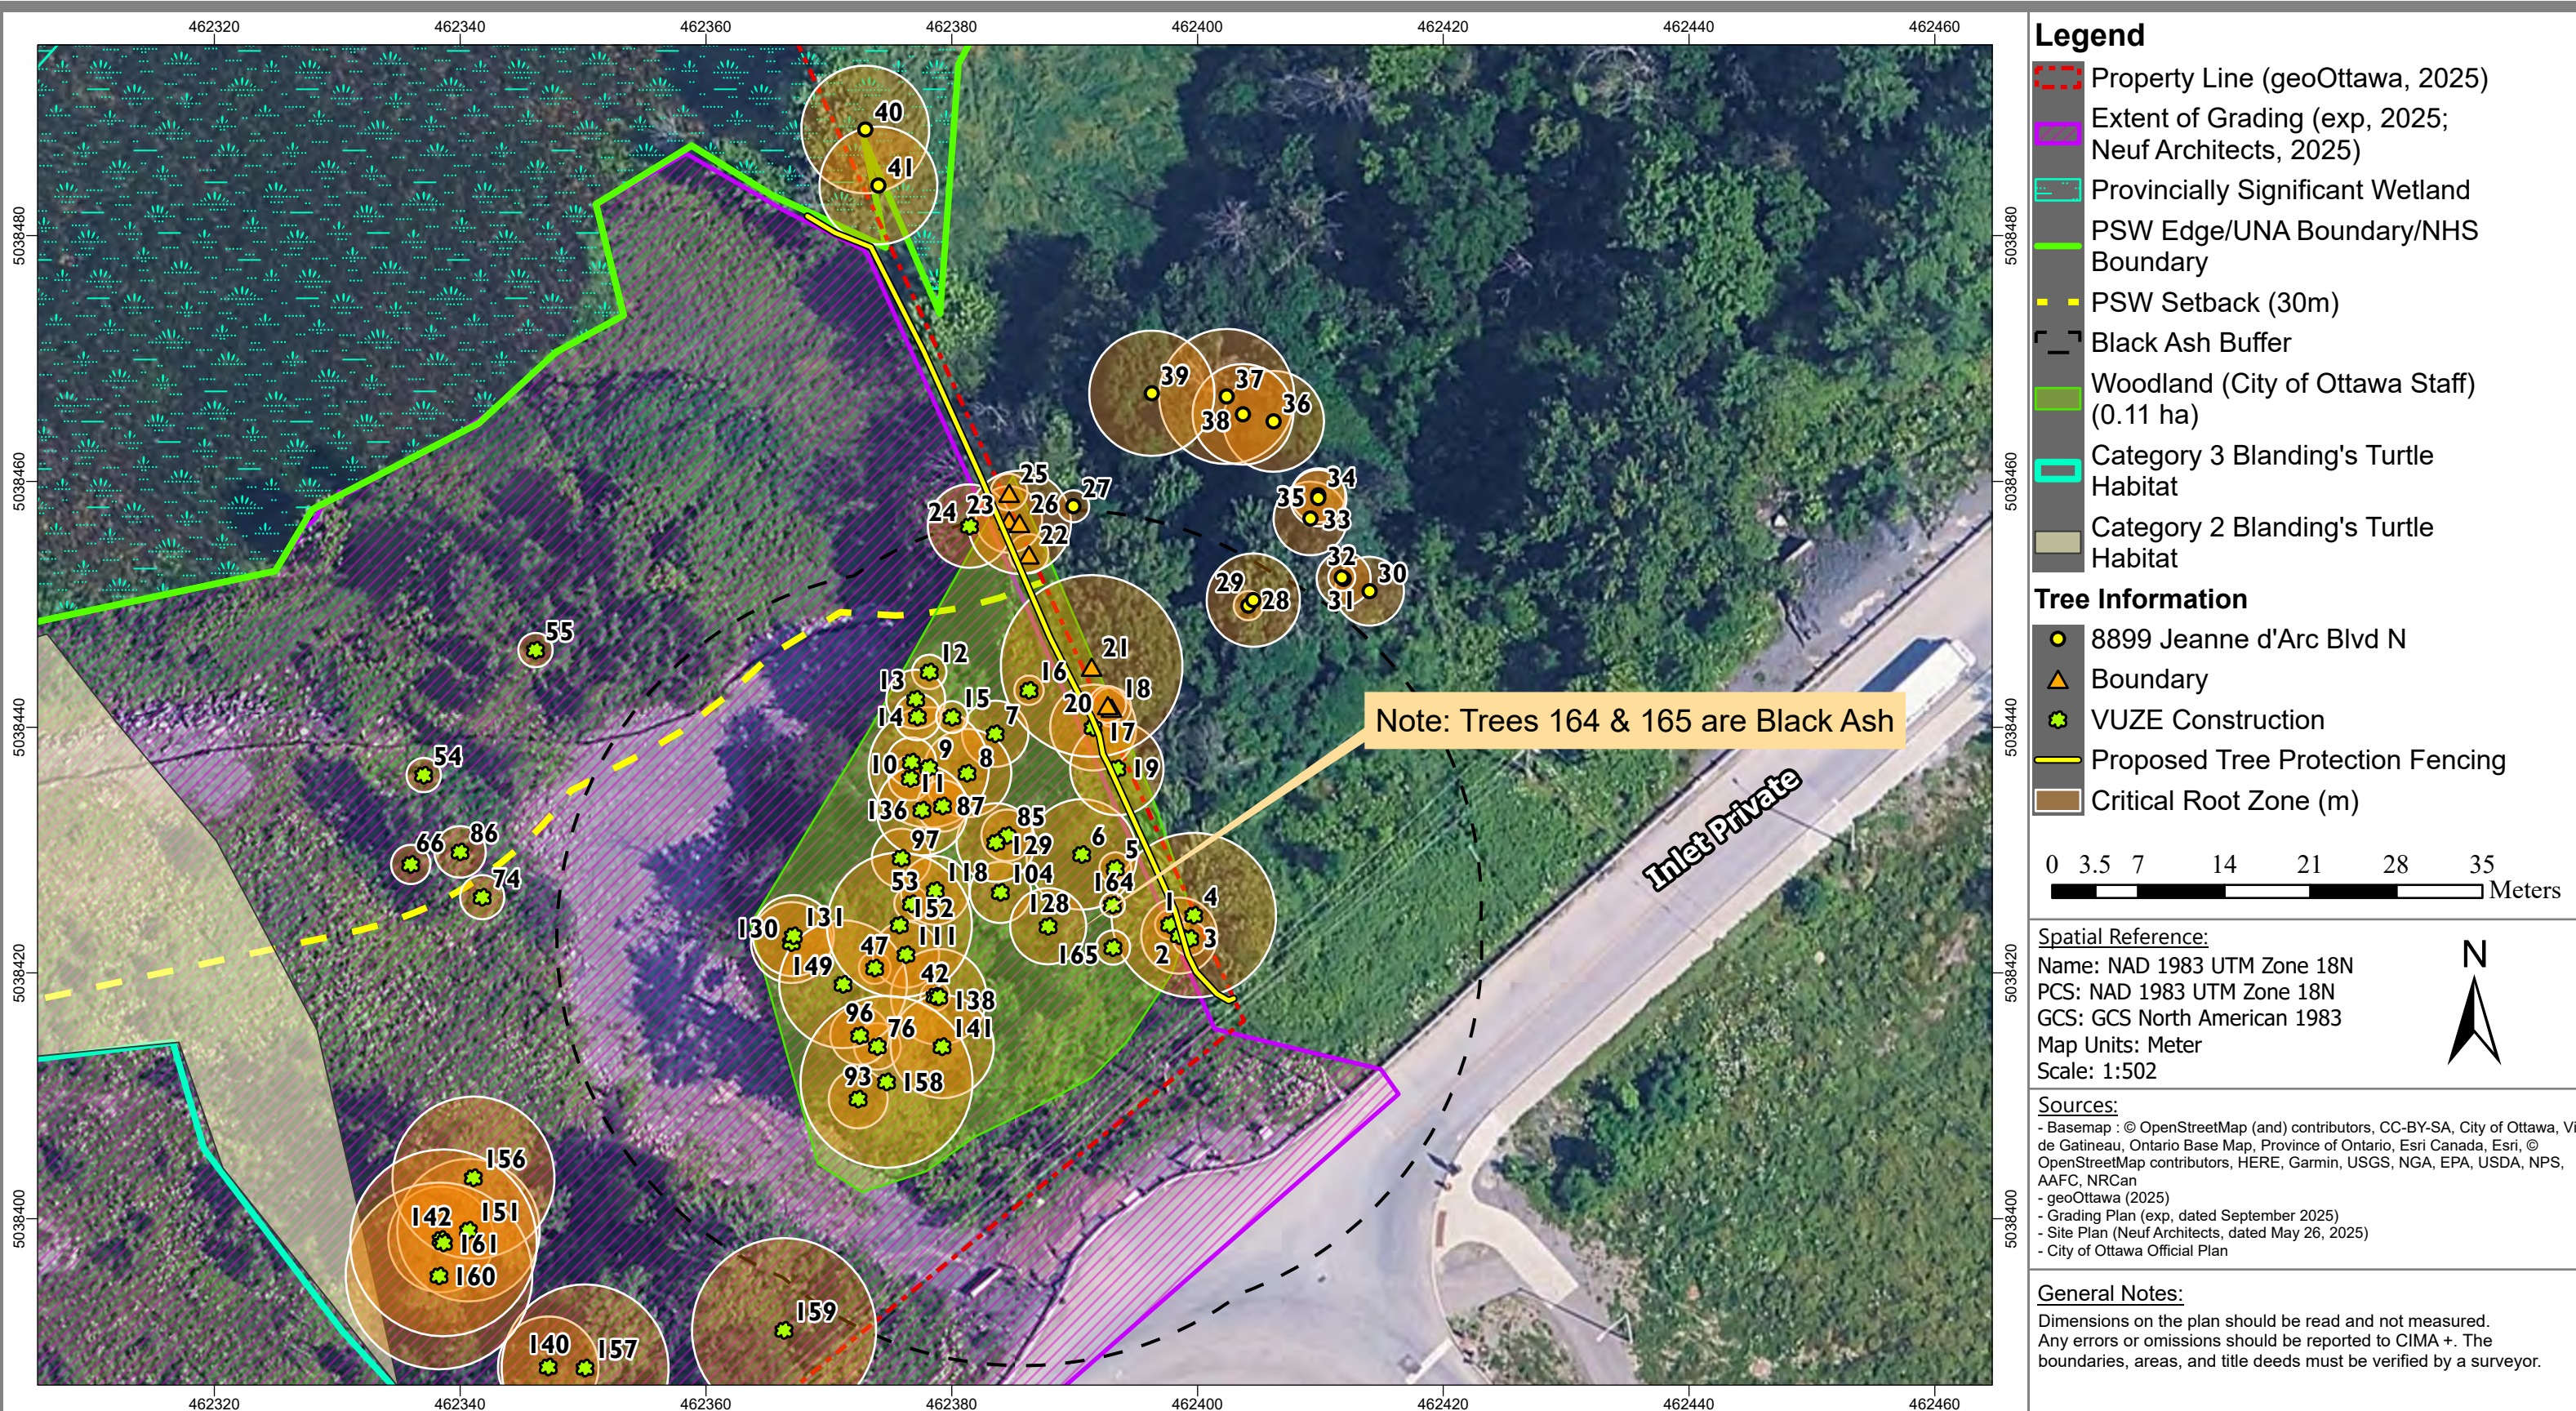
## Appendix A Map 1

The location of individual trees are depicted on Map 1 and Map 2 (Appendix A, Appendix B).

- Provincially significant wetland on the north side of the Property
- Habitat of endangered and threatened species
  - Two (2) SAR Black Ash trees were found (Trees 164, 165) with dbh of 10 and 14 cm. These were located on the southeast corner of the Property.

- Trees to be Retained:
  - 1 tree (Tree 117) to be retained is owned by VUZE Construction. This tree, and its CRZ, is situated along Tweddle Road, north of the area to be graded.

- 3 of these trees have CRZs extending into the grading limits – Trees 21, 23, 26.

- Trees 21, 23 and 26 fall near the property line and are of shared ownership with the property owner to the east. These are recommended for retention and pruning, as grading will occur within their CRZs.
  - Tree 21 is a Bur Oak with dbh 74 cm
  - Tree 23 is an American Elm with dbh 23 cm.
  - Tree 26 is a Bur Oak with dbh 42 cm.

Three trees of shared ownership are proposed for retention and/or pruning as needed (Tree 21, 23, 26), as their minimum CRZ fall within the grading limits.
