# VUZE Construction

1015 Tweddle Road

## TREE CONSERVATION REPORT

CIMA+ file number: Z0018492  
18 November 2025 - Review 002

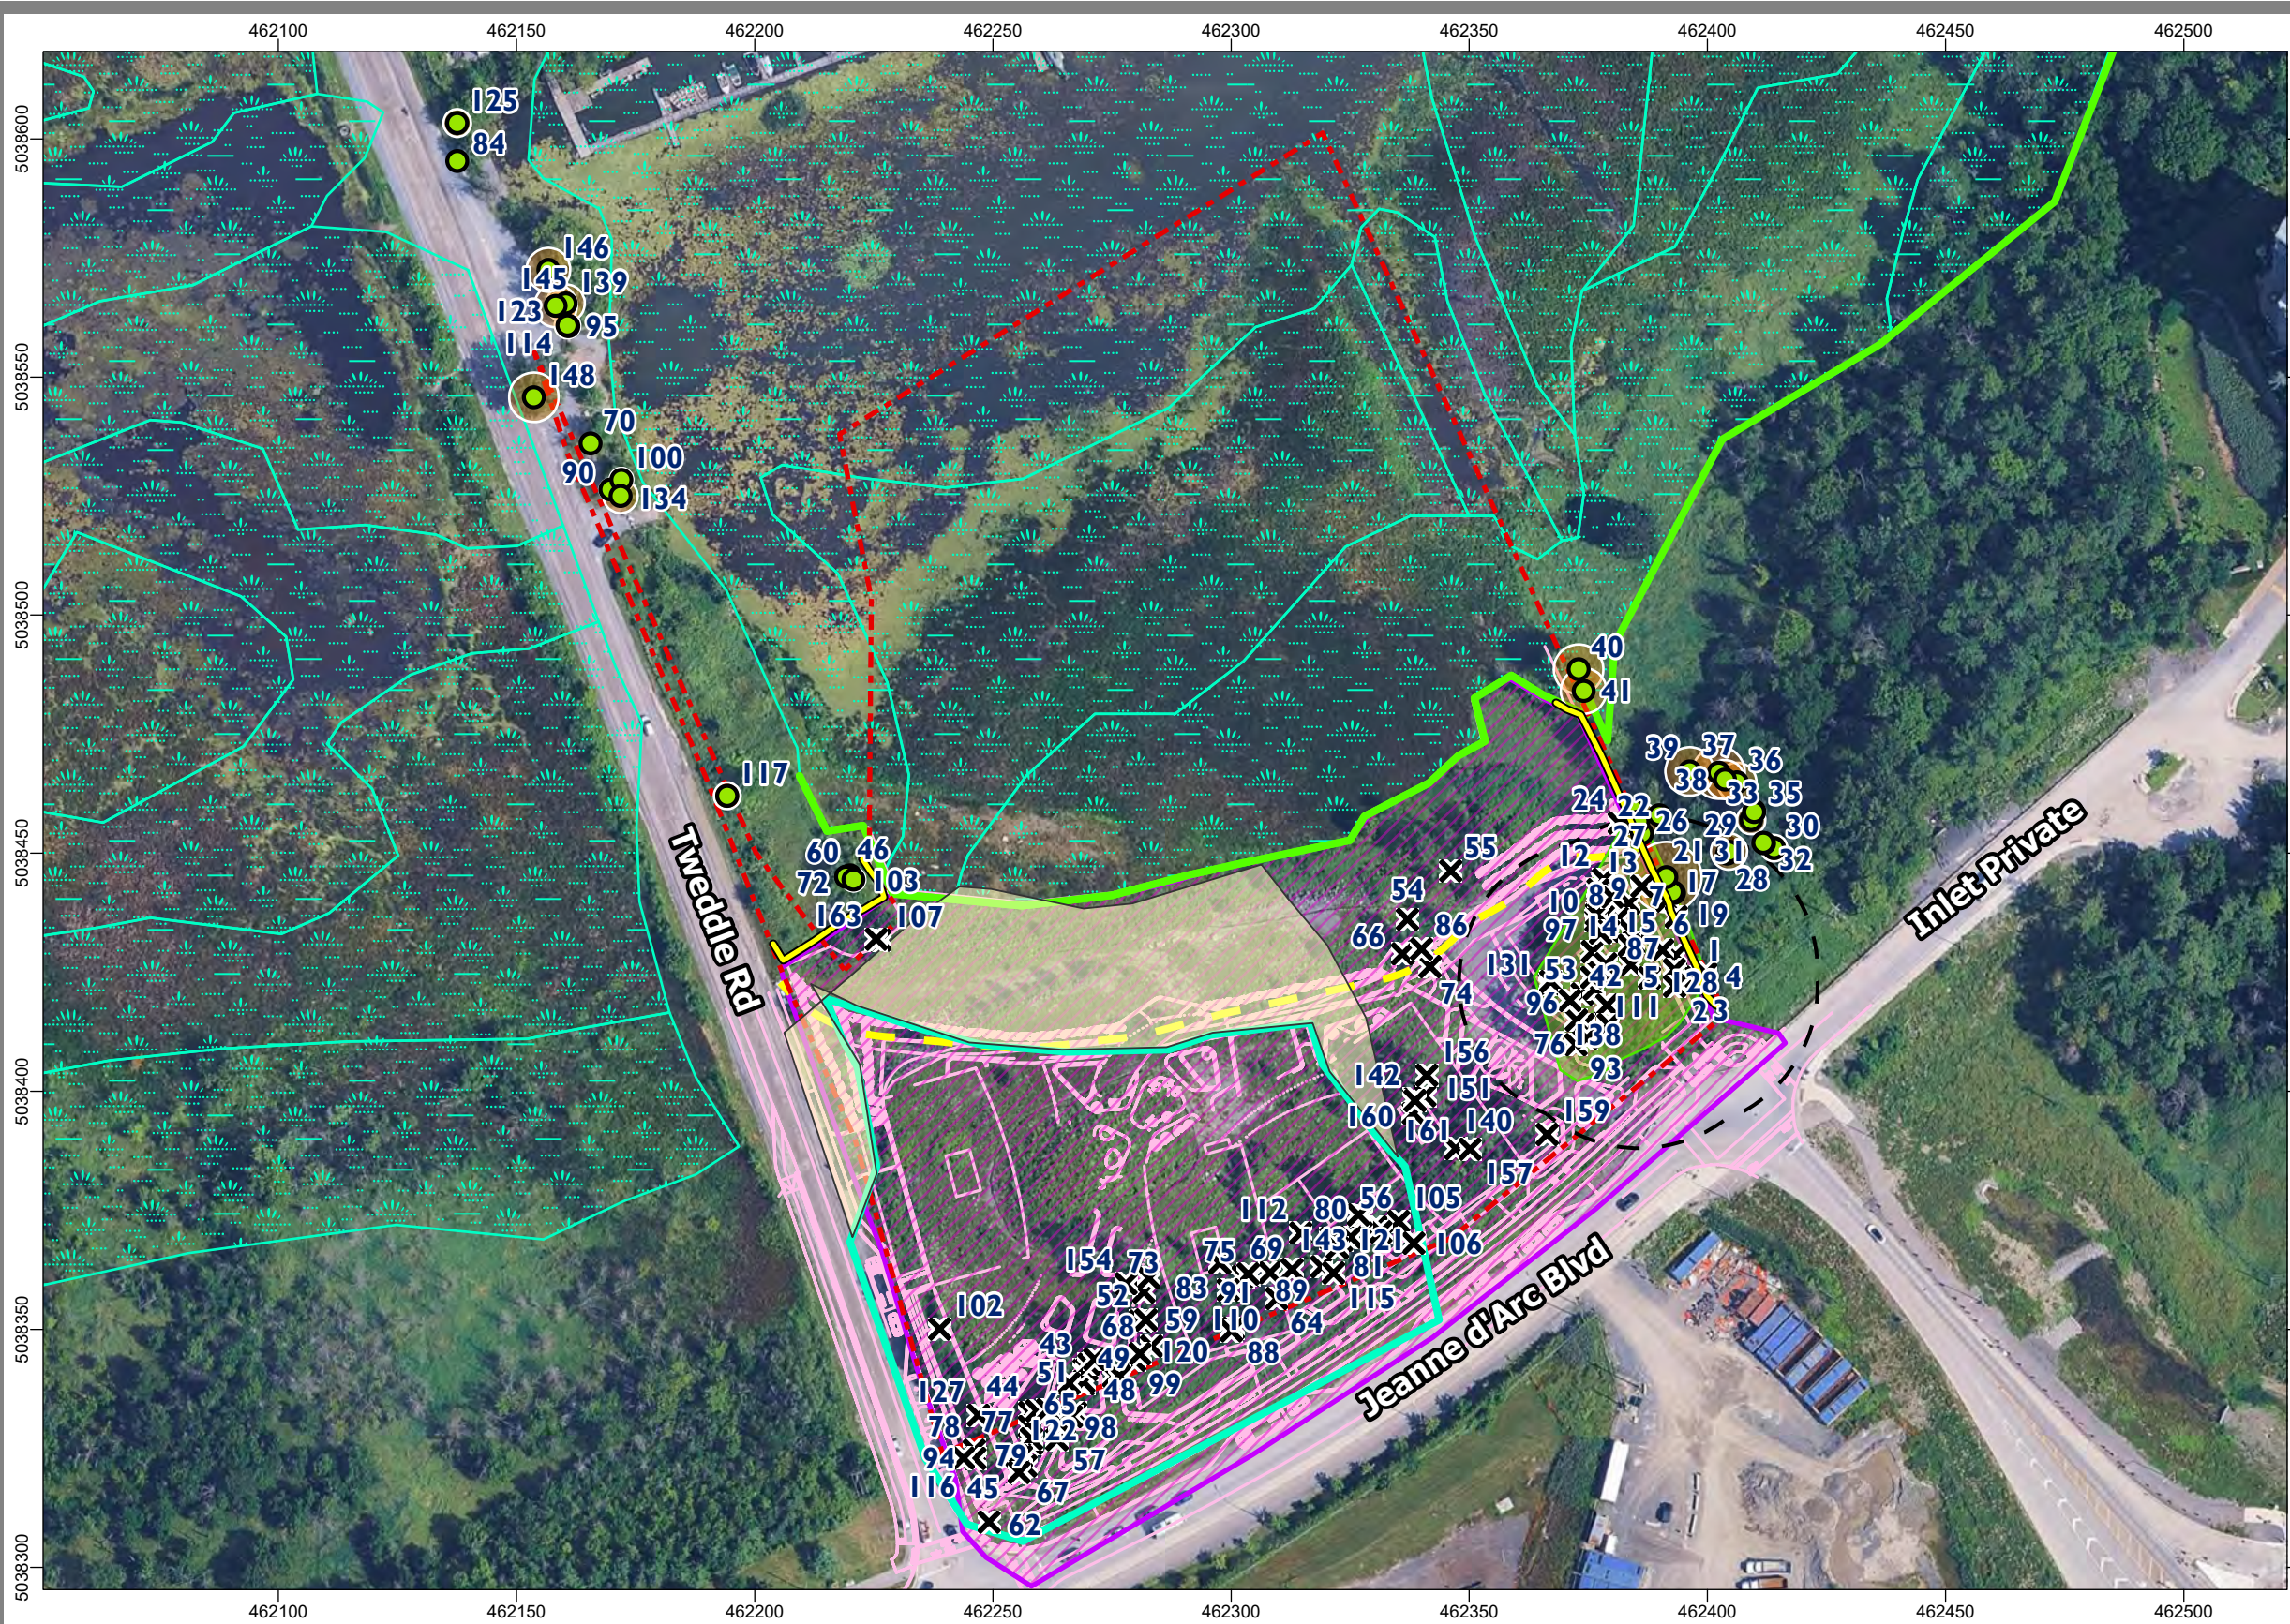
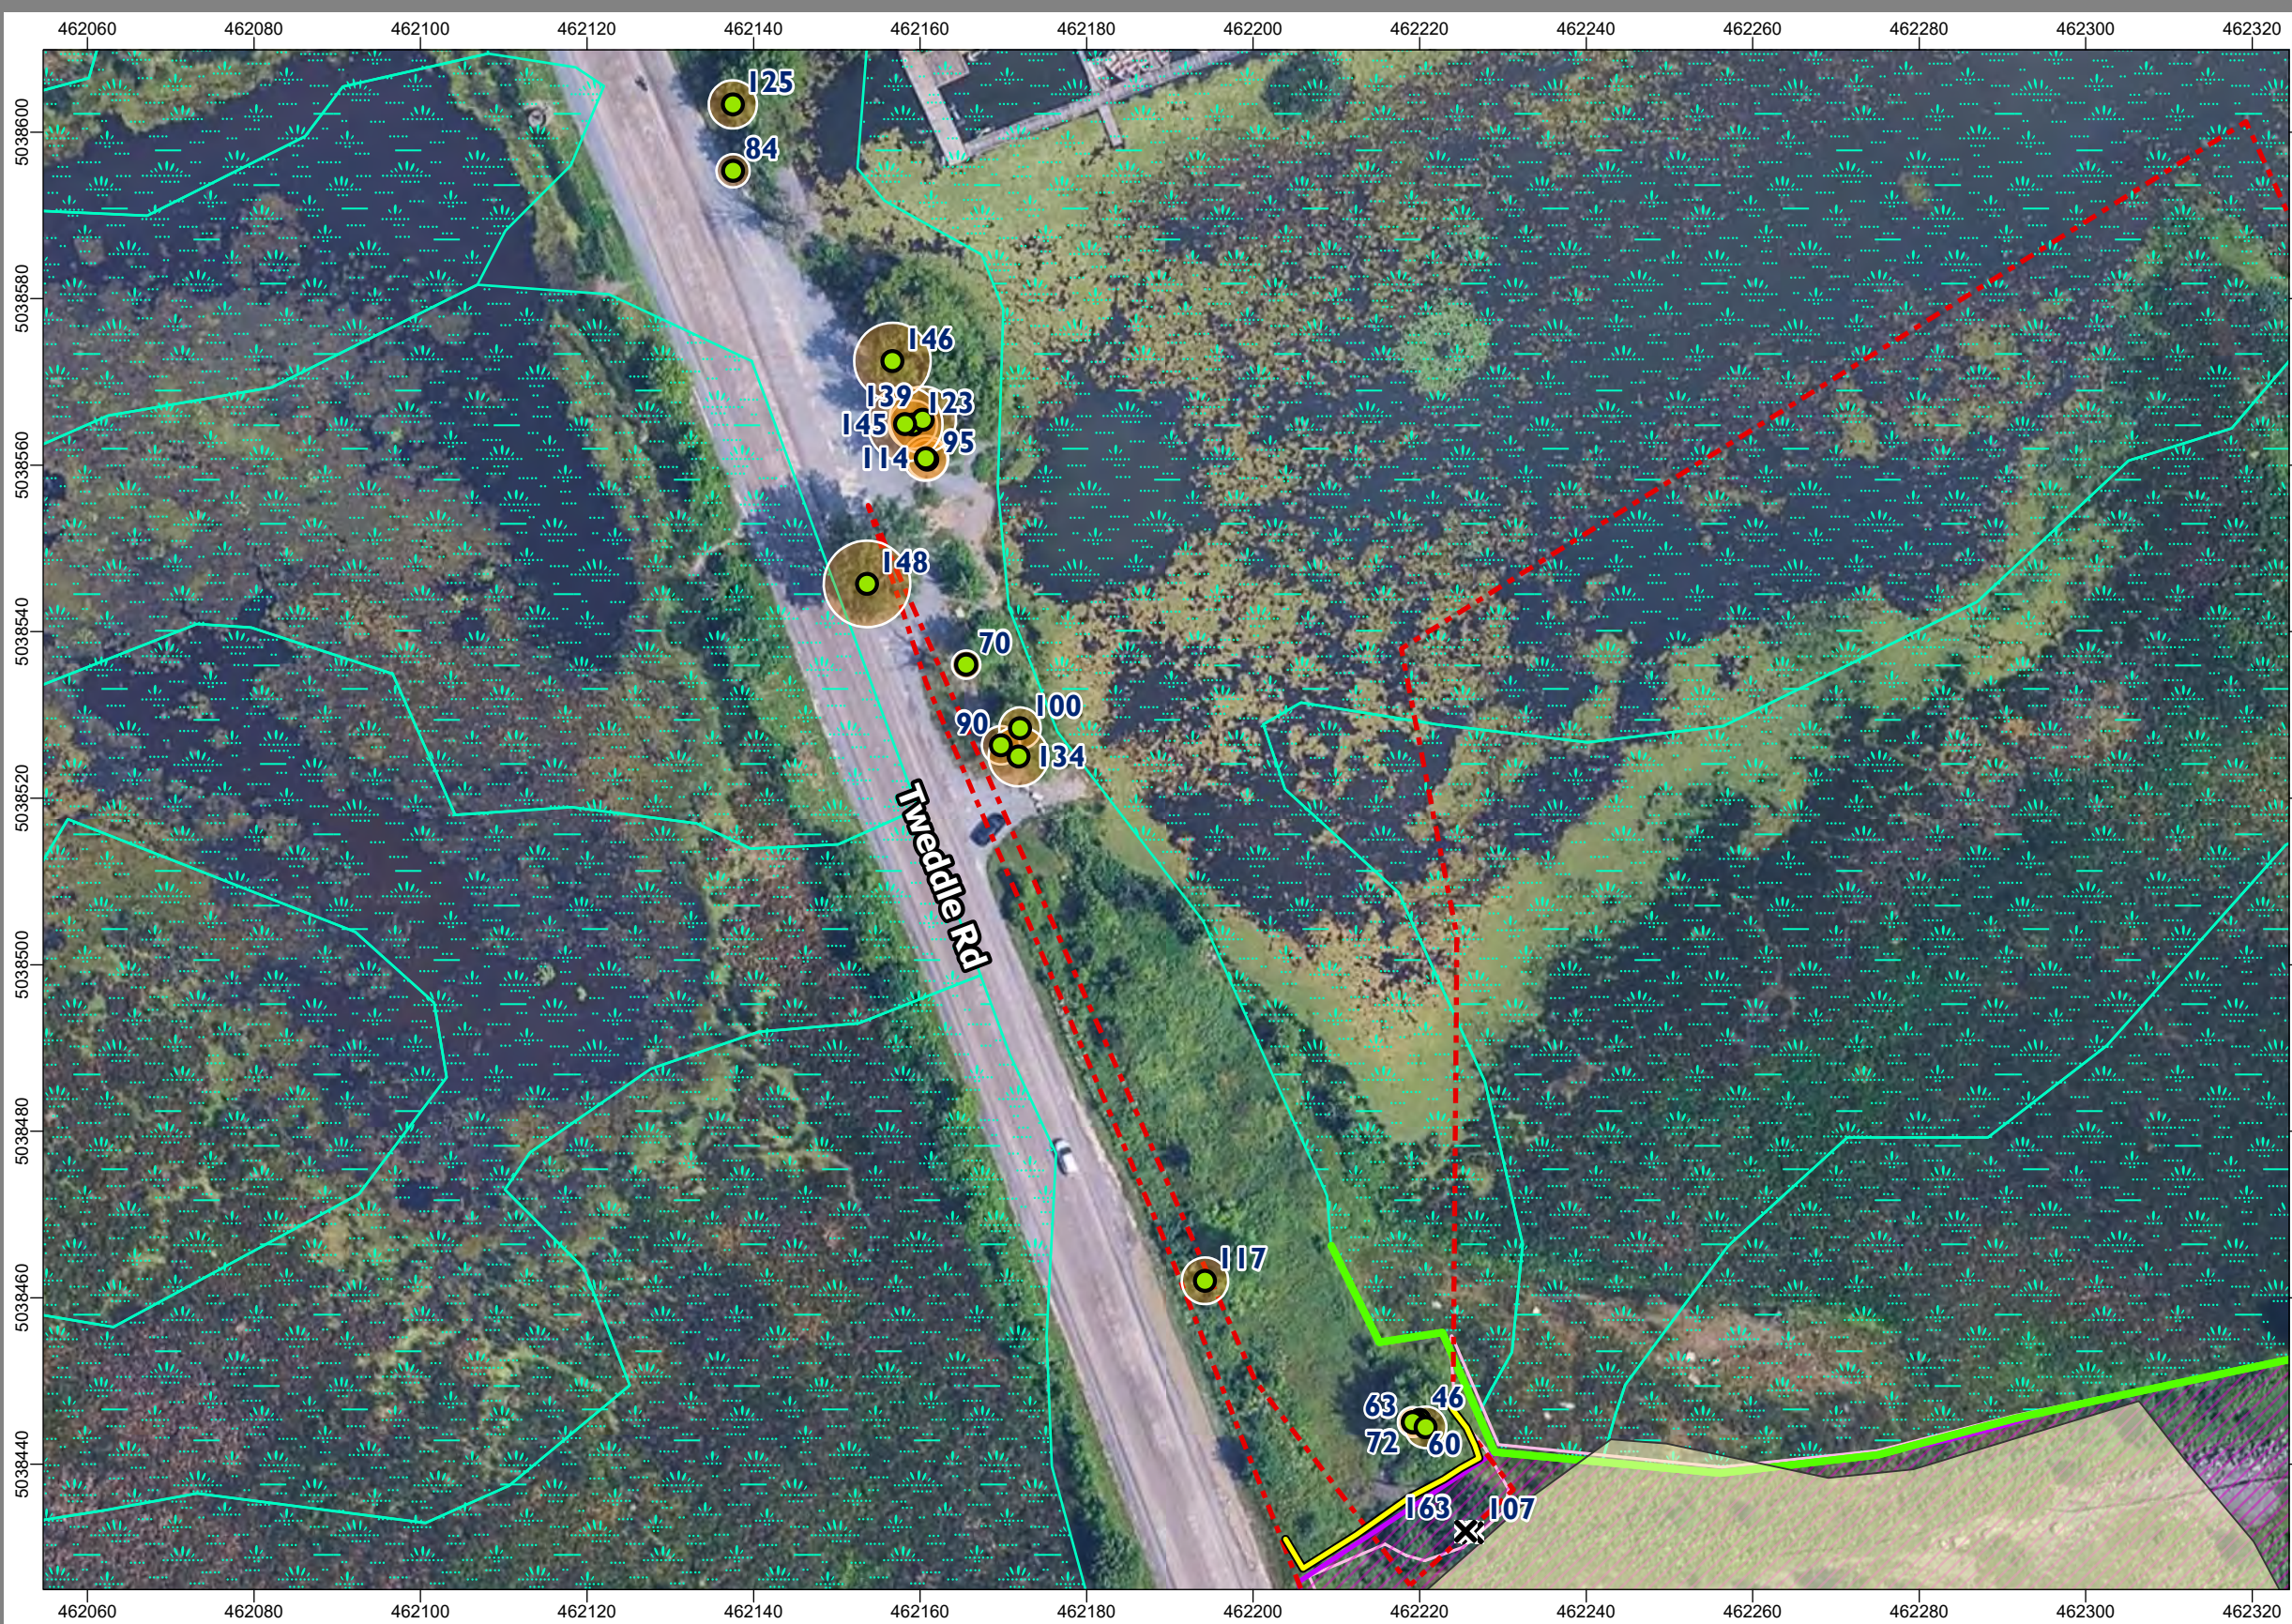
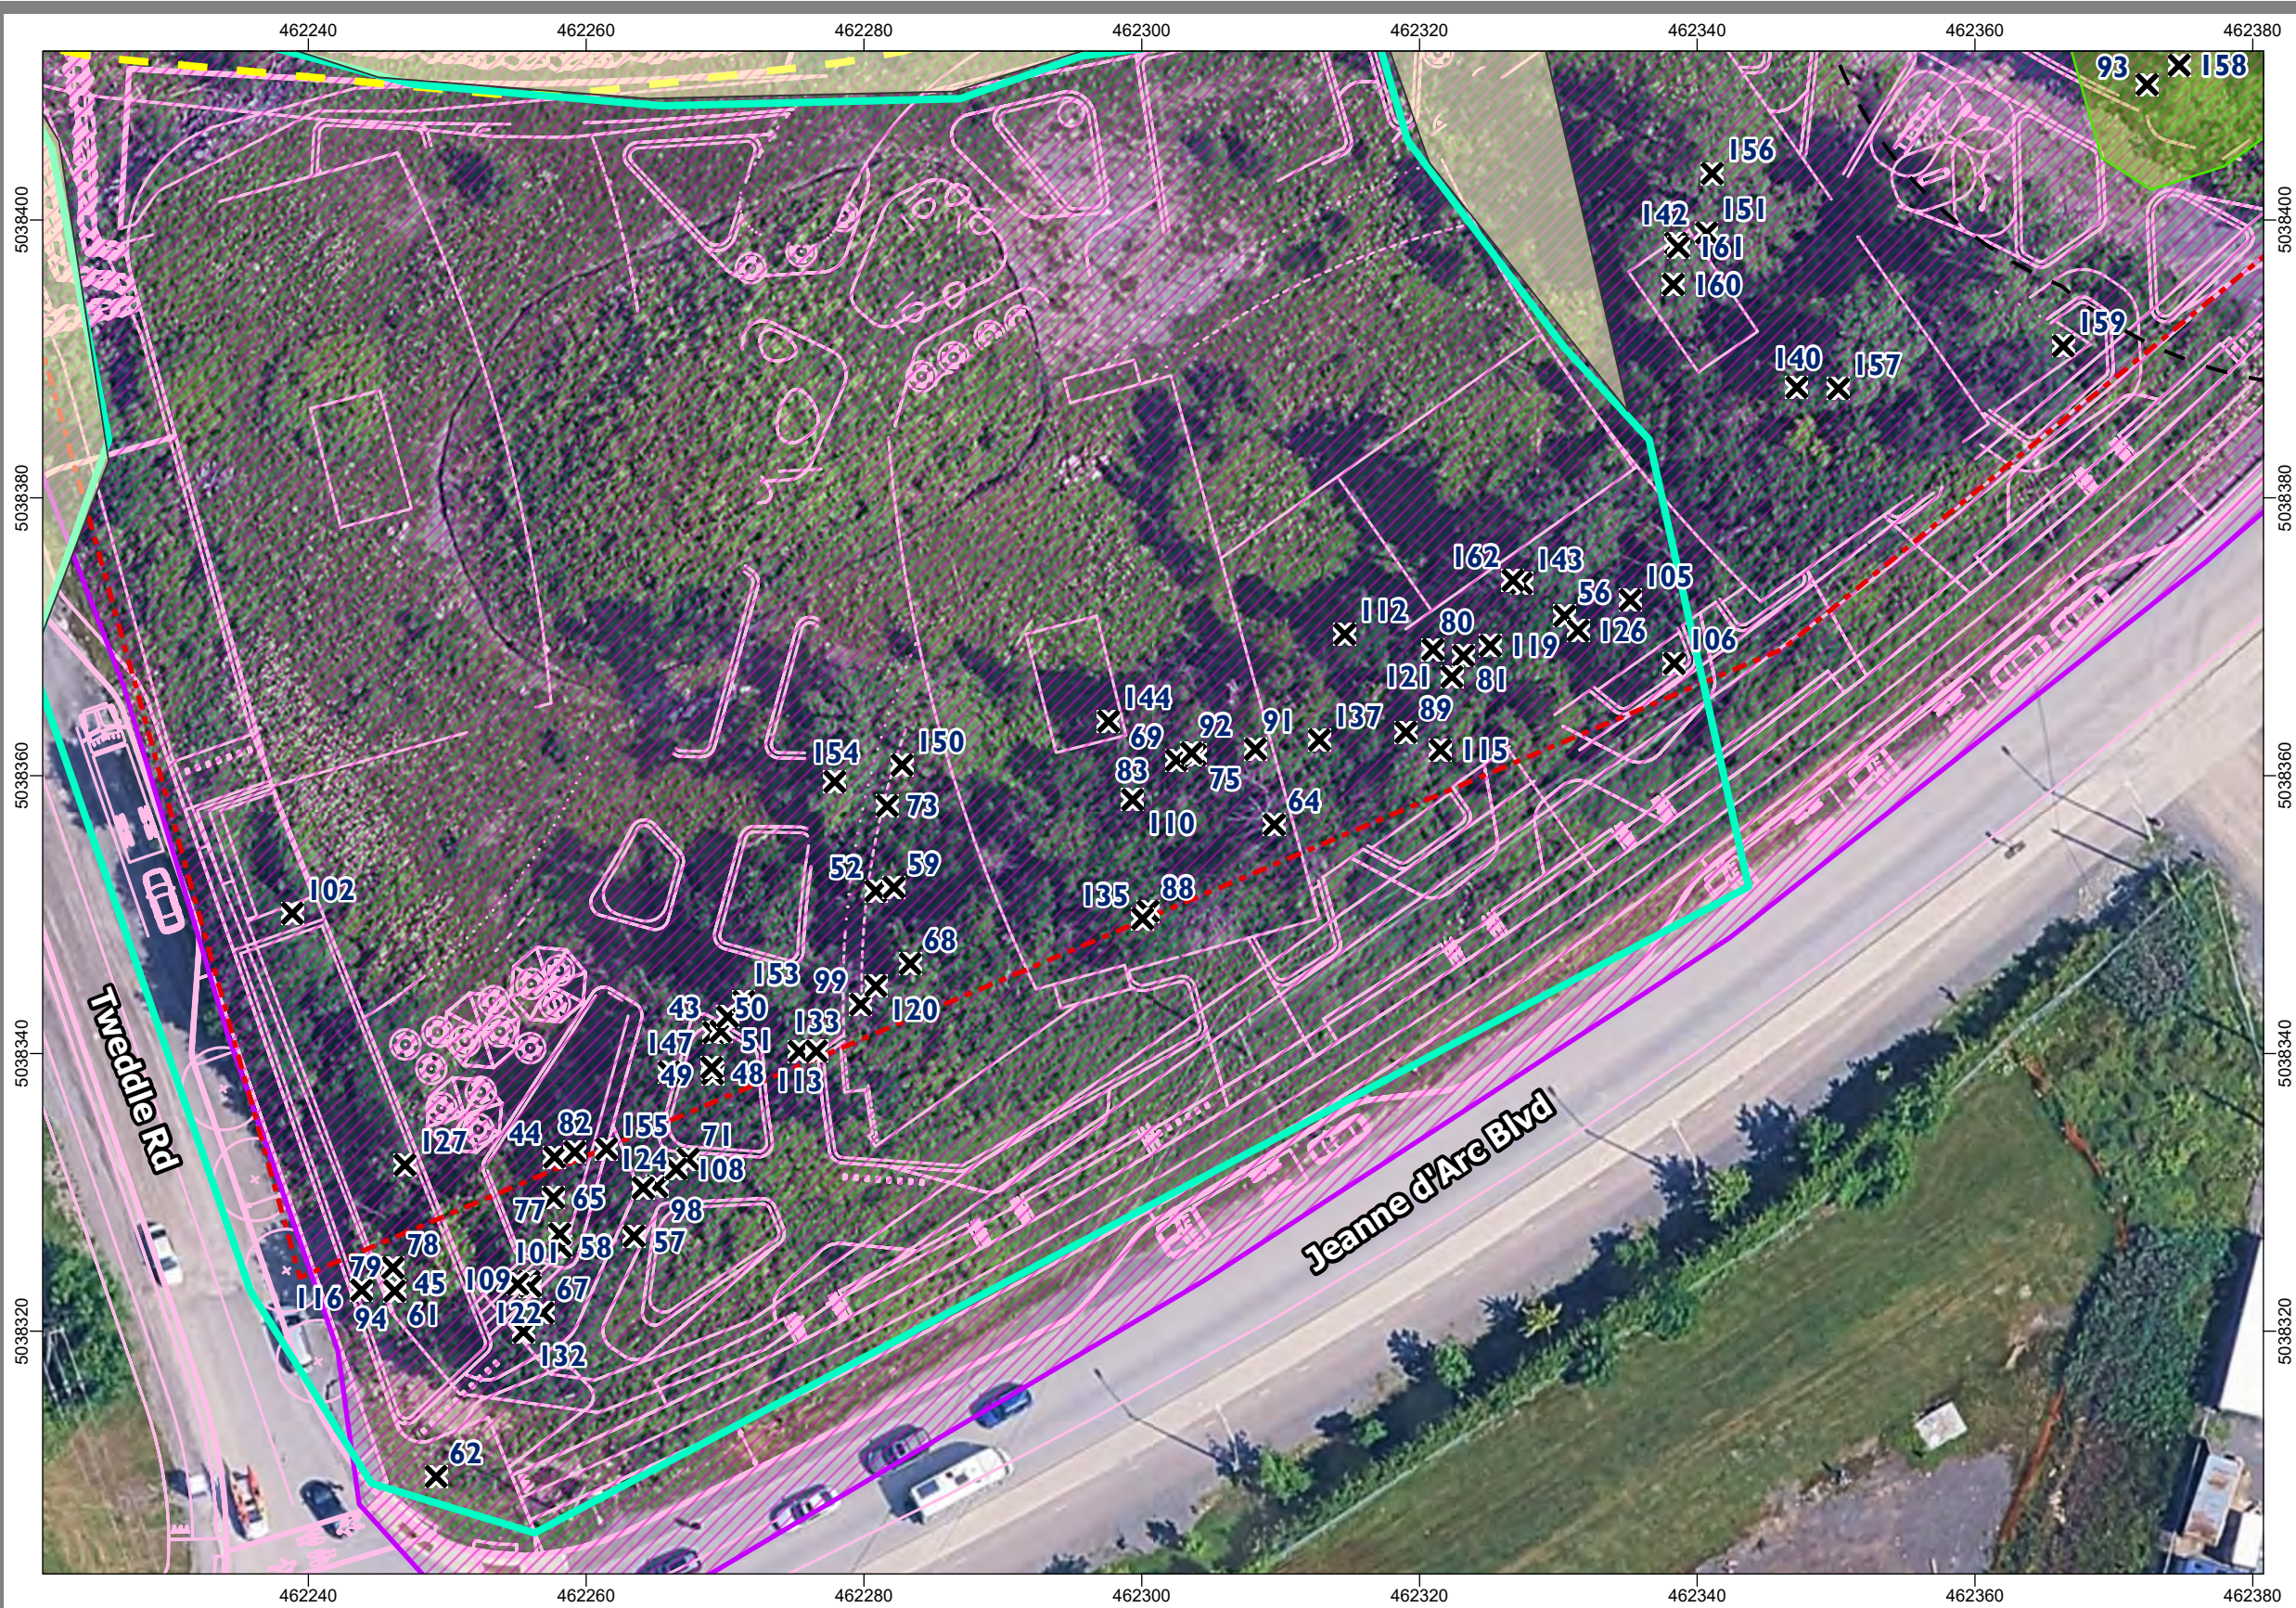
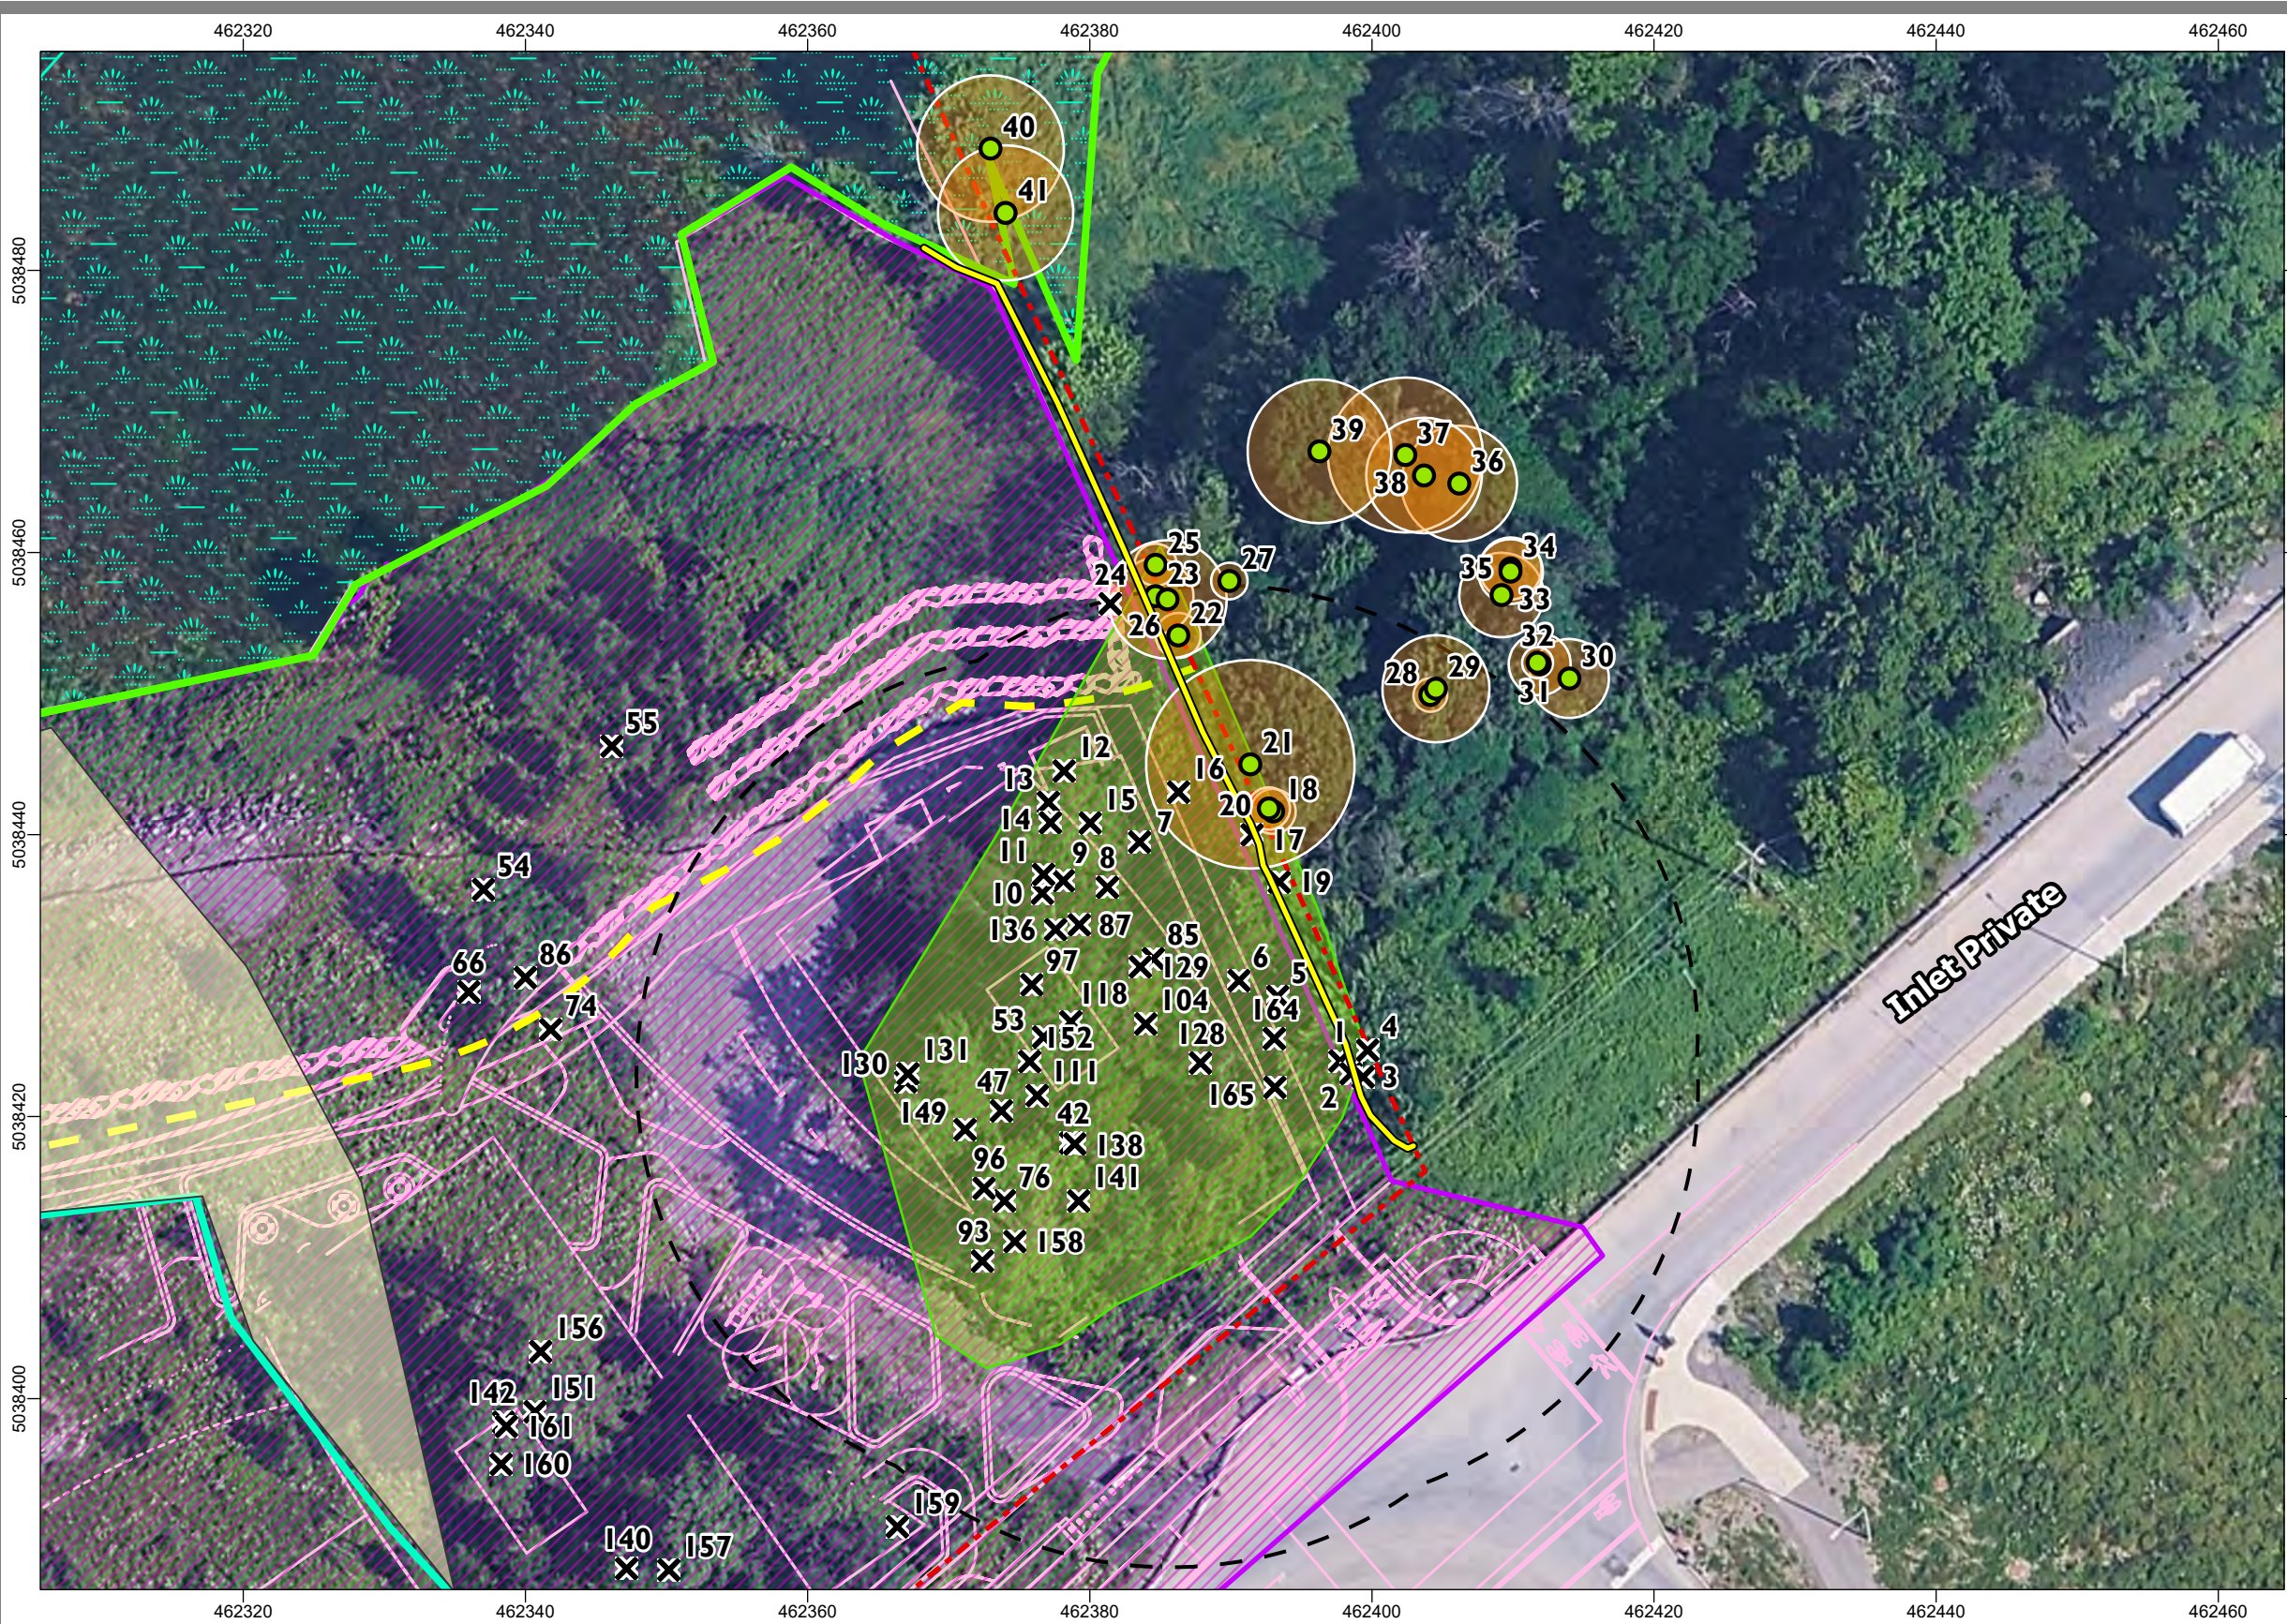
## Appendix B Map 2

The location of individual trees are depicted on Map 1 and Map 2 (Appendix A, Appendix B).
