Subject: **Slope Stability Review and Landslide Risk Assessment  
Proposed Multi-Storey Building Complex  
1009 Trim Road - Ottawa**

**1015 TWEDDLE ROAD, OTTAWA, ONTARIO  
LANDSLIDE HAZARD ASSESSMENT  
ADDENDUM**

**1009 TRIM ROAD  
OTTAWA, ONTARIO  
LANDSLIDE HAZARD ASSESSMENT**

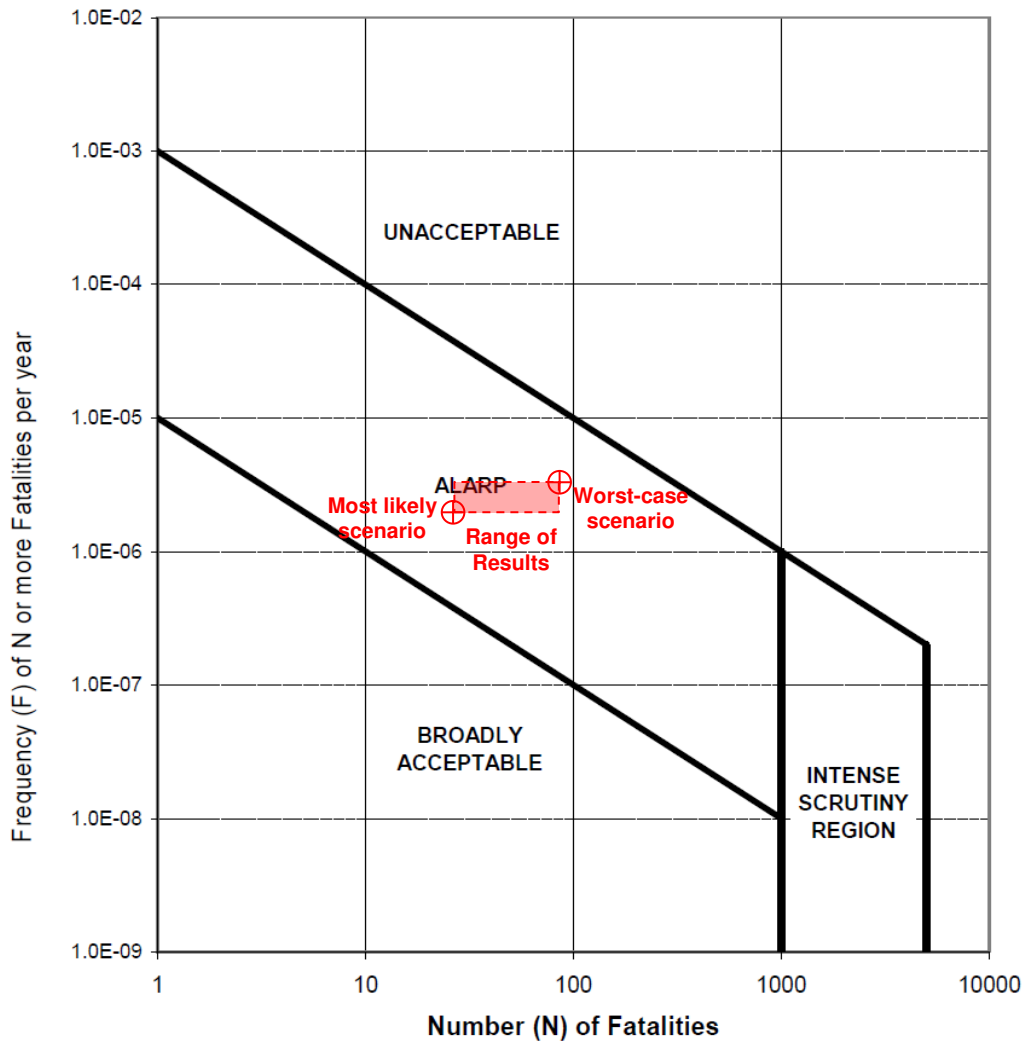
Figure 1: Societal Risk Frequency of Landslide vs Number of Fatalities

Both of these points are plotted on the F-N graph on Figure 1. Despite the vastly different estimates on probability and number of deaths, the two points still plot in the middle of the ALARP zone, which demonstrates the broad range of risks represented by this zone.

Societal risk estimates are based on F-N curves that plot the estimated number of fatalities versus the probability of landslide occurrence. When multiple landslide scenarios exist, each is plotted individually to create a series of points. Different landslide scenarios could include different magnitudes of landslides or different structures where the probability of spatial interaction or the vulnerability differ. However, in this situation, only one landslide hazard was considered and all of the occupants of the four towers were considered to be equally exposed.

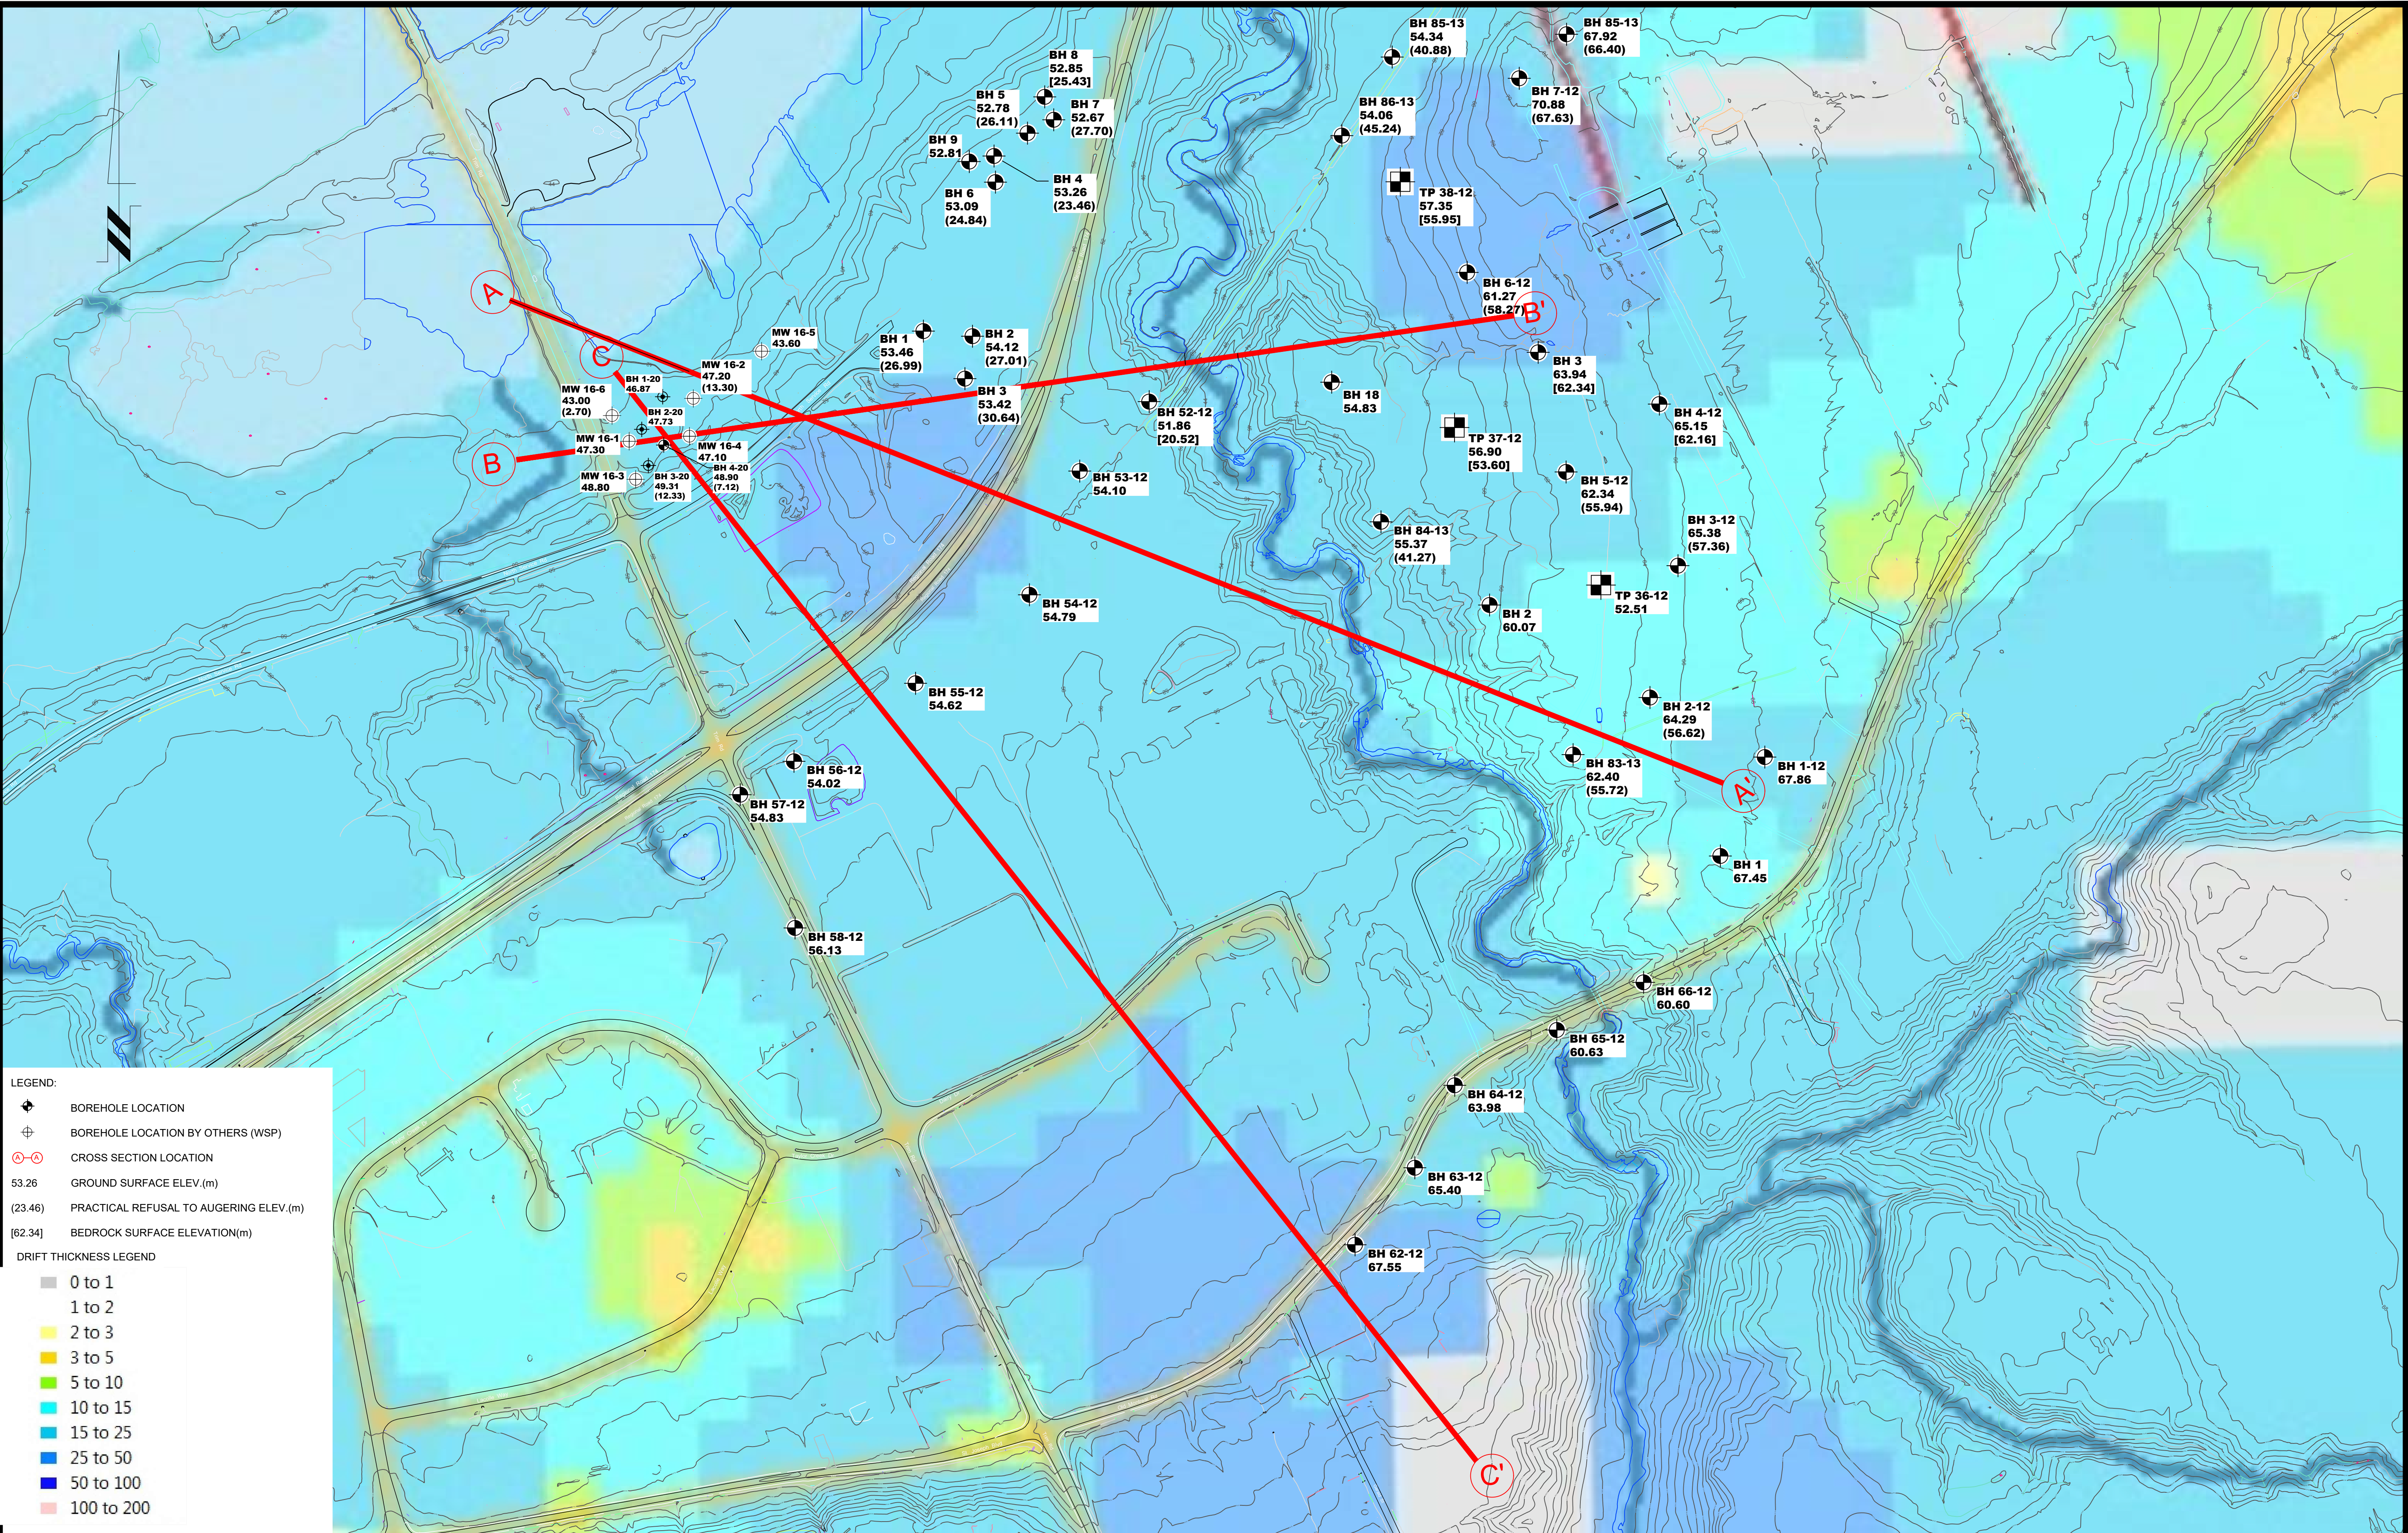
CROSS-SECTION & TEST HOLE LOCATION PLAN

- BOREHOLE LOCATION
- BOREHOLE LOCATION BY OTHERS (WSP)
- CROSS SECTION LOCATION
- 53.26 GROUND SURFACE ELEV.(m)
- (23.46) PRACTICAL REFUSAL TO AUGERING ELEV.(m)
- [62.34] BEDROCK SURFACE ELEVATION(m)

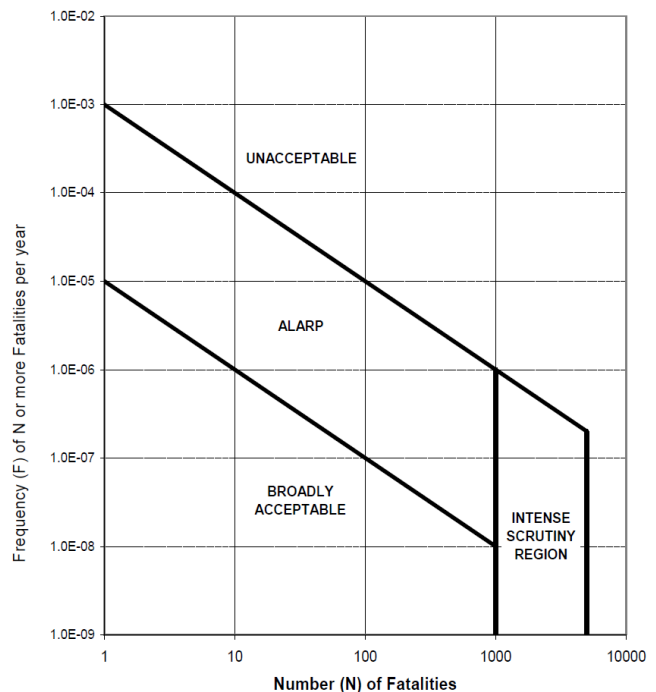
The example F-N curve in GSC OF7312 is shown in the figure to the right.

- <1:10,000 per annum probability for a landslide occurring and reaching the area of proposed development;
- <1:100,000 per annum risk of loss of life to individuals most at risk;
- group or societal risk of loss of life evaluated on an F-N curve, with ALARP (as low as reasonably possible) or broadly acceptable regions as the landslide safety criteria;
- tolerable slope deformation under seismic loading = 0.15 m (where it can be demonstrated that soils are not prone to earthquake-triggered liquefaction); and
- where appropriate, an allowance for 100 years of predicted toe erosion along river, lake, ocean, or reservoir shorelines.

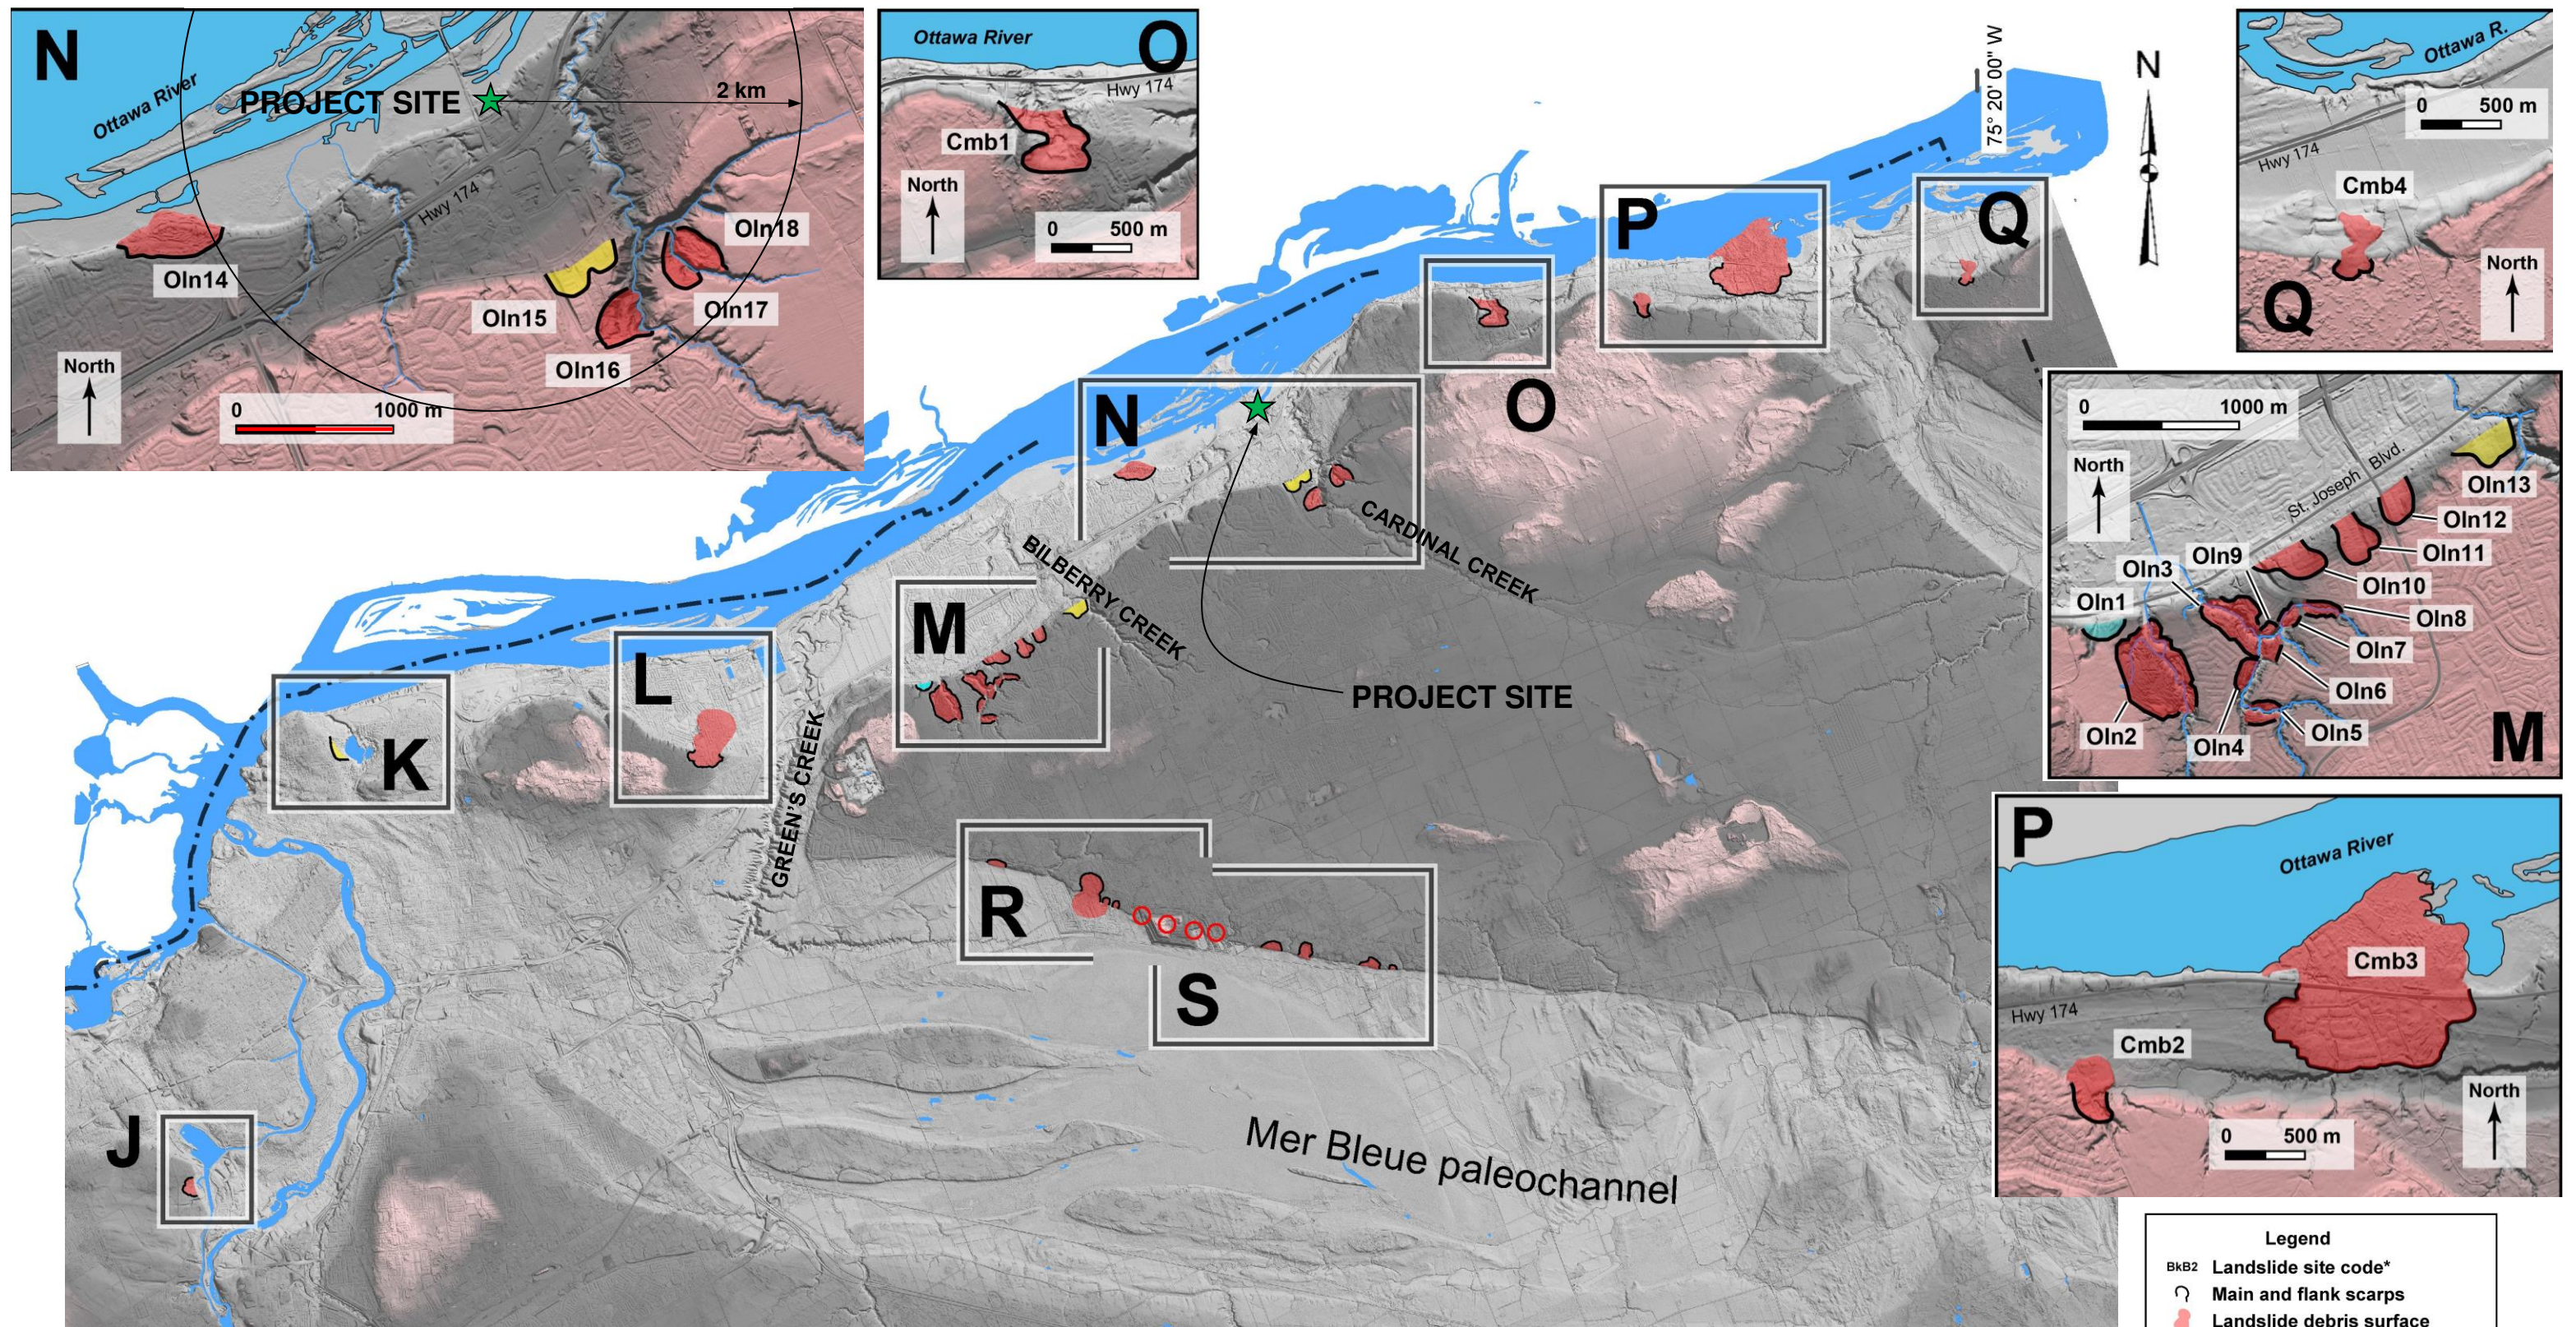
**FIGURE 1**  
**LOCATION OF PROJECT SITE**  
**& MAPPED LANDSLIDES**

From Geological Survey of Canada Open File 8600: *Sensitive Clay Landslide Inventory Map of Ottawa*. (Brooks, 2019)
