**PATERSON
GROUP**

PH4924-LET.01.REV.02

Subject: **Hydrogeological Assessment and Terrain Analysis
Proposed Commercial Development
5923 Ottawa Street
Ottawa, Ontario**

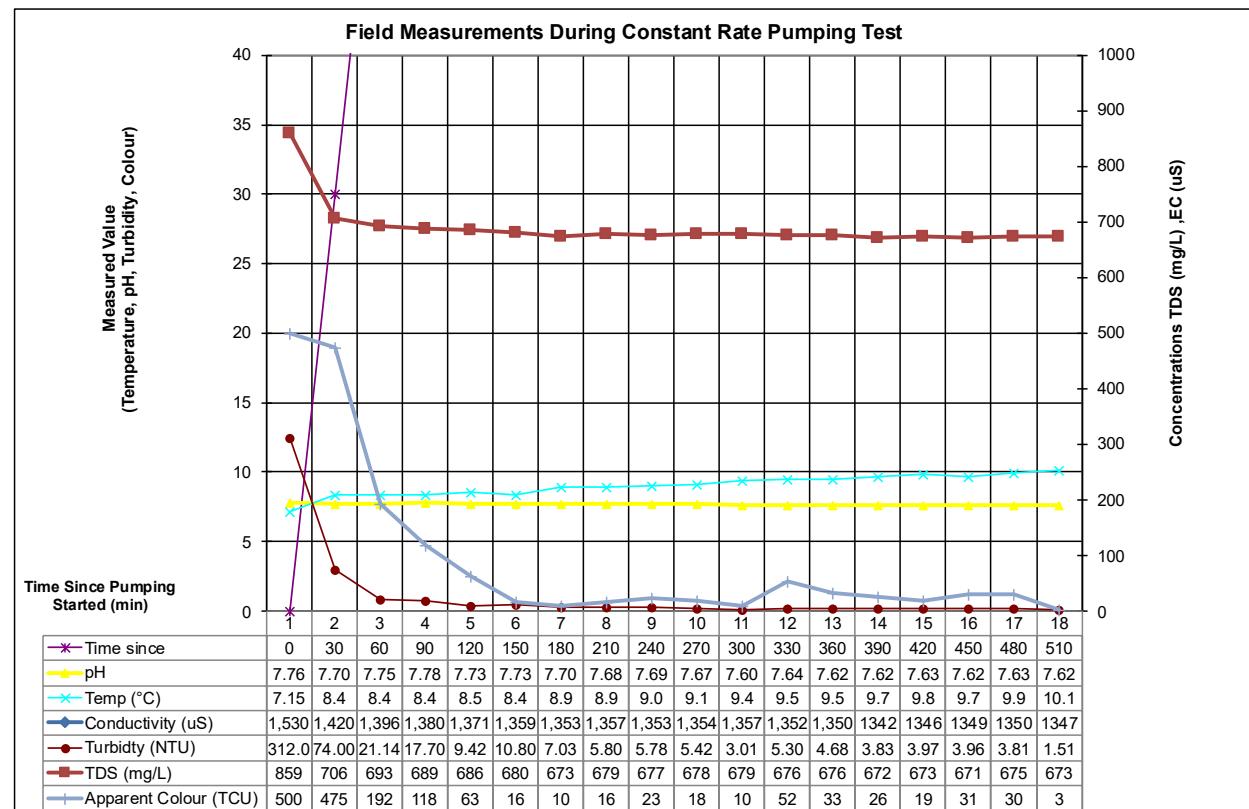
Figure 1: Field Measurements

Turbidity, electrical conductivity, total dissolved solids (TDS), pH, apparent colour and temperature were measured at the wellhead during the pumping test. The measurements and time intervals for each of these parameters are summarized on the graphical representation below. In addition, a HACH Pocket Colorimeter II chlorine reader was used to measure the free chlorine residual level. No chlorine residual was detected in the discharge water prior to the collection of the water samples.

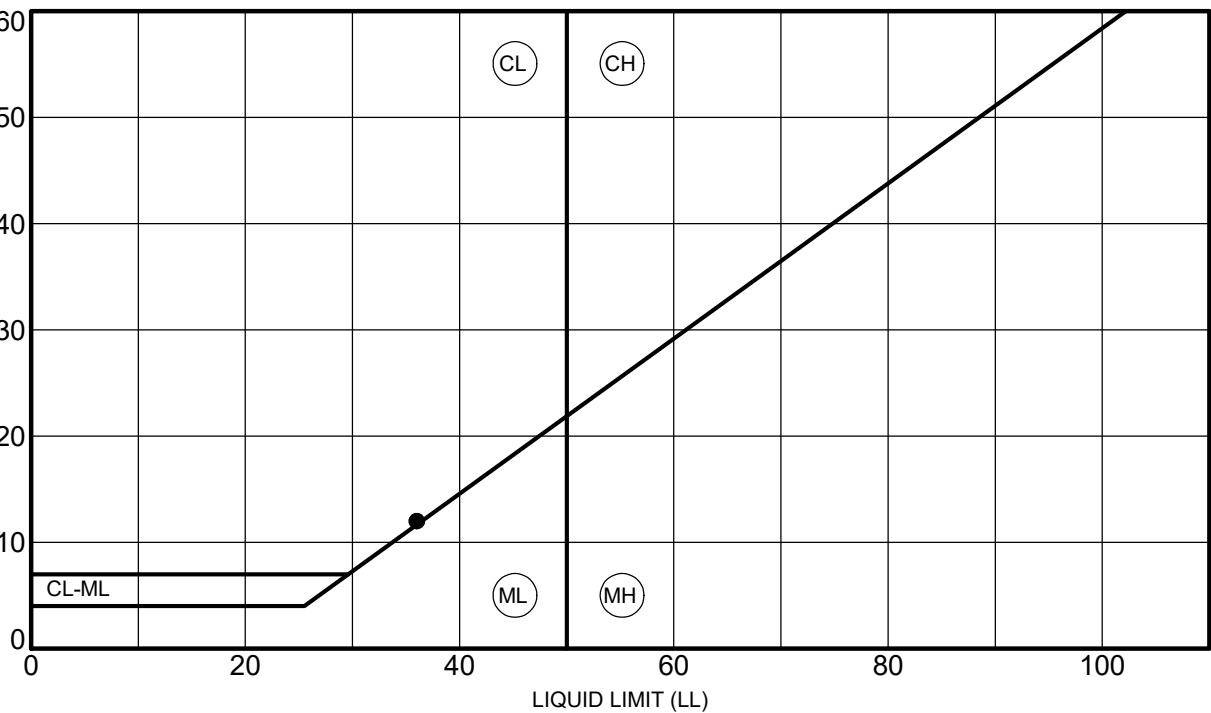
ATTERBERG LIMITS' RESULTS

CLIENT Stratford Foxrun
PROJECT Geotechnical Investigation - 5923 Ottawa Street

Analytical results from the sieve and Atterberg Limit analysis can be found attached.

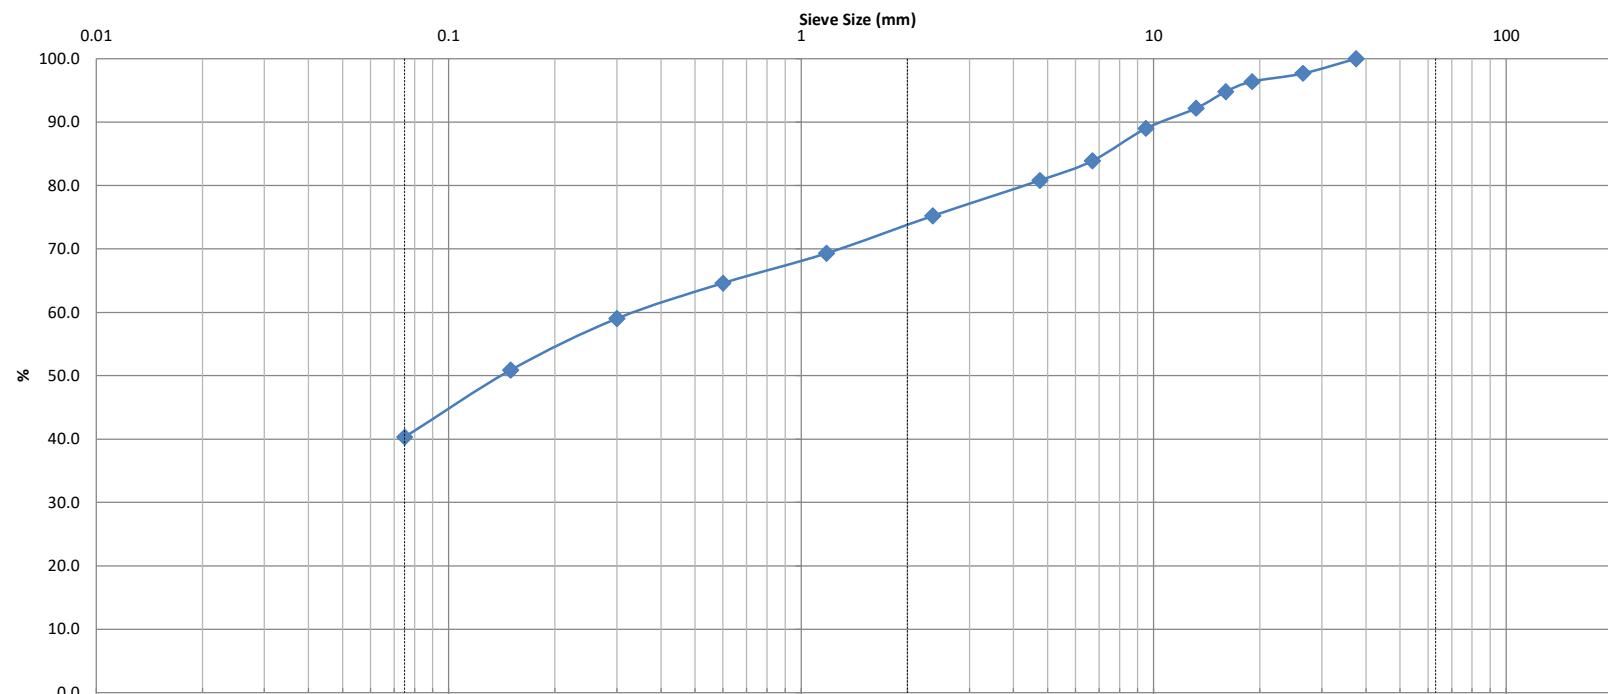
SIEVE ANALYSIS
ASTM C136

CLIENT:	Stratford Foxrun	DESCRIPTION:	Silty Sand w Gravel	FILE NO:	PG7183
CONTRACT NO.:	-	SPECIFICATION:	Silty Sand w Gravel	LAB NO:	53405
PROJECT:	5293 Ottawa Street	INTENDED USE:	-	DATE RECEIVED:	20-Jun-24
		PIT OR QUARRY:	-	DATE TESTED:	20-Jun-24
DATE SAMPLED:	-	SOURCE LOCATION:	BH2-24 SS3	DATE REPORTED:	5-Jul-24
SAMPLED BY:	Adam E.	SAMPLE LOCATION:	-	TESTED BY:	CP

Identification	Soil Classification					MC(%)	LL	PL	PI	Cc	Cu
	D100	D60	D30	D10	Gravel (%)						
	37.5	0.34	0.035	0.015	19.2	40.5				0.24	22.7
											Clay (%)
											40.3

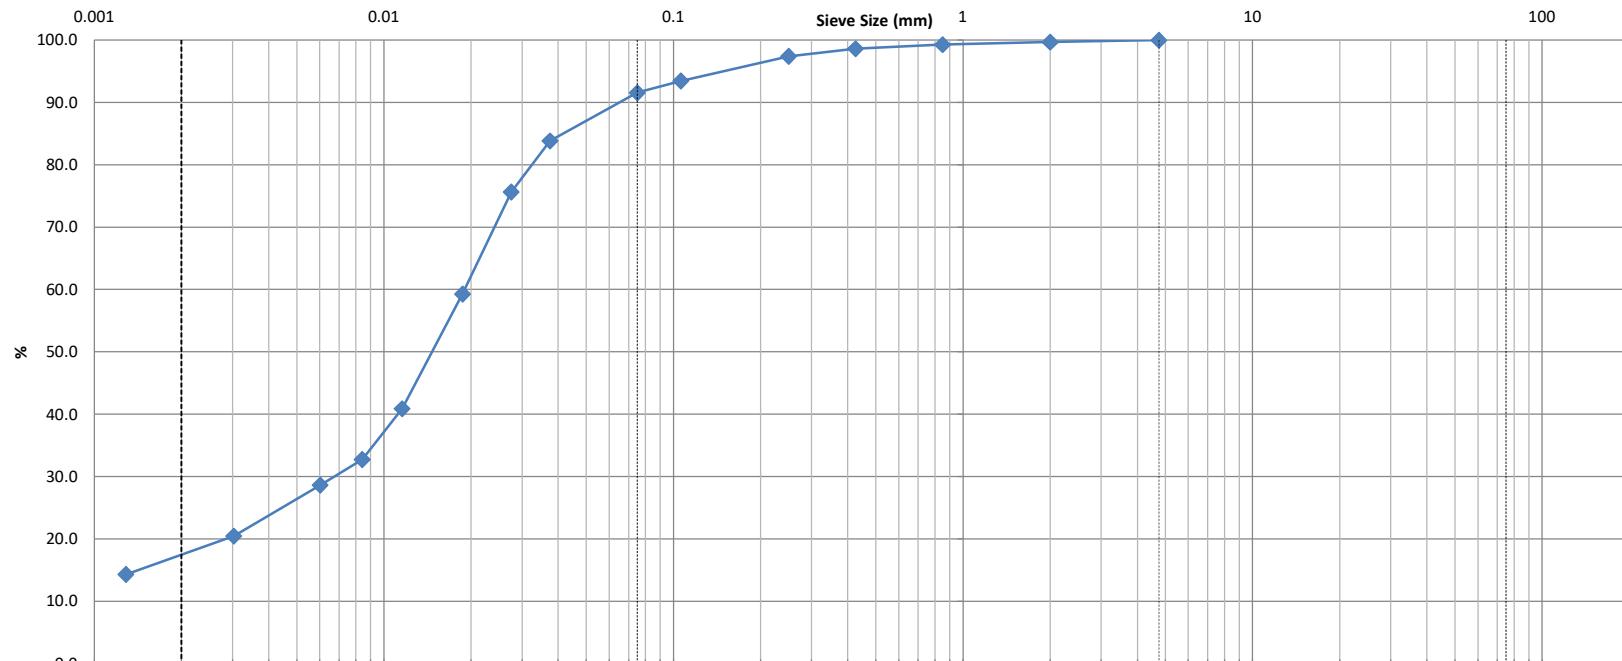
SIEVE ANALYSIS
ASTM C136

CLIENT:	Stratford Foxrun	DEPTH:	BH3-25 SS2	FILE NO:	PG7183
CONTRACT NO.:		BH OR TP No.:	-	LAB NO:	59250
PROJECT:	5923 Ottawa Street			DATE RECEIVED:	21-Apr-25
DATE SAMPLED:	17-Apr-25			DATE TESTED:	21-Apr-25
SAMPLED BY:	C.A.			DATE REPORTED:	28-Apr-25
				TESTED BY:	D.K

Identification	Soil Classification					MC(%)	LL	PL	PI	Cc	Cu
	D100	D60	D30	D10	Gravel (%)	23.9%					
					0.0		Sand (%)		Silt (%)		Clay (%)
							8.4		73.6		18.0

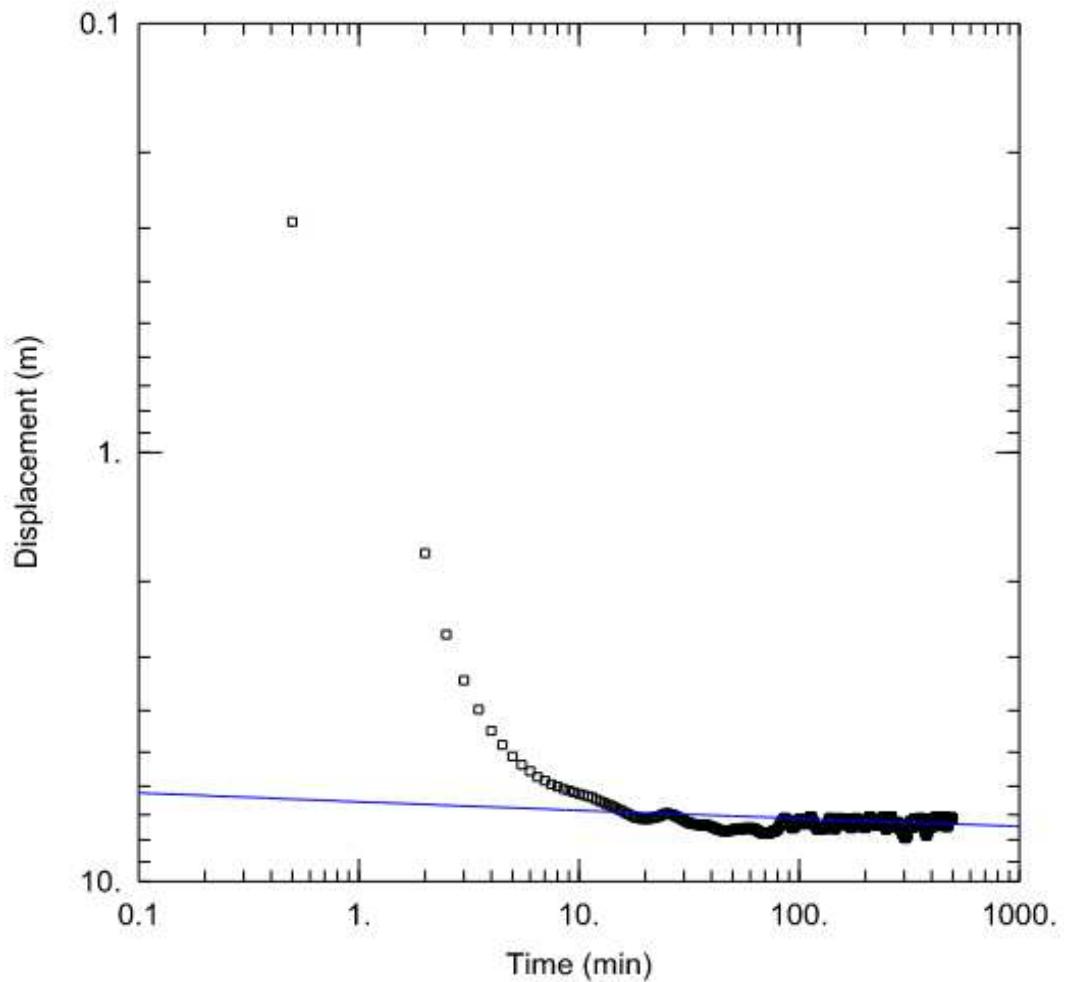
Pumping Test Analysis Report

File No.	PH4924	Well ID:	TW1
Date:	March 19, 2025	Solution Method:	Theis
Client:	Stratford Foxrun	Transmissivity (m^2/day):	65
Site Address:	5923 Ottawa Street, Ottawa	Discharge Rate (L/min)	78
Project:	Proposed Commercial Development	Analysis performed by:	ZB

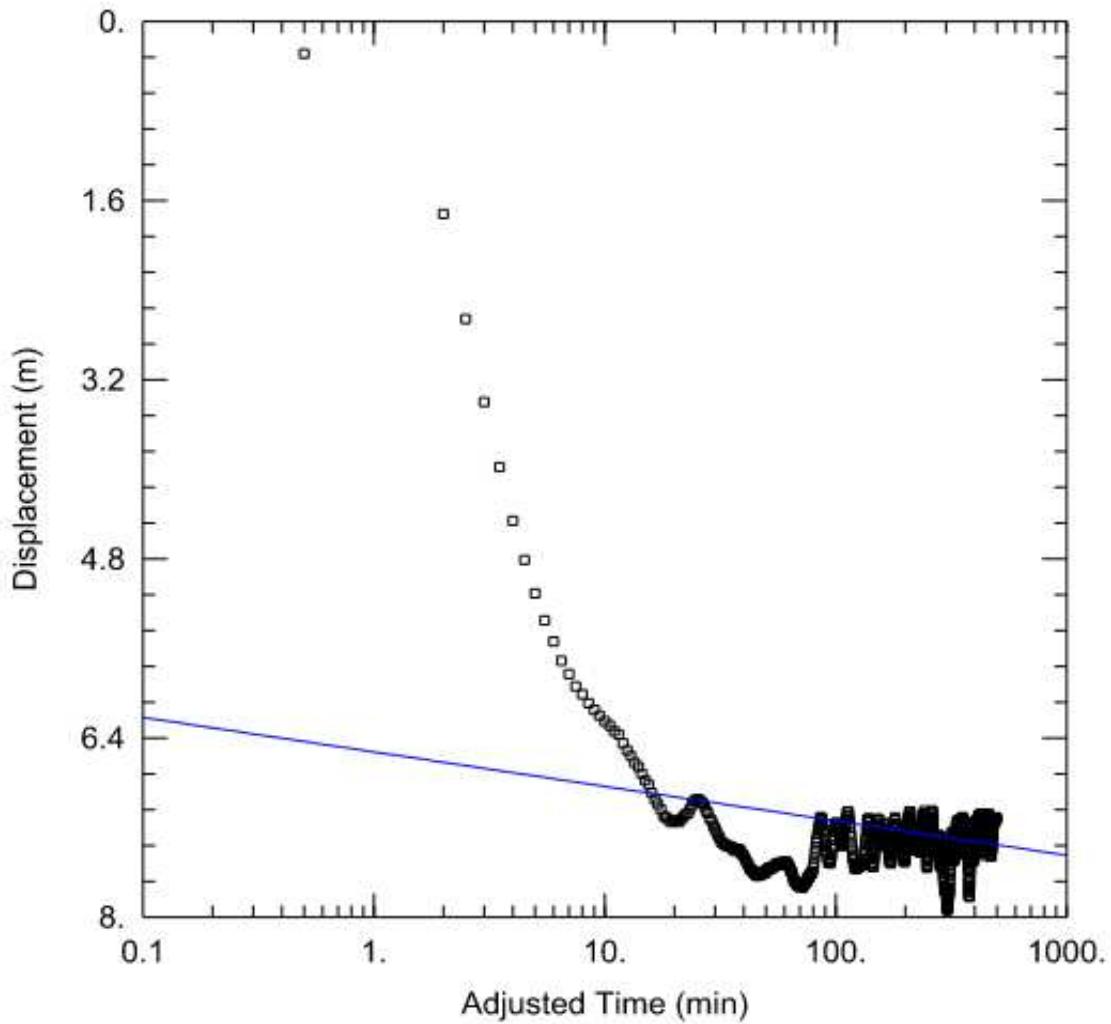
Pumping Test Analysis Report

File No.	PH4924	Well ID:	TW1
Date:	March 19, 2025	Solution Method:	Cooper-Jacob
Client:	Stratford Foxrun	Transmissivity (m ² /day):	65
Site Address:	5923 Ottawa Street, Ottawa	Discharge Rate (L/min)	78
Project:	Proposed Commercial Development	Analysis performed by:	ZB
