# TREE CONSERVATION REPORT

4405-4409 Innes rd

Tree Conservation Report submitted as Partial  
Requirements for a Site Plan Control Application,  
July 15, 2025

# Tree Conservation Report

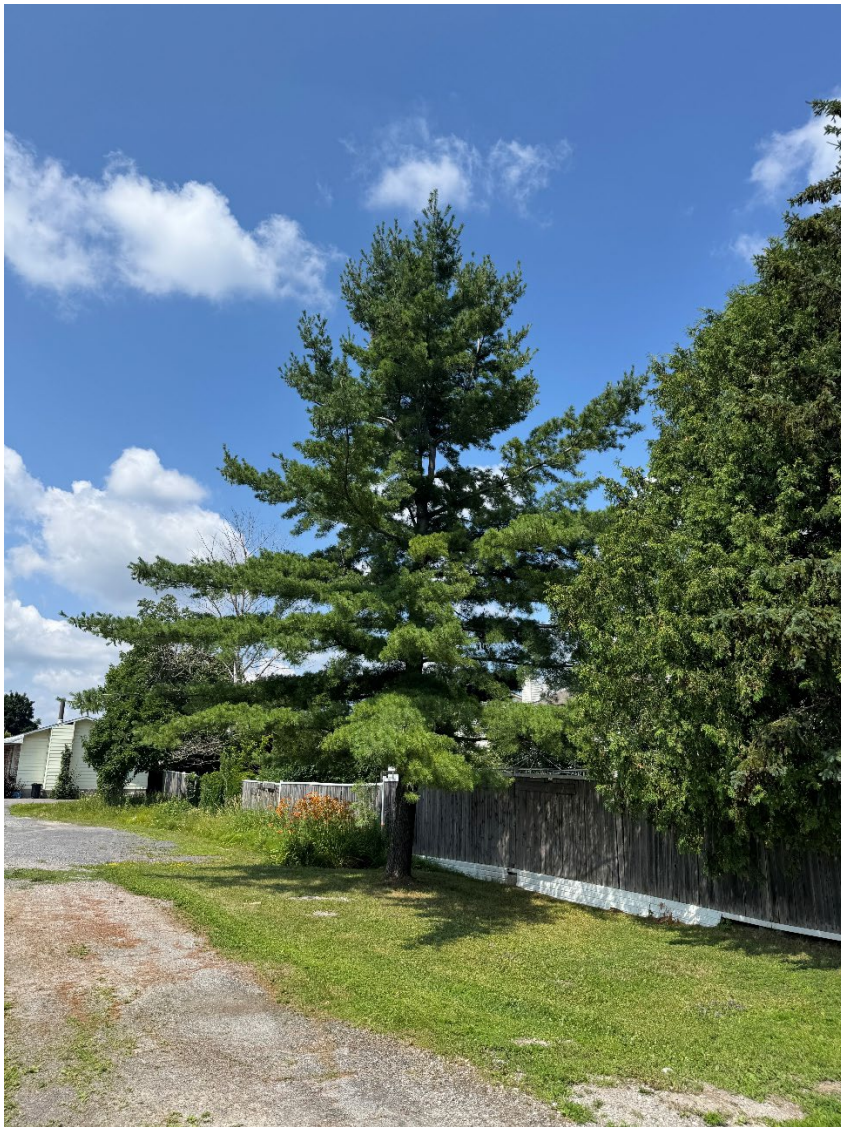
| Tree <sup>1,4</sup> | Species | DBH (cm) | Ownership <sup>2</sup> | Tree Condition | Forester recommendation |
|---|---|---|---|---|---|
| 6 | White pine ( <i>Pinus strobus</i> ) | 43 | Subject property | Good | Remove; in conflict with proposed laneway; <b>Tree Permit required</b> |

Figure 2: tree 6, white pine to be removed

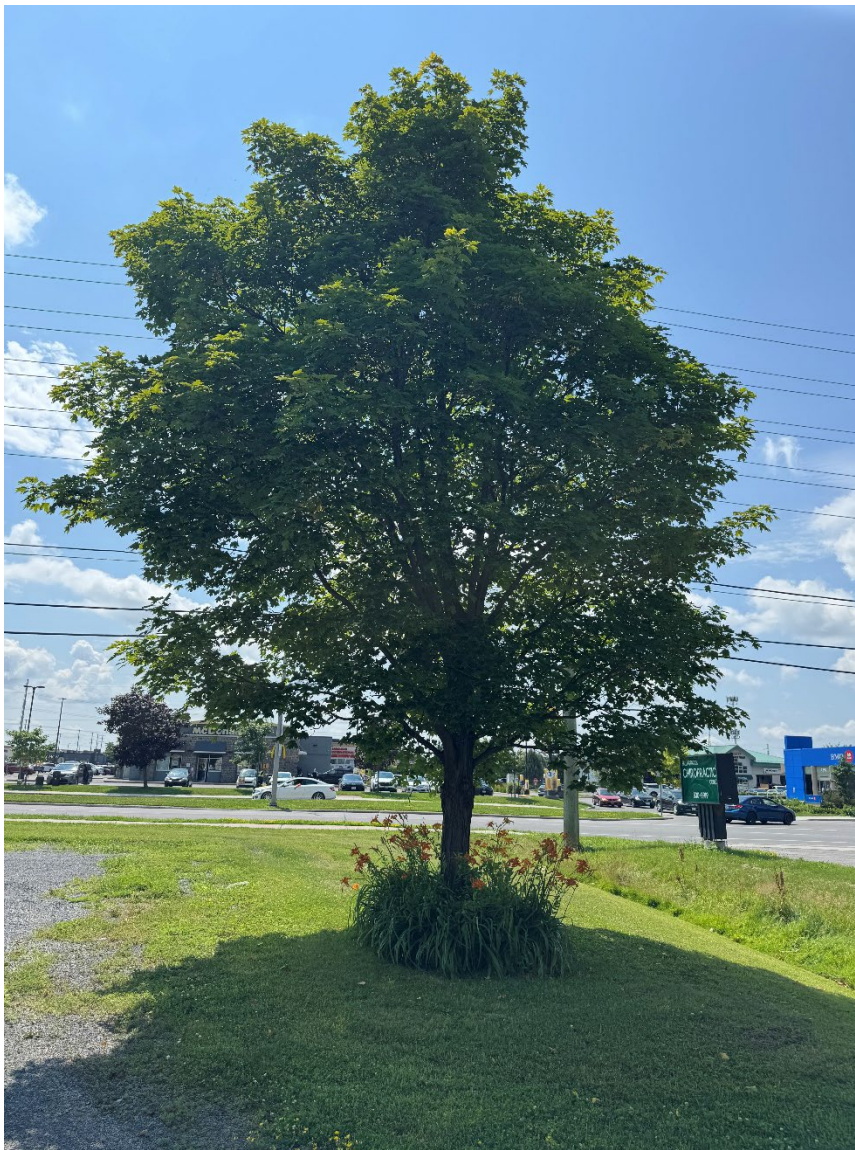
| Tree <sup>1,4</sup> | Species | DBH (cm) | Ownership <sup>2</sup> | Tree Condition | Forester recommendation |
|---|---|---|---|---|---|
| 7 | Sugar maple ( <i>Acer saccharum</i> ) | 30 | Subject property | Good | Remove; in conflict with proposed laneway; <b>Tree Permit required</b> |

Figure 3: Tree 7, sugar maple to be removed
