Geotechnical Investigation Report

Metcalfe Agricultural Society
2821 8th Line Road, Metcalfe, ON

Prepared by:
Stantec Consulting Ltd.

Project No. 121625761

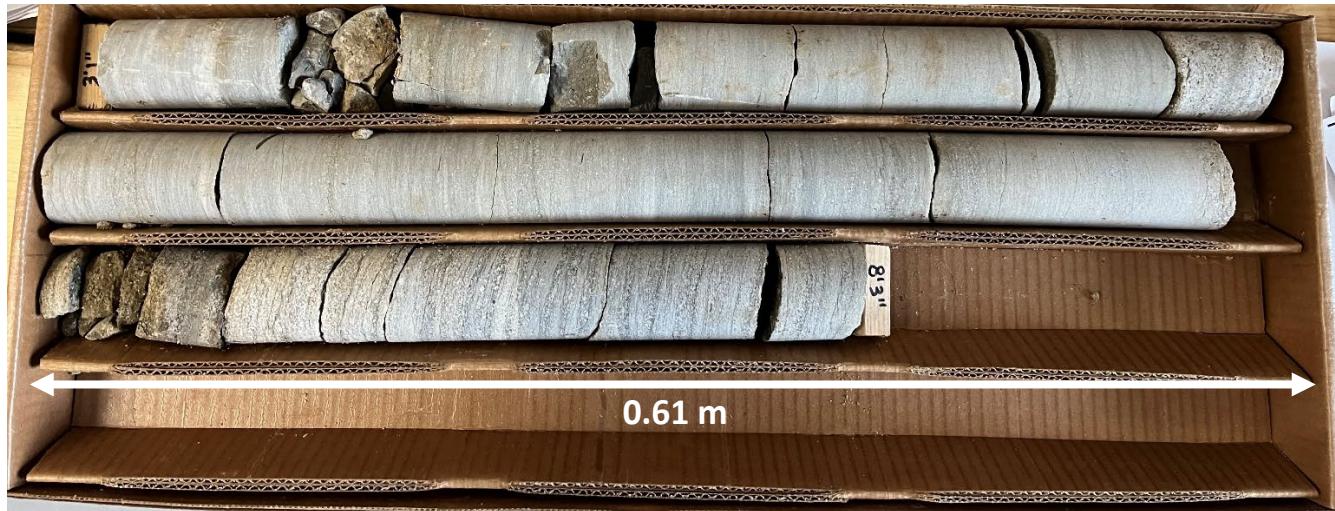
Rock Core Photo No.:	1	Borehole:	BH24-1A'	Depth:	0.9 m to 2.5 m
----------------------	---	-----------	----------	--------	----------------

The sampled bedrock consisted of grey limestone with a thin layer of sandstone. The rock has been noted as being horizontally bedded and extremely close to close spaced joints. The Rock Quality Designation (RQD) value ranged from 6% to 33%, indicating a very poor to poor quality.
