Roof Maintenance Solutions Inc.

Phase II Environmental Site Assessment
Revision 2.0 Remediation
3210 Albion Road South
Ottawa, Ontario

SDC1023

July 23, 2025

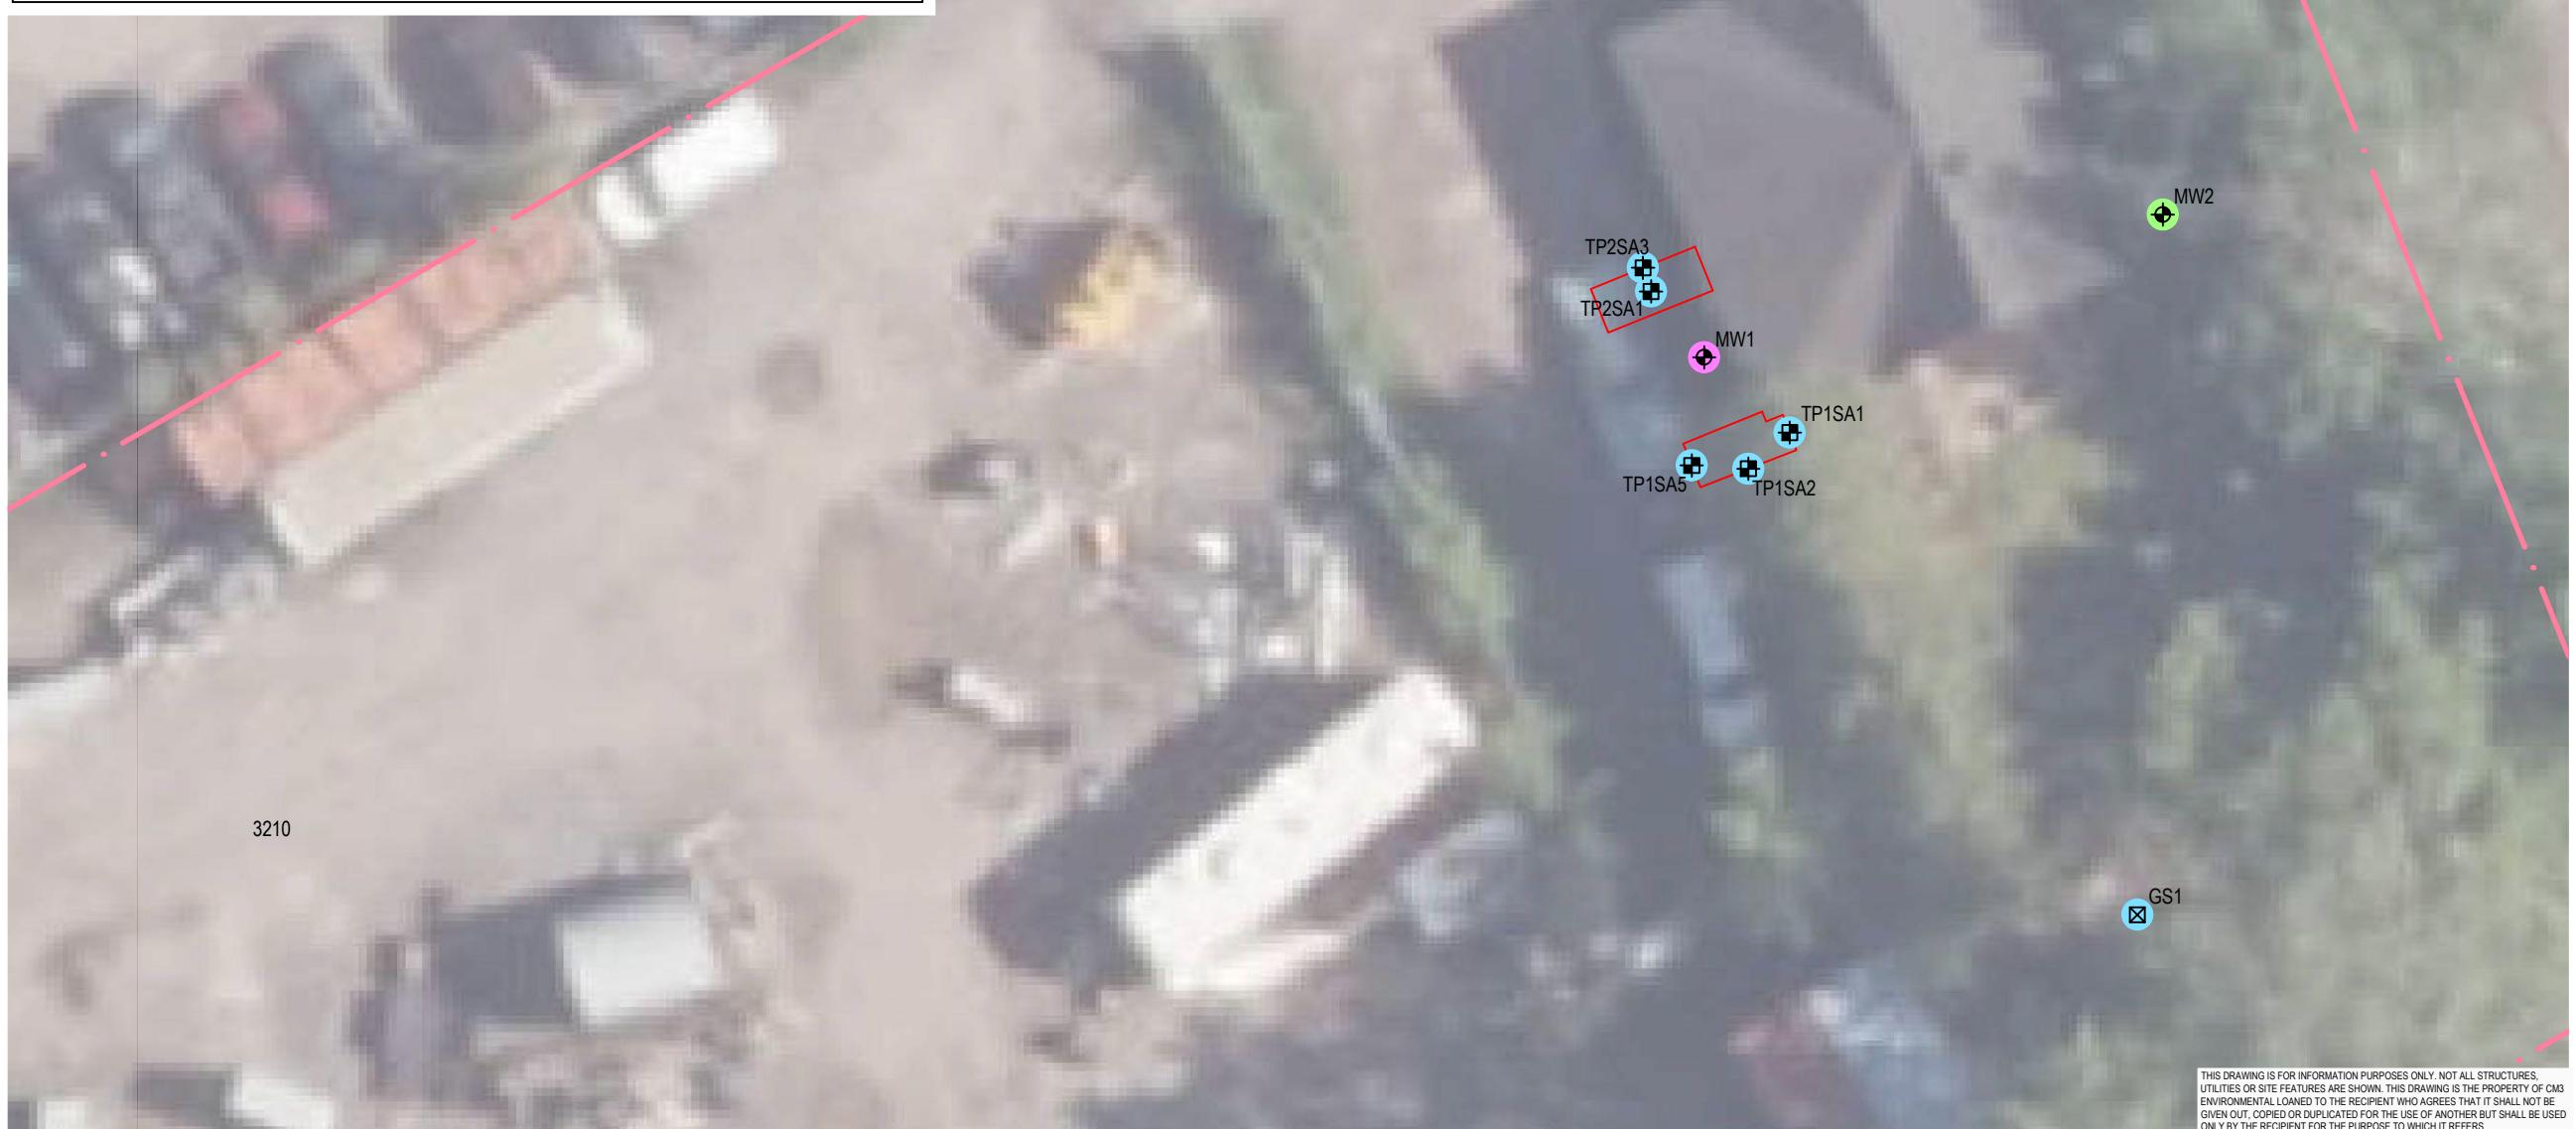
DELINEATION SOIL QUALITY

One borehole (MW1) and two test pits (TP1 and TP2) were completed at APEC 2 and seven soil sample were analysed for PHCs in the F1 to F4 fractions. The results were either non-detectable or had concentration of BTEX and/or PHCs in the F1 to F4 fractions that comply with the Table 3 SCS except for one sample, (MW1SA3). The soil sample MW1SA3 had detectable levels of PHCs in the F1 to F3 fraction with the F2 fraction exceeding the Table 3 SCS. All other parameters in soil sample MW1SA3 were non-detectable.

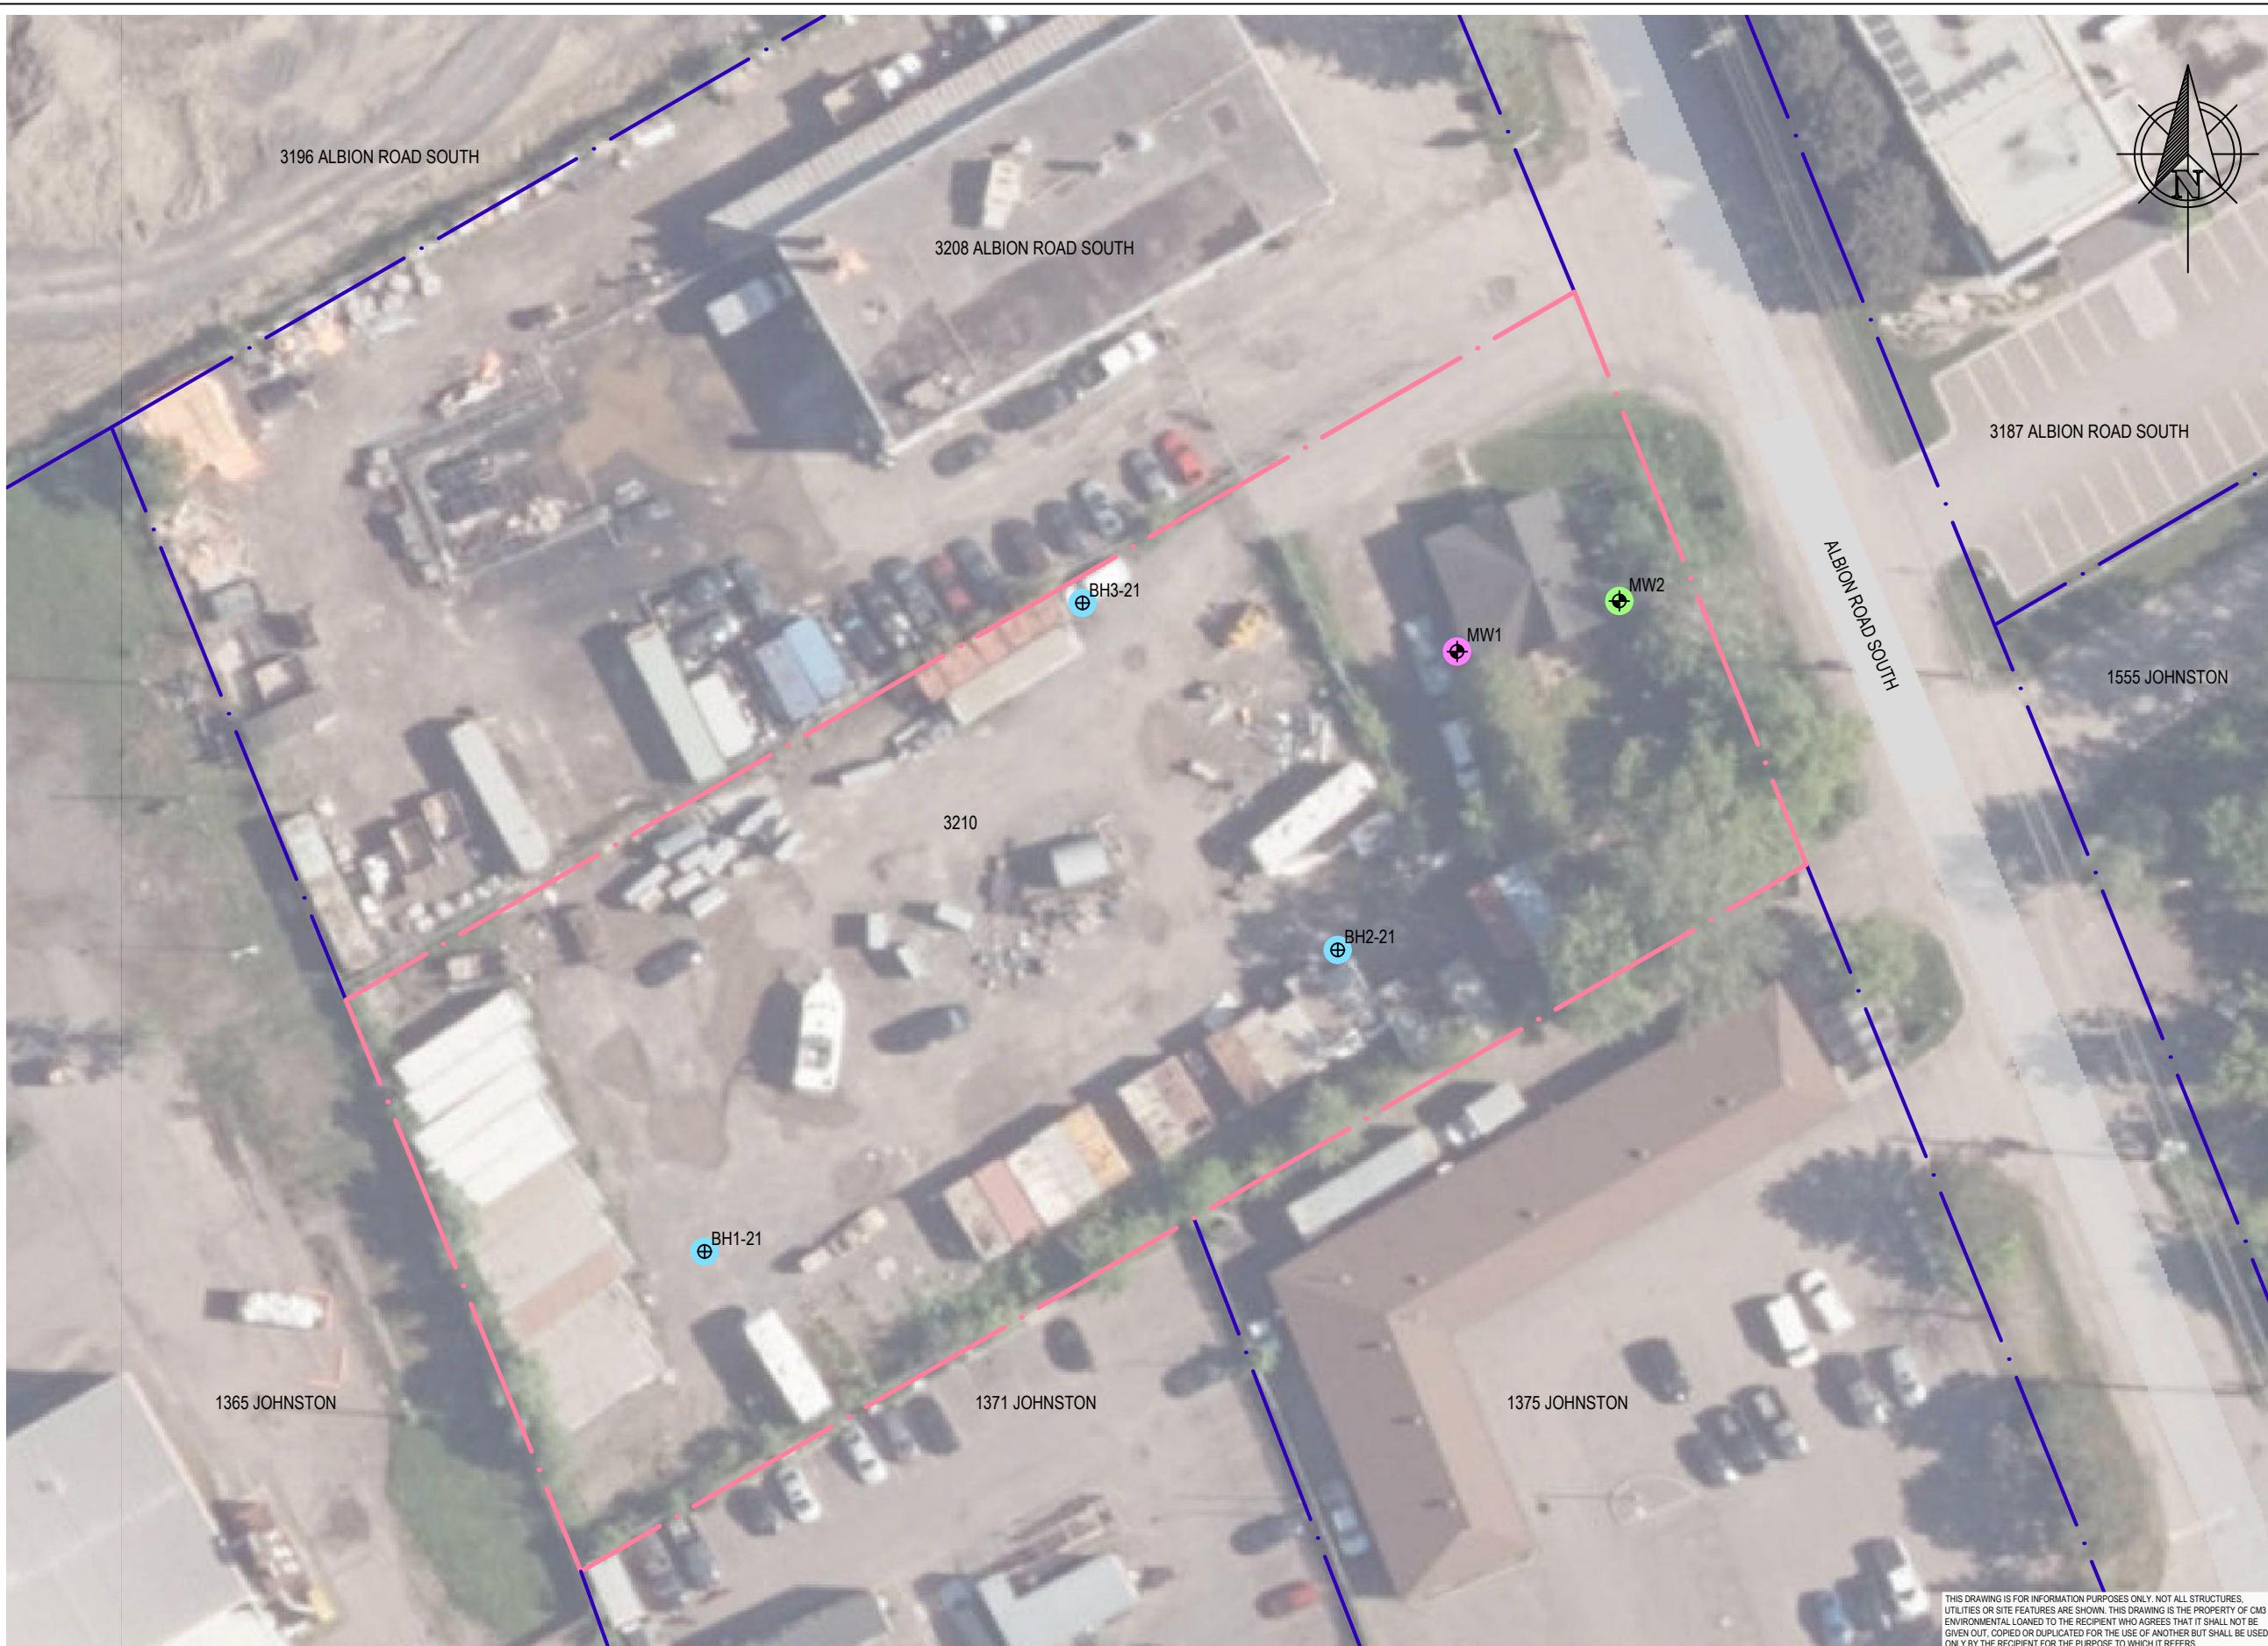
GROUNDWATER QUALITY

One monitoring well (MW1) was installed at APEC 2 and one groundwater sample was analysed for COCs including PHCs and BTEX. Laboratory results indicated that groundwater sample 'MW2' did not have detectable concentrations of BTEX or PHCs in the F1 and F4 fractions but did have

detectable levels of PHCs in the F2 and F3 fractions. The concentrations of PHCs in the F2 and F3 fractions exceeded the Table 3 SCS.

The groundwater sample analytical results are summarized in Table 4. The monitoring well locations and groundwater quality are provided on Figure 4. The groundwater sample laboratory reports are provided in Appendix B.
