# ENVIRONMENTAL IMPACT STATEMENT ADDENDUM

Playvalue Toys, 130 David Manchester Road, Carp, ON

Project No.: CCO-21-0619

**Version 004  
September 20, 2021**

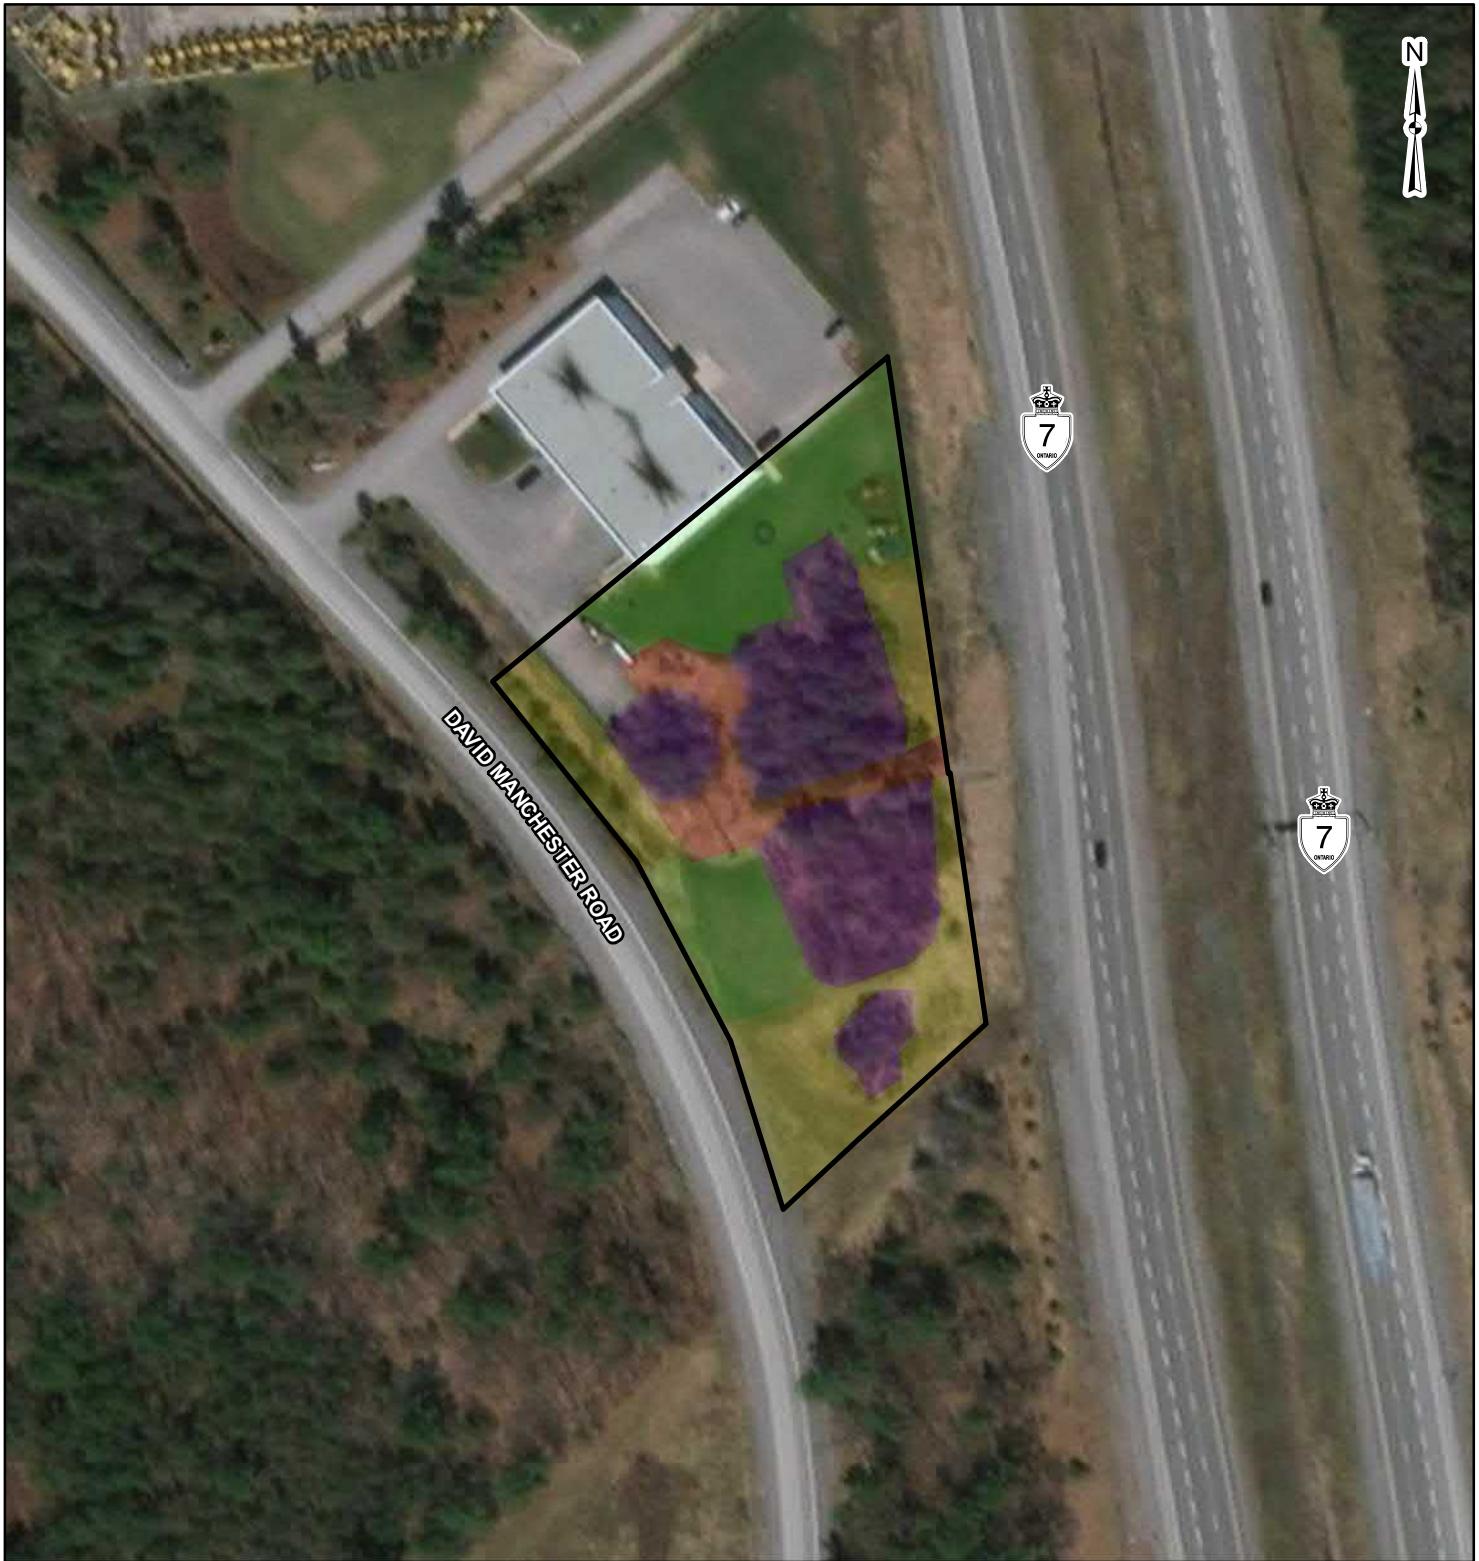
Vegetation Community 3 was classified through ELC as a Fresh-Moist Graminoid Meadow (MEGM2) (**Photos 3 - 5**). This community consisted of a swale with damp soils that cut through the Fresh-Moist White Cedar-Hardwood Woodland community in a west-east orientation. This swale linked drains under David Manchester Road and Highway 7. The swale also stretched northwards to the northern boundary of the study area. The swale consisted of vegetation dominated by grasses and broad-leaved cattail (*Typha latifolia*). For a detailed map of vegetation communities present within the study area, refer to **Figure 2**. Refer to **Table 2** for a complete listing of species observed within the study area.

Vegetation Community 1 was classified through ELC as a Dry-Fresh Forb Meadow (MEFM1) (**Photos 3 and 8**). This community lacked significant woody vegetation. It was previously cleared and is considered a disturbed area with herbaceous growth regenerating the area. The dominant species included grass (Poaceae spp.), common milkweed (*Asclepias syriaca*), and common non-native plants. The northwest end of this community is maintained by mowing (**Photo 8**). This community was present along the west, south, and east boundaries of the study area.

Vegetation Community 2 was classified through ELC as a Fresh-Moist White Cedar-Hardwood Mixed Woodland (WOMM4-1) (**Photos 1, 3, 4, 7, 10**). This community occupies the majority of the study area and is located in the middle of the study area. Tree inventory zones 1, 2, and 3 consist of this vegetation community. The canopy of this community consisted of a mix of mature eastern white-cedar (*Thuja occidentalis*), white ash (*Fraxinus americana*), and eastern white pine (*Pinus strobus*). Understory species was dominated by glossy buckthorn (*Frangula alnus*). The narrow stand of mature trees contained in this community most likely represents mature forest that was previously present throughout the surrounding lands prior to clearing. Based on Google Earth (Maxar Technologies, 2020) satellite imagery, this community was intact as early as 2004.

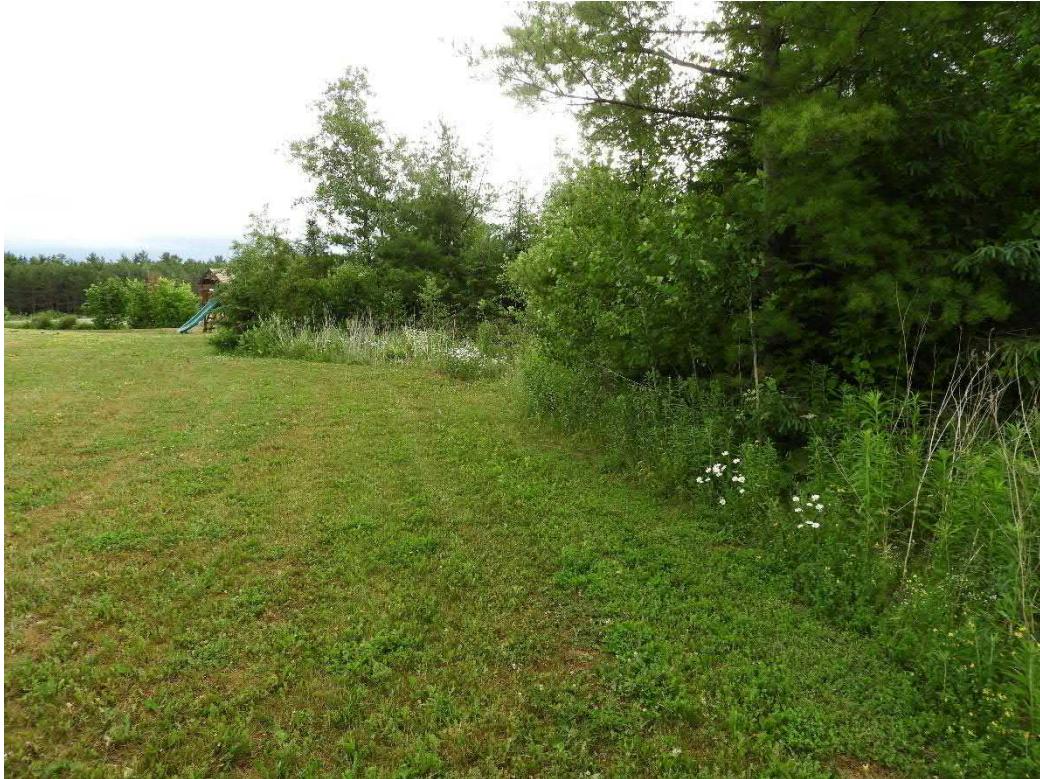
*Photo 1: Mown lawn (left) and fresh-moist white cedar-hardwood mixed woodland (right) in the north end of the study area where development is proposed. 25 June 2020.*

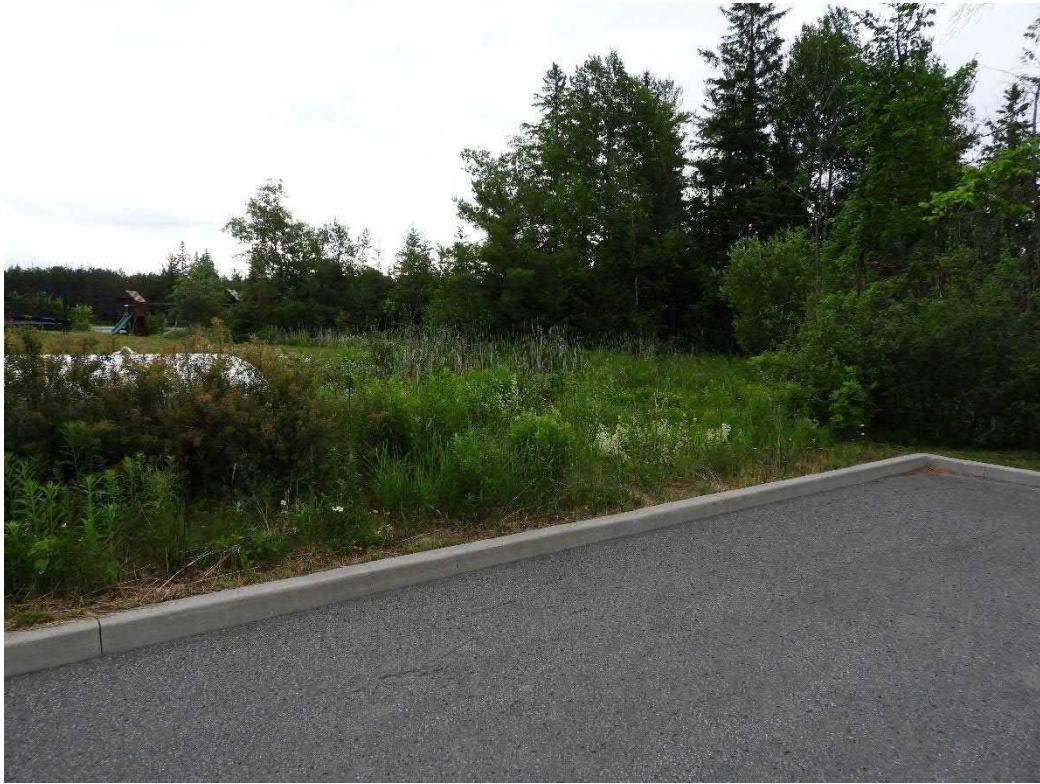
*Photo 2: Northwest end of the study area (looking southeast) where the driveway extension is proposed. 25 June 2020.*

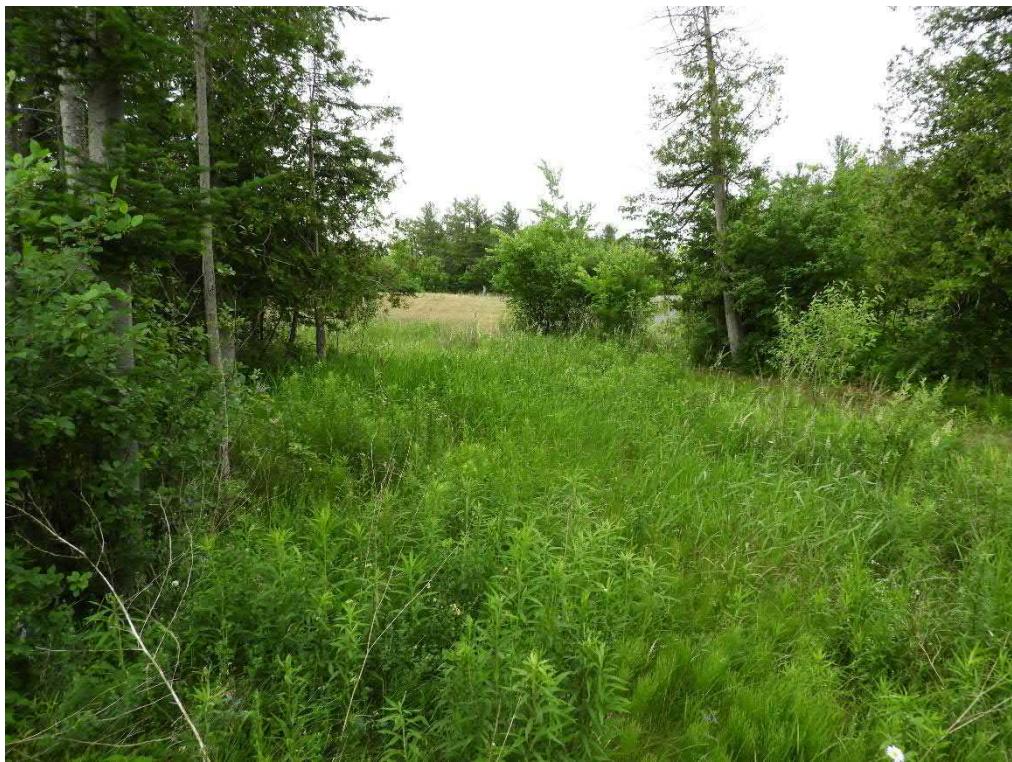
*Photo 3: Fresh-moist graminoid meadow (swale) in the north end of the study area between fresh-moist white cedar-hardwood mixed woodland areas. 25 June 2020.*

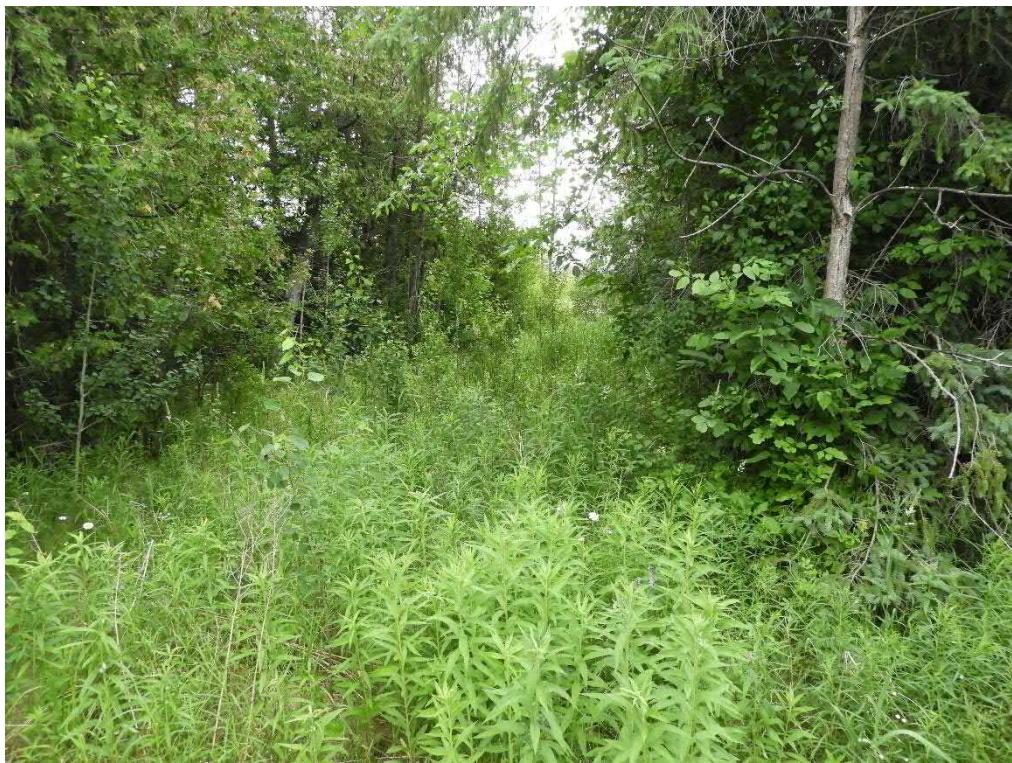
*Photo 4: Fresh-moist graminoid meadow (swale) in the middle of the study area between fresh-moist white cedar-hardwood mixed woodland areas connecting drains under David Manchester Road and Highway 7. 25 June 2020.*

During the field investigation, the soils were observed to have moderately poor drainage as was evident with the damp soils present in the middle of the study area. A wet swale was present through the wooded area which connected to a drain under Highway 7 at the east boundary and a drain under David Manchester Road at the west boundary. No surface water was observed.

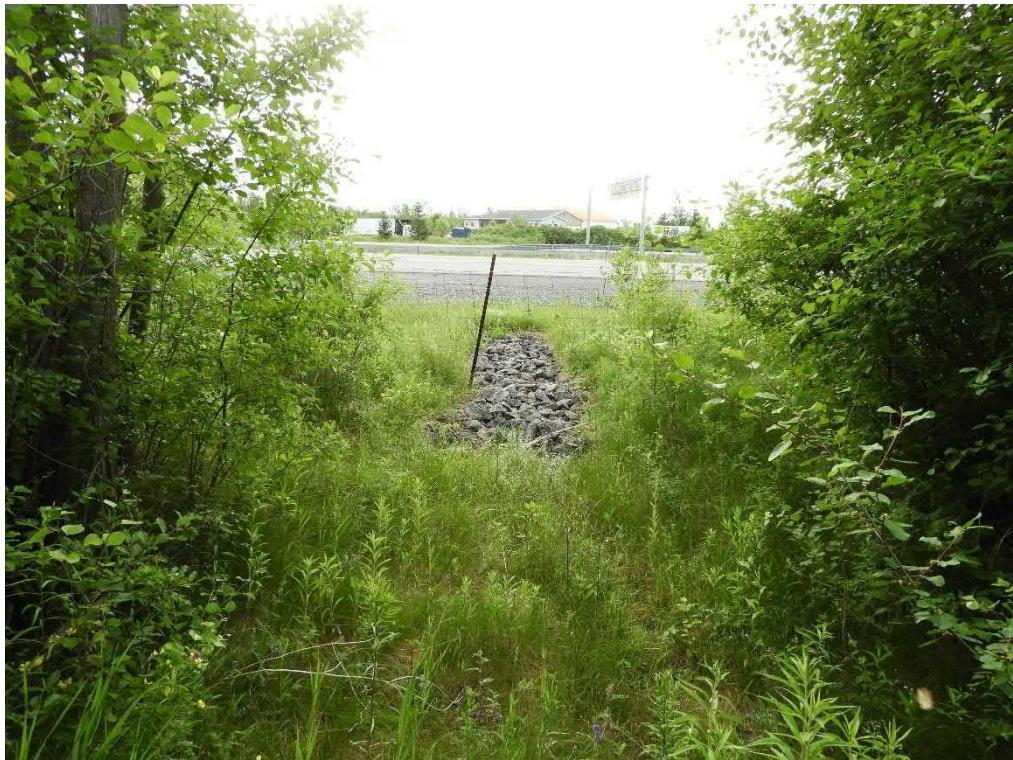
*Photo 5: Drain under Highway 7 at the east boundary of the study area. 25 June 2020.*

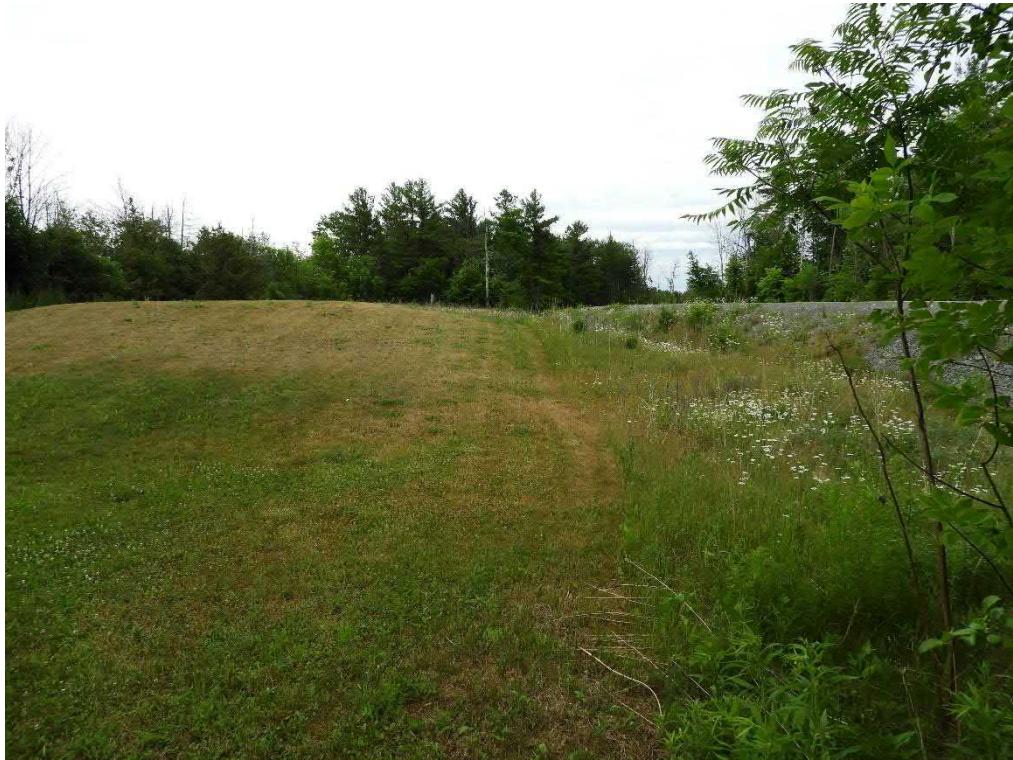
*Photo 6: Mown area in the southwest end of the study area. 25 June 2020.*

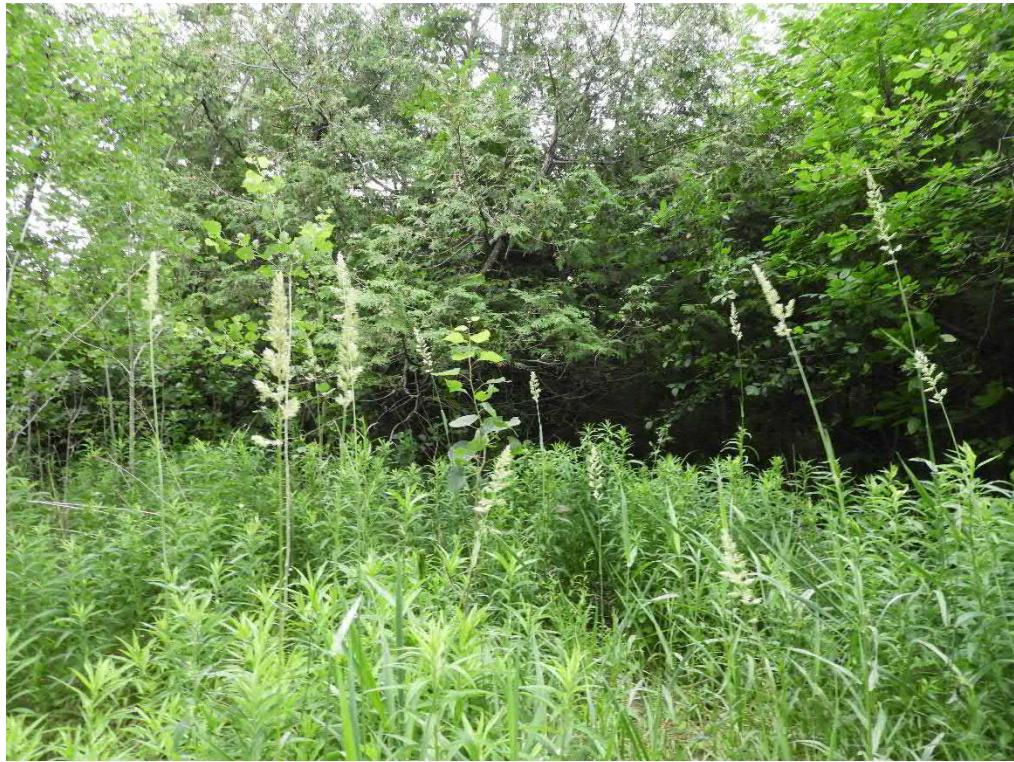
Photo 7: Fresh-moist white cedar-hardwood mixed woodland in the north end of the study area. 25 June 2020.

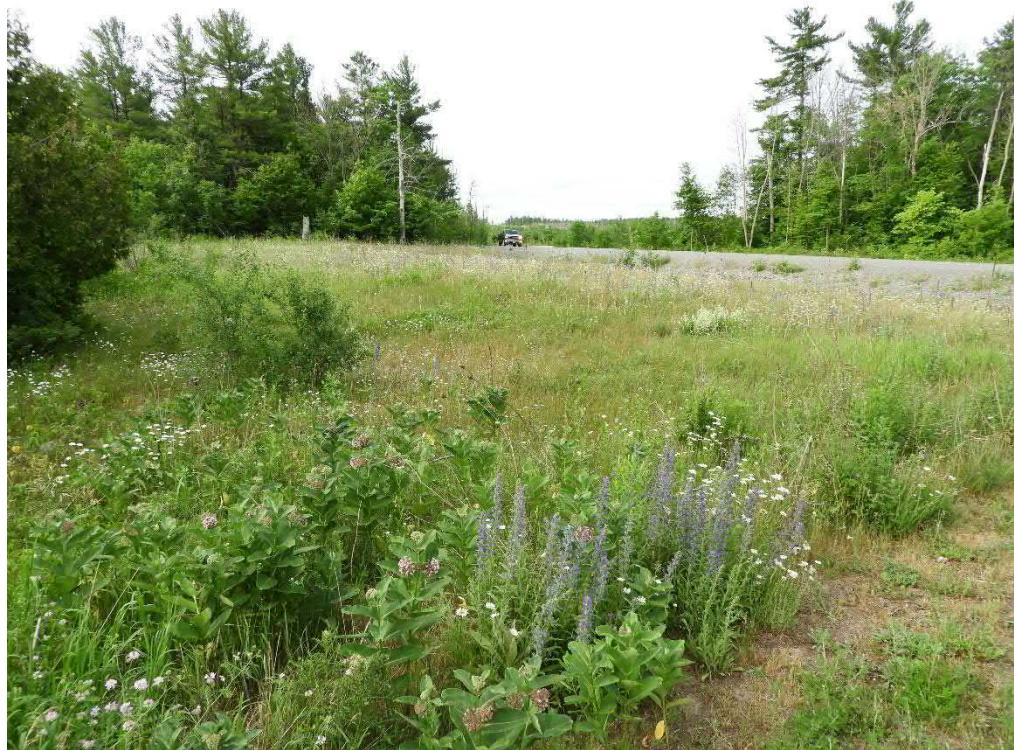
Photo 8: Dry-fresh forb meadow in the south end of the study area which included Monarch habitat in the form of a patch of common milkweed (*Asclepias syriaca*) (foreground left). 25 June 2020.

Monarchs habitat was observed in the dry-fresh forb meadow in the south end of the study area. This area contained a stand of common milkweed which provides suitable habitat for all life processes of the Monarch. No Monarchs were observed within the study area during the field investigation. The south end of the study area containing the stand of common milkweed is outside of the footprint of the proposed warehouse expansion. It is not anticipated that negative impacts will occur to Monarchs as part of the project works.

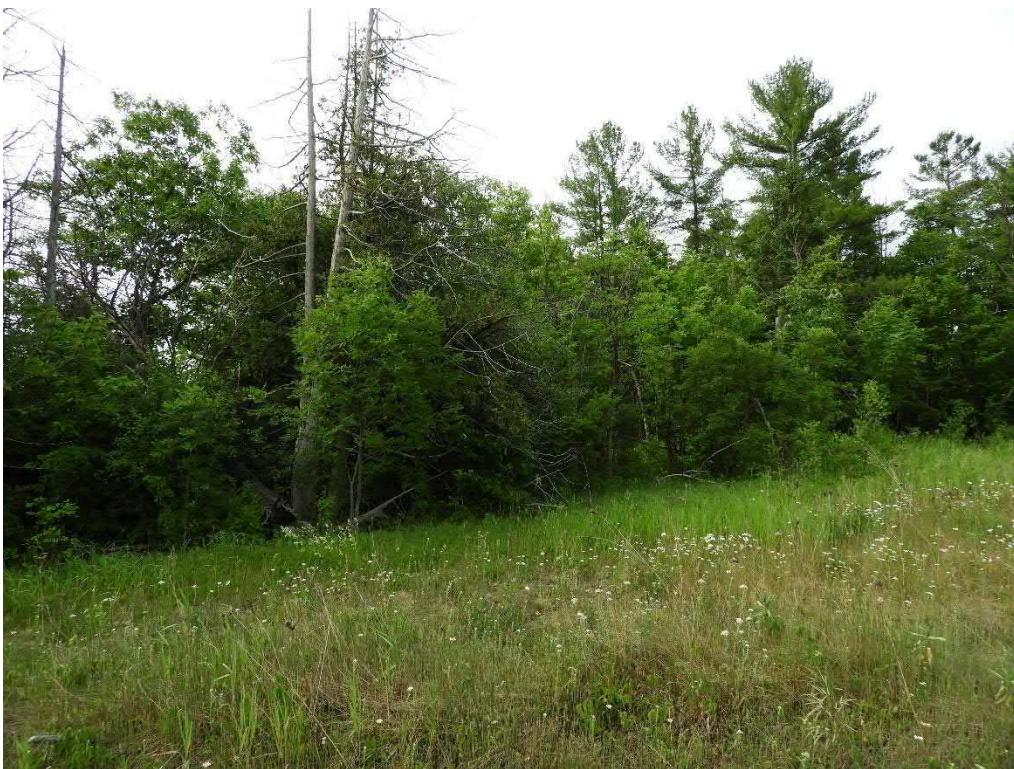
*Photo 10: Fresh-moist white cedar-hardwood mixed woodland in the south end of the study area. 25 June 2020.*

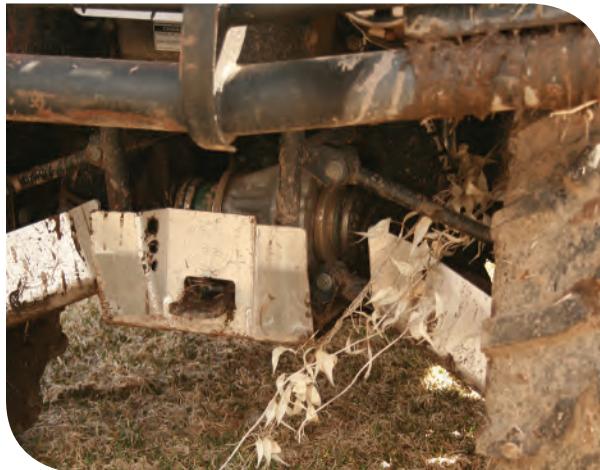
**Dog-strangling Vine plants attached to ATV.**

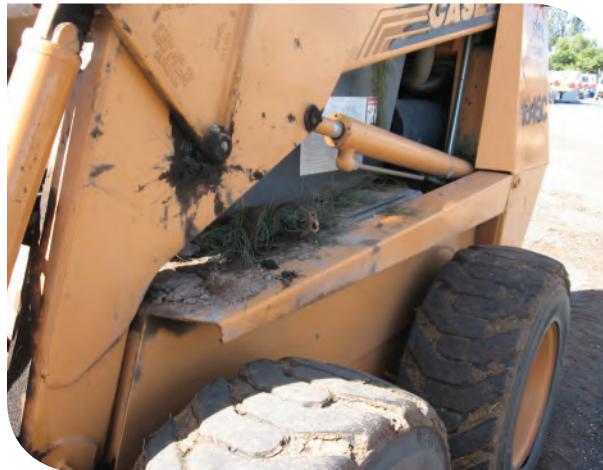
**Plant material attached to bobcat.**

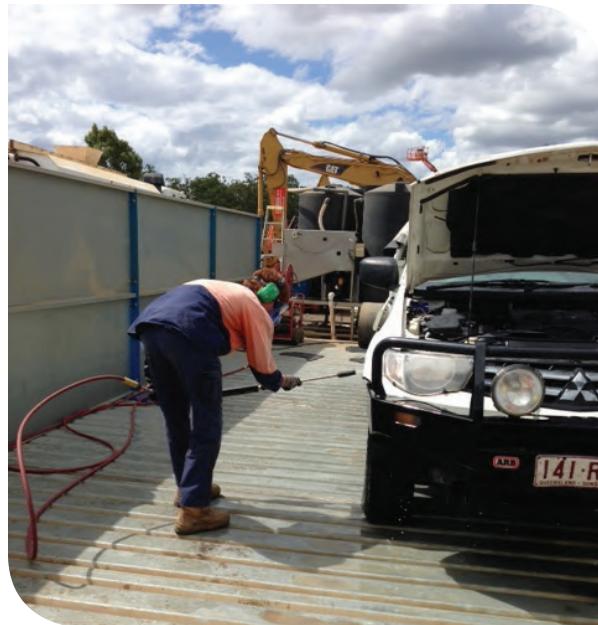
**Hosing down a vehicle in Queensland Australia**

For equipment such as water trucks that may be exposed to aquatic invasive species, trucks should be disinfected with bleach solution before conducting work in a new area. For further information please refer to the Invading Species Awareness Program's Technical Guidelines listed under Contacts and Resources.

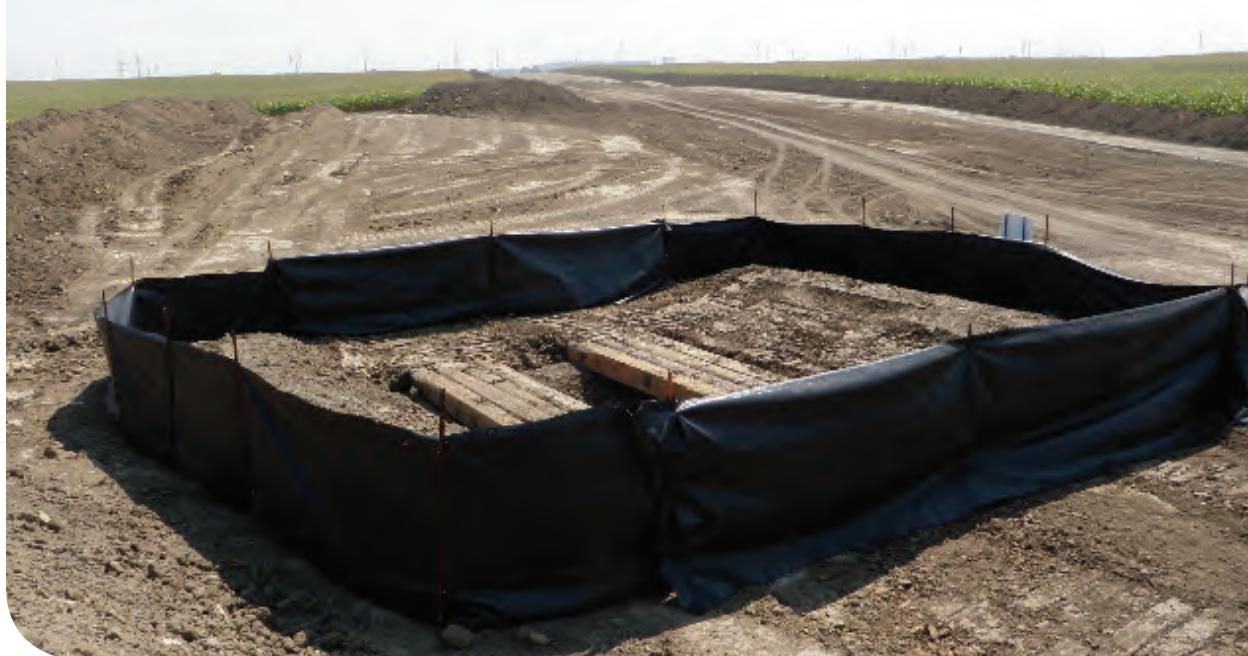
**Cleaning station at construction site.**  
Photo by: Mark Heaton, OMNR

- A pump and high pressure hose OR High pressure water unit
- Minimum water pressure for vehicle cleaning should be at least 90 pounds per square inch. Water can be supplied as high volume/low pressure or low volume/high pressure (NOAA Fisheries Service).
- Air compressor and blower OR Vacuum
- Shovel
- Pry bar
- Stiff brush or broom
