REPORT ON

**PHASE I
ENVIRONMENTAL SITE ASSESSMENT
1626 OLD PRESCOTT ROAD
OSGOODE WARD, GREELY
CITY OF OTTAWA, ONTARIO**

March 2012

120080

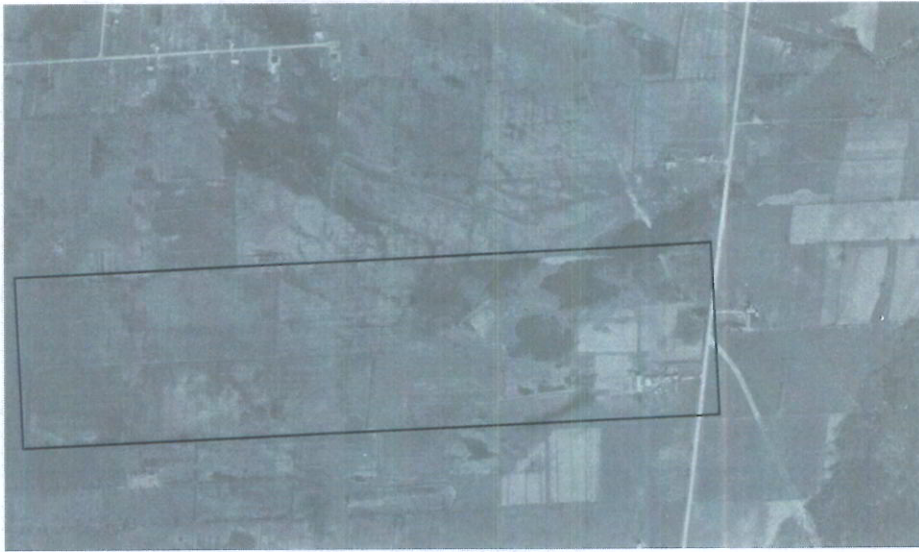
A review of air photographs of the site for the years 1969, 1975, 1989, 2002, 2005 and 2011 was carried out as part of this Phase I ESA (see Attachment B). The 1969 air photograph indicates four buildings in a cluster near Old Prescott Road at the site and a cleared trail crossing through the northeast corner of the property. The air photo also indicates a pathway leading to a clearing near the north central portion of the site. The 1975 air photograph indicates only two buildings in that cluster remain along with a disturbed area and a larger disturbed area and possible buildings have been added southwest of the original cluster of buildings noted above. The air photograph also indicates a lake has been created west of the site. The 1989 air photograph indicates one building in the original cluster and two buildings and a silo in the area southwest of the original cluster exist at the site. The air photograph also indicates a disturbance to the ground surface near the center of a series of treed areas near the north center portion of the site. The air photograph indicates another lake has been created adjacent to the southwest corner of the site. The air photograph indicates that development has steadily increased in the vicinity of the site. The 2002 air photograph indicates five buildings and a silo exist at the site. The air photograph indicates a large granular surface area near the silo and buildings. The air photograph indicates two fill piles located northwest of the buildings at the site. Some scattered debris was observed throughout the areas of

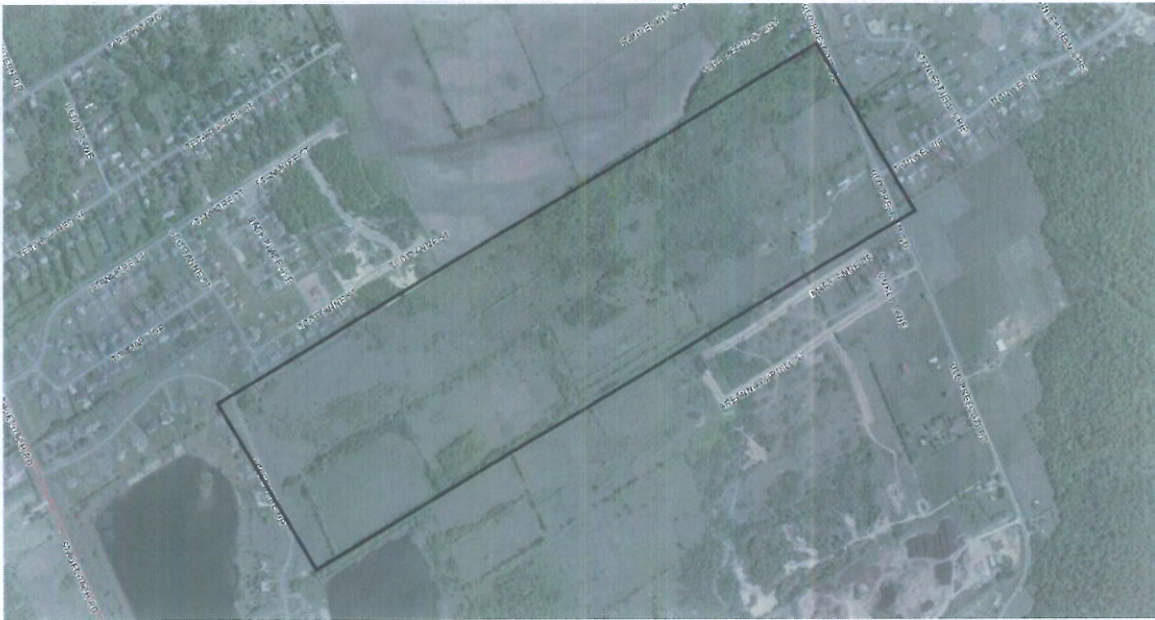
these existing buildings. The air photograph also indicates a roadway has been developed immediately west of the subject site. The 2005 air photograph indicates more debris has been added on the ground surface in the vicinity of the silo and nearby building. The 2011 air photograph indicates a building near the silo has been removed or demolished and more debris is present in the vicinity of the silo. The air photograph also indicates a large and a small building have been removed near the building closest to Old Prescott Road. The air photograph indicates a few vehicles parked near the silo. No other significant changes at the site were identified from the review of the air photographs.

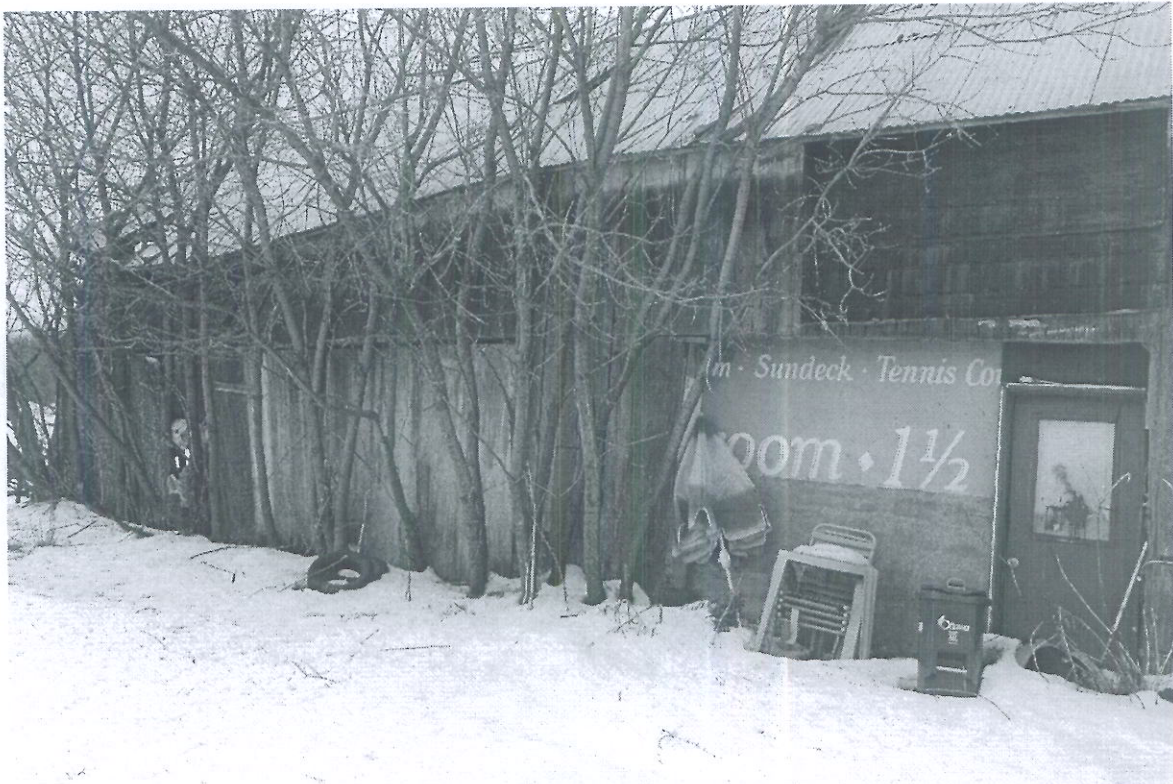
South Side of Storage Barn
