Greenbank (Burnett Municipal Drain)

Headwaters Report

Claridge Homes (South Nepean) LP

Bowfin Environmental Consulting
and
Muncaster Environmental Planning Inc.

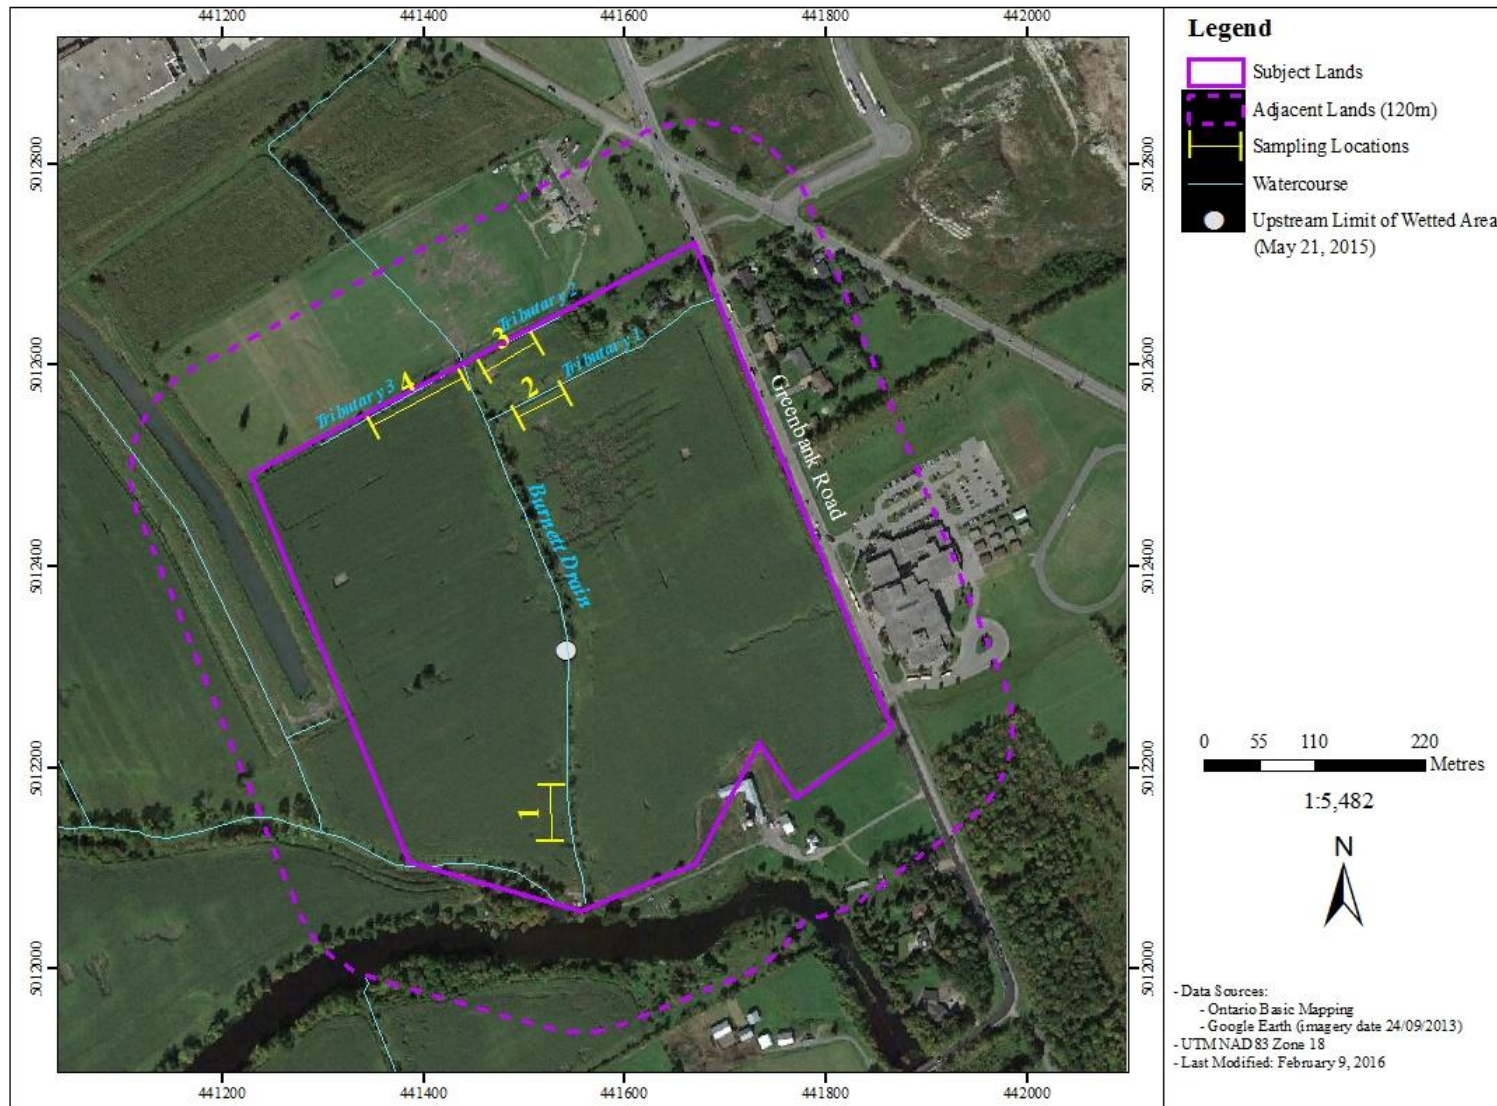
Figure 2 Location of Headwater Features and Stations

There were four watercourses within the subject lands: The Burnett Municipal Drain and three tributaries to the Burnett Municipal Drain. One station was established on each watercourse (stations 1-4).

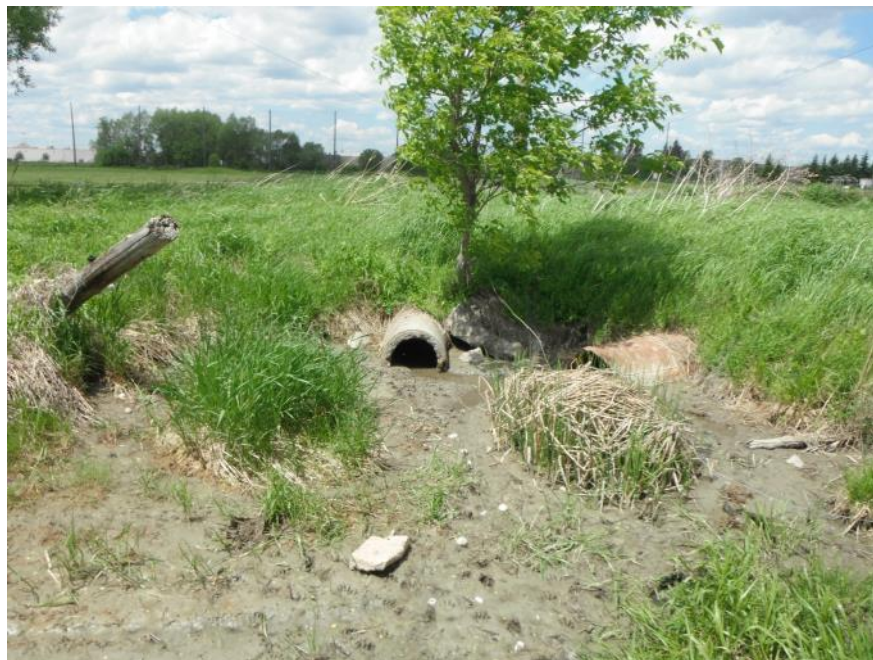
Photo 1 Looking upstream at downstream end of the piped section of the Burnett Municipal Drain (May 21, 2015)

The Burnett Municipal Drain is a tributary to the Jock River and travels through the centre of study area. This drain flowed north to south and its total length (inside and outside of the study area) was estimated at 1.3 km. At a distance of approximately 550 m upstream of the confluence with the Jock River the drain is piped under a driving range for a distance of approximately 170 m (Photo 1). The channel was confined with a straight pattern. There is a potential for fish to access the site during the spring under high flows but based on the observations made during spring 2015 the duration of the connection would be short lived. The culvert was old and flow was travelling through holes in the culvert and under it during the May 1st visit (Photo 2). By the May 21st, 2015 visit the upstream portion of the channel, beginning immediately upstream of the station, was dry (Figure 2). The whole of the drain was dry come summer.

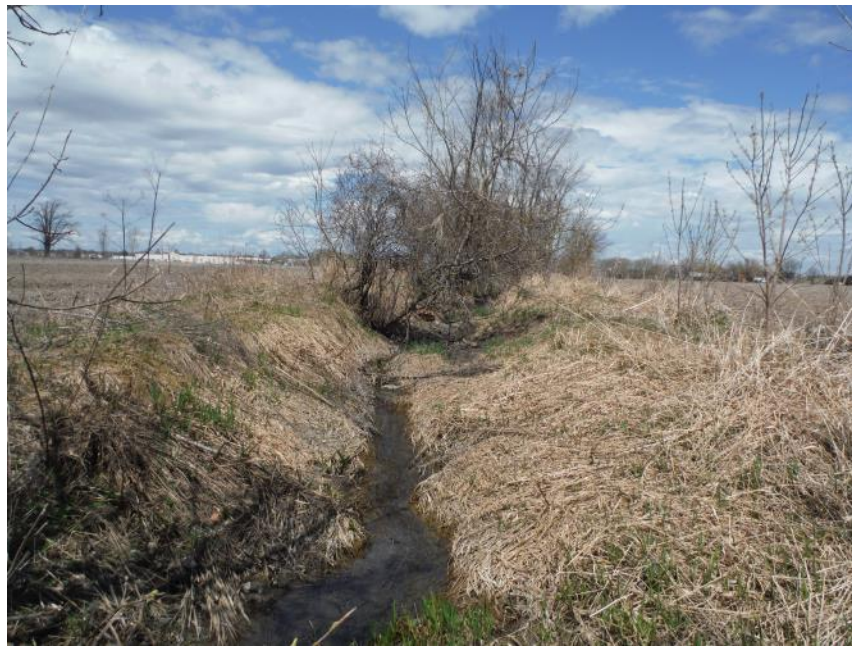
Photo 3 Station 1 looking upstream from the downstream end (May 1, 2015)

Station 1 was located approximately 74 m upstream of the confluence with the Jock River and was 55 m in length. The average channel and wetted widths were 2.1 m and 0.3 m respectively. The average bankfull depth was approximately 16 cm. The average water depth on May 21st was 2 cm (range 1-5 cm). The site was dry by July 27th, 2015 (Table 4). The habitat type consisted of glide morphological units. The substrate consisted of fines. The in-water cover consisted of overhanging vegetation. The canopy cover was poor. There were no signs of erosion throughout the station.

The top of the banks were fully vegetated with herbaceous vegetation and the occasional woody species. The most common species were: reed canary grass, spotted jewel-weed, Virginia creeper, hawthorn species, wild red raspberry, tartarian honeysuckle, American elm and green ash

During the May 1st, 2015 site visit the station was shocked for 255 seconds over an area of approximately 72 m². The average wetted width and water depth present during the spring sampling were 1.3 m and 5 cm (range 3-12 cm), respectively. No fish were captured.

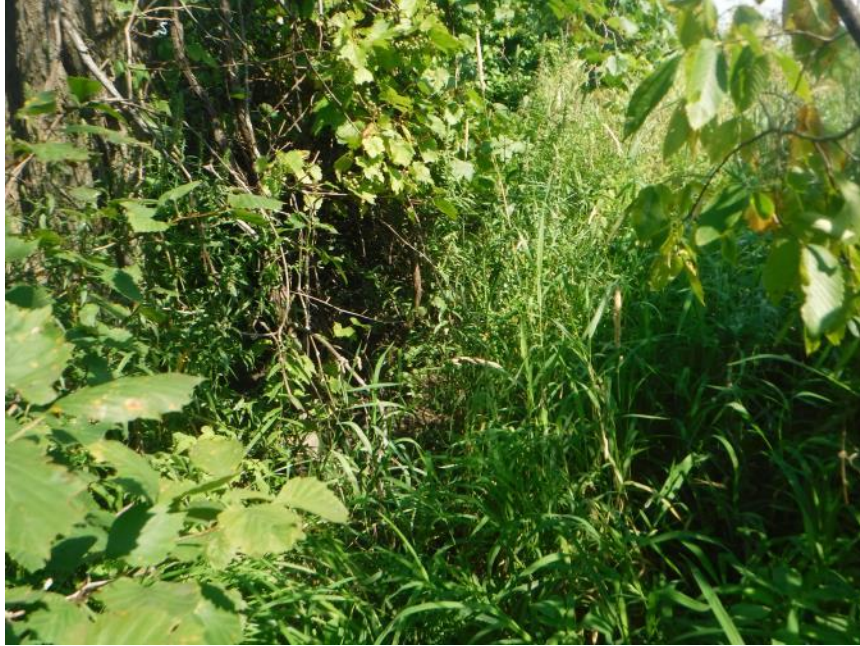
Photo 4 Station 1 looking upstream from the downstream end (July 27, 2015)

The site was not sampled during the summer visit due to lack of water.

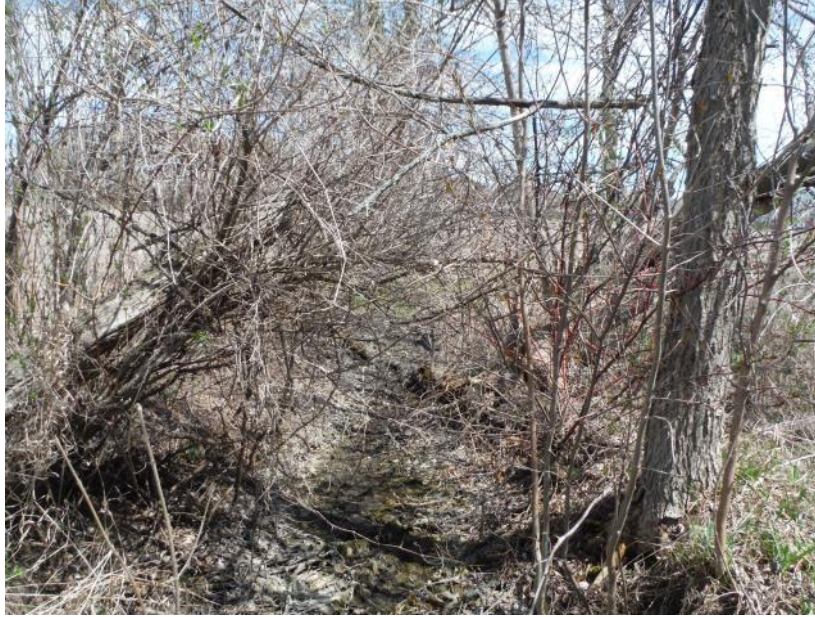
Photo 5 Tributary 1 (Station 5) looking upstream from the downstream end (May 1, 2015)

Station 2 was located within a tributary on the east bank of the Burnett Municipal Drain. This tributary flowed east to west, was located 500 m upstream of the confluence with the Jock River, and was approximately 260 m in length.

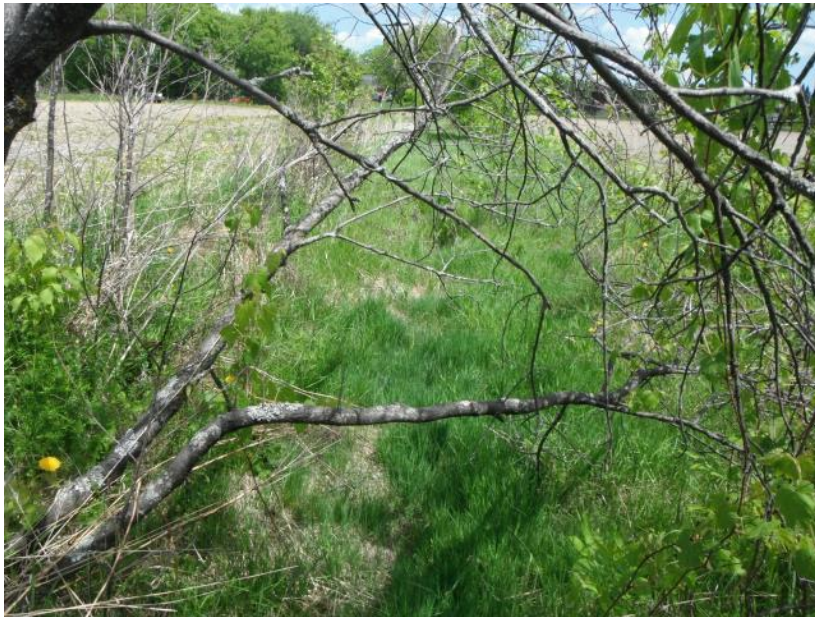
Photo 6 Station 2 looking upstream from the downstream end (May 21, 2015)

Station 2 was located approximately 30 m upstream of the confluence with Burnett Municipal Drain and was 50 m in length. The station was dry. The average channel width and average bank height were 1.1 m and 18 cm. The substrate consisted of fines. Cover consisted of aquatic vegetation, (reed canary grass). There was no canopy cover present. The station had no signs of erosion.

The top of the banks were fully vegetated with herbaceous vegetation and the occasional woody species. The most common species were: reed canary grass, spotted jewel-weed, Virginia creeper, hawthorn species, wild red raspberry, tartarian honeysuckle, American elm, and green ash.

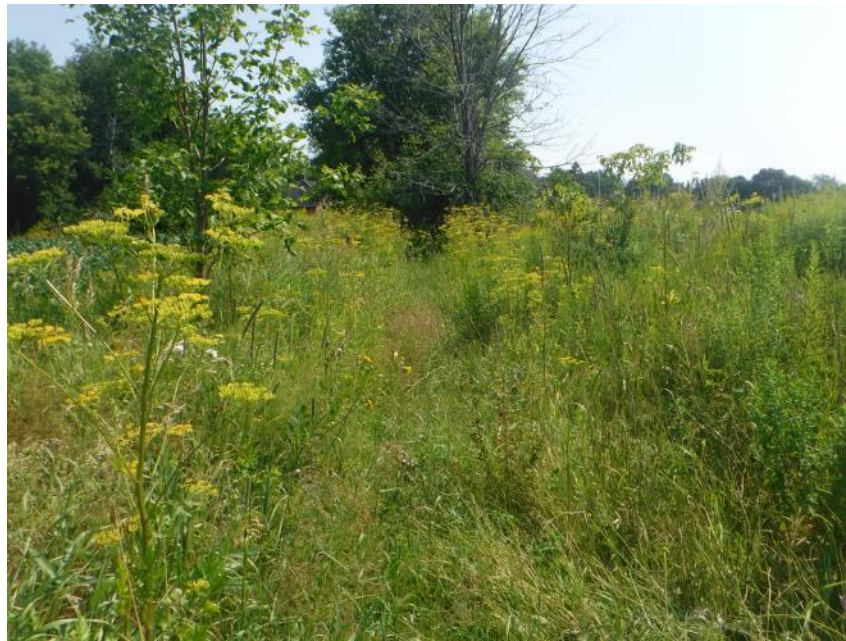
Photo 7 Station 2 looking upstream from the downstream end (July 27, 2015)

No sampling was conducted at this station due to lack of water and dense vegetation.

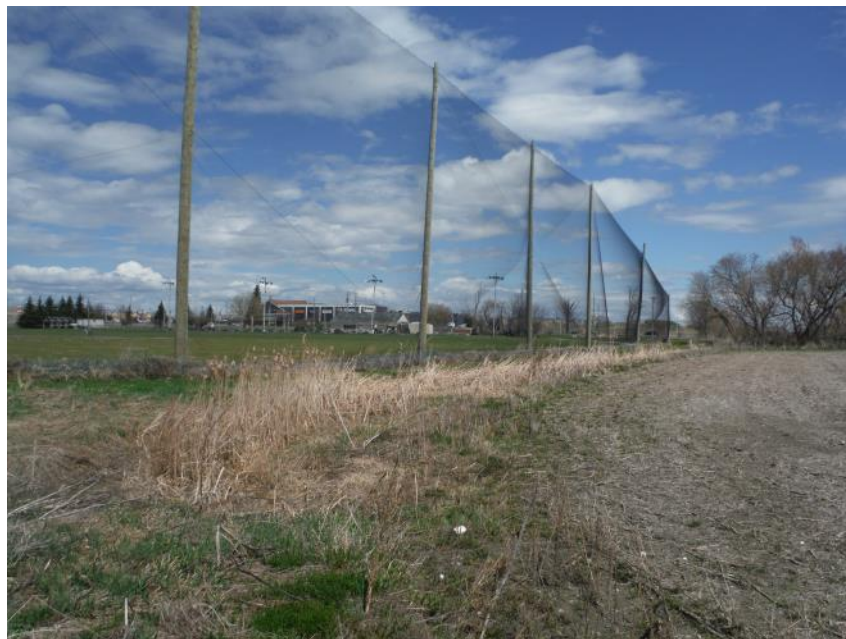
Photo 8 Tributary 3 (Station 6) looking upstream from the downstream end (May 1, 2015)

Station 3 was located within a tributary on the east bank of the Burnett Municipal Drain. This tributary flowed east to west, was located 560 m upstream of the confluence with the Jock River, and was approximately 110 m in length.

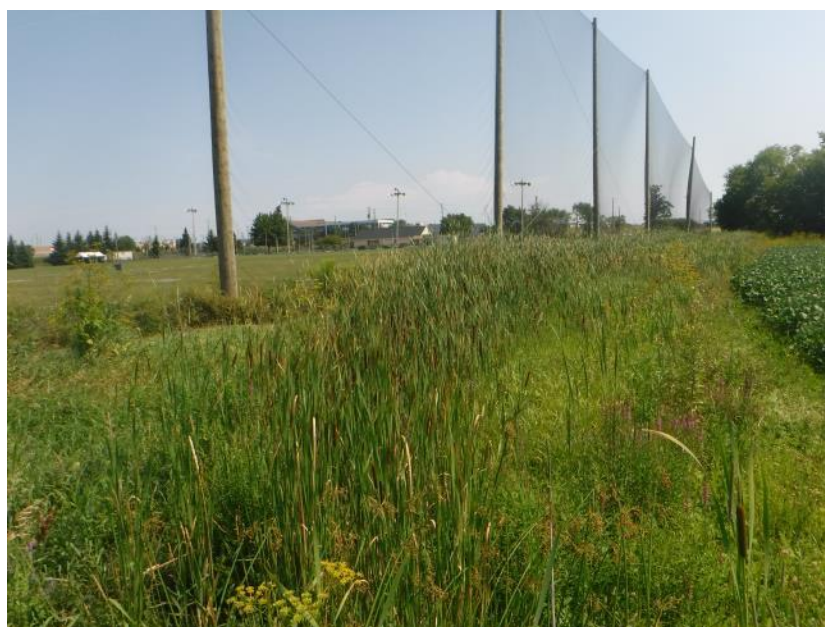
Photo 9 Station 3 looking upstream from the downstream end (July 27, 2015)

Station 3 was located approximately 20 m upstream of the confluence with Burnett Municipal Drain and was 52 m in length. This site was dry. The average channel width and bank height were 2.5 m and 24 cm respectively. The substrate consisted of fines. Cover consisted of aquatic vegetation (narrow-leaved cattail). There was no canopy cover. No signs of erosion were noted.

The top of the banks were completely vegetated with herbaceous vegetation. The most common species were: reed canary grass and smooth bedstraw.

No sampling was conducted at this station due to lack of water and dense vegetation.

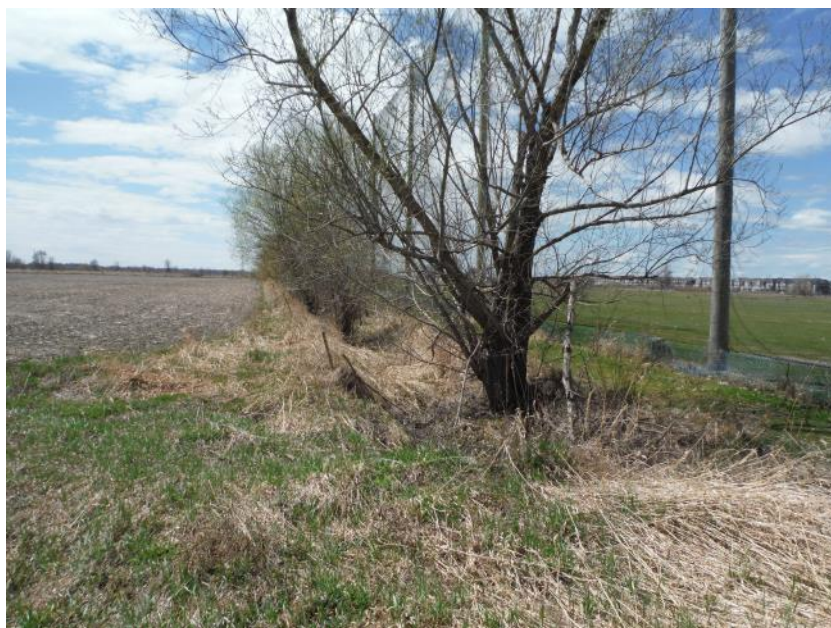
Photo 10 Tributary 3 (Station 4) looking upstream from the downstream end (May 1, 2015)

Station 4 was located within a tributary on the west bank of the Burnett Municipal Drain. This tributary flowed west to east, was located 560 m upstream of the confluence with the Jock River, and was approximately 160 m in length.

Station 4 was located approximately 10 m upstream of the confluence with Burnett Municipal Drain and was 95 m in length. The station was completely dry during all visits. The average channel width and bank height were 1.6 m and 24 cm respectively. The substrate consisted of fines. Cover consisted of aquatic vegetation (reed canary grass). The canopy cover was poor. There were no signs of erosion throughout the station.

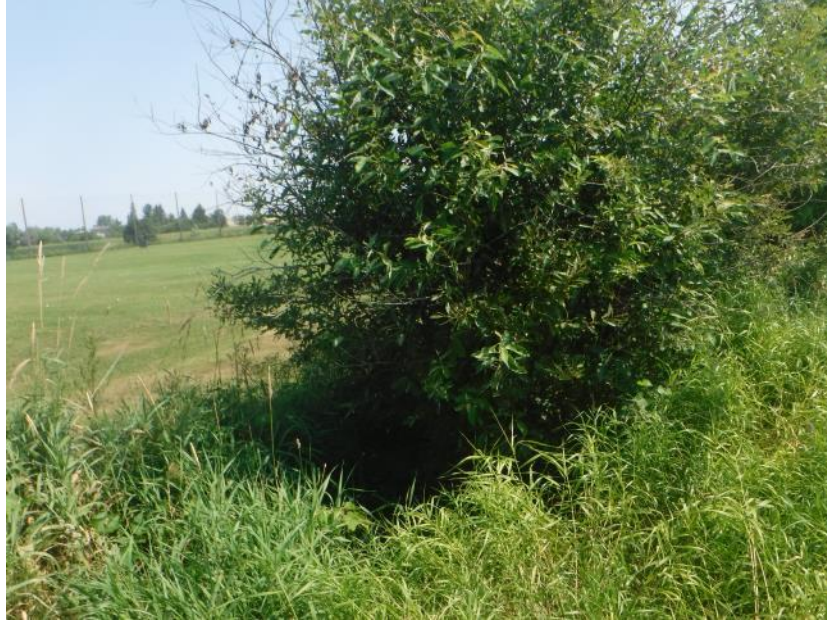
Photo 11 Station 4 looking downstream from the upstream end (July 27, 2015)

The top of the banks were fully vegetated with herbaceous vegetation and the occasional woody species. The most common species were: reed canary grass, common dandelion, pussy willow, Manitoba maple and crack willow.

No sampling was conducted at this station due to lack of water and dense vegetation.
