FINAL REPORT ON

Phase I Environmental Site Assessment 4789 Bank Street Ottawa, Ontario

Report Number: 13-1121-0186

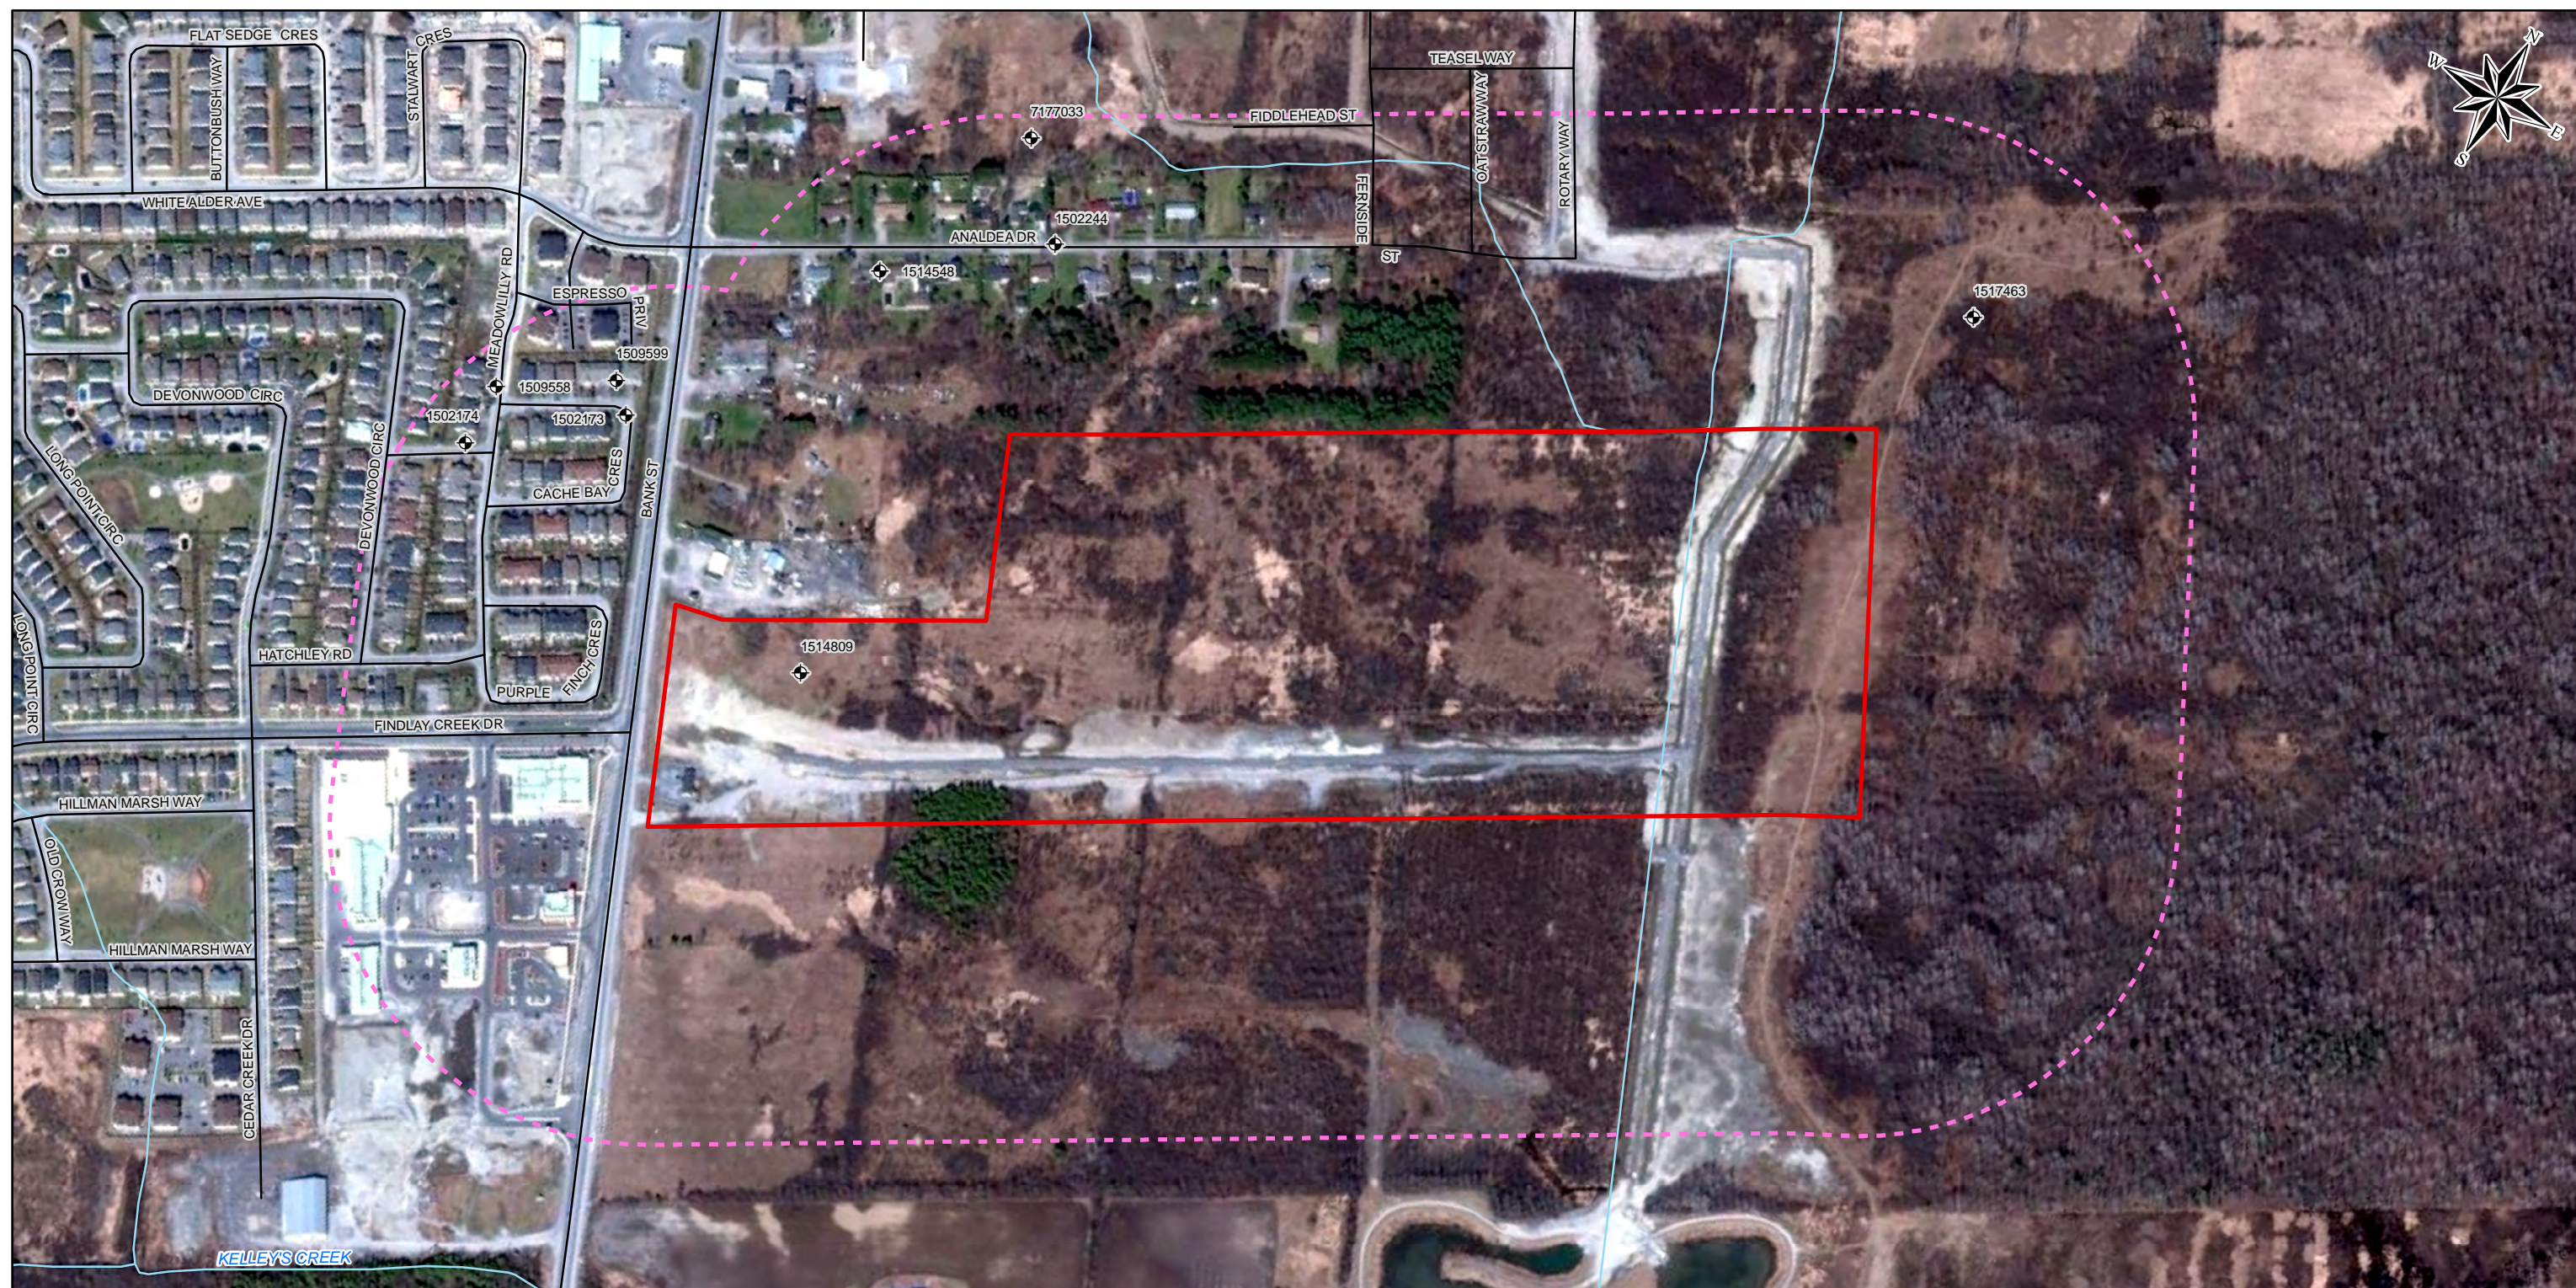
A Phase One ESA is a preliminary qualitative assessment of the environmental condition of a property, based on a review of current activities and historical information for the Site and a review of relevant and readily available environmental information for the surrounding properties located within a 250 metre (“m”) radius of the municipal boundary of the Site (collectively referred to as the “Phase One Study Area”). The boundaries of the Phase One Study Area are presented in Figure 2.

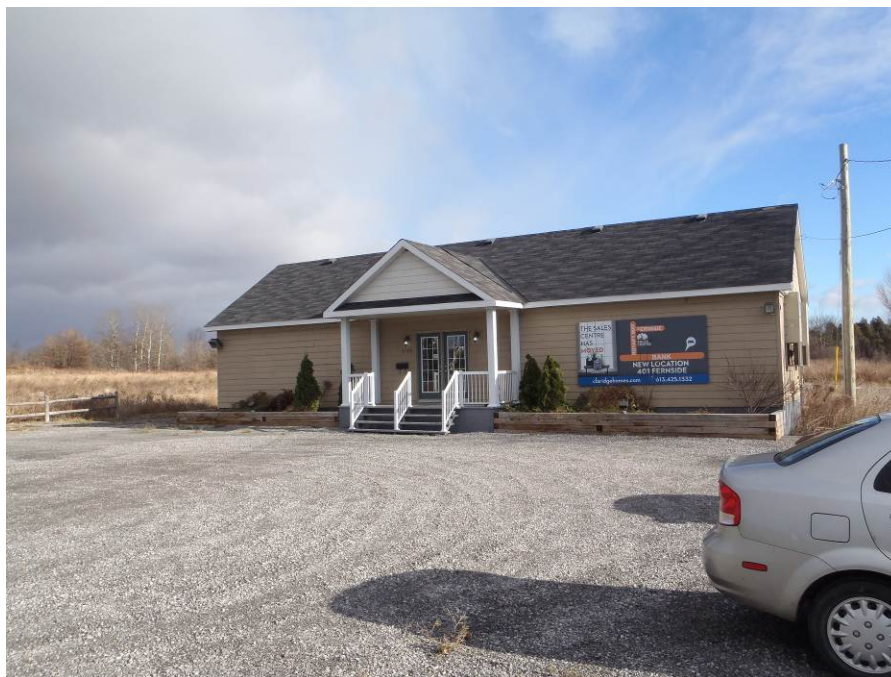
Photograph 1: Looking east towards the sales centre building located at the western end of the Site, near the intersection of Bank Street and Findlay Creek Drive.

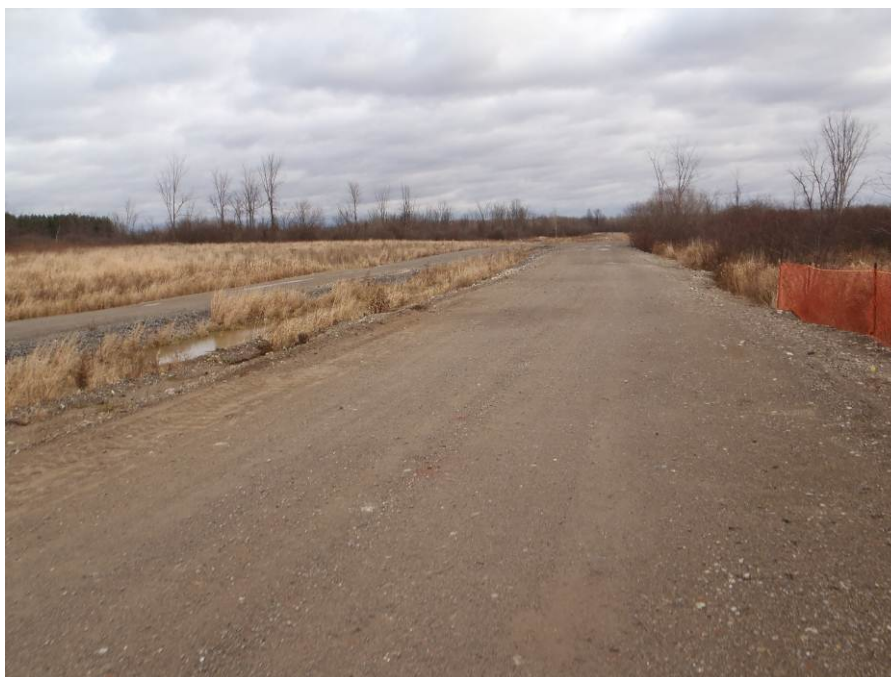
Photograph 2: Looking east towards the access road along the southern Site boundaries.

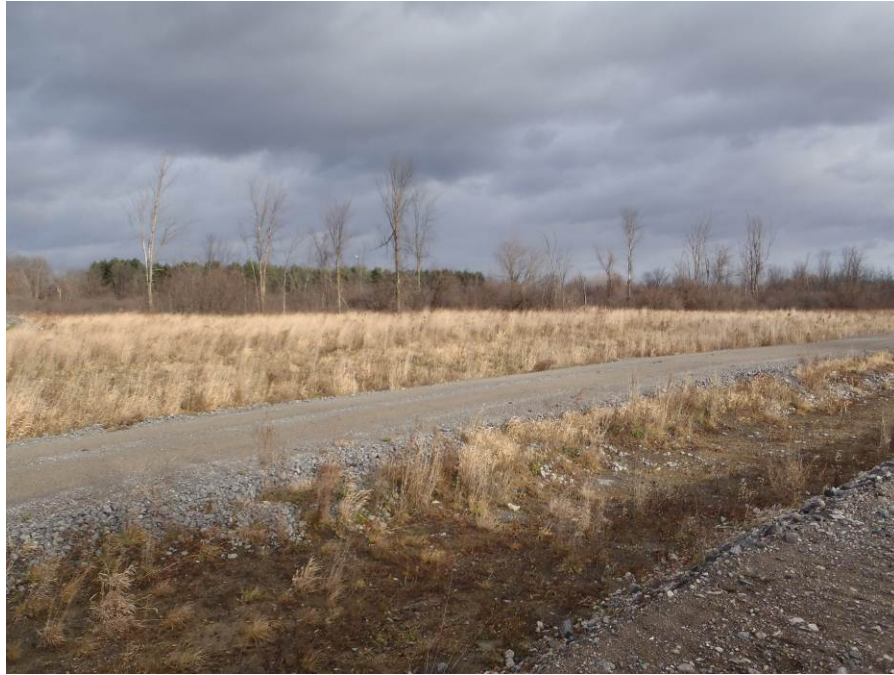
Photograph 3: Looking northeast, from the access road along the southern Site boundary, towards the trunk sanitary and storm sewer alignment and the vacant/forested lands beyond.

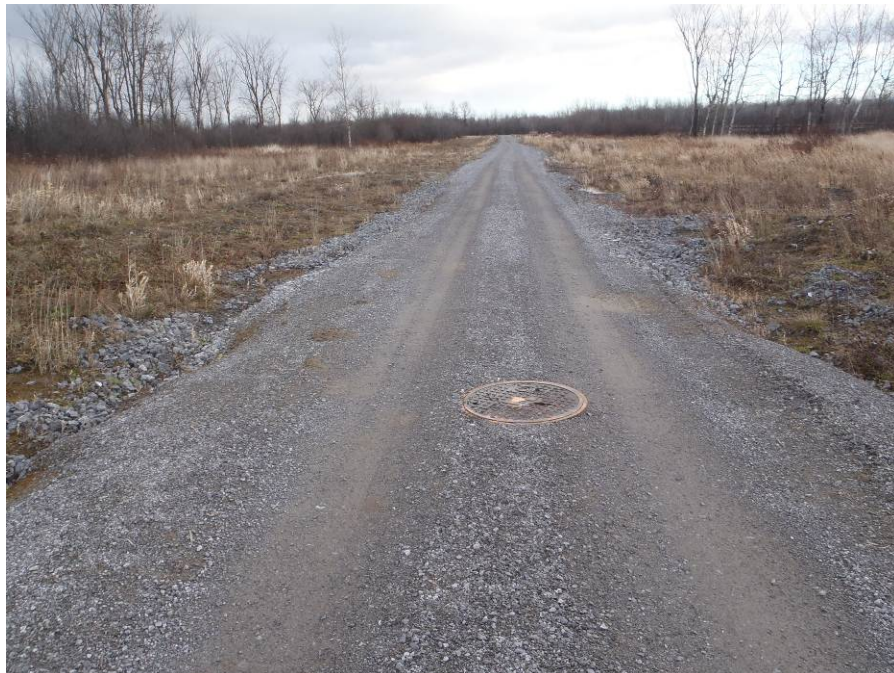
Photograph 4: Looking east along the trunk sanitary and storm sewer alignment with vacant land on the north and south sides of the alignment.

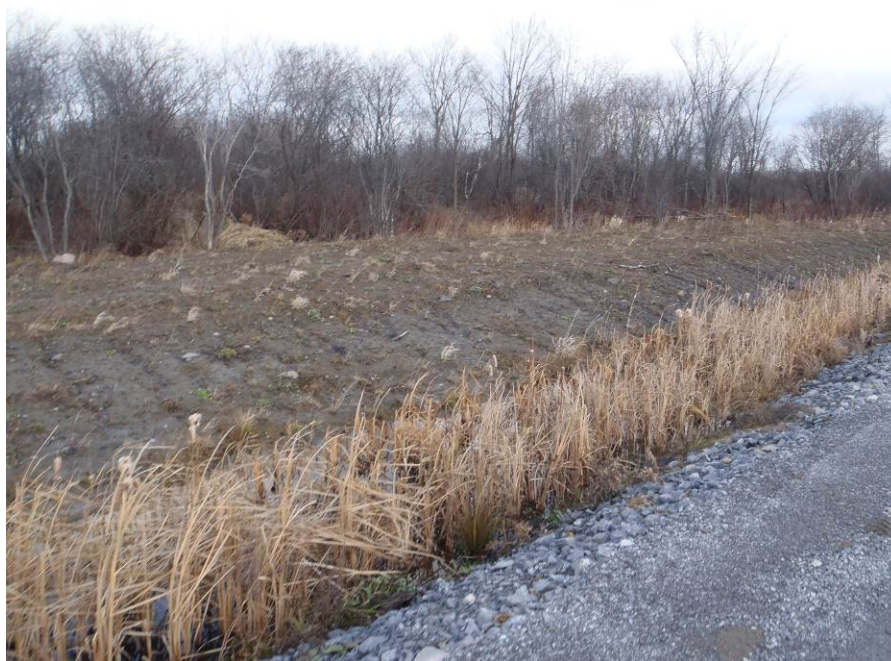
Photograph 5: Looking northeast towards the ditch that runs along the trunk sanitary and storm sewer alignment.

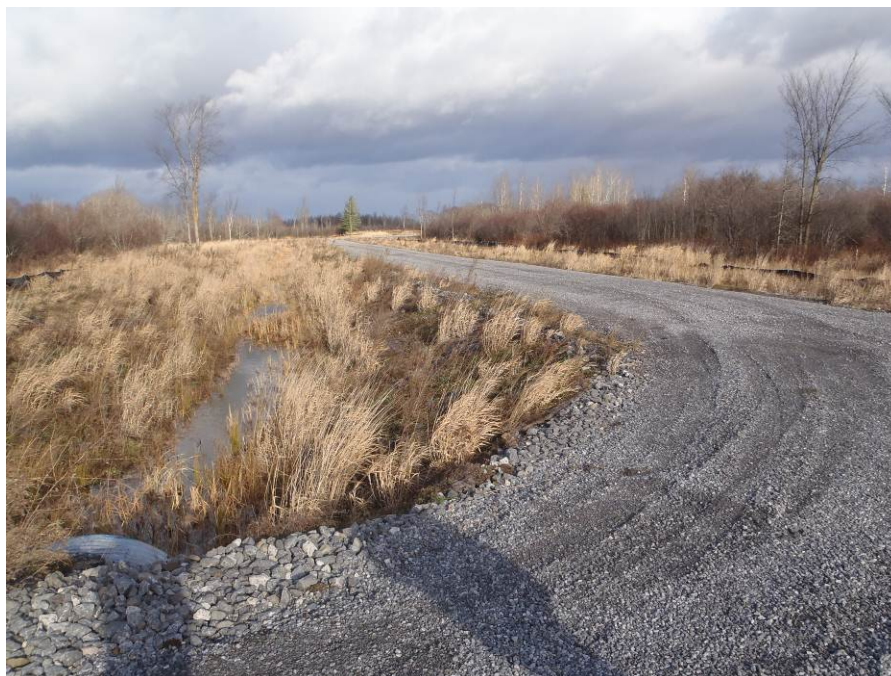
Photograph 6: Looking north towards the intersection where the trunk sanitary and storm sewer alignment splits and runs north-south along the eastern end of the Site.

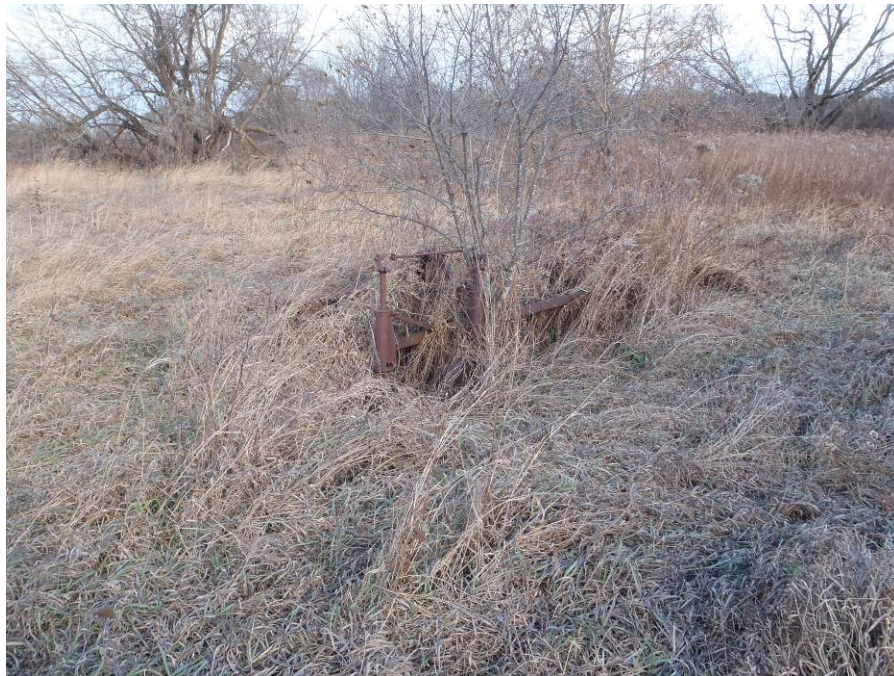
Photograph 8: Old farm equipment observed in the western section of the Site.

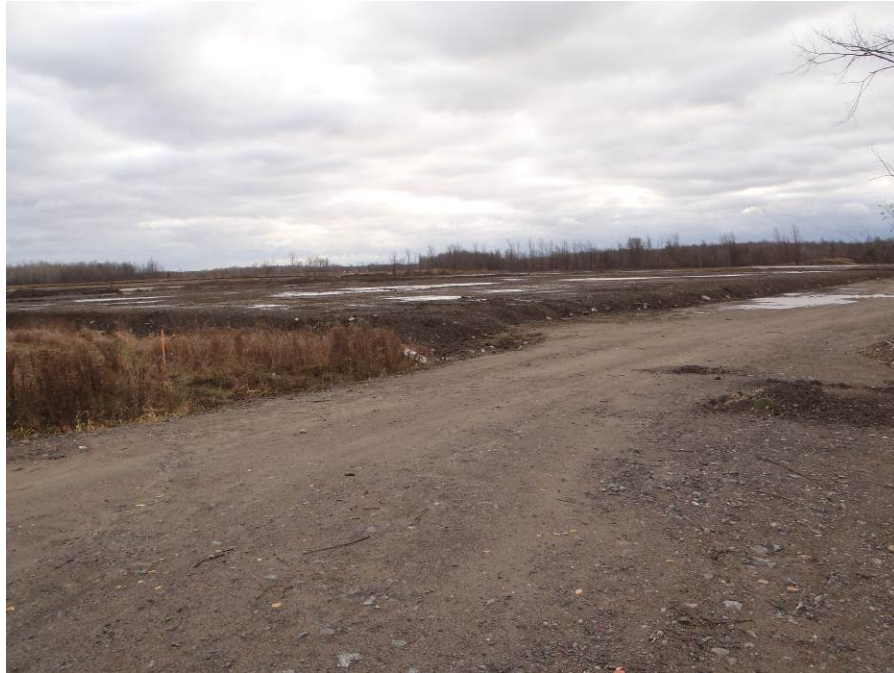
Photograph 13: Looking south towards the cleared and infilled lands on the eastern portion of the lands adjacent to the south of the Site.
