## **Phase I Environmental Site Assessment**

1154, 1172, 1176, 1180, and 1208 Old  
Montreal Road, Ottawa, Ontario

OTT-00234493-A0

August 19, 2016

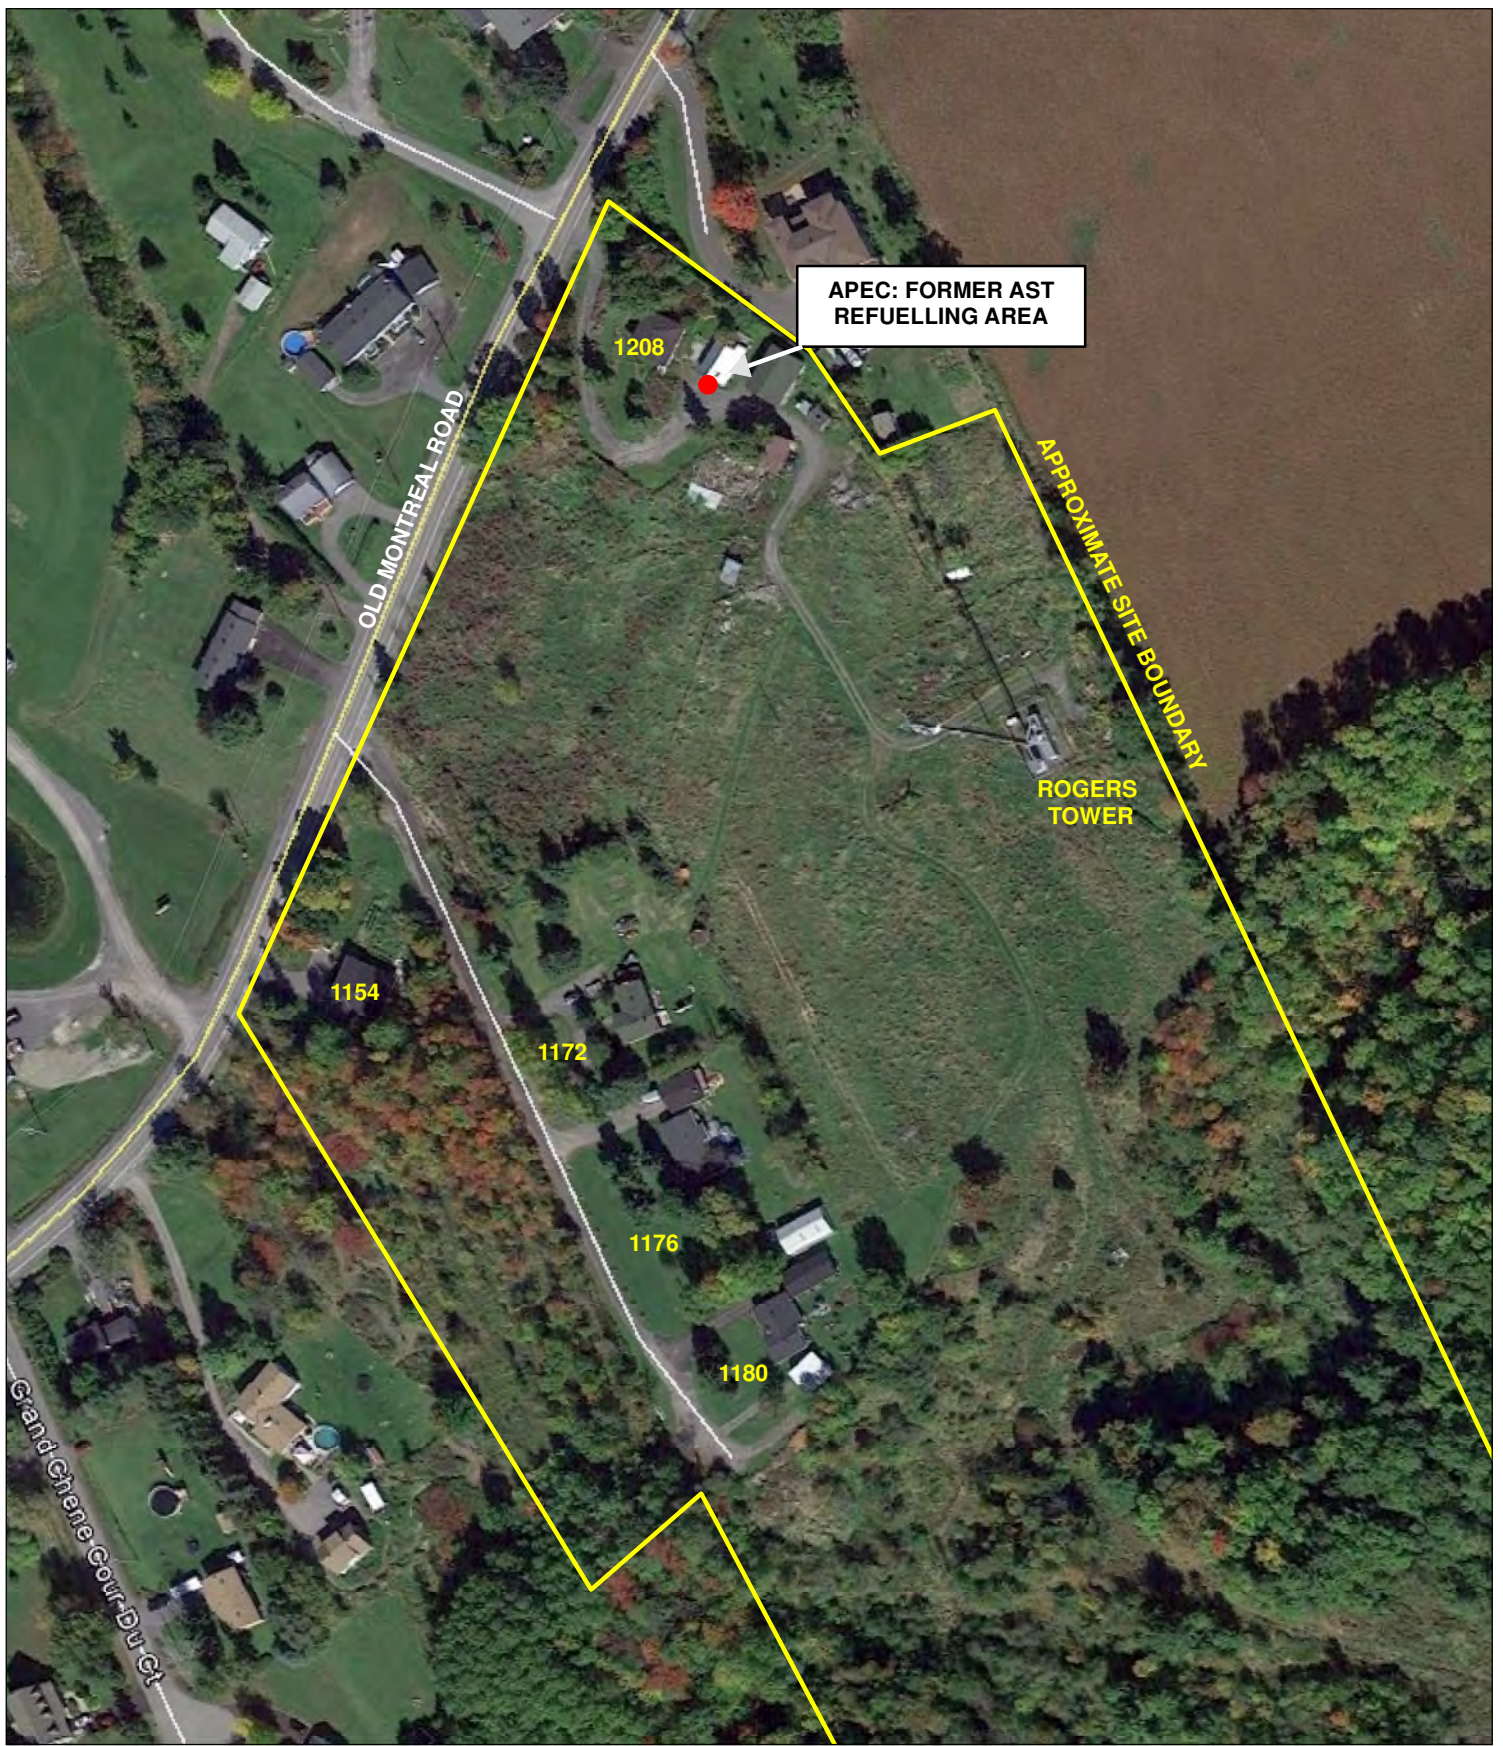
**APEC - Area of Potential Environmental Concern**  
**AST - Aboveground Storage Tank**

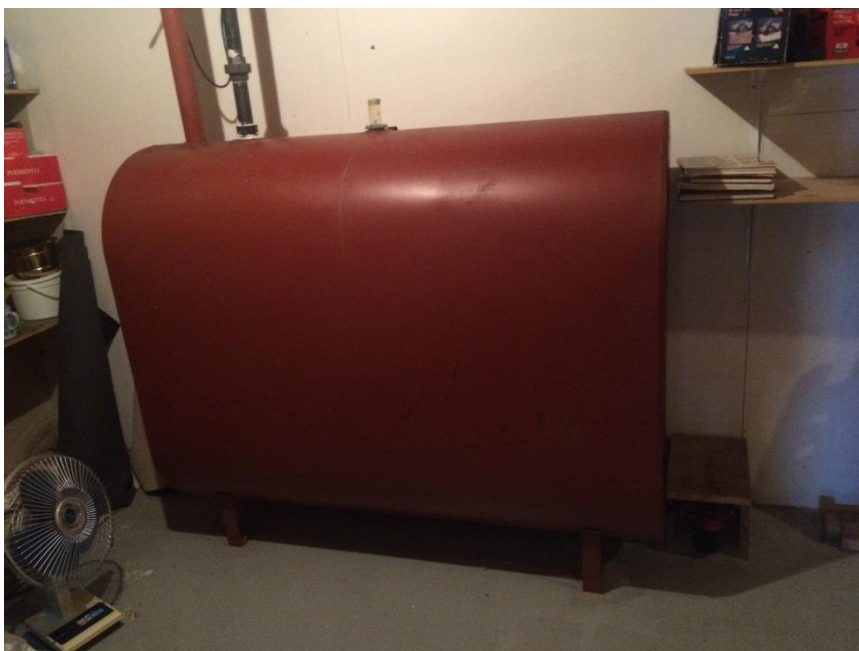
**Photograph No. 2**

- A heating oil tank in the basement of 1180 Old Montreal Road. The tank was installed above a concrete floor in good condition, and there was no staining in the vicinity of the tank. This does not represent an APEC.

The basement oil tank in 1180 Old Montreal Road (not an APEC)

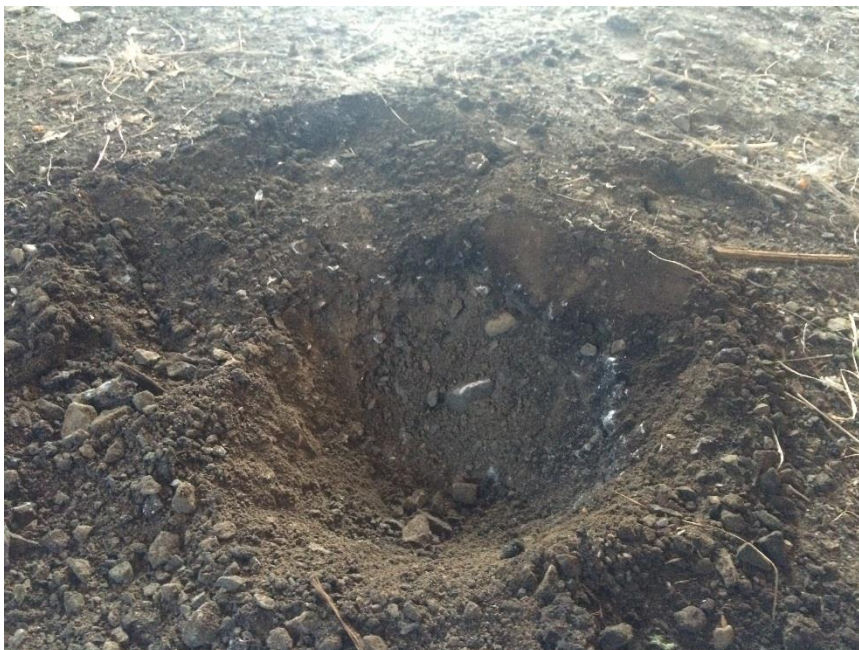
**Photograph No. 3**

An area of staining was observed on some gravel in the shed at 1180 Old Montreal Road. A small shovel hole was advanced through the staining and the staining was found to be surficial. During land development, the small area of impacted gravel and soils will need to be disposed of in a landfill. Gross contamination is not anticipated, and this does not represent an APEC.

The surficial staining in the shed of 1180 Old Montreal Road

An area of staining was observed on gravel in the shed at 1180 Old Montreal Road. A small shovel hole was advanced through the staining and the staining was found to be surficial. During land development, the small area of impacted gravel and soils will need to be disposed on in a landfill. Gross contamination is not anticipated, and this does not represent an APEC.

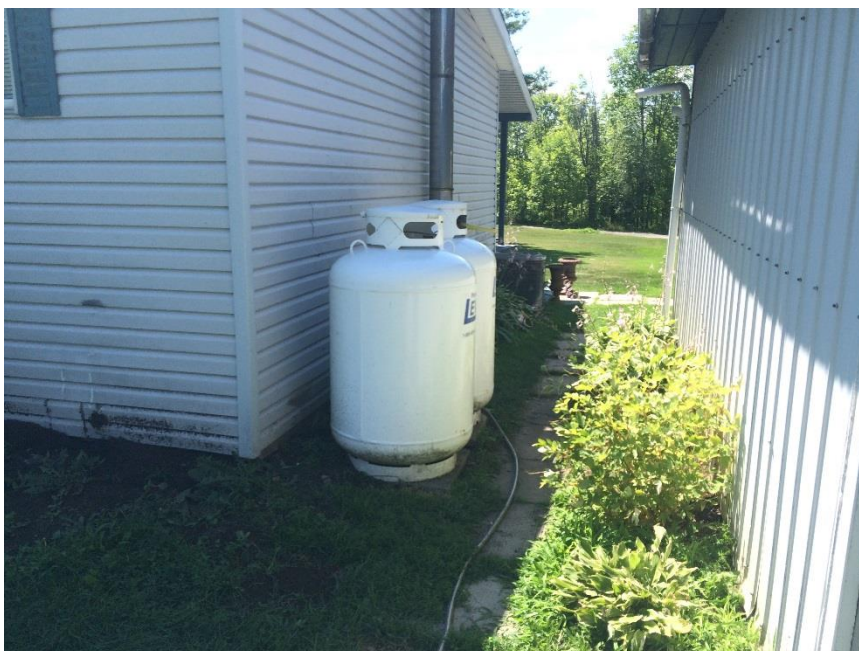
**Photograph No. 4**

- A former heating oil tank was located in the basement of 1176 Old Montreal Road, which was replaced with propane a few years ago. No staining was observed on the concrete floor in the former tank location. This does not represent an APEC.

View of the propane service to 1176 Old Montreal Road

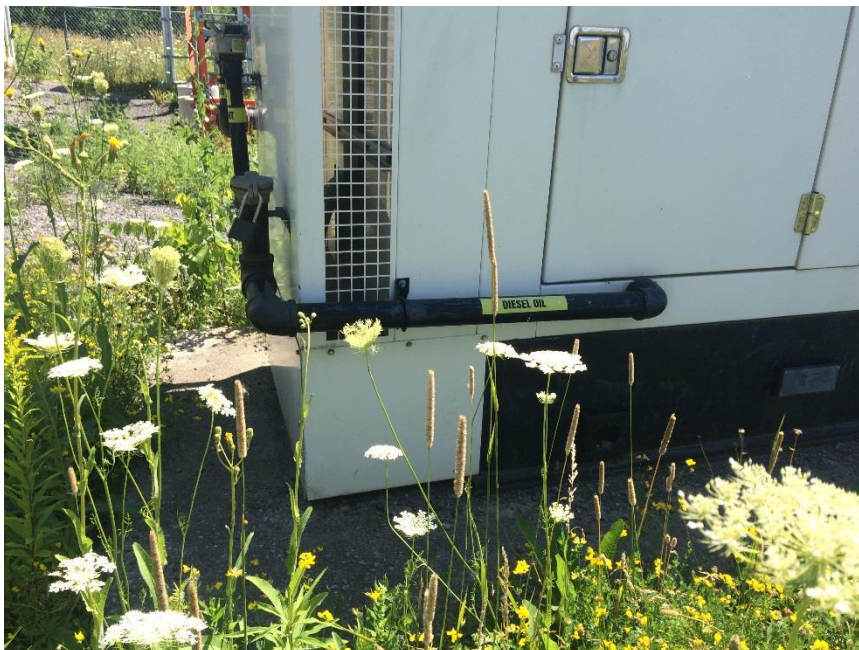
**Photograph No. 5**

The tank associated with the generator for the Rogers communication tower (not an APEC)

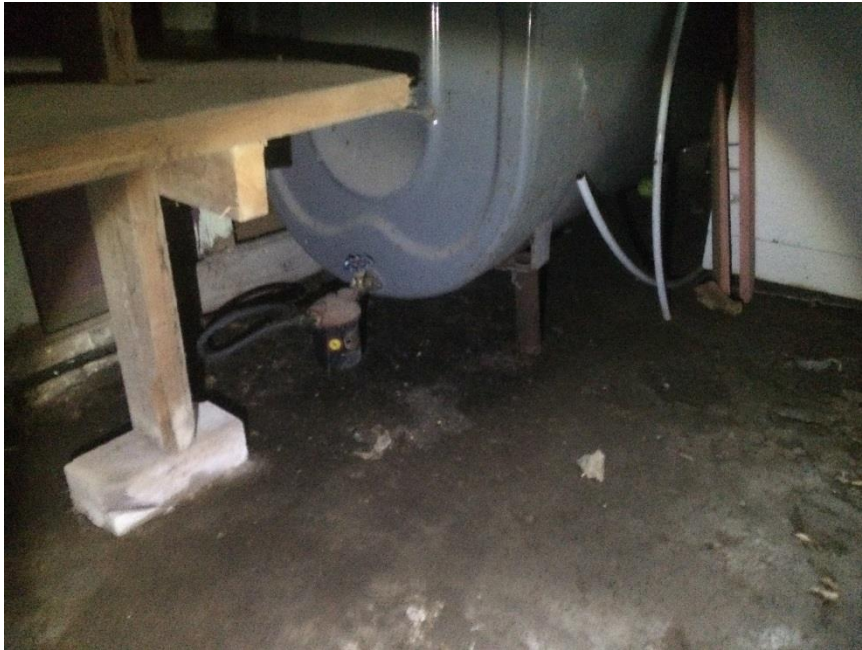
**Photograph No. 7**

- A heating oil tank in the basement of 1208 Old Montreal Road. The tank was installed above a concrete floor in good condition. There was some staining observed on the concrete floor below the tank, although the staining appeared to be contained within the building footprint. This does not represent an APEC.

A small area of staining was observed on the concrete floor below the heating oil tank in the basement of 1208 Old Montreal Road. The staining appeared to be contained within the footprint of the building and there was no obvious cracking below the staining, and this does not represent an APEC.

The basement oil tank with minor staining on the concrete floor in 1208 Old Montreal Road (not an APEC)

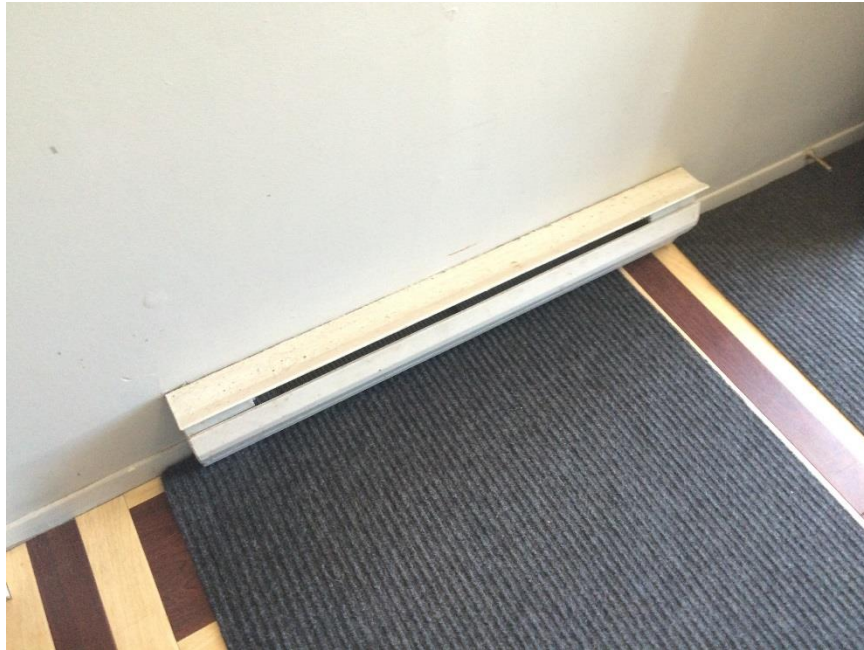
**Photograph No. 7**

Electric heating inside 1154 Old Montreal Road
