**Phase Two Environmental
Site Assessment
1158 Second Line Road,
Ottawa, Ontario**

OTT-00245054-A0

Final

November 22, 2018

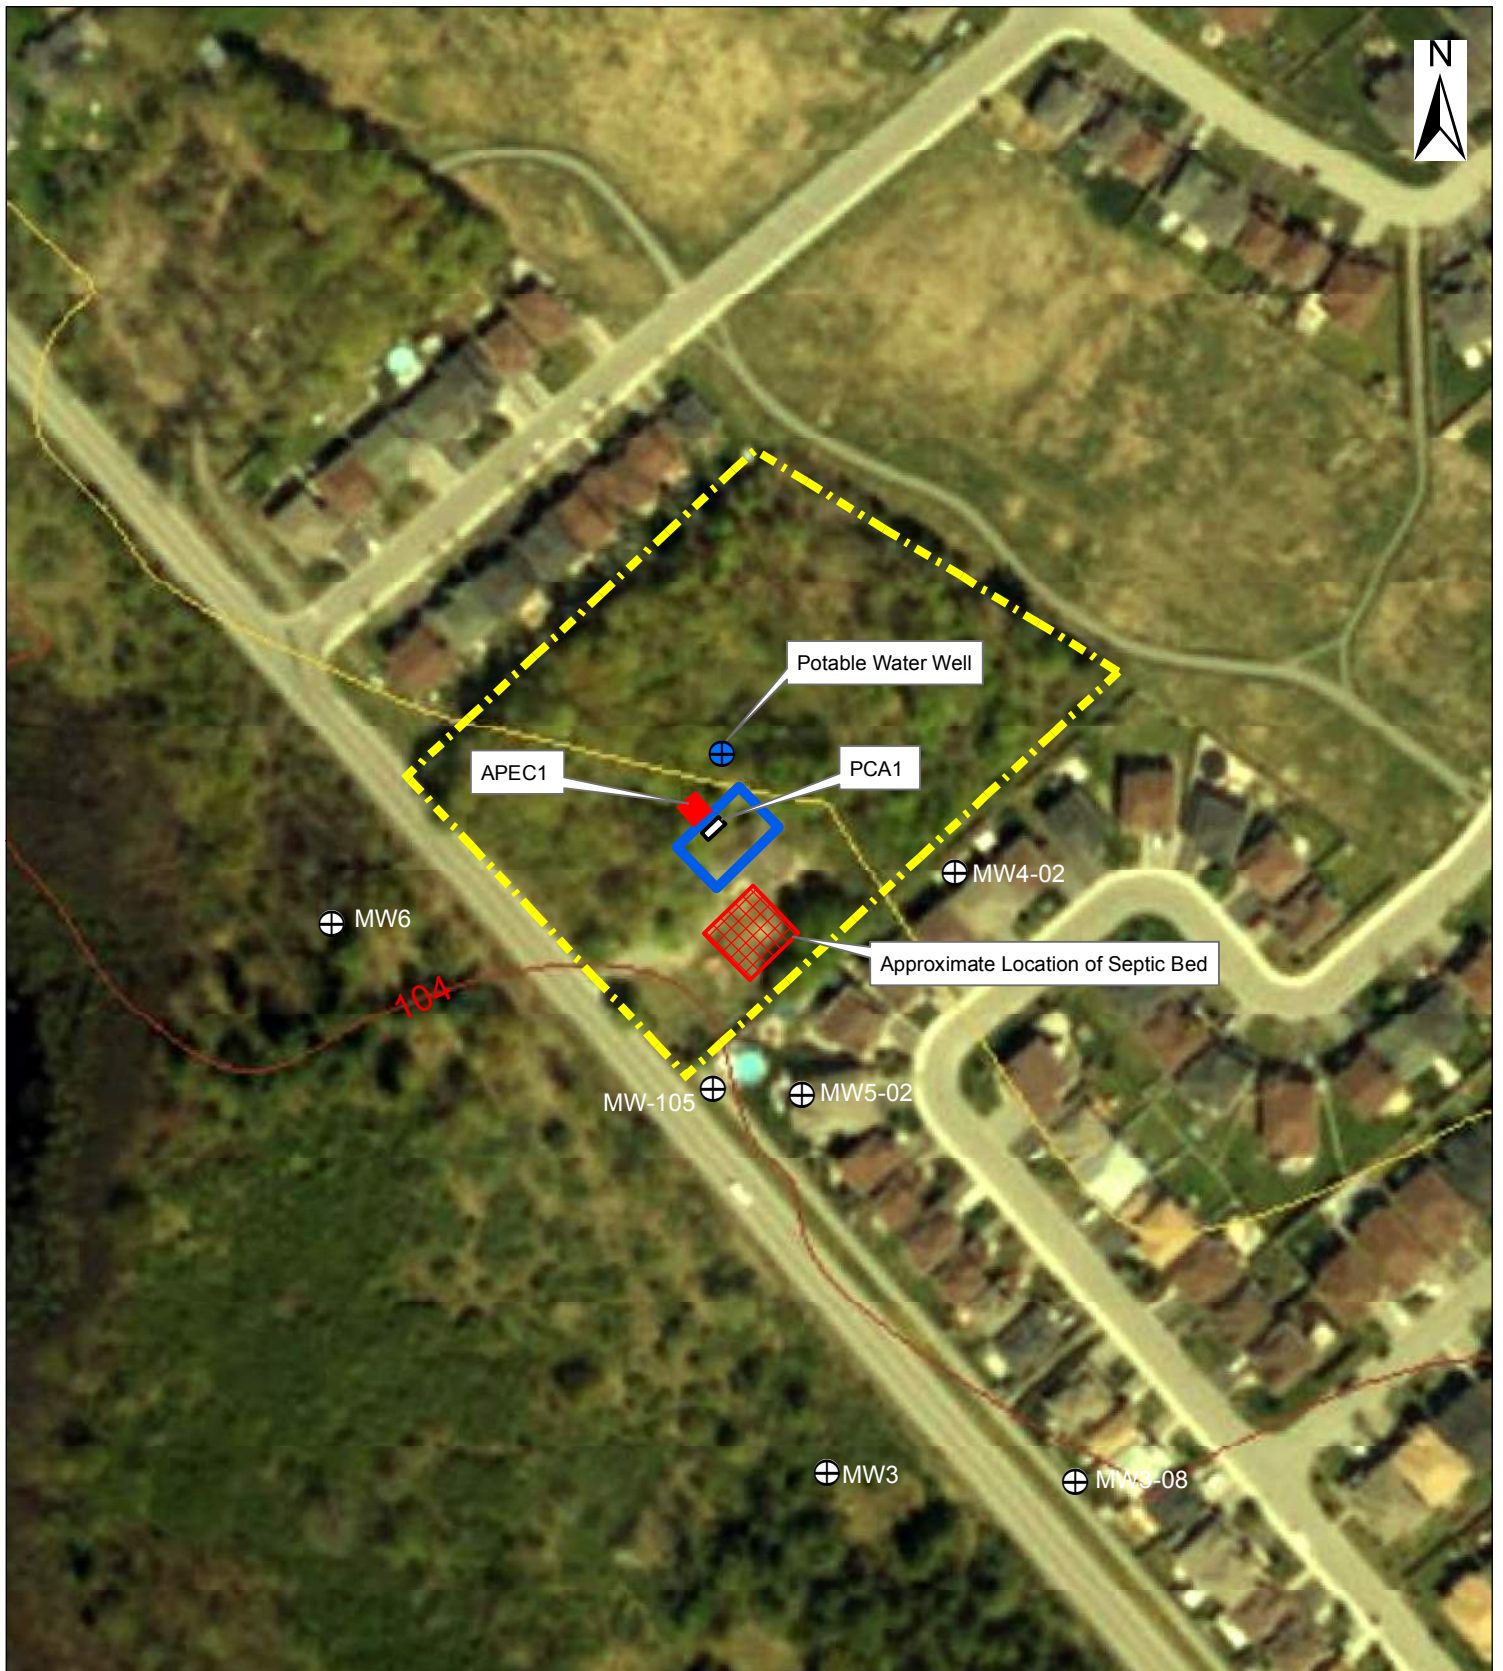
DRAWING TITLE:
CONCEPTUAL SITE MODEL

The Phase Two CSM provides a narrative and graphical interpretation of the Phase One Property surface features, near surface geologic and hydrogeologic conditions, PCOCs, contaminant fate and transport mechanisms, and relevant receptors and exposure pathways. These components are discussed in the following sections and summarized in Table 1 in the Tables appendix.

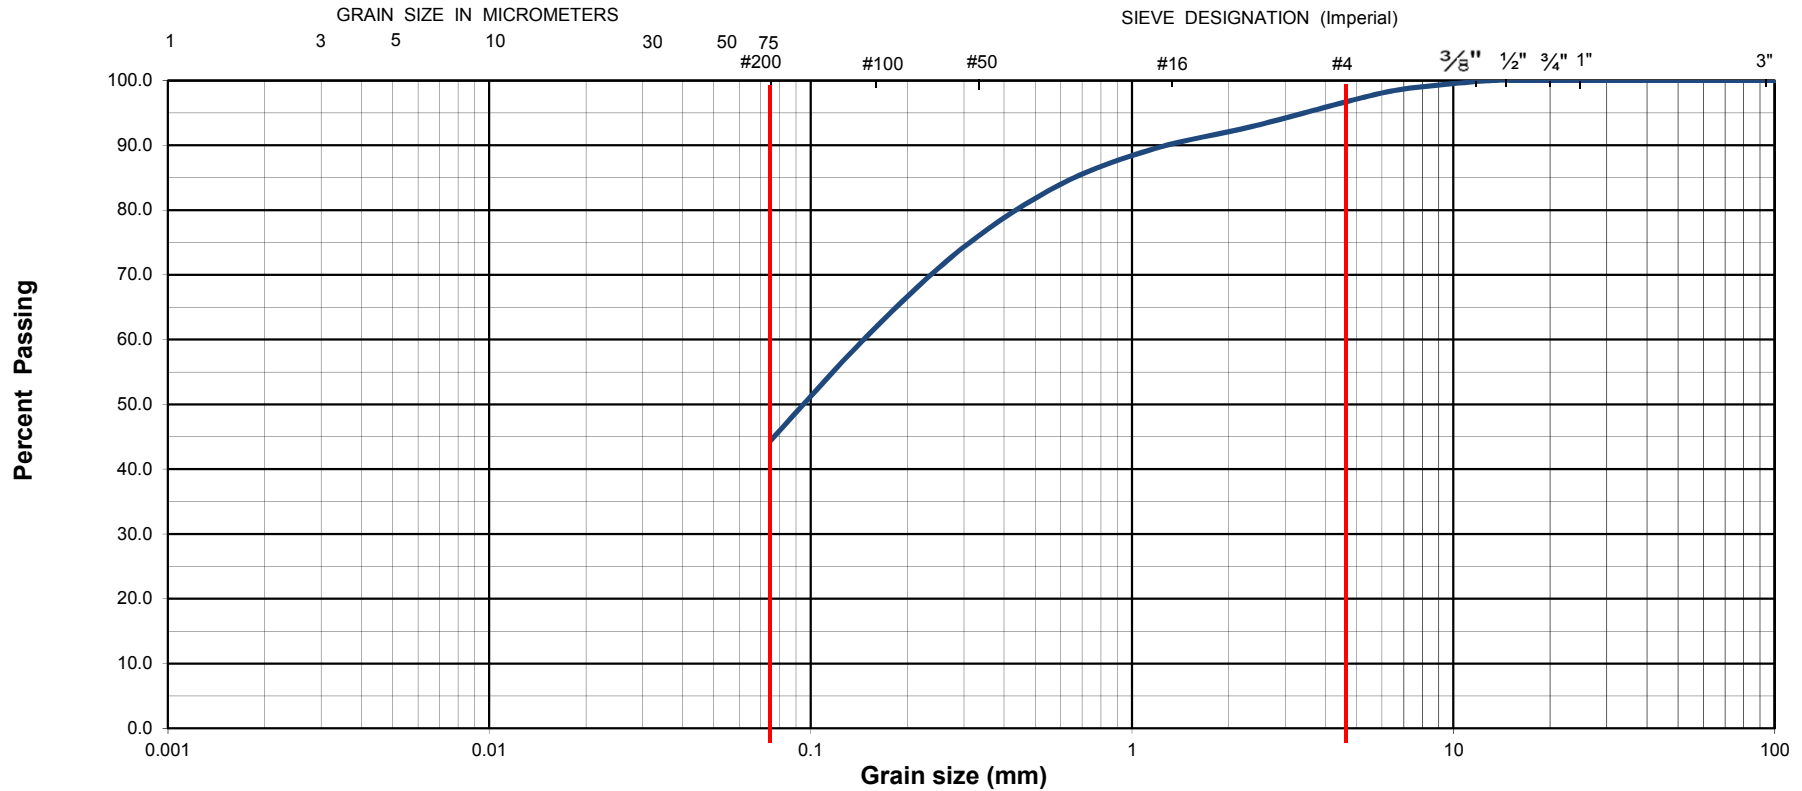
EXP Project No.:	OTT-00245054	Project Name :	Geotechnical Investigation Proposed Residential Development		
Client :	Theberge Homes	Project Location :	1158 Second Line Road, Ottawa		
Date Sampled :	February 16, 2018	Test Pit No:	TP1	Sample:	SS1
Sample Description :	Silty Sand (SM)			Depth (m) :	0.3-1.2
				Figure :	15

The grain size analyses showed that less than 50% of the soil had a grain size of silt or finer. This indicates that the native soil is coarse grained. The results of the grain size analyses are found in Appendix A.
