Phase I Environmental Site Assessment

Vacant Property
The Meadows – Borrisokane Road
Ottawa, Ontario

Tamarack (Nepean) Corporation

Report: PE0190-3

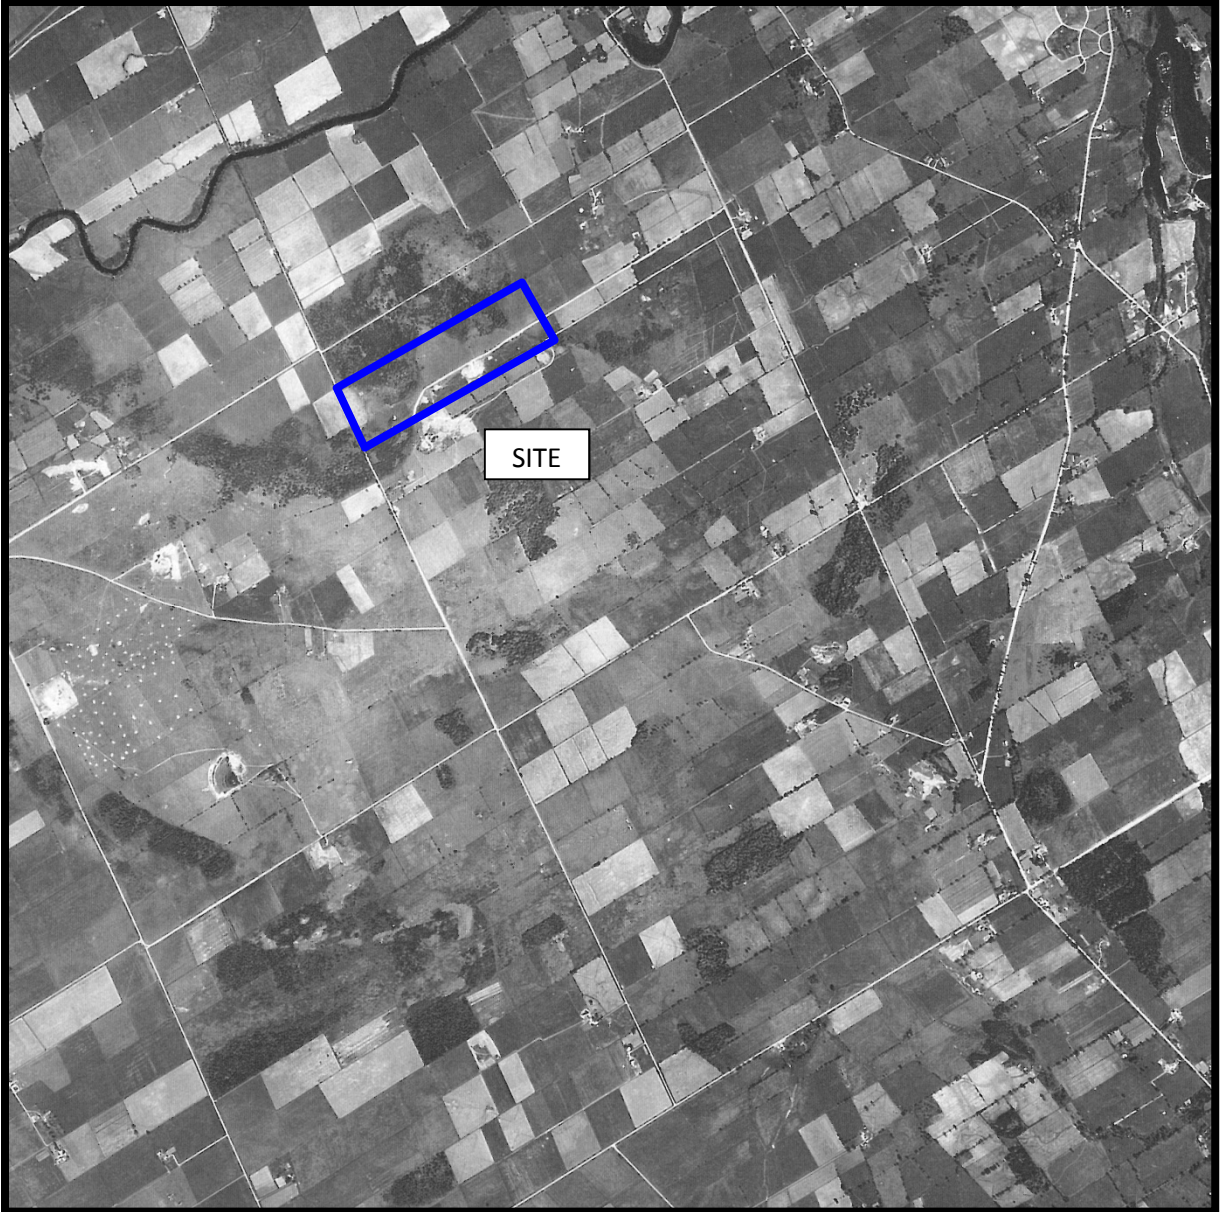
AERIAL PHOTOGRAPH
1959

- 1959 The subject property is vacant, and partially tree covered. A road runs through the south part of the site, extending from Greenbank Road to Borrisokane Road (then Cedarview Road). A small part of the site surface near the southern boundary appears to be disturbed and may be an aggregate pit. Surrounding properties are treed to the north and west, and agricultural fields to the east and south. An aggregate pit appears to be present to the southwest.

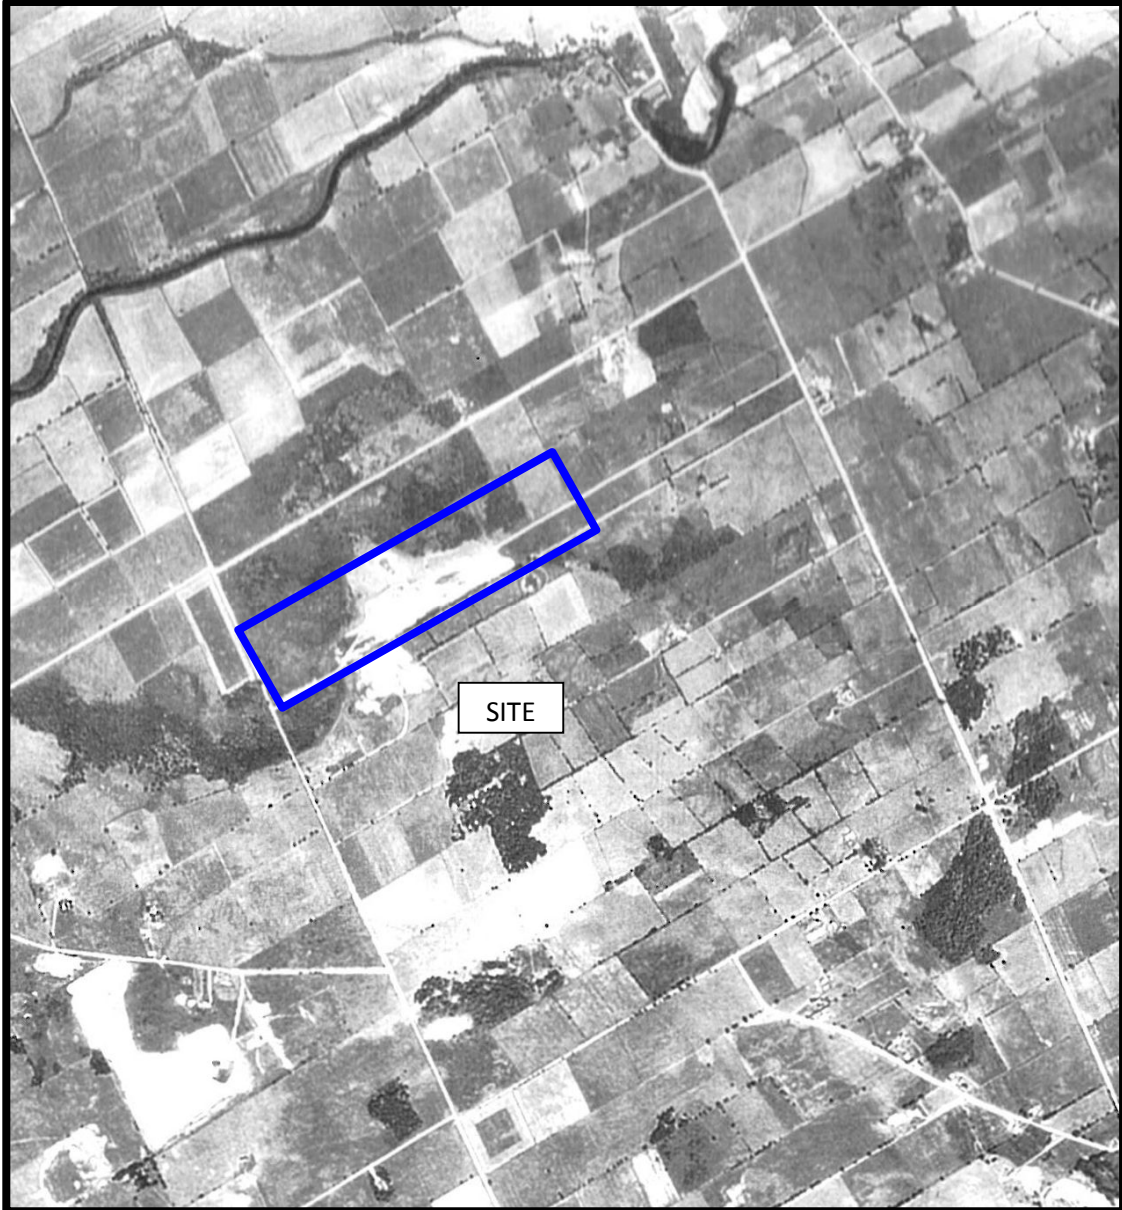
AERIAL PHOTOGRAPH
1966

- 1966 A larger area of the property surface has been disturbed and is used as an aggregate quarry. The quarry extends to the south of the subject site as well. No further significant changes have been made to the surrounding land.

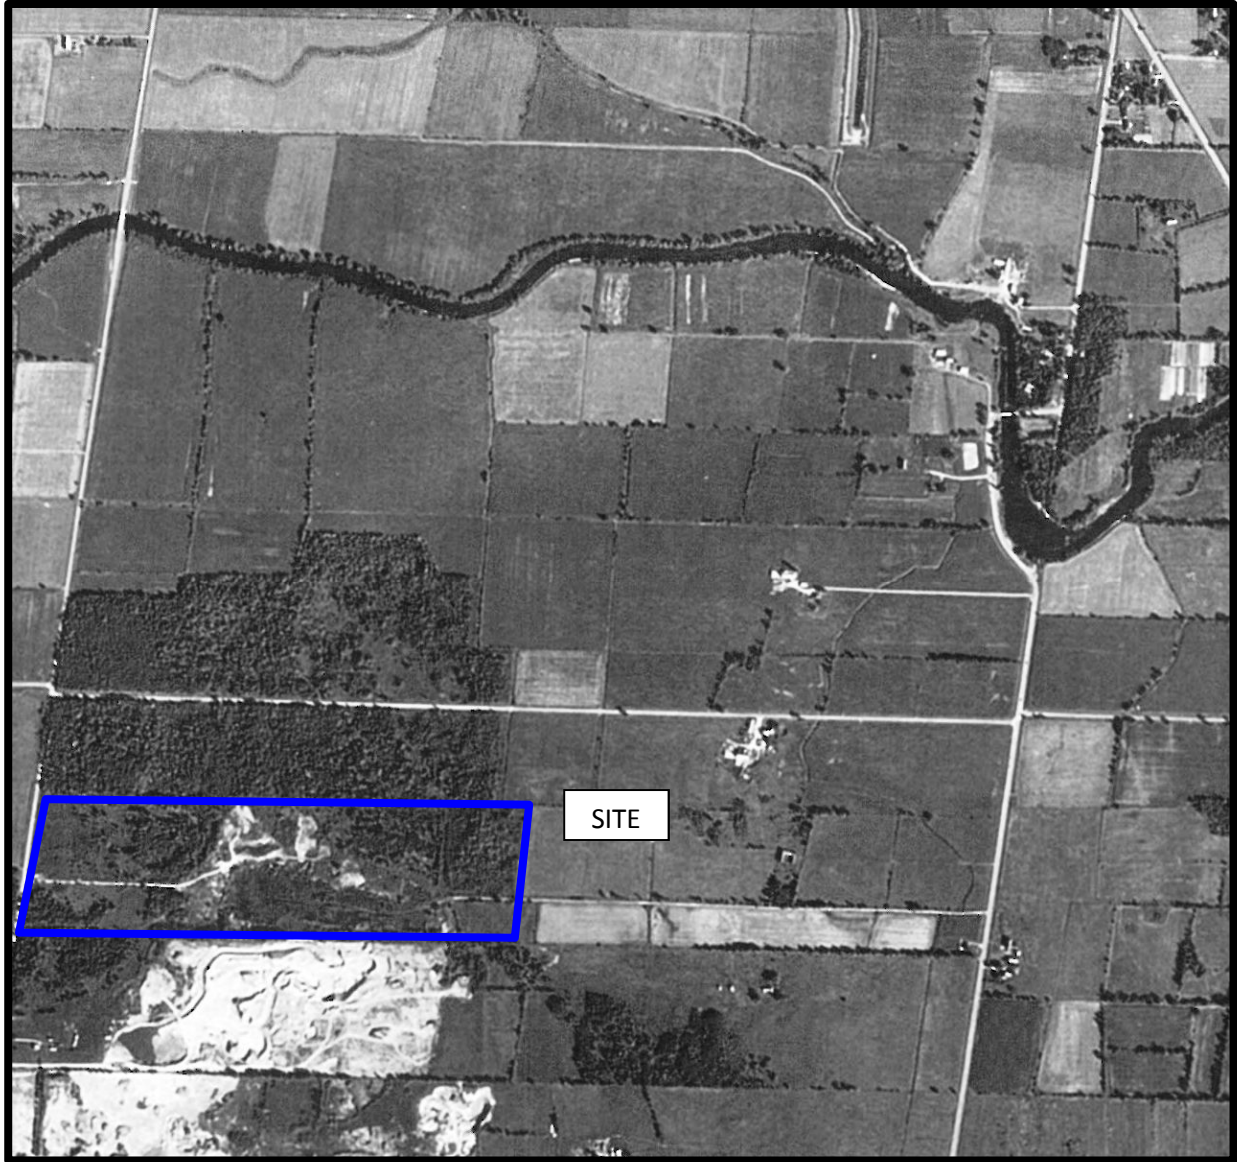
AERIAL PHOTOGRAPH
1987

- 1987 The southern part of the quarry on the subject property appears to have been abandoned. The adjacent property to the south has been further developed as an aggregate pit.

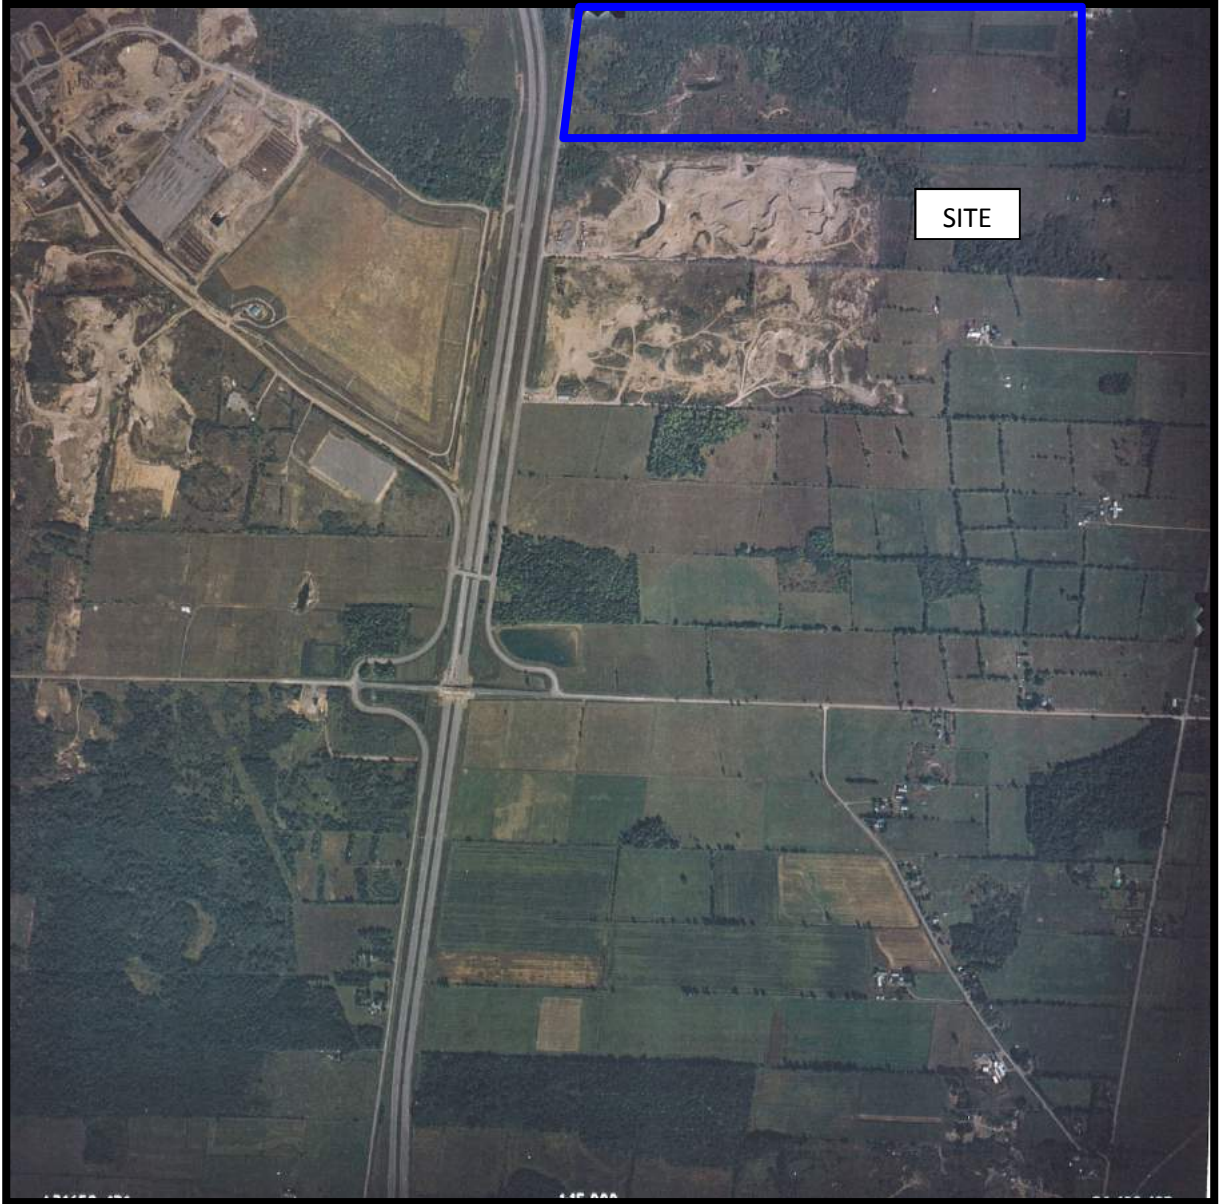
AERIAL PHOTOGRAPH
1993

- 1993 The subject site does not appear to be in use. Some of the previously clear land is tree covered, with some agricultural fields on the eastern side of the site. Highway 416 has been constructed to the west of Cedarview Road / Borrisokane Road. No other significant changes have been made to the surrounding properties.

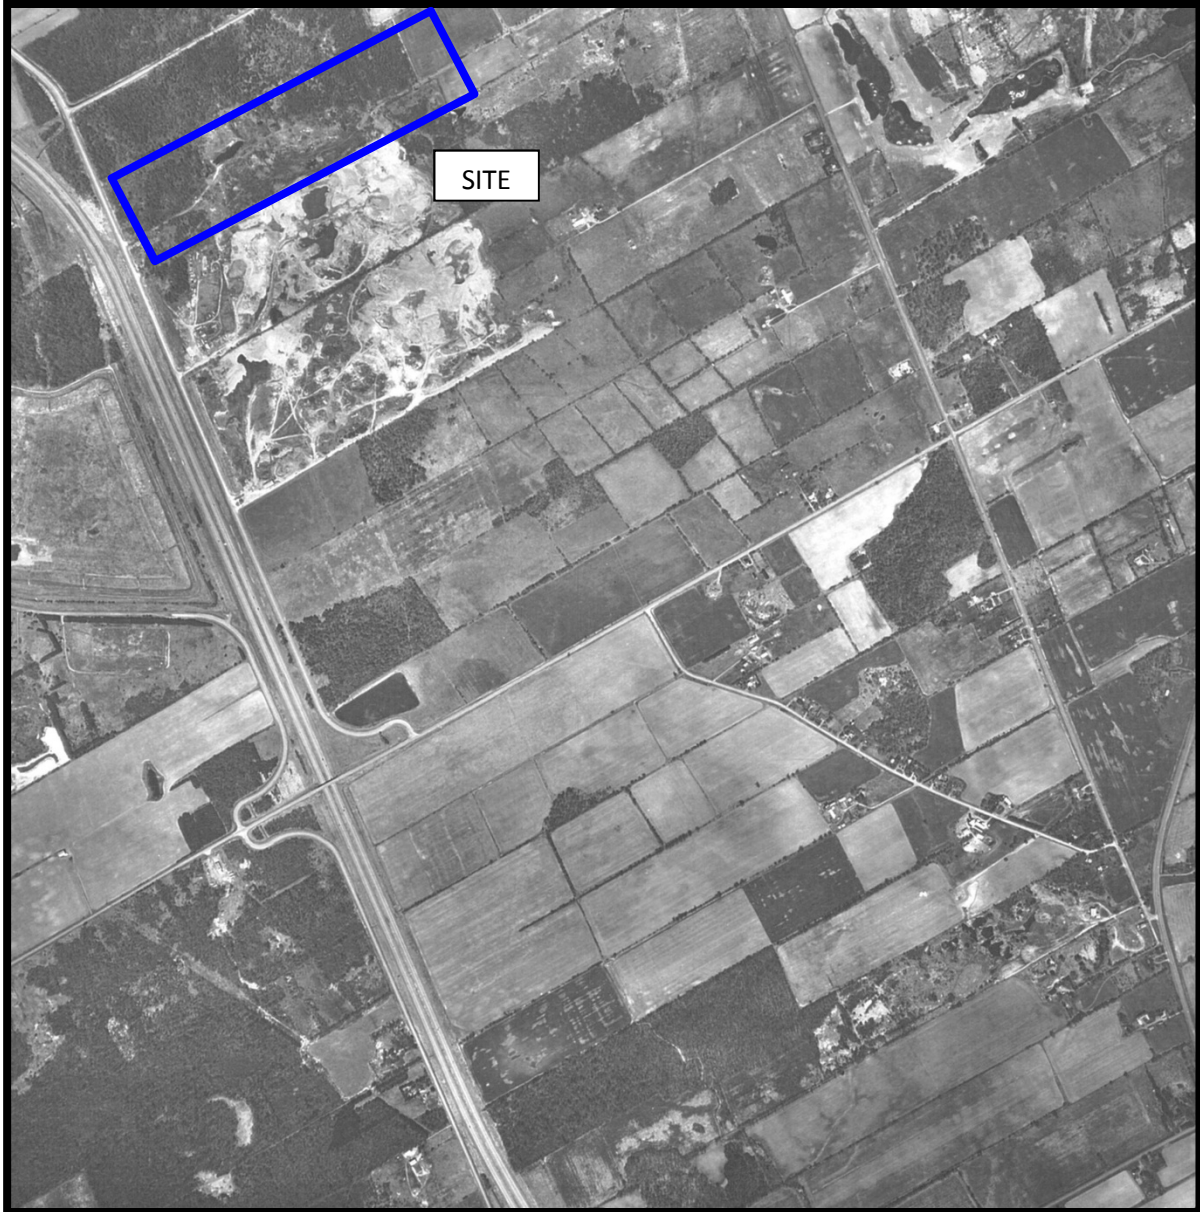
AERIAL PHOTOGRAPH
2001

- 2001 Part of the subject site previously developed as an aggregate site appears to contain water. Some of the formerly agricultural fields in the eastern part of the site are unused and partly tree covered. The property to the south continues to be occupied by a quarry.

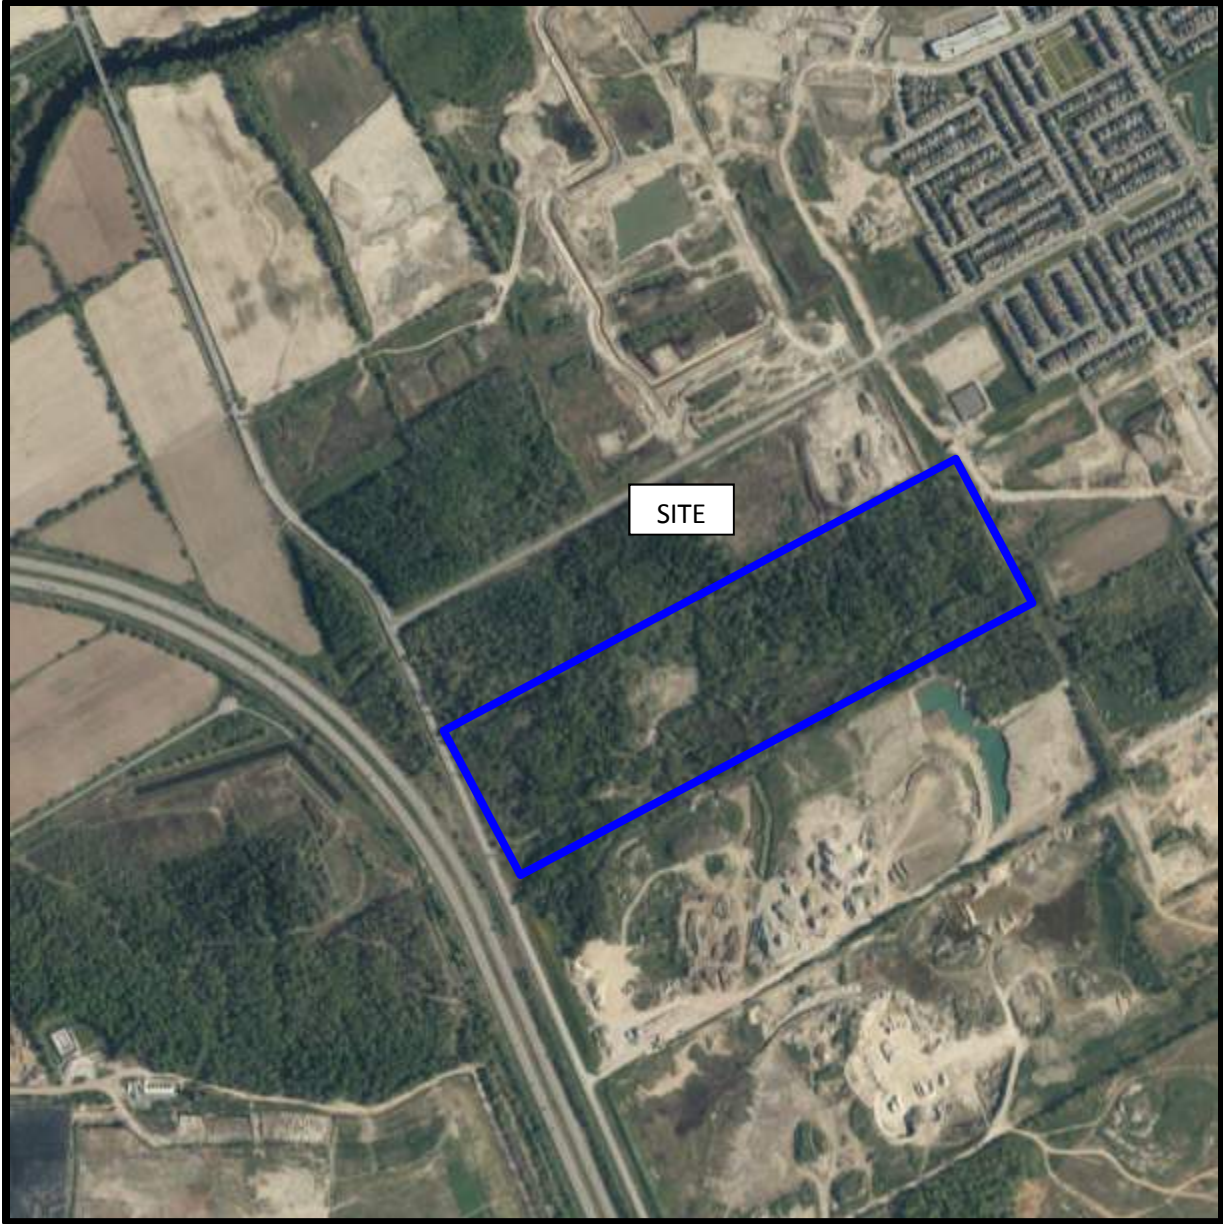
AERIAL PHOTOGRAPH
2017

- 2017 (City of Ottawa website) The majority of the site is tree covered. Residential developments are present further to the northeast, on roadways including River Mist Road and Cambrian Road.

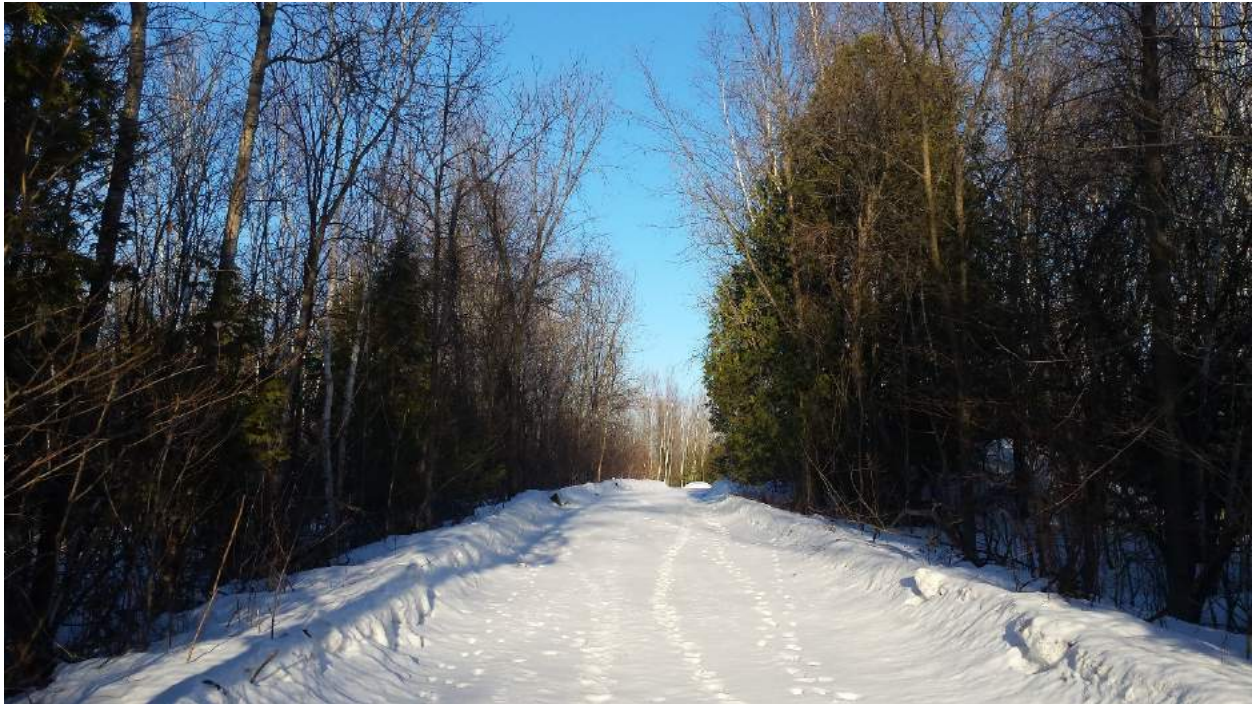
Photograph 1: Access road from Borrisokane Road leading towards the subject property. Looking east.

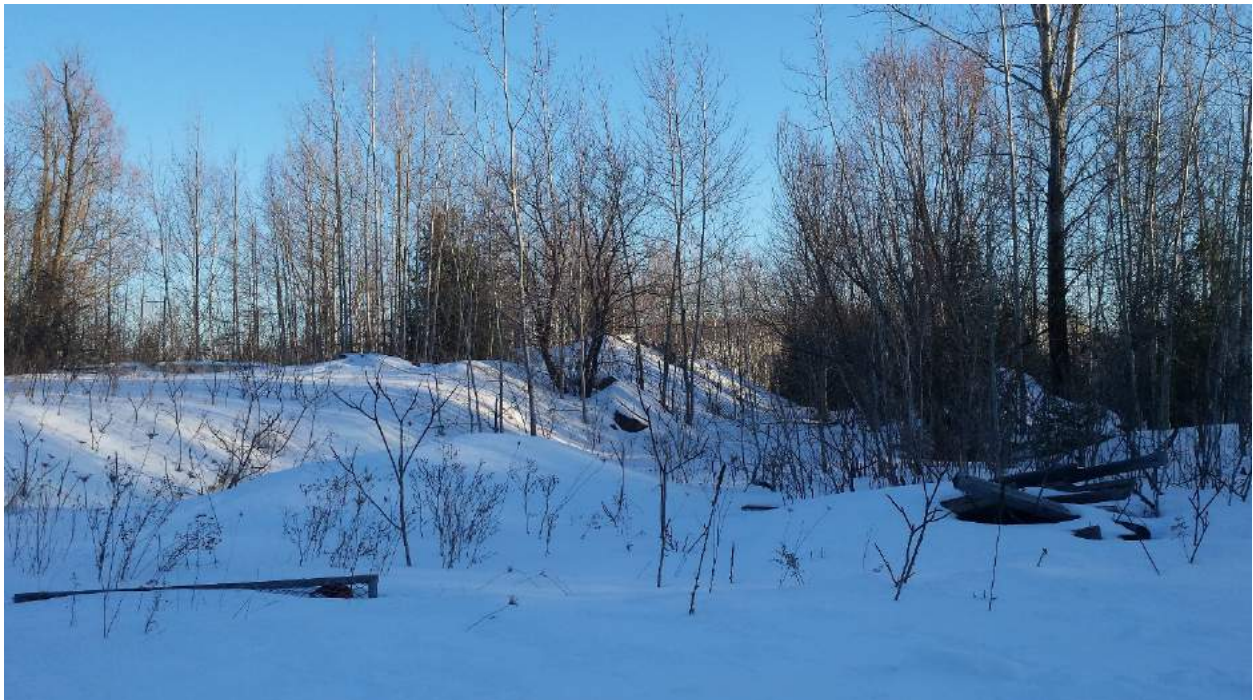
The lands on either side of the access roadways on the site were observed to be occupied by occasional waste items/debris, including: building materials, furniture, and plastic and metal barrels.

Photograph 2: Some construction debris, with Costello aggregate pit property behind, near the western boundary of the subject property.

It is recommended that all discarded/waste items be properly disposed of during the future development of the land.

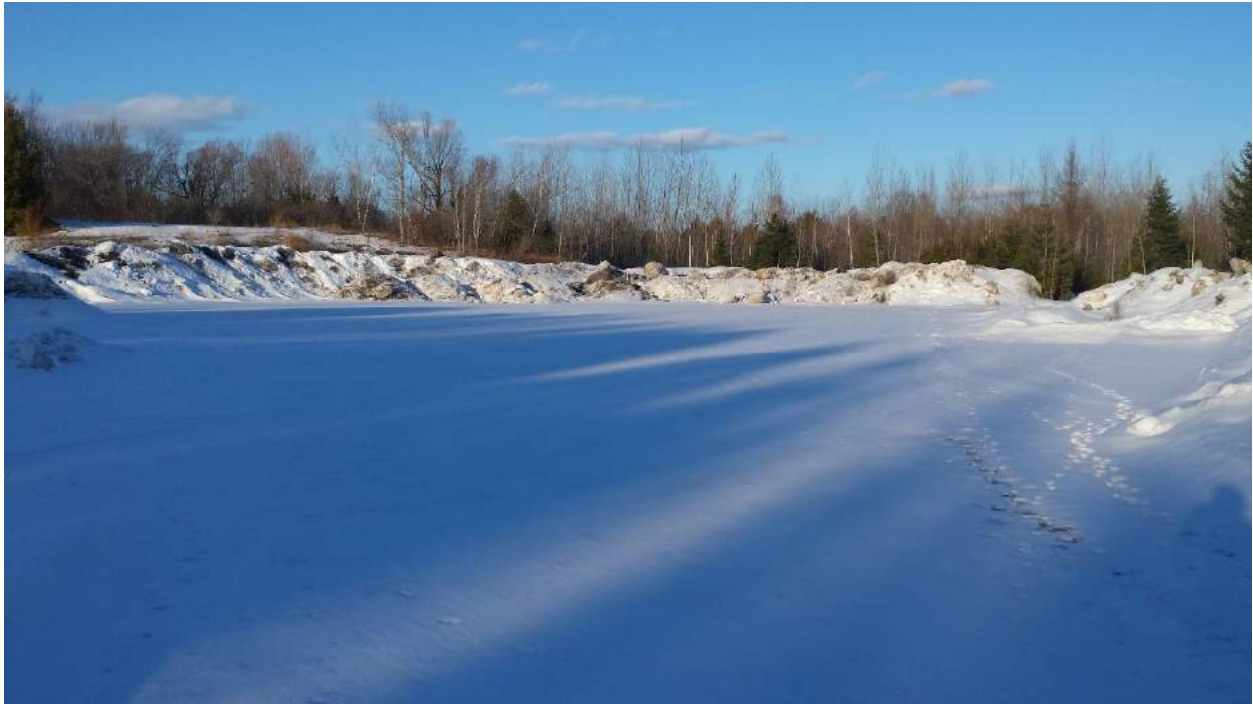
Photograph 3: Open space near the western side of the subject property; former aggregate extraction pit.

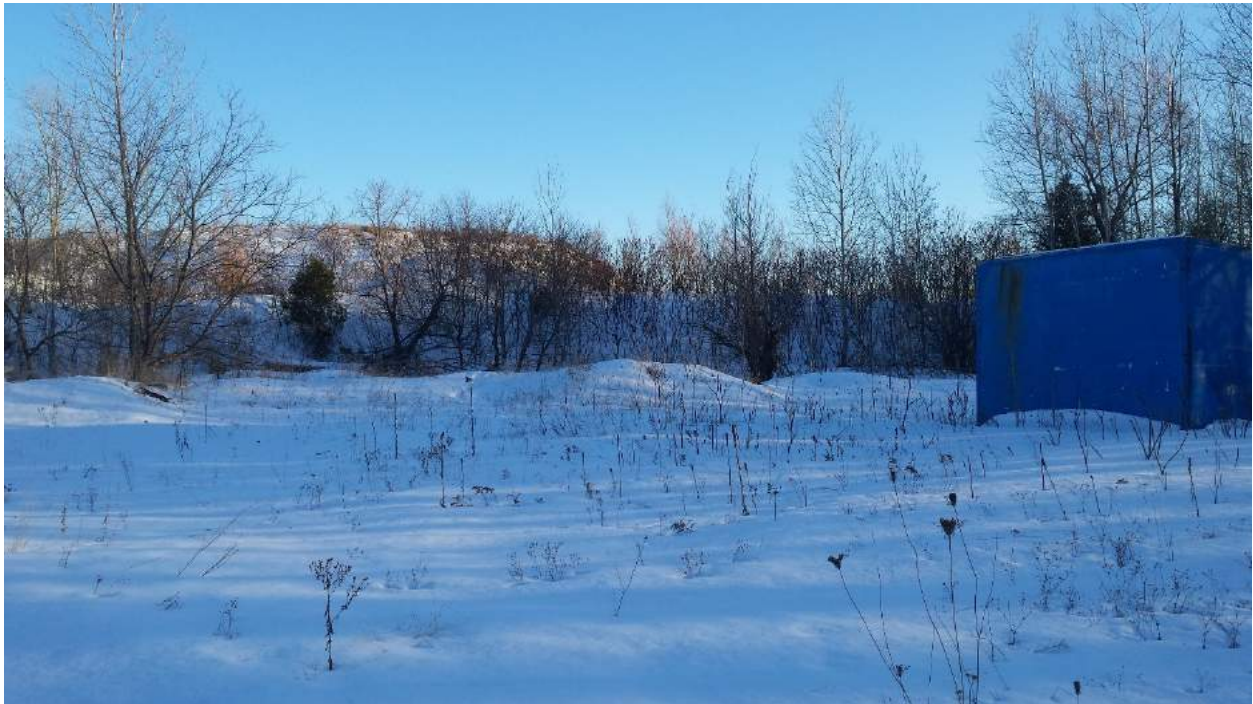
Photograph 4: Storage container with unknown contents near former aggregate pit.
