1053/1075/1145 March Road
Headwaters Drainage Assessment (HDA) (Revised)

November 2019
Prepared for CU Developments Inc.

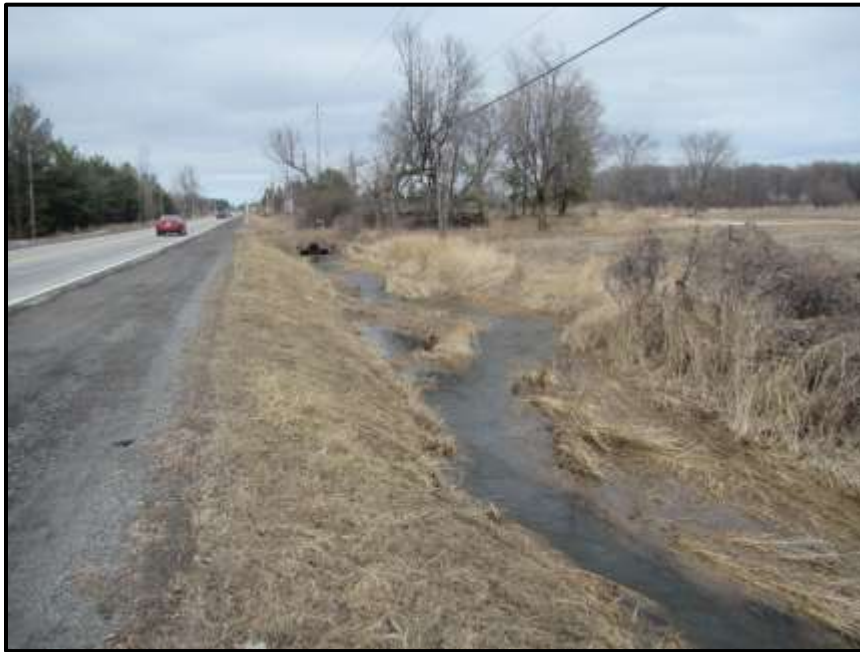
Photograph 1: Survey Site #1 downstream, facing upstream (March 30th, 2018).

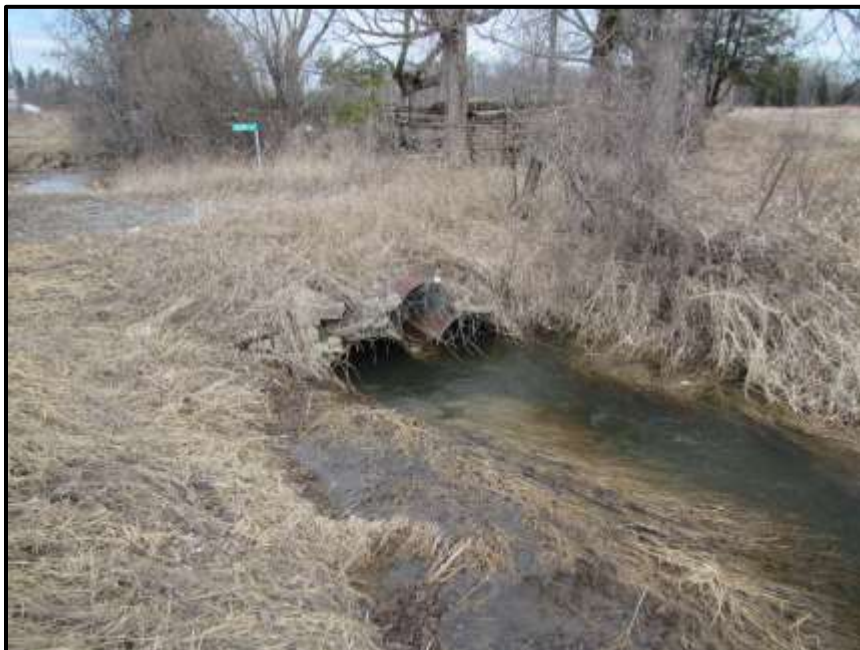
Photograph 2: Survey Site #1 - Three (3) stacked 60 cm CSP culverts under the old farm driveway, east of March Road (facing upstream) (March 30th, 2018).

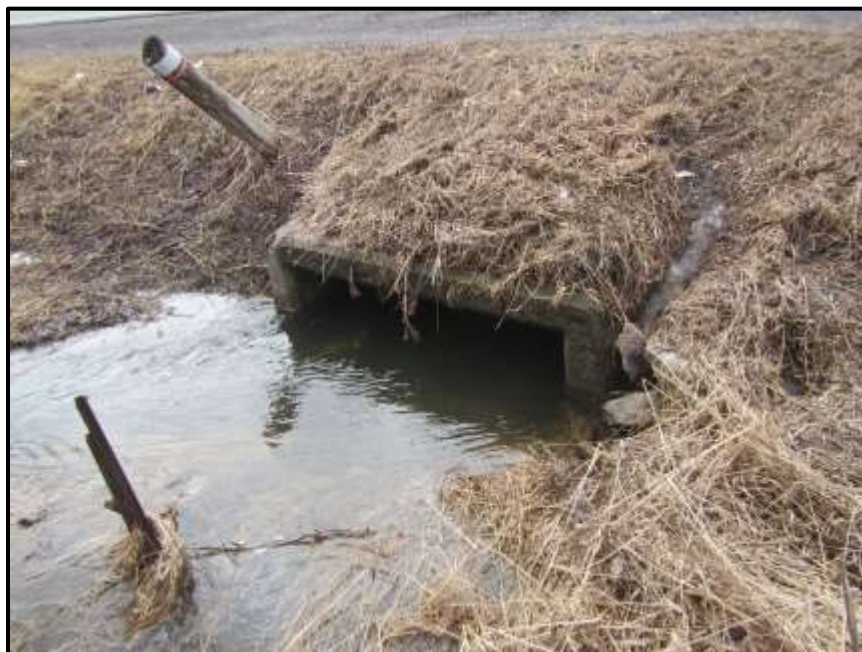
Photograph 3: Survey Site #1 - 2 m concrete box culvert under March Road (facing upstream) (March 30th, 2018).

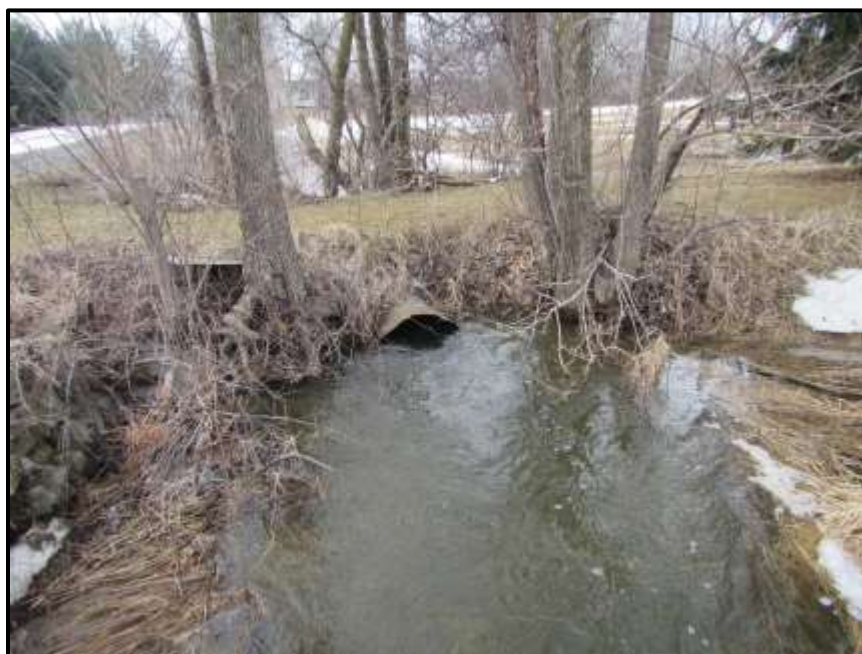
Photograph 4: Survey Site #1 - 60 cm CSP culvert under the driveway west of March Road (facing upstream) (March 30th, 2018).

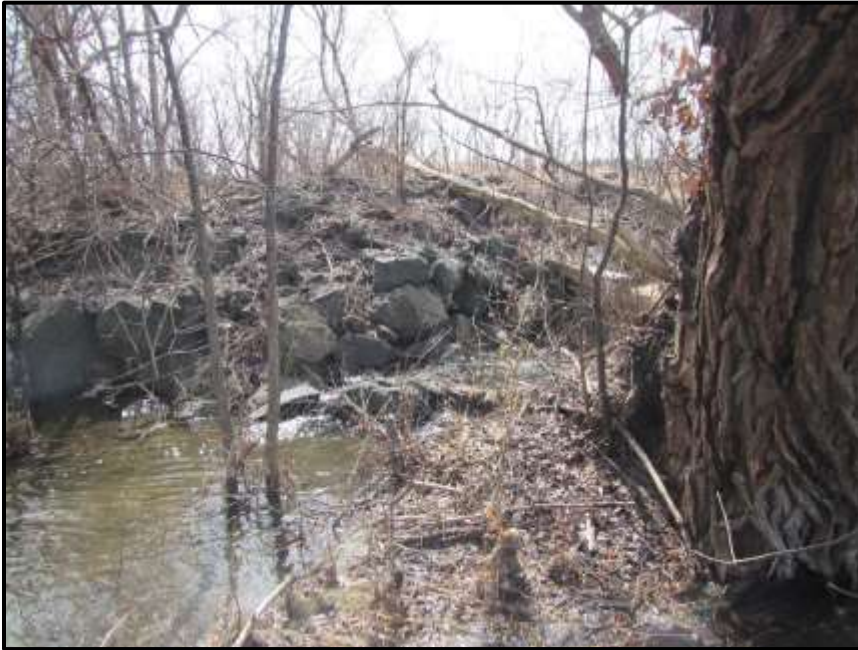
Photograph 7: Old Stone Weir downstream of pond in Survey Site #2 (March 30th, 2018).

As noted above, west of 1035 March Road water flow is held back by a crushed stone weir, which creates a 0.08 ha inline pond. The pond includes a deep pool that reaches standing water depths of greater than 1 m (MEP 2016). The substrate of the pond consists primarily of muck. Aquatic plant species grow around the margins of the pond, however, the majority of the feature consists of open water throughout the summer.

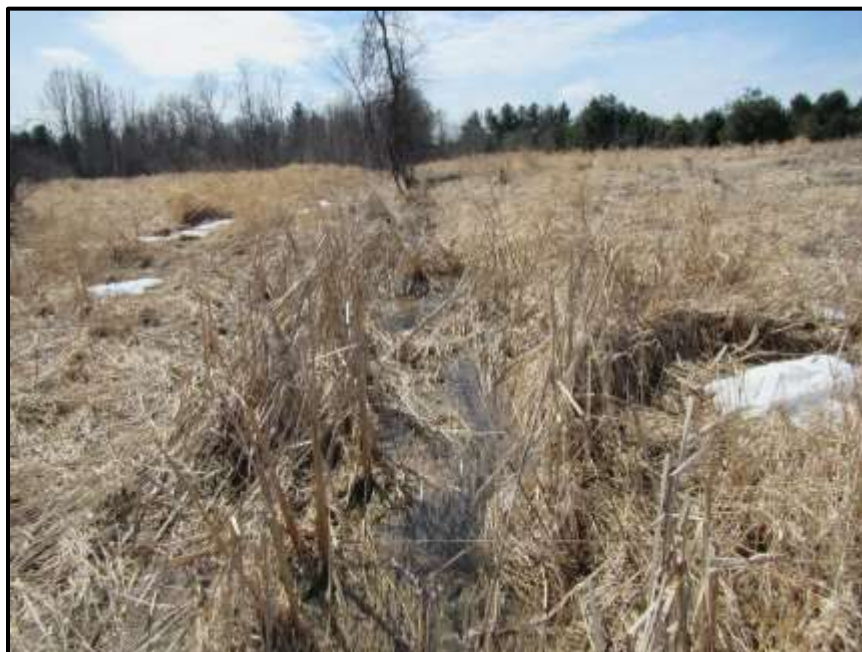
Photograph 11: Survey Site #3 (Channel F), facing upstream (March 30th, 2018).

As described above, Drainage Channel F is a stormwater swale that receives intermittent flow and is dry throughout the majority of the growing season. No evidence of amphibian breeding or direct fish habitat was documented for Drainage Channel F. Within the Kanata North Urban Expansion Area (KNUEA) Environmental Management Plan (EMP), Drainage Channel F was identified to be decommissioned (Novatech 2016b). Given the lack of habitat functionality observed within Drainage Channel F, removal of the feature is not considered a significant negative impact.
