Phase I Environmental Site Assessment

1053, 1075 and 1145 March Road
Ottawa, Ontario

CU Developments

Report: PE4376-1

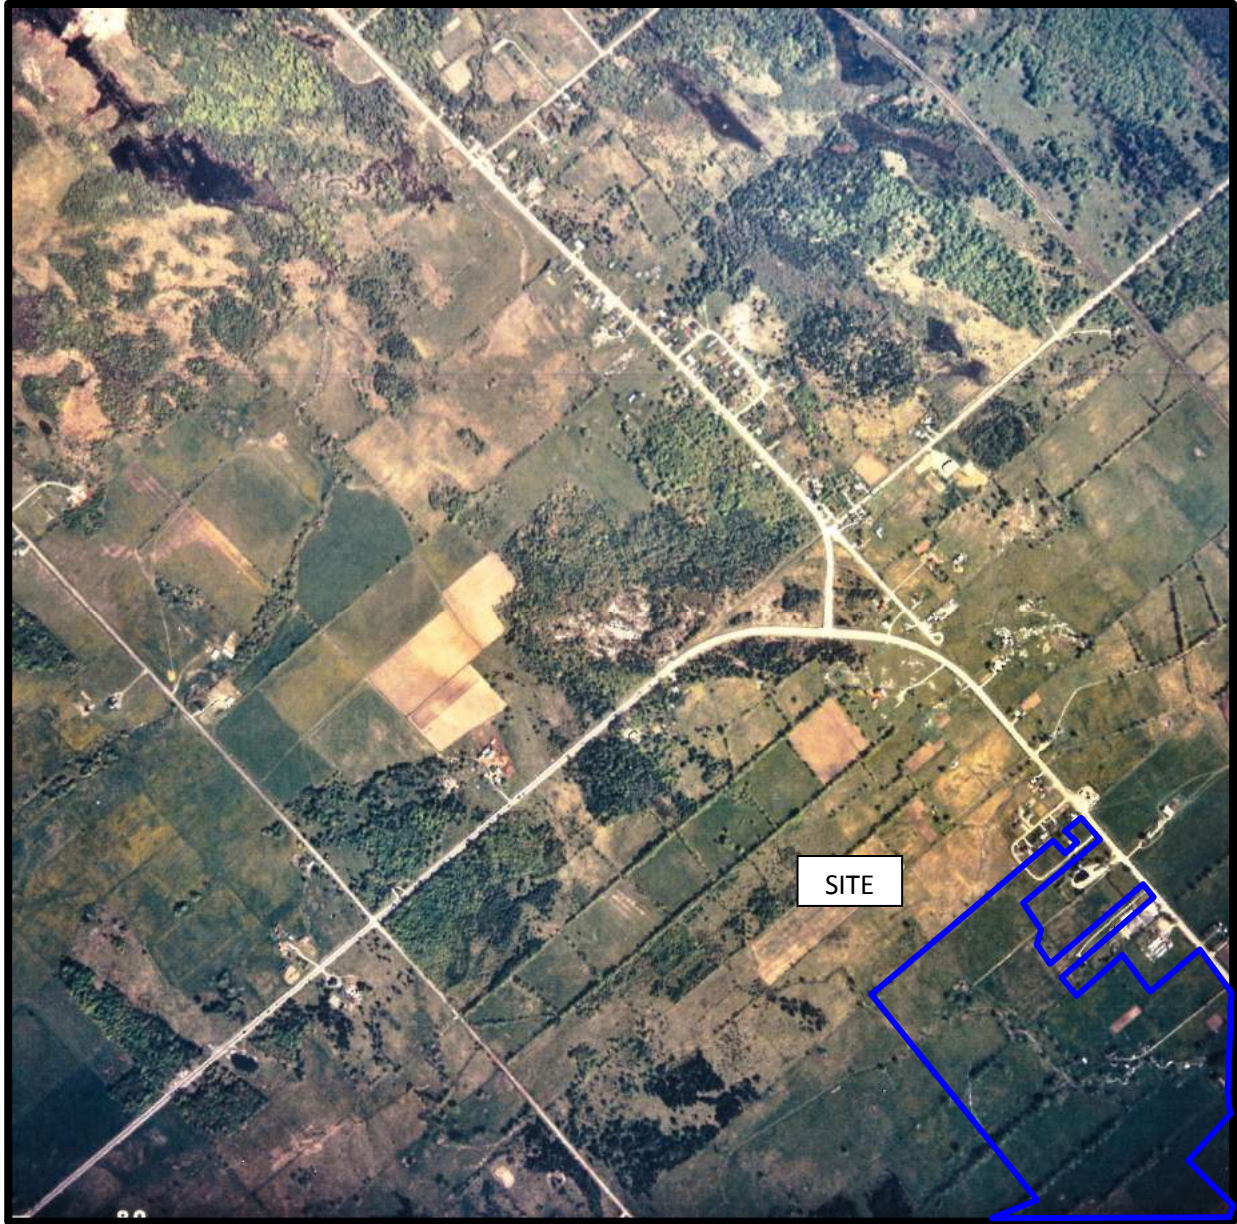
AERIAL PHOTOGRAPH
1978

| 1978 | No significant changes have been made to the subject site. The adjacent properties to the northeast of the subject site have been developed with a residential dwelling and a school. A retail fuel outlet appears to have been developed at 1156 March Road, to the northeast of the subject site. |

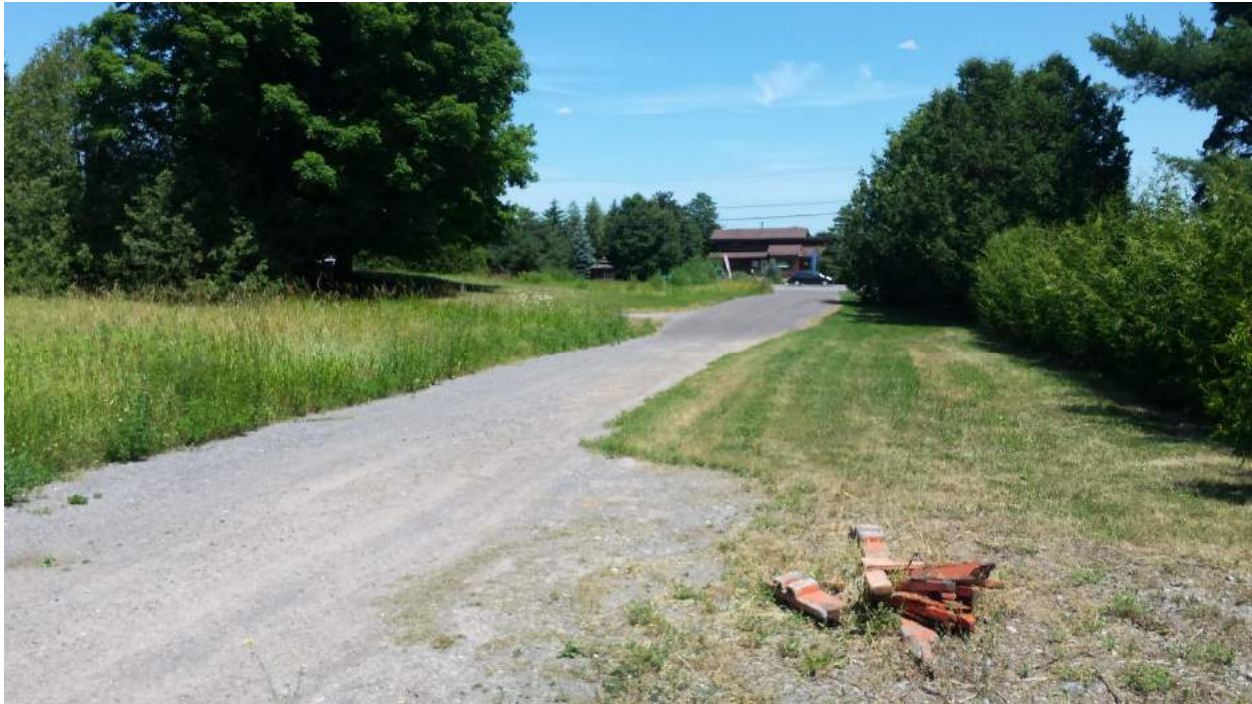
Photograph 1: View of gravel road (Murphy Court) access to the north part of the property, at 1145 March Road, looking northeast.

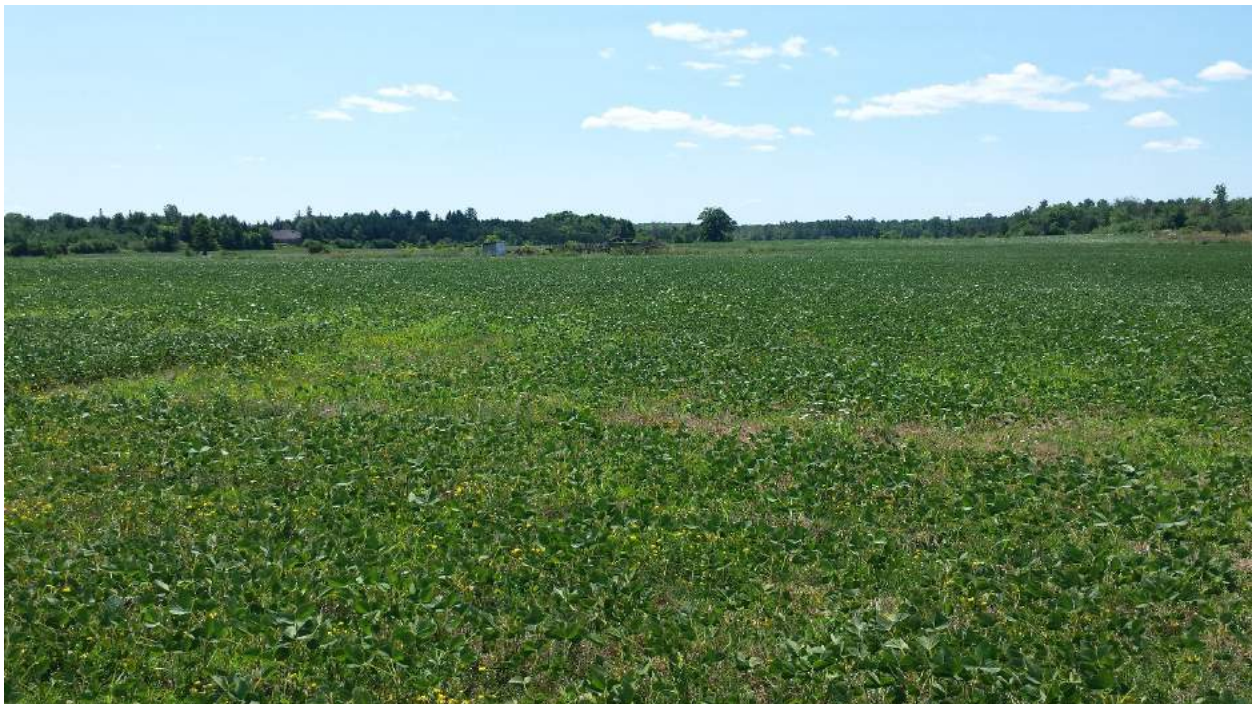
Photograph 2: View of the property addressed 1075 March Road, looking southwest.

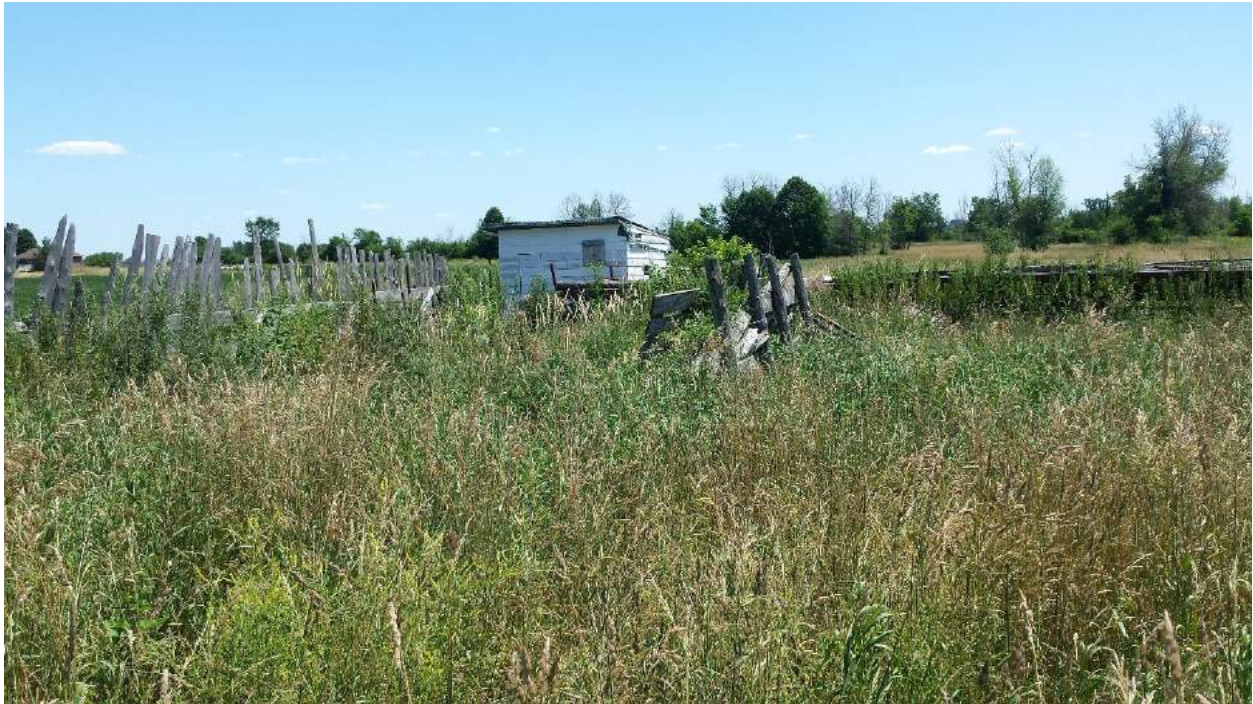
Photograph 3: Former livestock corral near the north end of 1075 March Road, looking southeast.

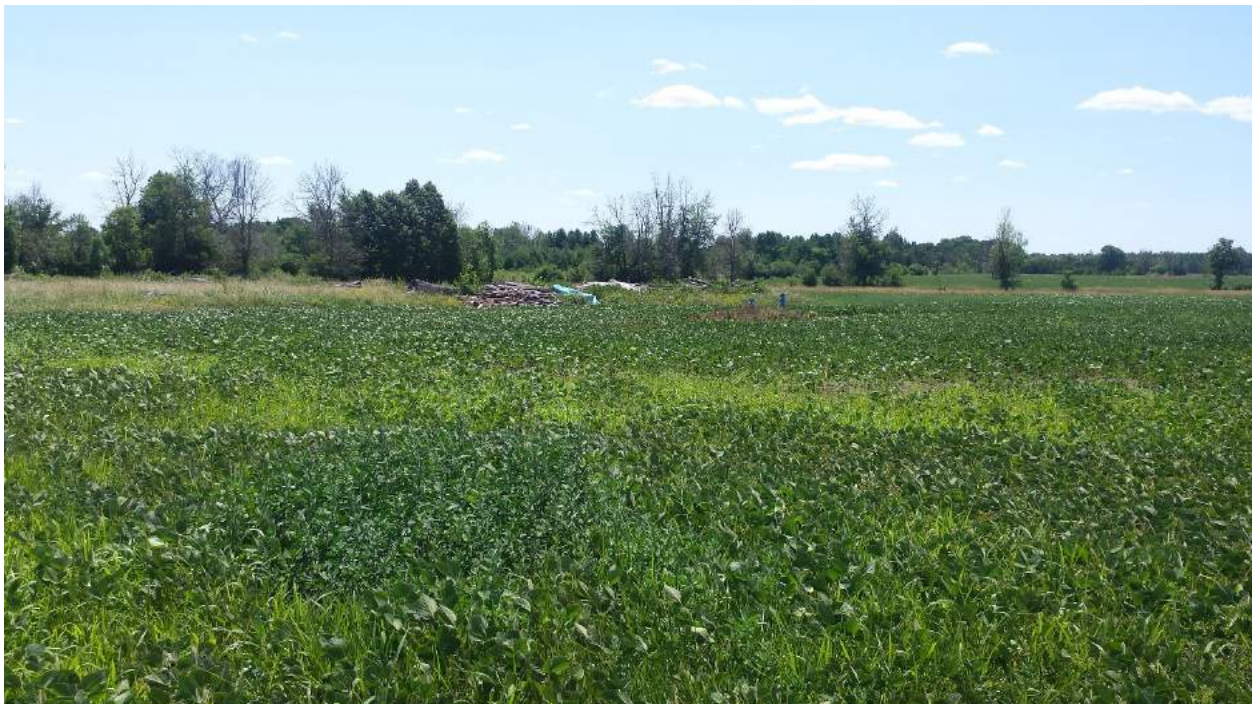
Photograph 4: Soy field at 1075 March Road, with wood building materials near the border with 1113 March Road, looking south.

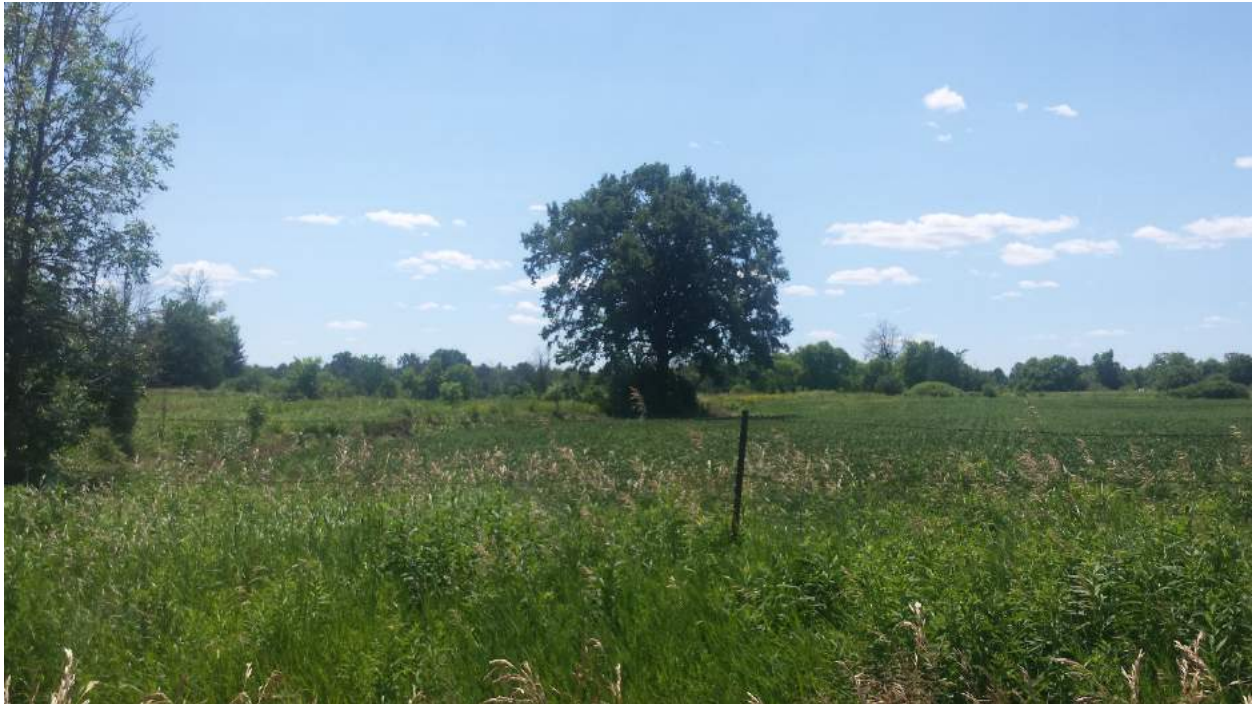
Photograph 5: View of the central part of 1075 March Road, near 1053 March Road, looking southwest from March Road.

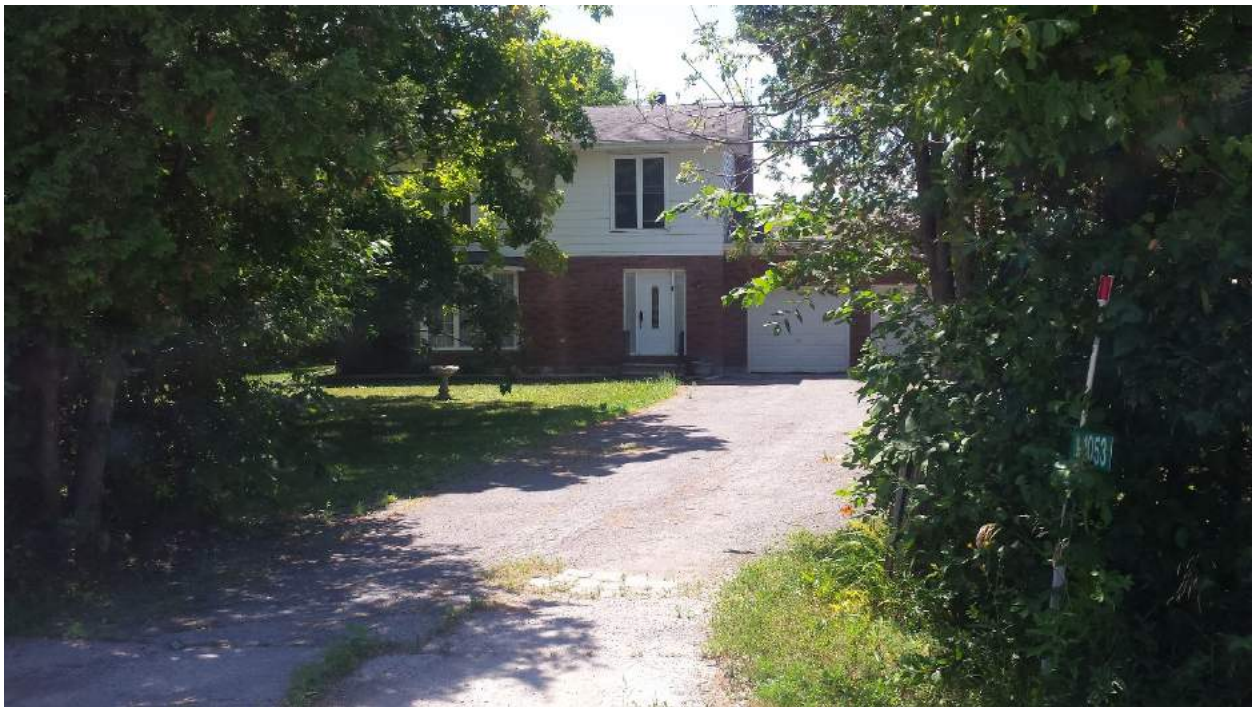
Photograph 6: View of the front of 1053 March Road, looking southwest from March Road.
