McKINLEY
ENVIRONMENTAL
SOLUTIONS

Combined Environmental Impact Statement &
Tree Conservation Report (Revised)
1053/1075/1145 March Road

November 2019
Prepared for CU Developments Inc.

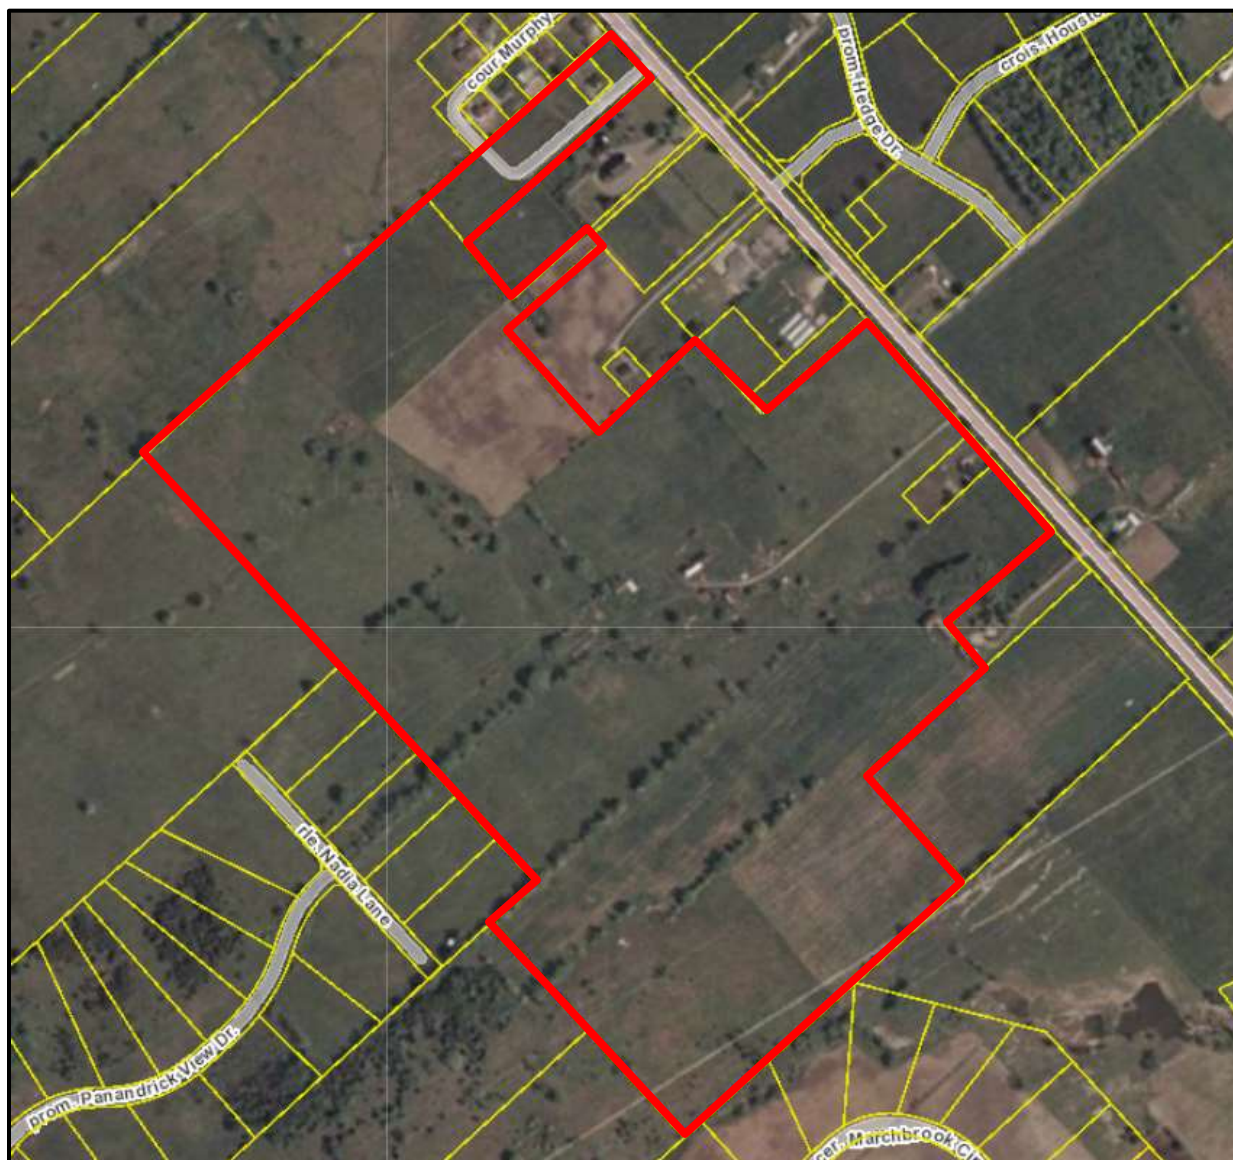
Historic Air Photograph 1: Historic Air Photo from 1976 (Site development limits shown in red). Note that the Study Area was intensively farmed and tree cover was limited to the hedgerows in 1976. Regeneration of trees and shrubs in the southwestern part of the Study Area was not yet underway in 1976 (Photos from City of Ottawa 2018).

Air photos from 1976, 1991 and 2005 are included below (Photos from City of Ottawa 2018). Recent air photos are included in the report figures. The oldest available historic air photo (from 1976), shows that the Study Area was intensively farmed and tree cover was limited to the hedgerows in 1976. Regeneration of trees and shrubs in the southwestern part of the Study Area was not yet underway by 1976. The majority of the Study Area continued to be farmed in 1991, and mature tree cover continued to predominantly be confined to the hedgerows. However, regeneration of trees and shrubs in the southwestern corner of the Study Area and surrounding areas was underway by 1991. Based on their size in the 1991 air photo, it is likely that the largest trees in the southwest corner of the Study Area were approximately 10 years old at that time, which suggests that some stems may be up to approximately 40 years old in 2019. In 2005, the majority of the Study Area continued to be farmed, with mature tree cover limited to the hedgerows and Cultural Woodlots F and G. However, regeneration of trees and shrubs in the southwestern corner of the Study Area and surrounding areas had advanced significantly by 2005.

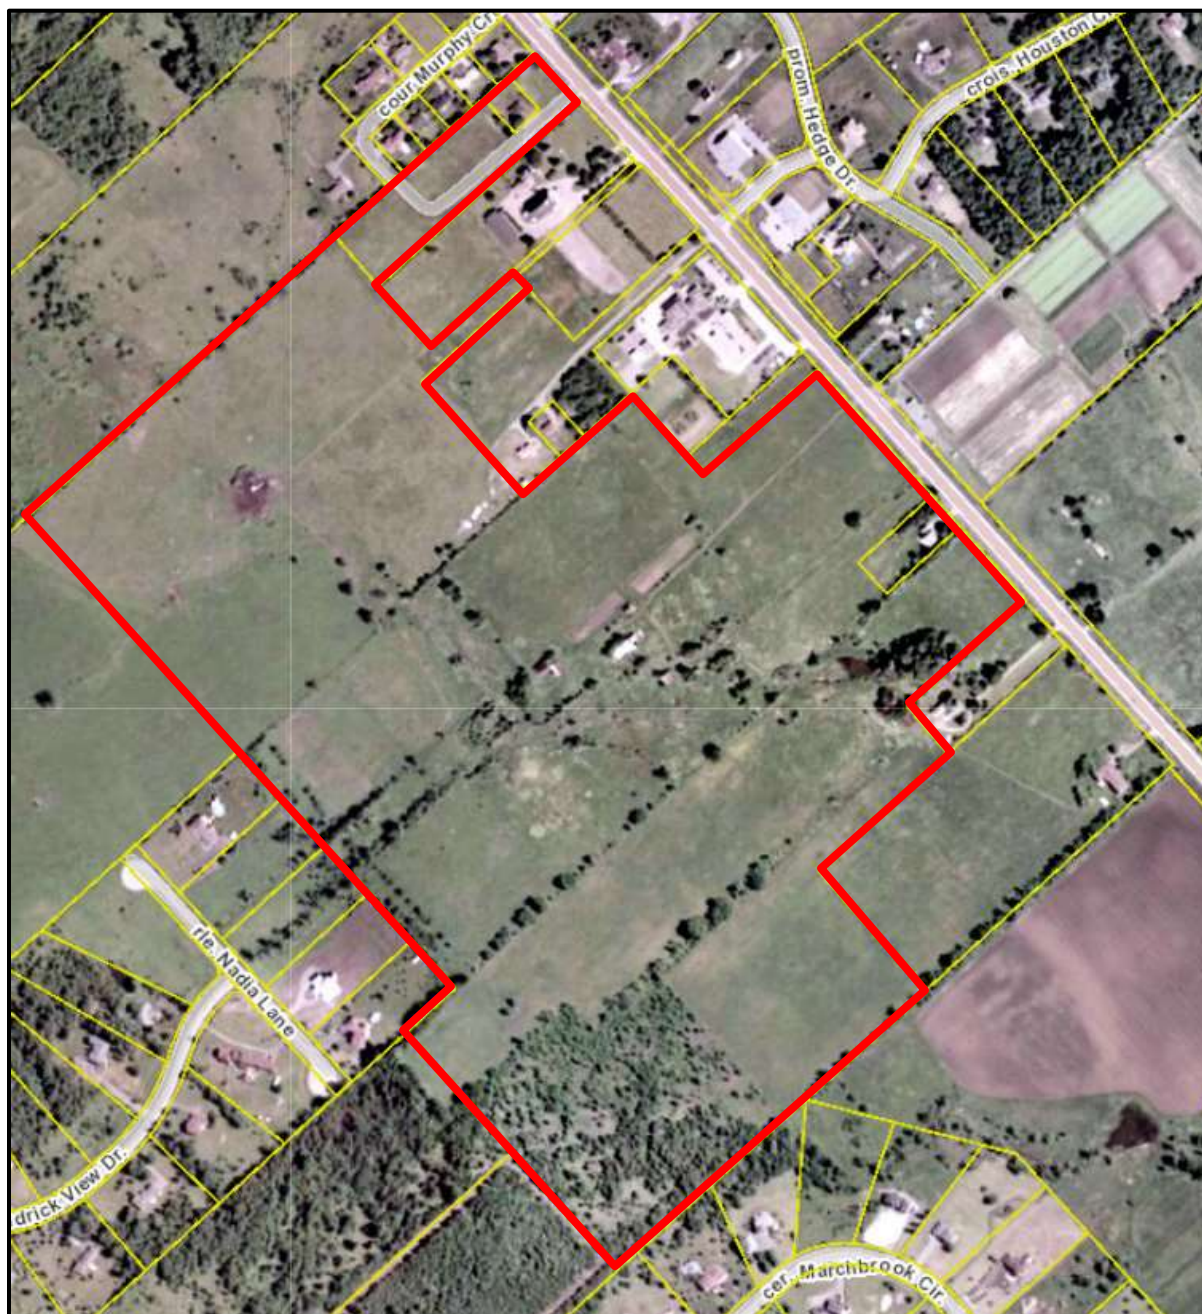
Historic Air Photograph 3: Historic Air Photo from 2005 (Site development limits shown in red). Note that the majority of the Study Area continued to be intensively farmed. Tree cover was limited to the hedgerows and Cultural Woodlots F and G in 2005. However, regeneration of trees and shrubs in the southwestern corner of the Study Area and surrounding areas had advanced significantly by 2005 (Photos from City of Ottawa 2018).

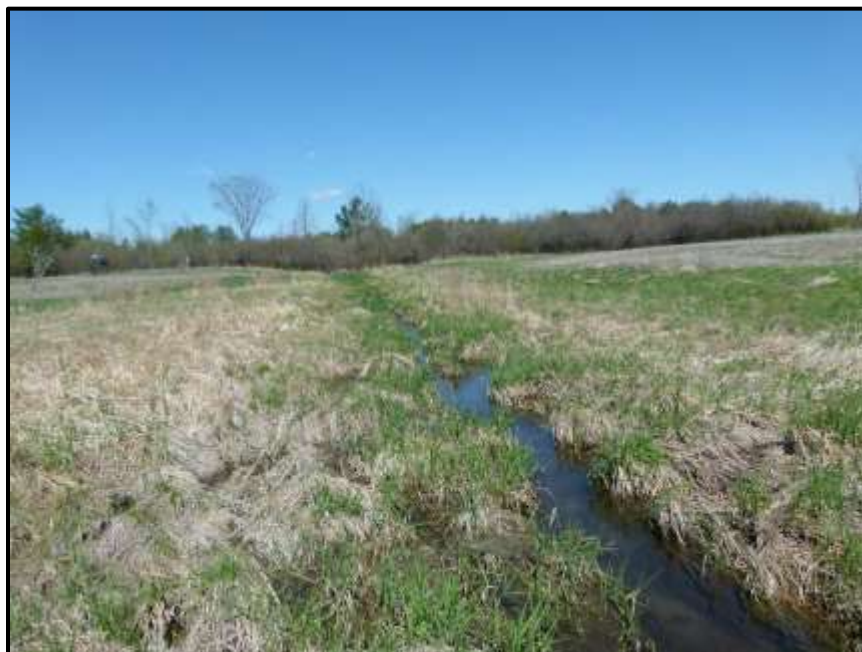
Photograph 24: HDA Survey Site #4 upstream – north fork, facing upstream. Note that the channel is narrow and relatively shallow, even in the spring. The area shown is typical of the North Tributary throughout the Study Area (May 12th, 2018).

Select photographs of the North Tributary are included below. A complete photographic record of the Headwaters Drainage Assessment survey conditions is included in MES (2019a). Refer to MES (2019a) for additional photographs of the North Tributary.

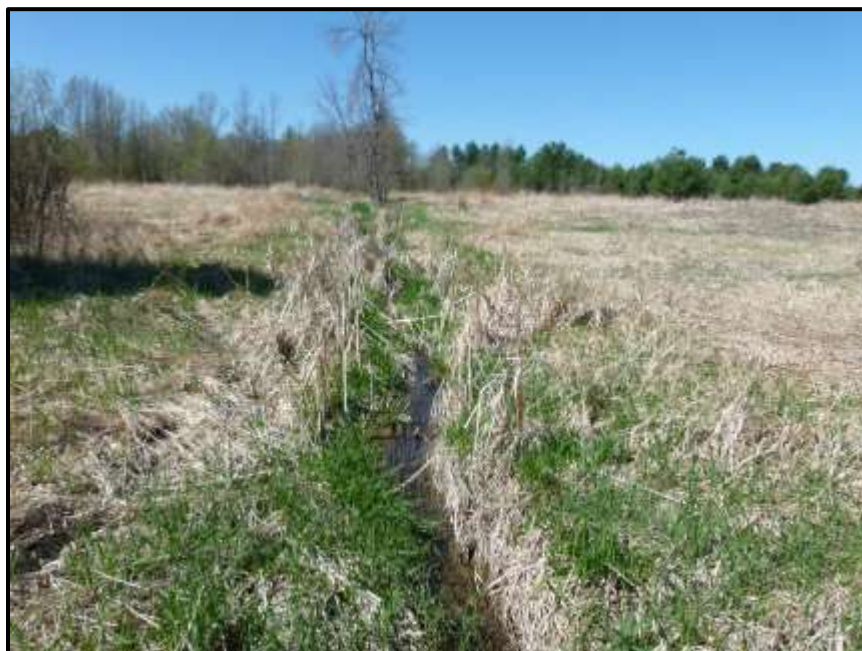
Photograph 25: HDA Survey Site #3 (Channel F), facing upstream. Note that Channel F does not convey substantial water flow, even in the spring (May 12th, 2018).

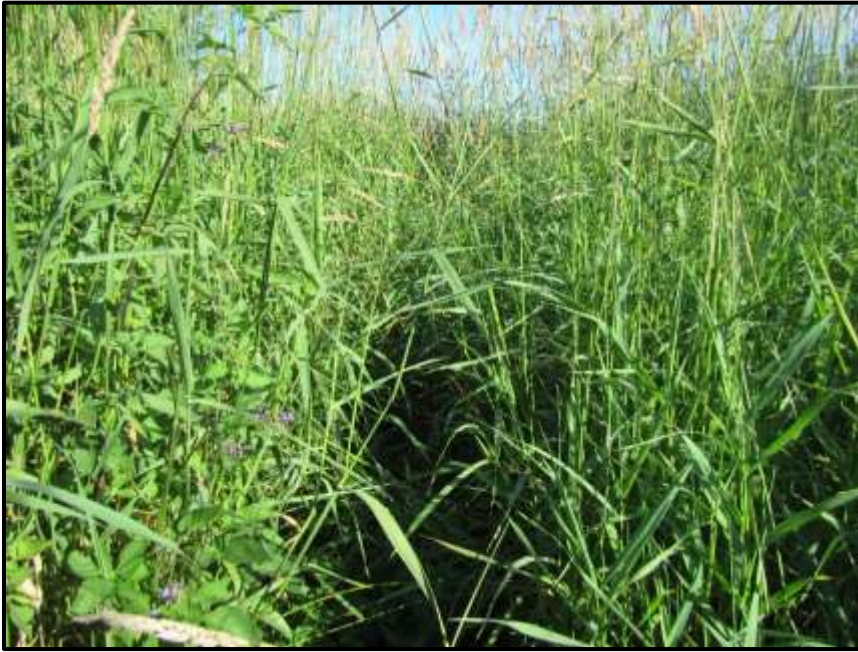
Photograph 26: HDA Survey Site #3 (Channel F) downstream, facing upstream. Note that Channel F is completely overgrown and dry in the summer (July 4th, 2018).

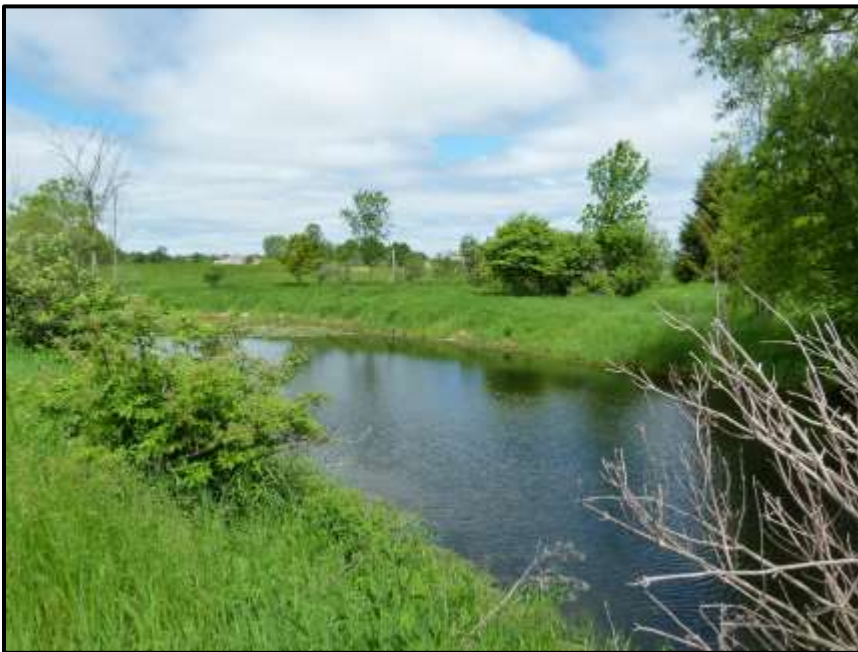
Photograph 27: Looking west at the pond. Note that the majority of the pond's surface area remains as open water, even in mid-summer (June 3rd, 2017).

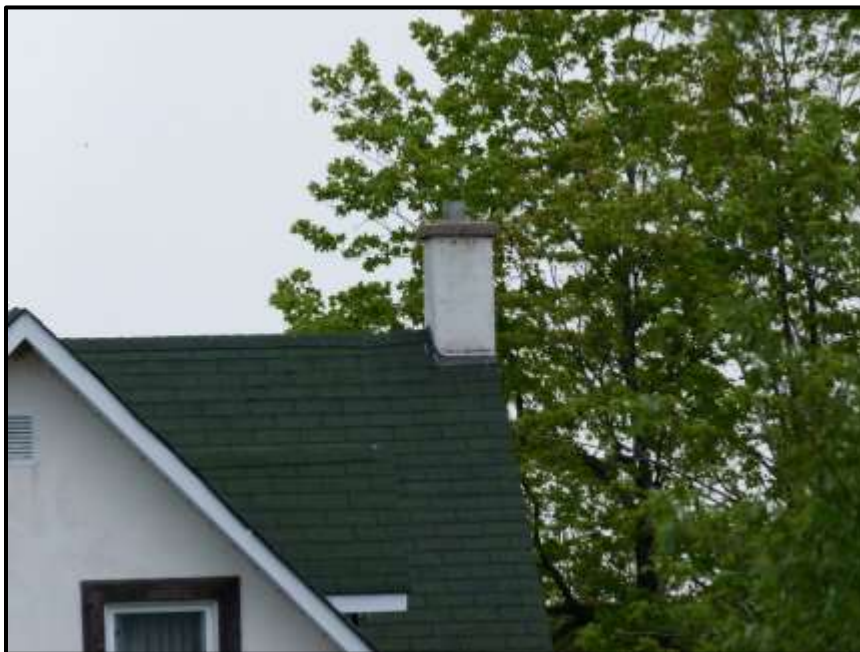
Photograph 32: Chimney at 1035 March Road. Note the metal liner (May 24th, 2017).

Photographs of the chimneys are included below. Chimney Swift typically will not nest in chimneys with ceramic liners, as they are unable to affix their nests to the smooth interior surface. Chimney Swift are unable to enter chimneys with wire mesh or metal caps. There are therefore no chimneys within the Study Area which may be suitable for Chimney Swift nesting. Due to the absence of potentially suitable chimneys within the Study Area, a survey for Chimney Swifts was not required.

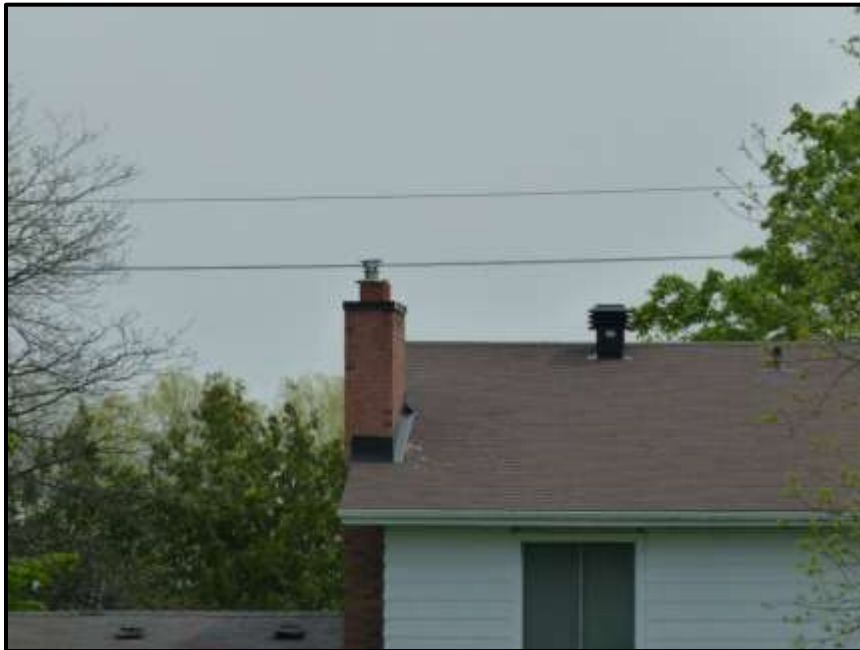
Photograph 33: Chimney at 1053 March Road. Note the ceramic liner and metal cap (May 24th, 2017).

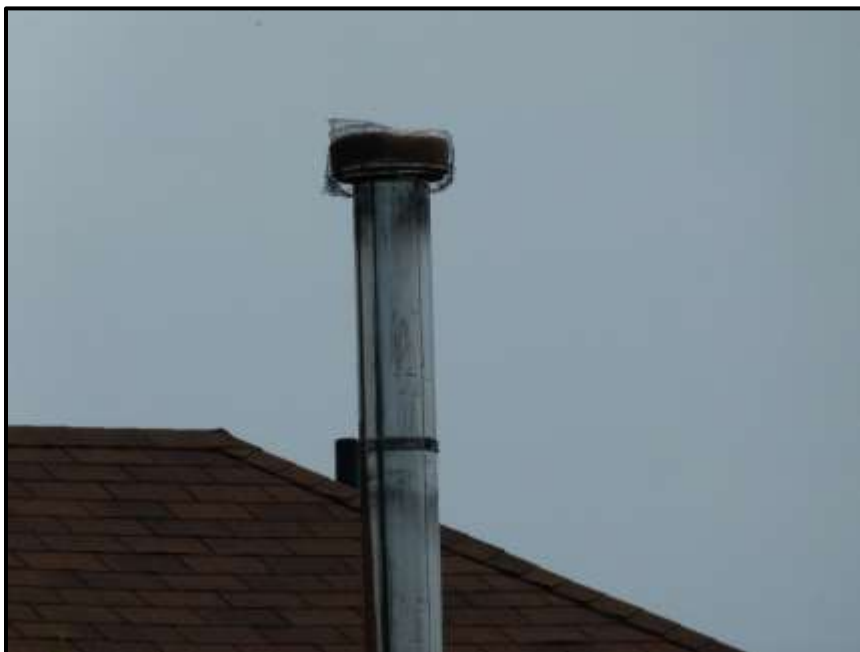
Photograph 34: Chimney at 1113 March Road. Note the metal liner and wire mesh cap (May 24th, 2017).

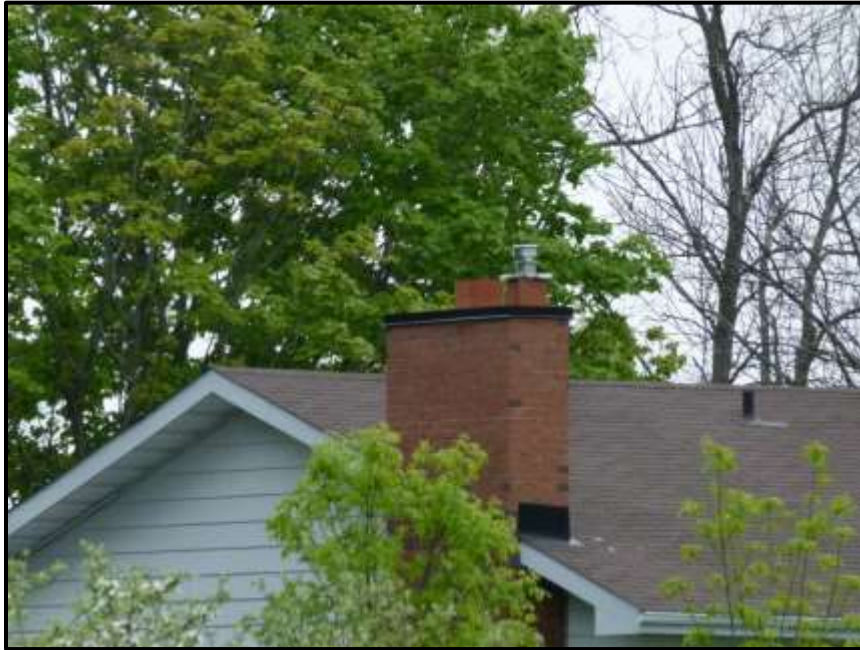
Photograph 35: Chimney at 1145 March Road. Note the ceramic liner and metal cap (May 24th, 2017).
