REPORT ON

**HYDROGEOLOGICAL INVESTIGATION
PROPOSED RESIDENTIAL DEVELOPMENT
HEMPHILL STREET, RICHMOND
OTTAWA, ONTARIO**

May 2018

File No. 017630

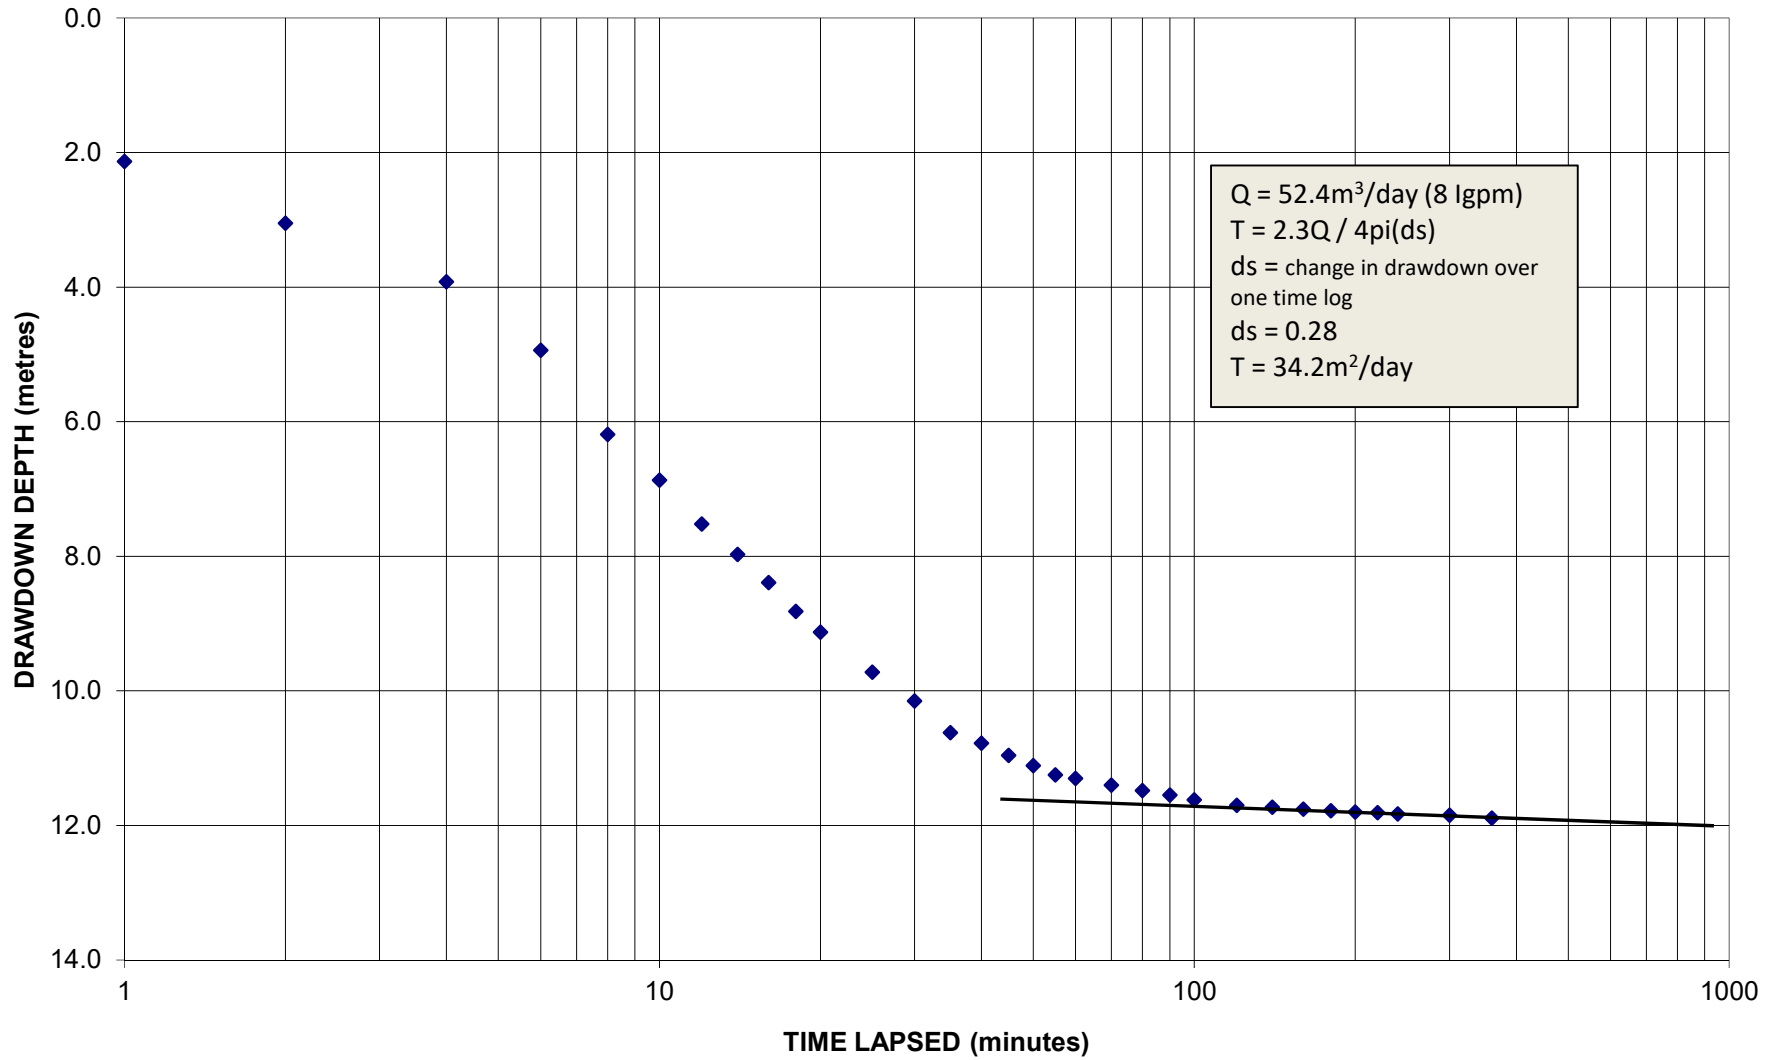
TW1 WELL DRAWDOWN VS. TIME

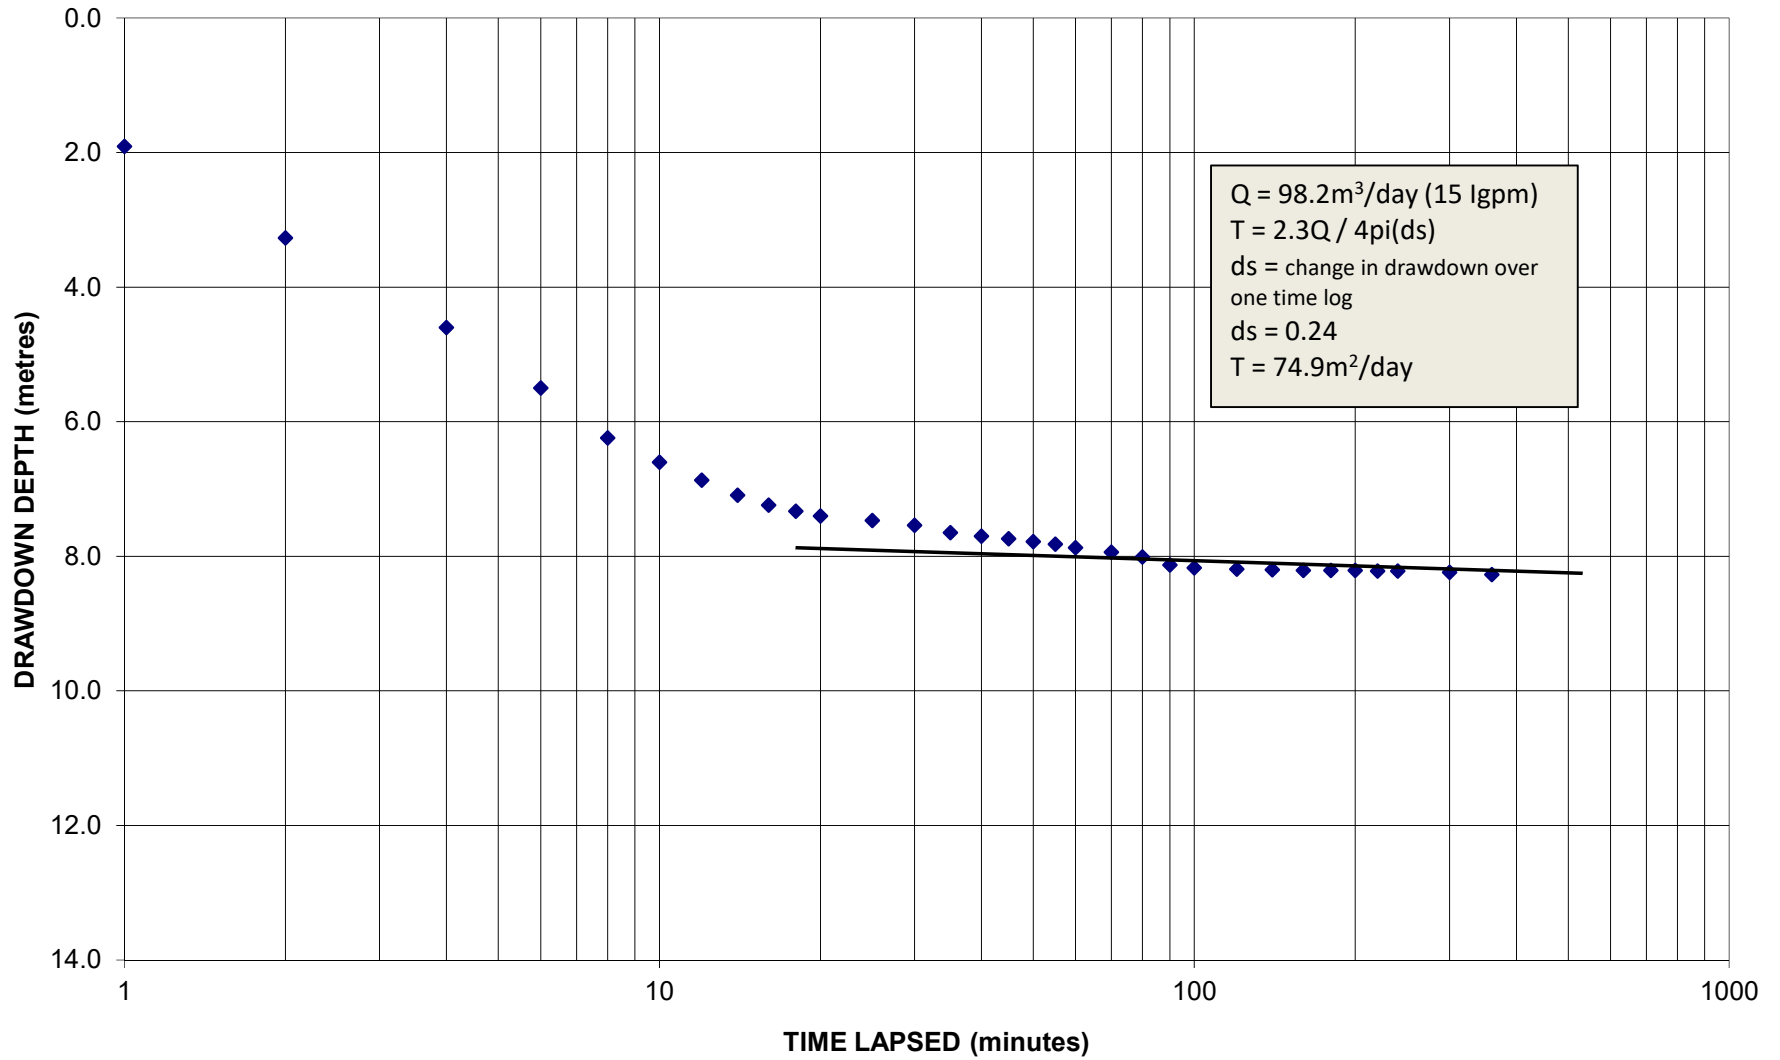
TW2 WELL DRAWDOWN VS. TIME

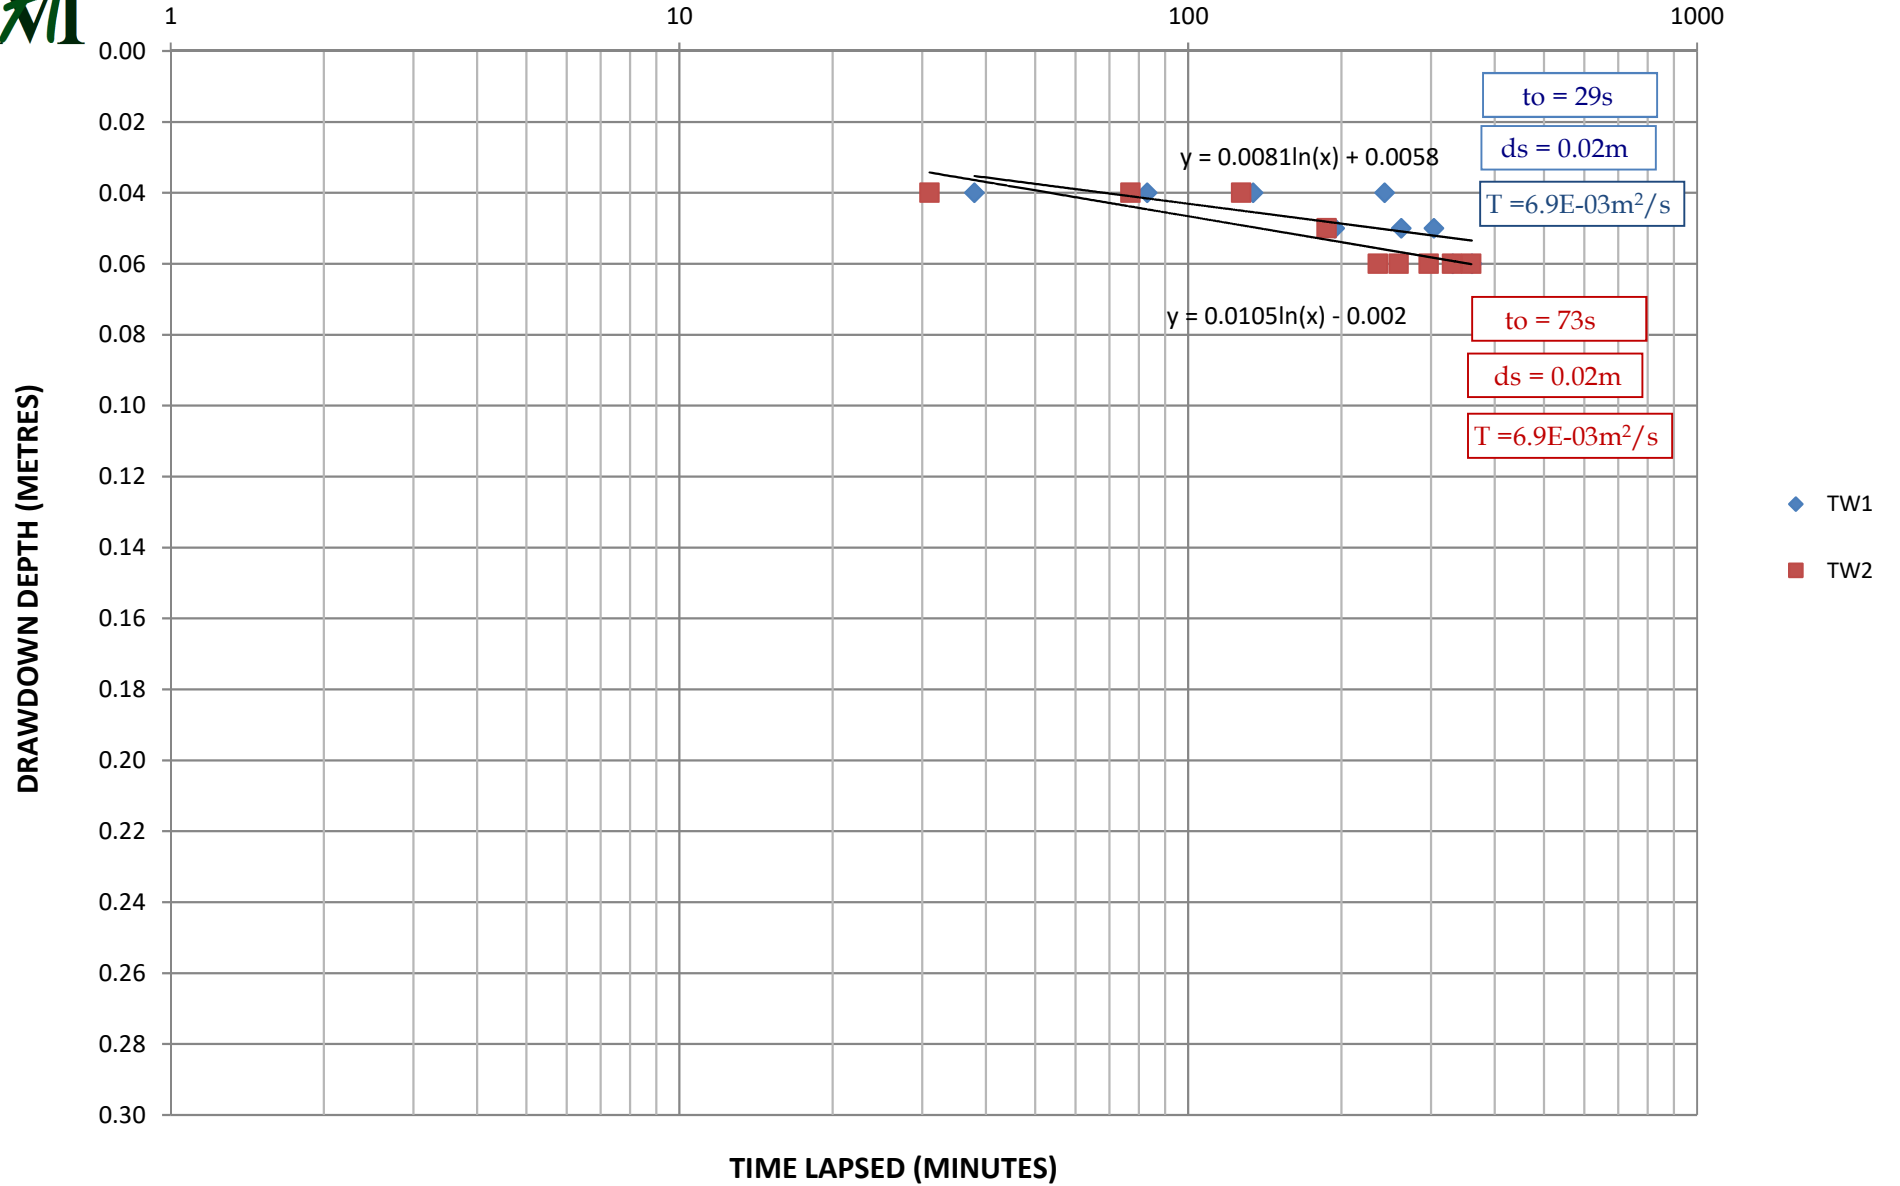
DRAWDOWN VS. TIME IN OBSERVATION WELLS (TW1 & TW2) DURING PUMPING TEST OF TW3
