## Geotechnical Investigation

Proposed Development  
936 March Road  
Ottawa, Ontario

November 28, 2018

Report: PG4554-1  
Revision 2

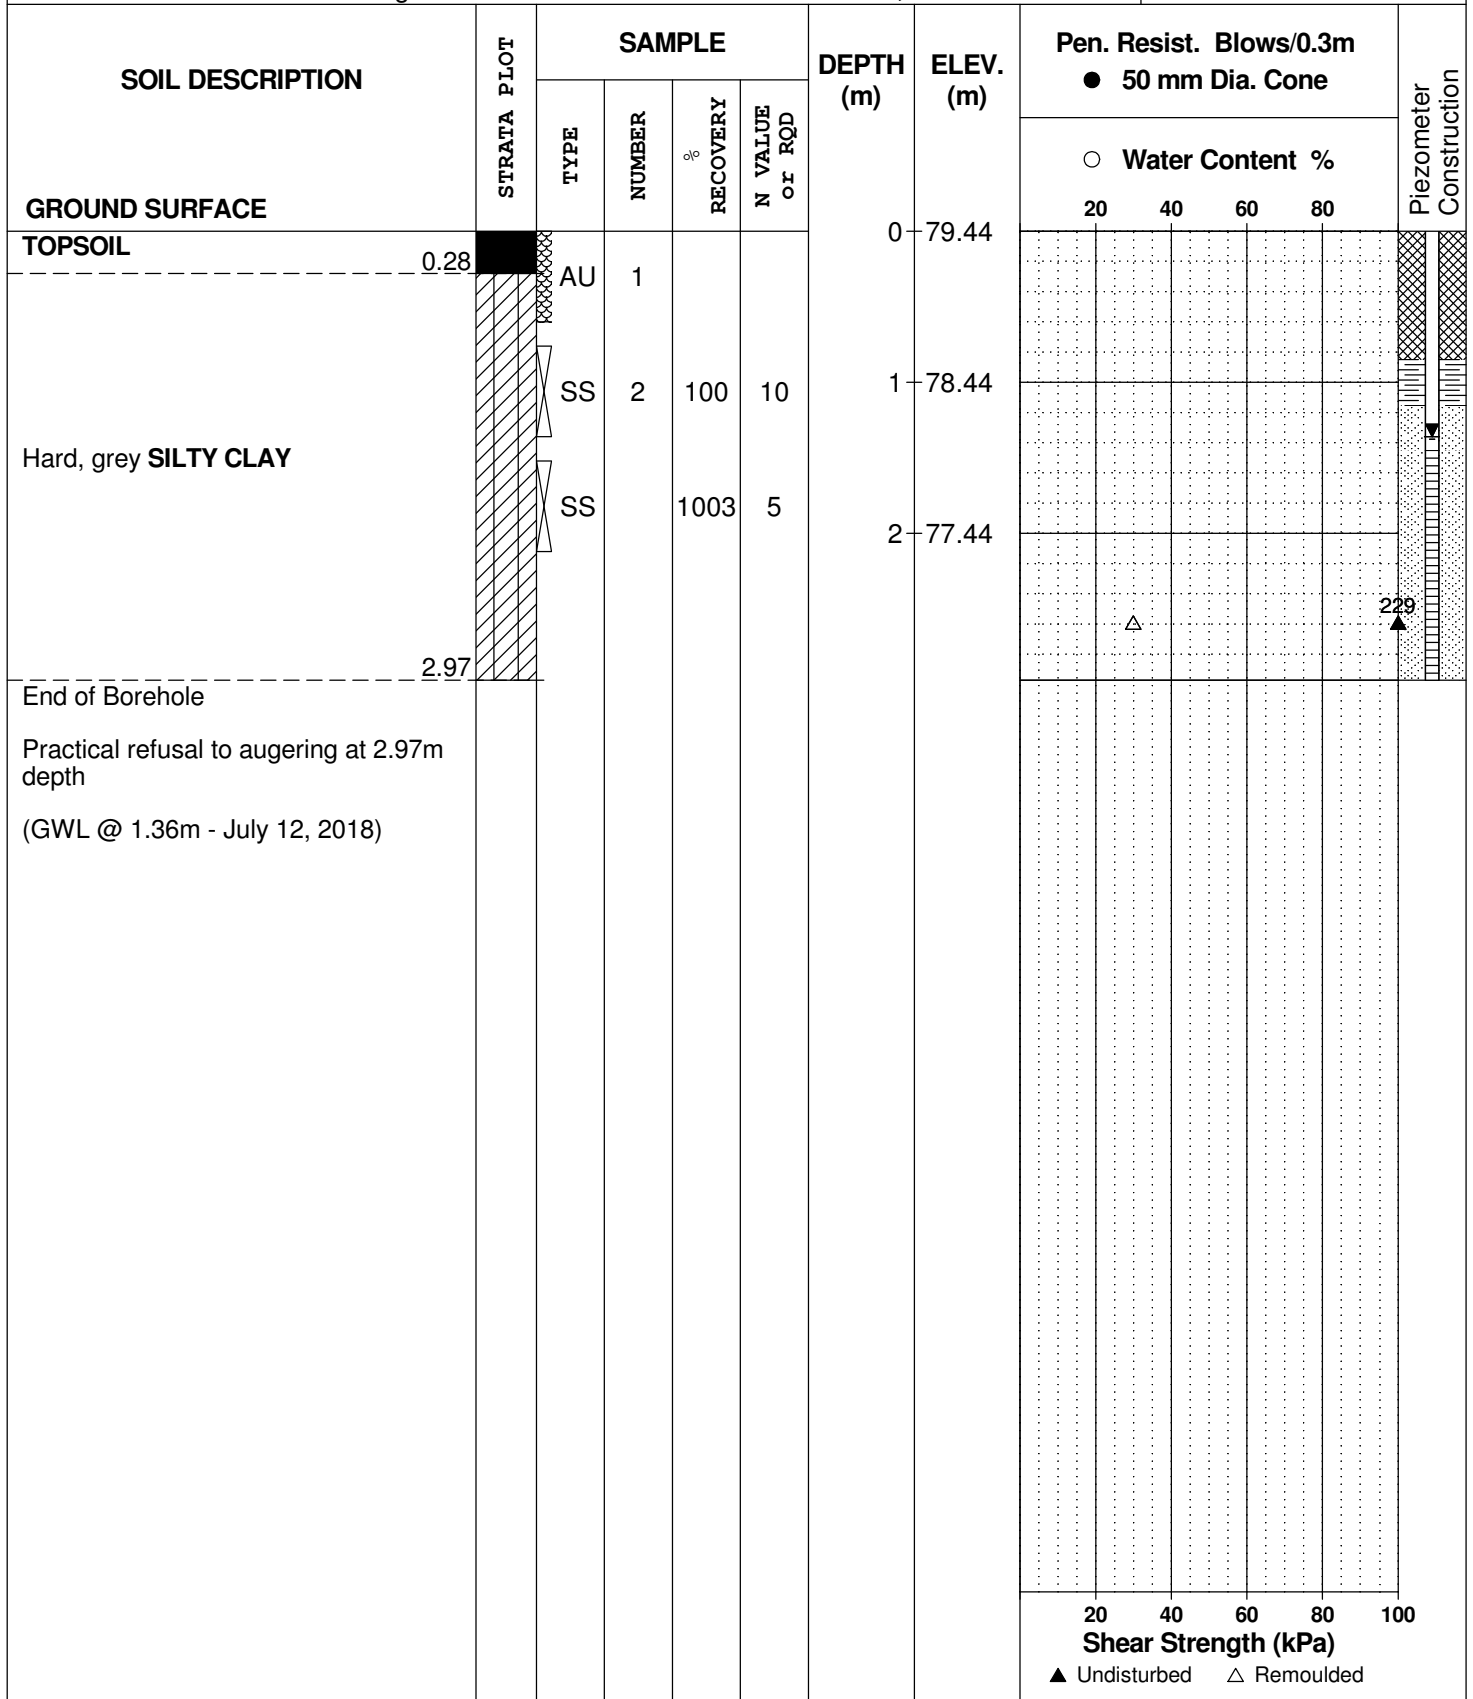
HOLE NO. **BH 1**

The subsurface conditions observed in the test holes were recorded in detail in the field. The soil profiles are presented on the Soil Profile and Test Data sheets in Appendix 1 of this report.

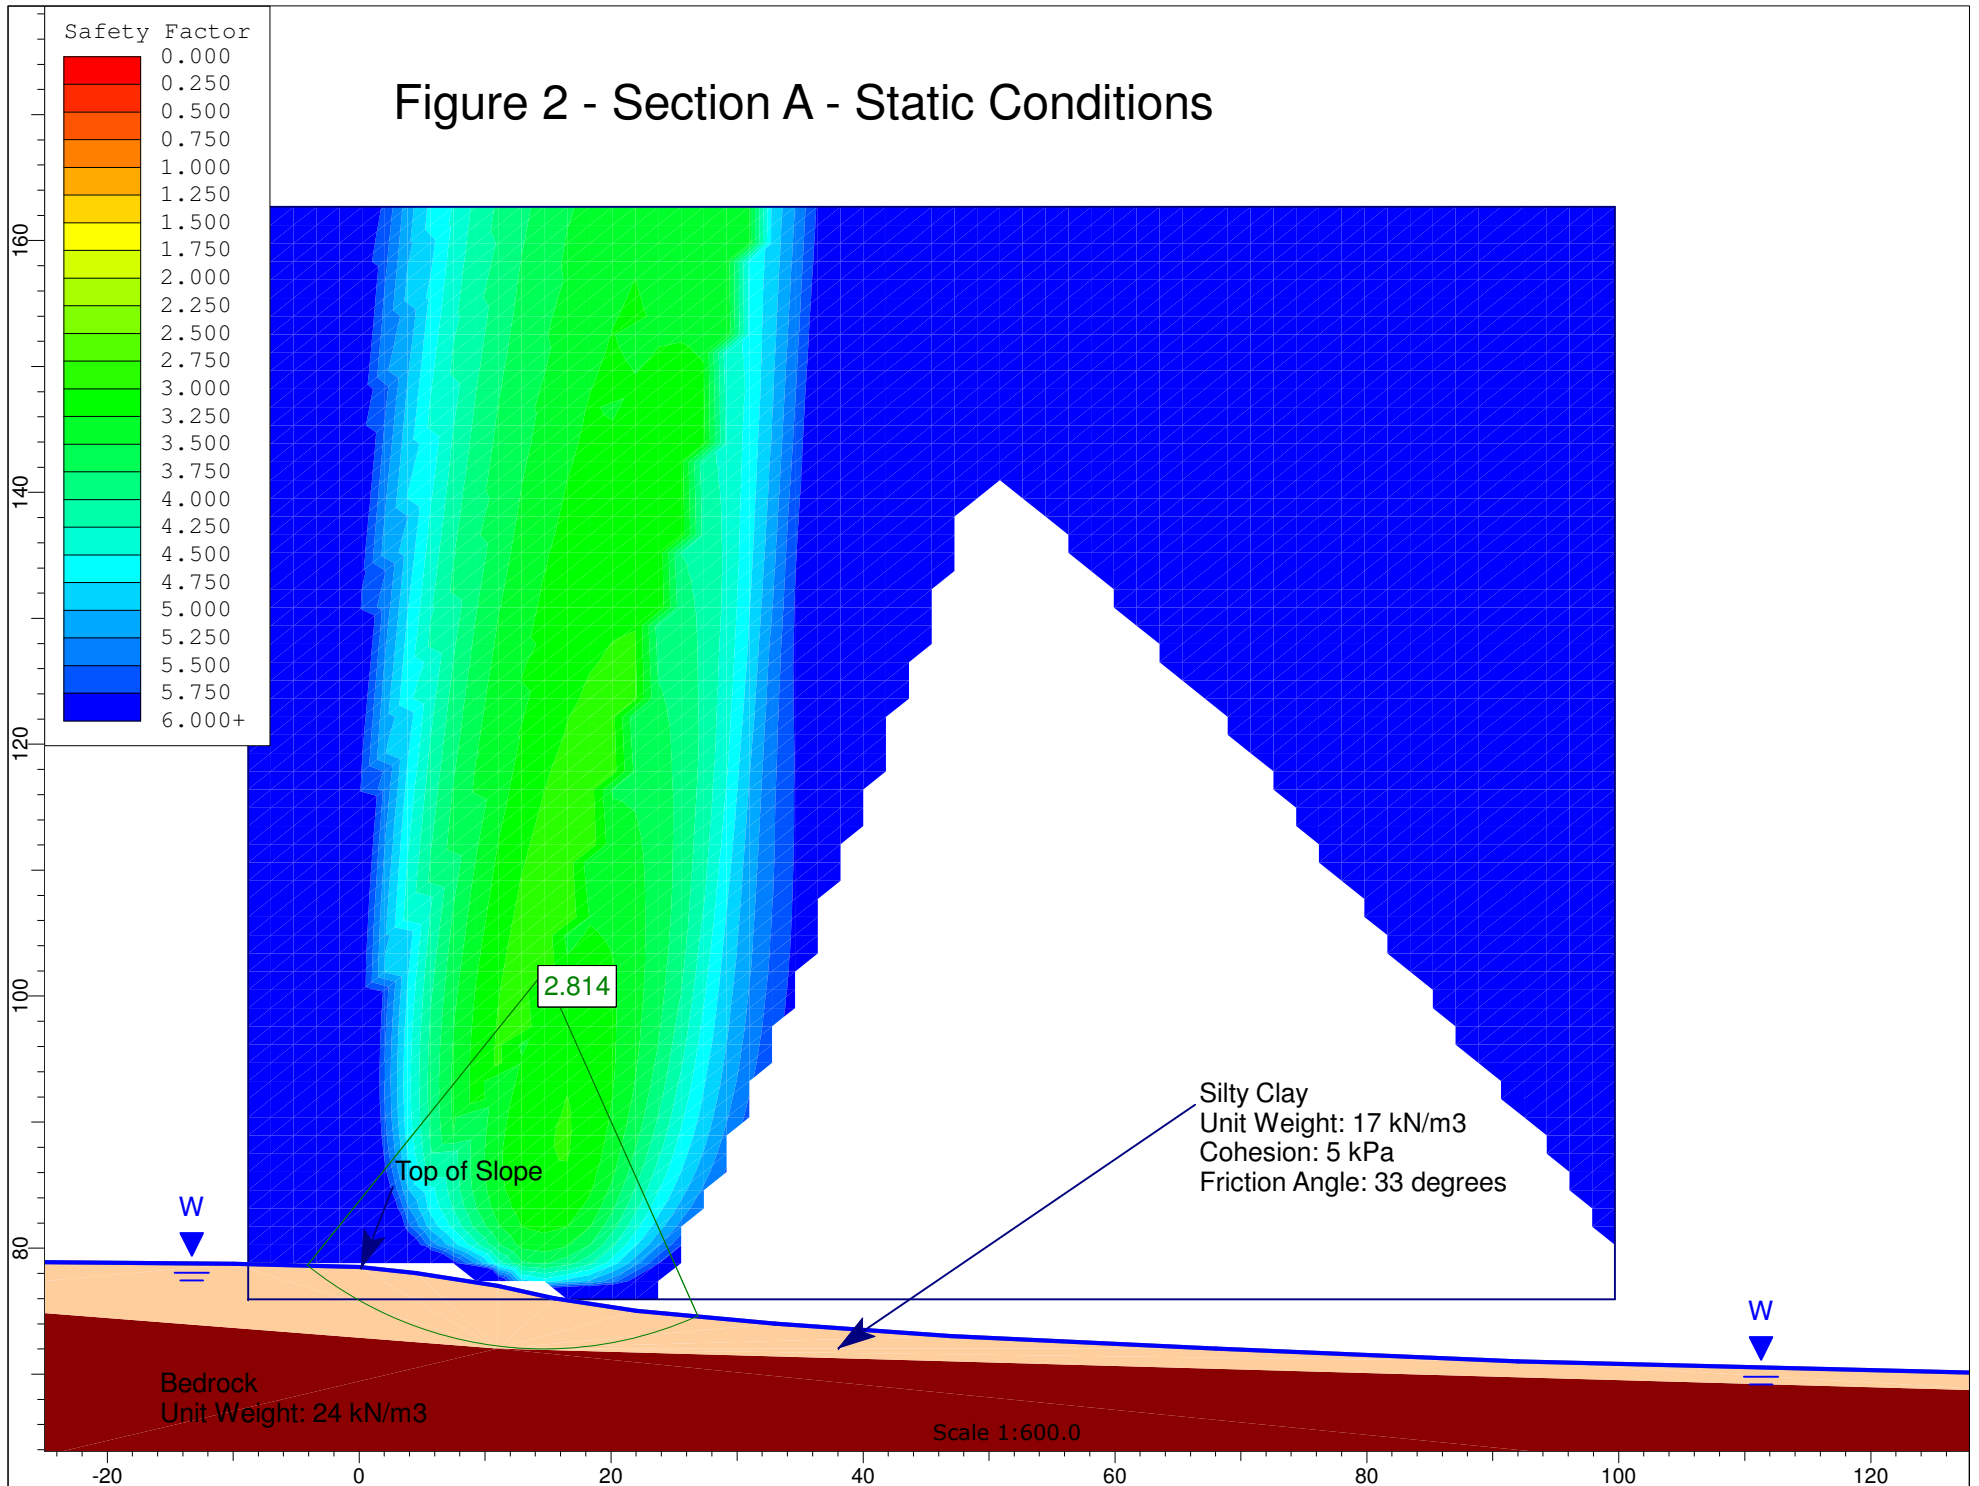
# Figure 2 - Section A - Static Conditions

The slope stability analysis was modeled in SLIDE, a computer program which permits a two-dimensional slope stability analysis calculating several methods including the Bishop's method, which is a widely accepted slope analysis method. The program calculates a factor of safety, which represents the ratio of the forces resisting failure to forces favoring failure. Theoretically, a factor of safety of 1.0 represents a condition where the slope is stable. However, due to intrinsic limitations of the calculation methods and the variability of the subsurface soil and groundwater conditions, a factor of safety greater than 1.0 is generally required for the failure risk to be considered acceptable. A minimum factor of safety of 1.5 is generally recommended for conditions where the slope failure would comprise permanent structures. An analysis considering seismic loading was also completed. A horizontal acceleration of 0.16 g was considered for the sections for the seismic loading condition. A factor of safety of 1.1 is considered to be satisfactory for stability analyses including seismic loading.

Four (4) slope cross-sections (Sections A, B, C, and D) were studied as the worst case scenarios. The cross section locations are presented on Drawing PG4554-1 - Test Hole Location Plan in Appendix 2. It should be noted that details of the slope height and slope angle at the cross-section locations are presented in Figures 2 through 9 in Appendix 2 from the topographic data identified on Drawing PG4554-1 - Test Hole Location Plan in Appendix 2.

For the approximately 6 m slope in the western portion of the site (Sections A and B), given that no watercourse is present near the toe of the slope and no signs of active erosion were observed, an erosion access allowance is not considered to be required for this slope.
