**McKINLEY**  
ENVIRONMENTAL  
SOLUTIONS

Combined Environmental Impact Statement &  
Tree Conservation Report  
Minto Communities and 2559688 Ontario Inc.  
Kanata North Development (936 March Road)

November 2018

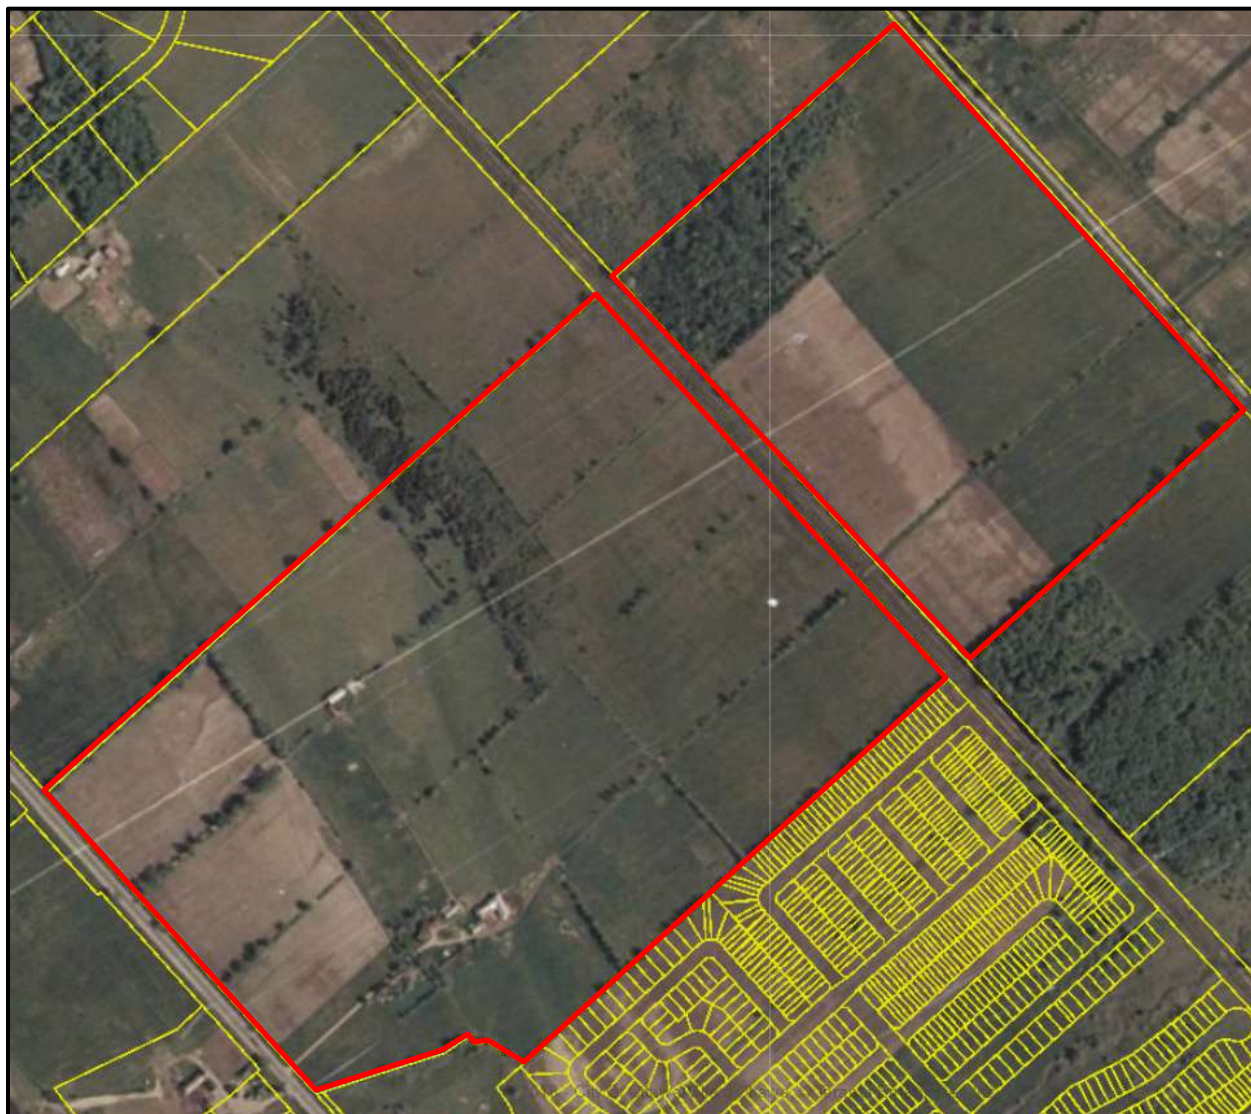
**Historic Air Photograph 1:** Historic Air Photo from 1976 (Study Area limits shown in red). Note the overall composition of the Study Area was similar in 1976, with most of the Study Area intensively farmed. The western portions of both Woodlot S-20 and Woodlot S-23 are present in 1976, however, the eastern portion of both features and the southern portion of Woodlot S-20 appear to be largely clear of tree cover. The Cultural Woodlot surrounding the farmhouse at 936 March Road is largely absent (Photos from City of Ottawa 2018).

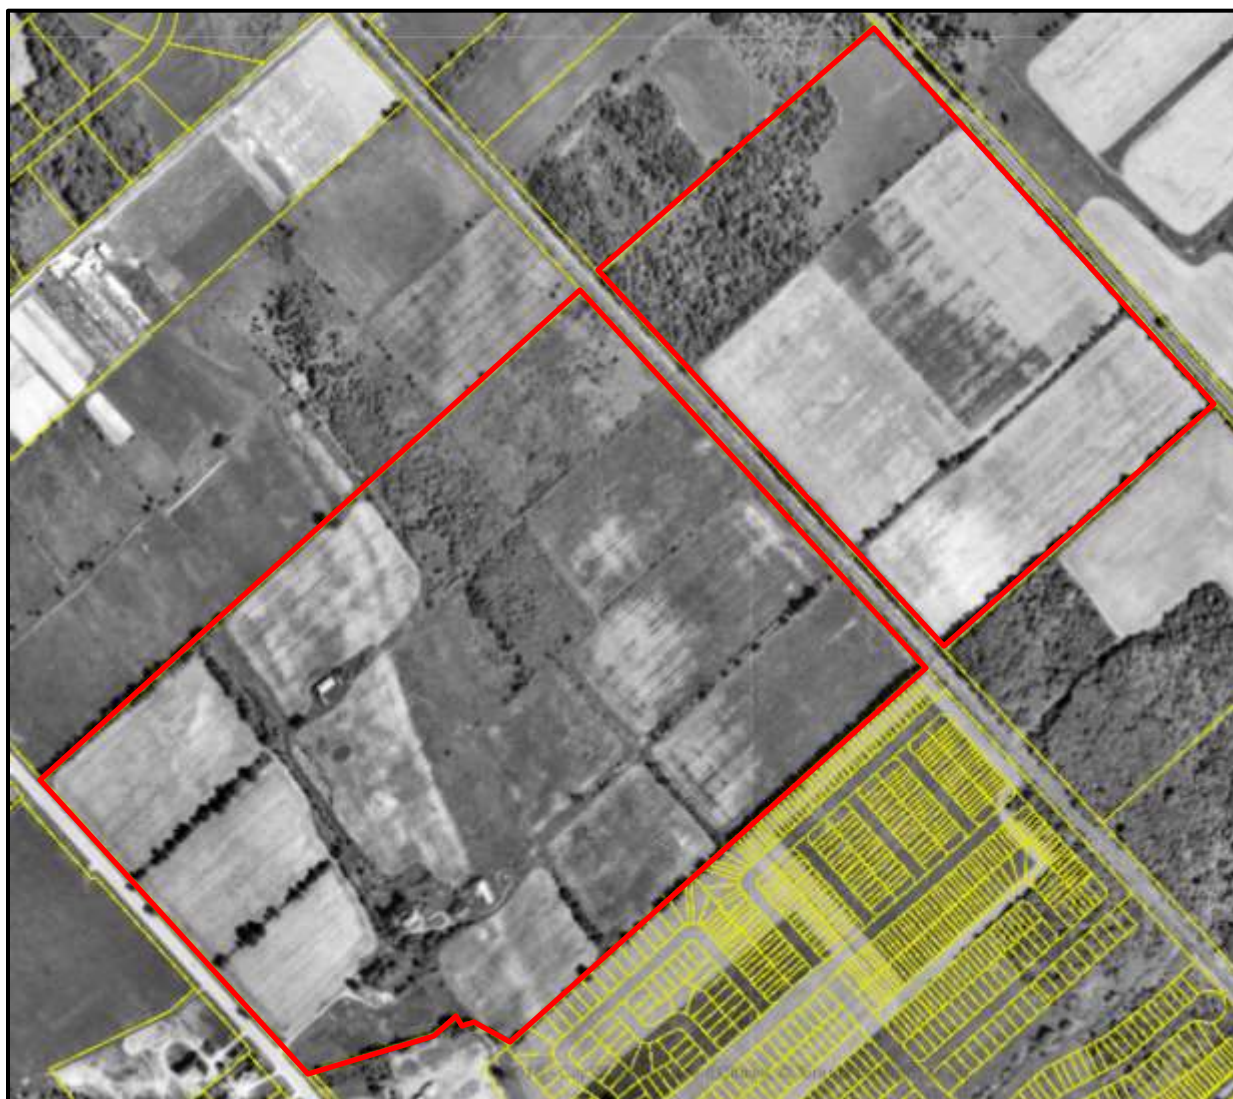
**Historic Air Photograph 2:** Historic Air Photo from 1991 (Study Area limits shown in red). Note the overall composition of the Study Area was similar in 1991, with most of the Study Area intensively farmed. The western portions of both Woodlot S-20 and Woodlot S-23 are present in 1991, however, the eastern portion of both features continues to be largely absent in 1991. The southern portion of Woodlot S-20 is also largely absent. The Cultural Woodlot surrounding the farmhouse at 936 March Road has expanded by 1991 (Photos from City of Ottawa 2018).

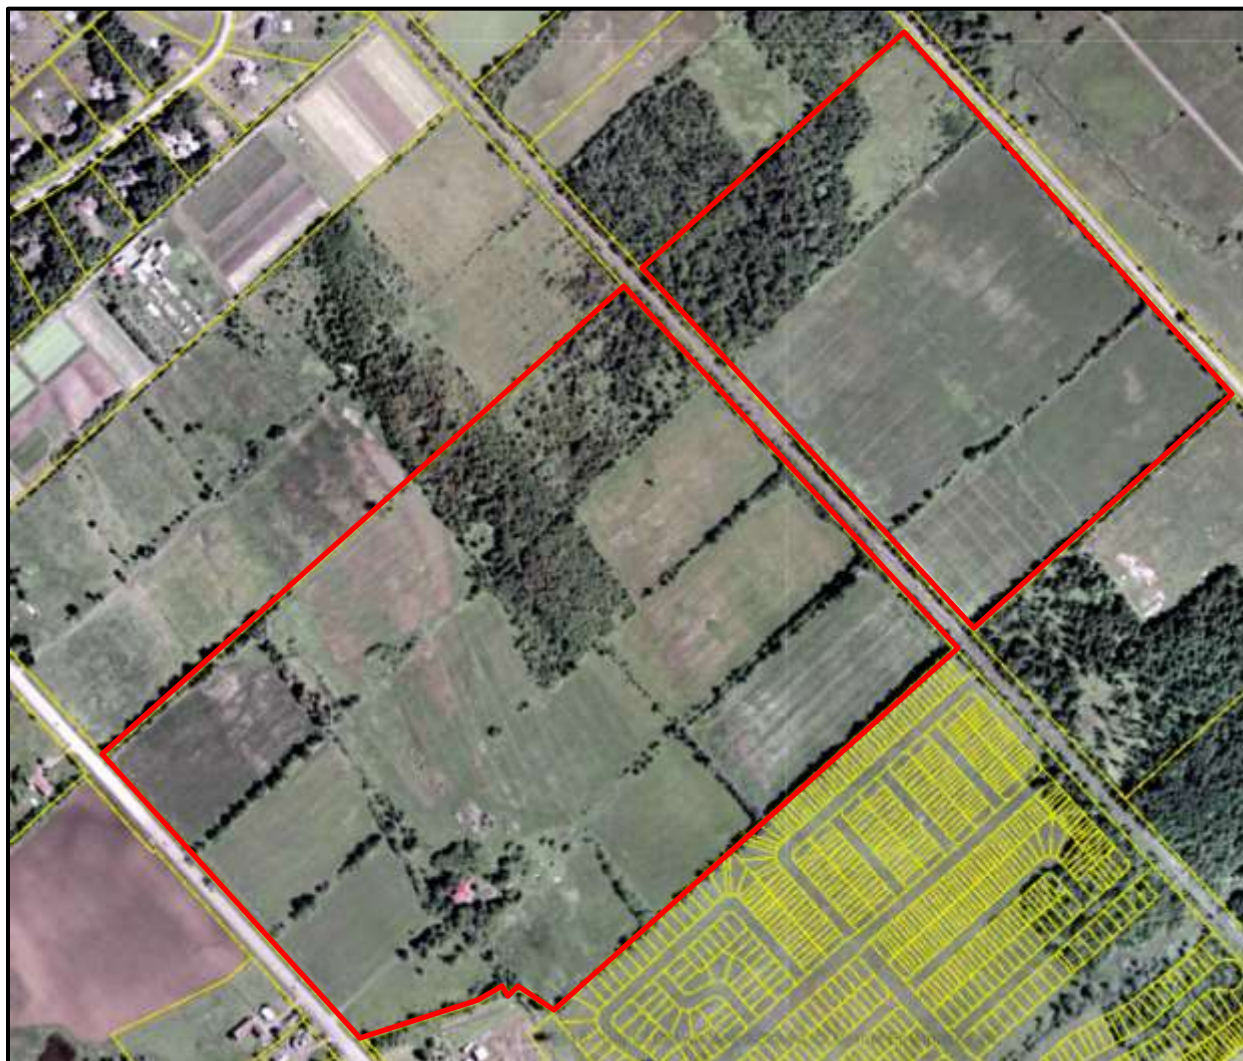
**Historic Air Photograph 3:** Historic Air Photo from 2005 (Study Area limits shown in red). Note the overall composition of the Study Area was similar in 2005, with most of the Study Area intensively farmed. The western portions of both Woodlot S-20 and Woodlot S-23 are present in 2005. By 2005, the eastern and southern portions of Woodlot S-20 are visibly regenerating. However, the area east of Woodlot S-23 remains largely clear of tree cover. The Cultural Woodlot surrounding the farmhouse at 936 March Road is similar to its current size in 2005 (Photos from City of Ottawa 2018).

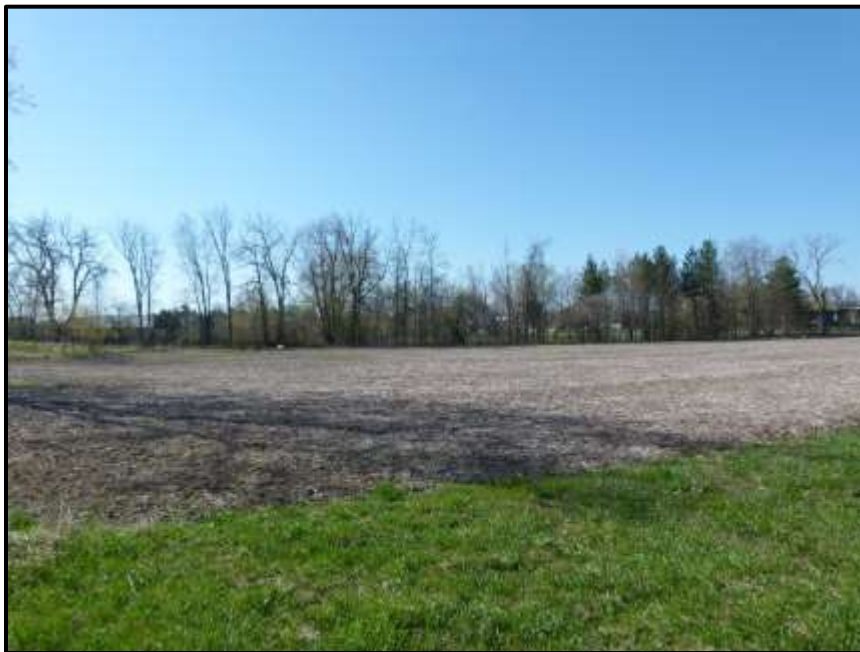
**Photograph 3:** Looking south at the Deciduous Hedgerow (Feature C), shown in center and left. The Coniferous Hedgerow (Feature B) is visible (at right) (May 8<sup>th</sup>, 2018).

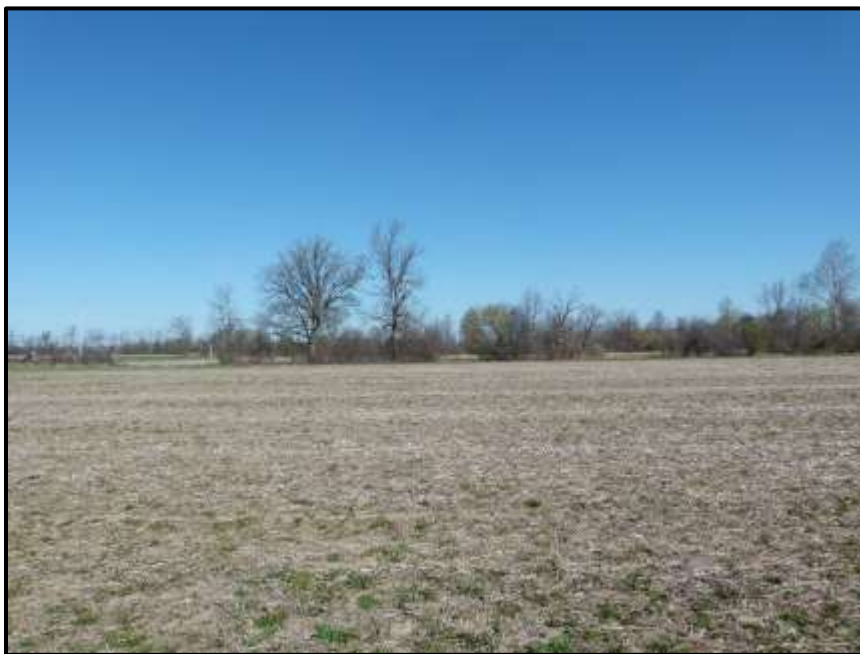
**Photograph 4:** Looking north at the Deciduous Hedgerow (Feature D). A 107 cm dbh Bur Oak and a 96 cm dbh White Ash are visible in the middle of the photograph (May 8<sup>th</sup>, 2018).

- **Deciduous Hedgerows C to F:** As noted above, White/Green Ash are the dominant trees within Deciduous Hedgerows C to F. Sugar Maple, Bur Oak, and Trembling Aspen are also well represented. Exceptionally large trees include a 107 cm dbh Bur Oak and a 96 cm dbh White Ash (declining) found within Deciduous Hedgerow F. Deciduous Hedgerow E also includes an 86 cm dbh Sugar Maple, a 91 cm dbh Sugar Maple, and a 96 cm dbh White Ash (declining).

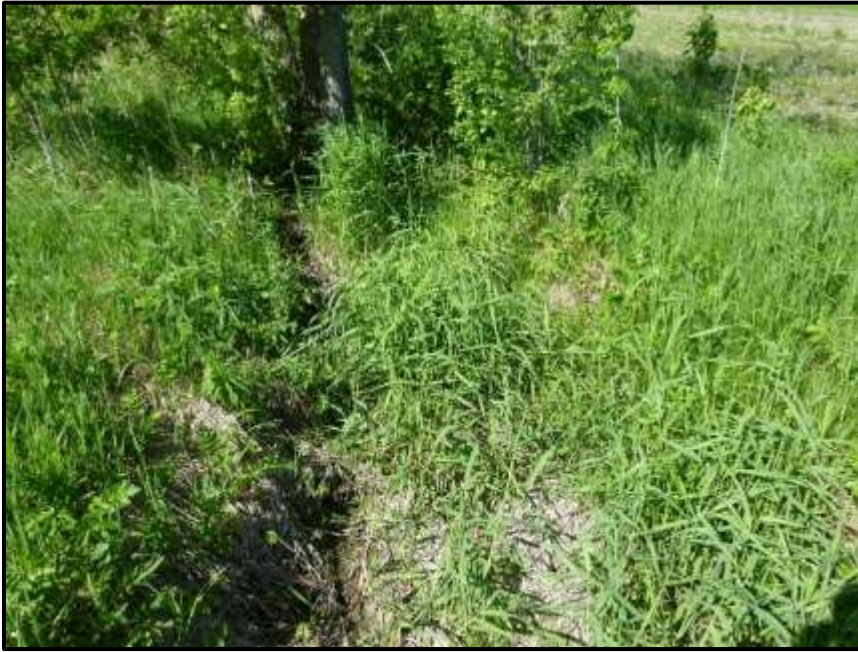
**Photograph 38:** Ephemeral Farm Drainage Channel in the southeastern part of the Study Area, east of the Former CN Railway Corridor. Note the channel is entirely dry by late May (May 29<sup>th</sup>, 2016).

All of the Ephemeral Farm Drainage Channels are fed by surface drainage from the surrounding fields, and none of these features include direct upstream connection to any adjacent watercourses. The Ephemeral Farm Drainage Channels generally have a limited hydro-period that is confined to the early spring and/or immediately following storm events, during which the drains are fed by surface runoff from the surrounding fields (MEP 2015). As a result, the Ephemeral Farm Drainage Channels are dry for the majority of the growing season. In 2018, all of these features were observed to be completely surface dry by early June. The features are generally overgrown with terrestrial vegetation throughout the majority of the growing season. Terrestrial vegetation coverage varies, but is essentially the same as the adjacent terrestrial vegetation communities within which the Ephemeral Farm Drainage Channels occur (e.g. Deciduous Hedgerows, Forest, and/or Fallow Agricultural Fields). As discussed below, fish habitat functionality was found to be very limited. Due to their limited hydro-period and general lack of aquatic habitat, the Ephemeral Farm Drainage Channels were not shown to provide Category 2 Blanding's Turtle habitat (DST 2015). The CDP and EMP did not recommend retention of any of the Ephemeral Farm Drainage Channels, unless those channels fall within other designated retained areas (e.g. the retained portion of Woodlot S-23). Overall, the Ephemeral Farm Drainage Channels are not considered significant ecological features. Refer to MEP (2015) for a discussion of management and mitigation recommendations for the Ephemeral Farm Drainage Channels.

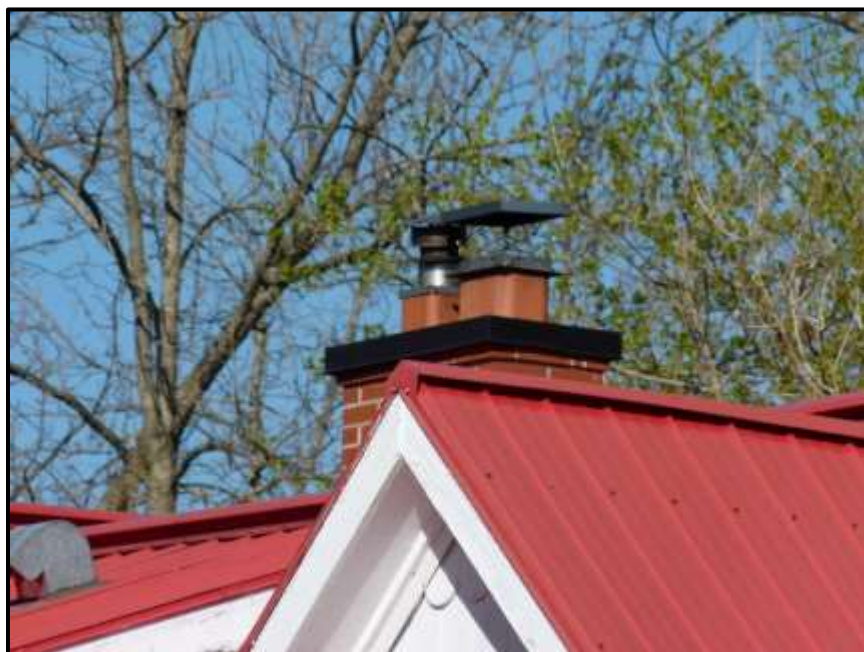
Photograph 42: The capped chimney on the farmhouse at 936 March Road (May 8<sup>th</sup>, 2018).

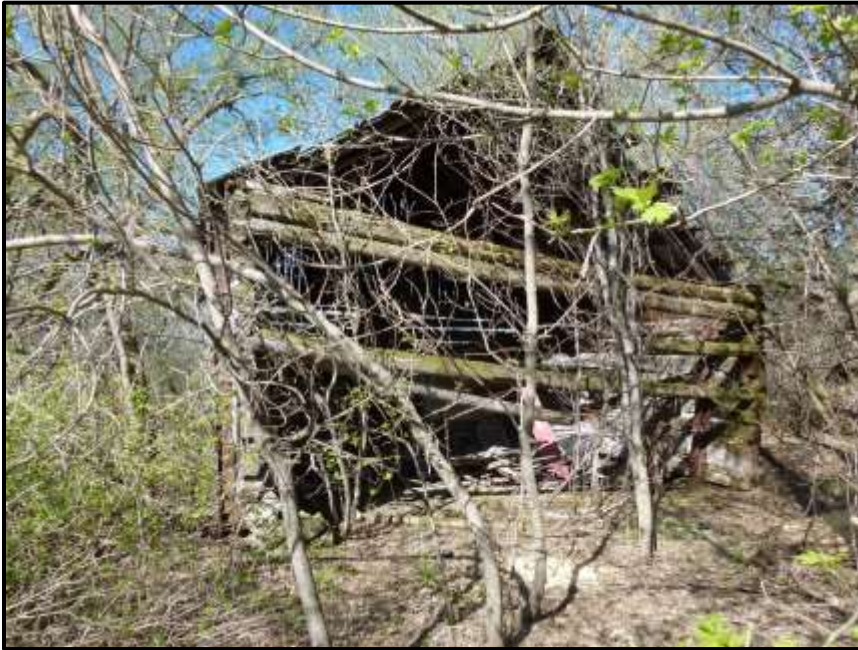
Photograph 47: Building #6 – Looking west at the collapsing barn (May 8<sup>th</sup>, 2018).
