Phase I-Environmental Site Assessment

936 March Road
Ottawa, Ontario

Minto Communities
and 2559688 Ontario Inc.

Report: PE4343-1

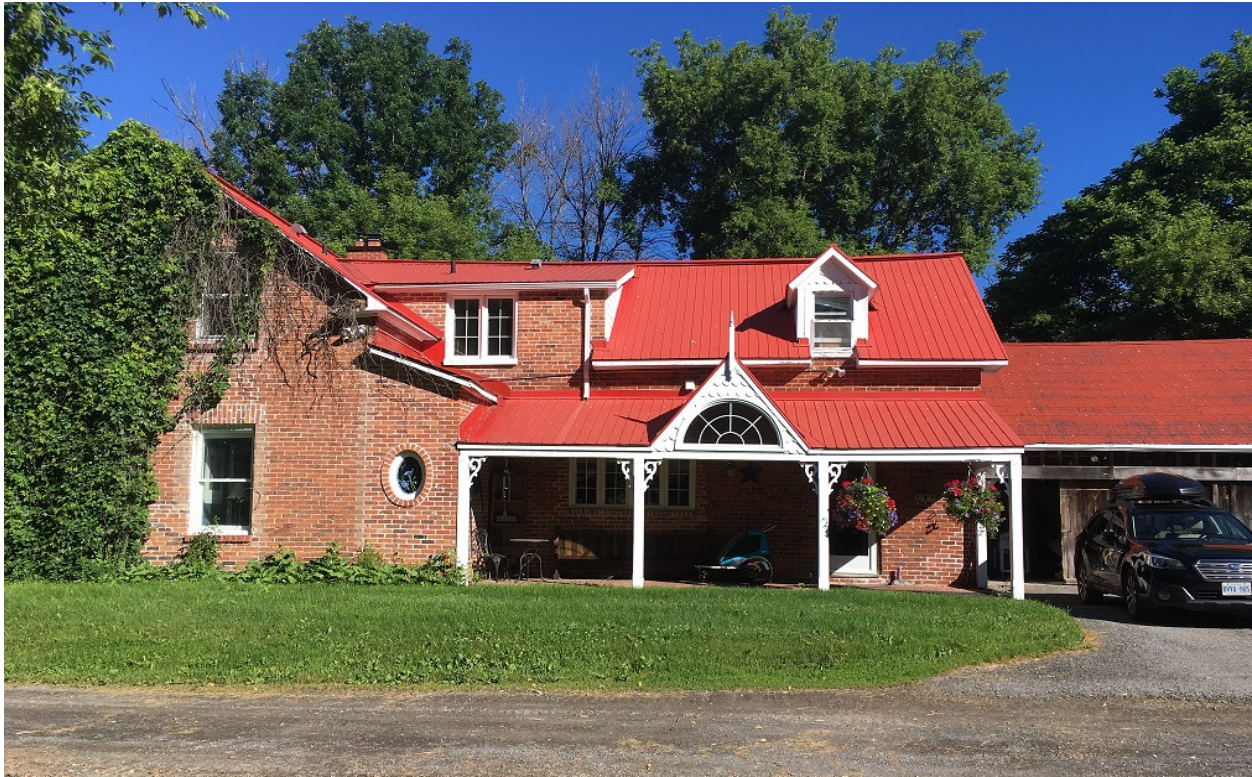
The Phase I Property is occupied by a two-storey residential dwelling with a basement level, a private garage and two (2) outbuildings associated with the original farmstead. The dwelling, reportedly constructed in the late 1800's, has a stone and mortar foundation and is finished on the exterior with red brick and a metal roof.

Photograph 1: Photograph illustrates residential dwelling and private garage, facing north.

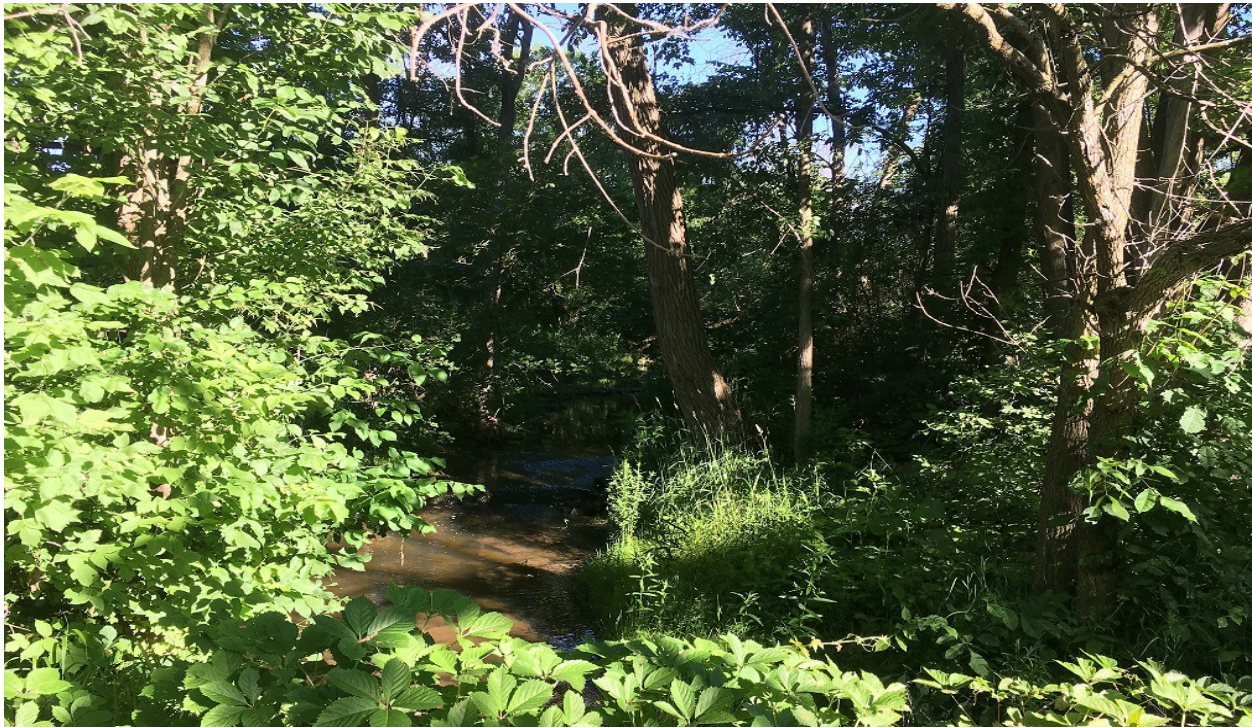
A slope, approximately 6m high, runs in a north-south direction within the western portion of the subject site, sloping downward to the east. The slope was noted to be stable and shaped to an approximate 8H:1V slope or less. Overall, the ground surface across the subject site slopes downward from southwest to northeast from an elevation of approximately 80m above sea level (asl) to an elevation of approximately 65m asl. Site drainage consists of surficial infiltration and sheet flow to onsite drainage ditches and Shirley's Brook.

Photograph 2: Photograph illustrates Shirley's Brook on western portion of Phase I Property, facing northwest.

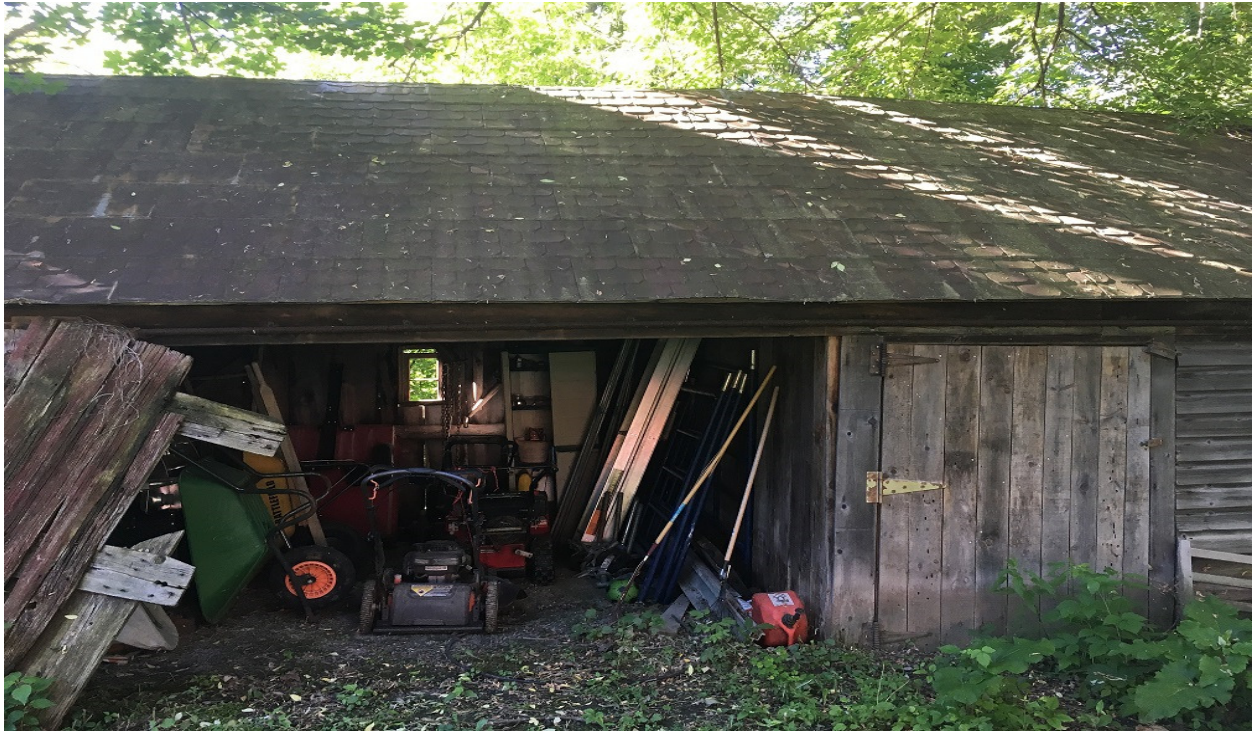
Photograph 3: Photograph illustrates former farm building east of residential dwelling, facing east.

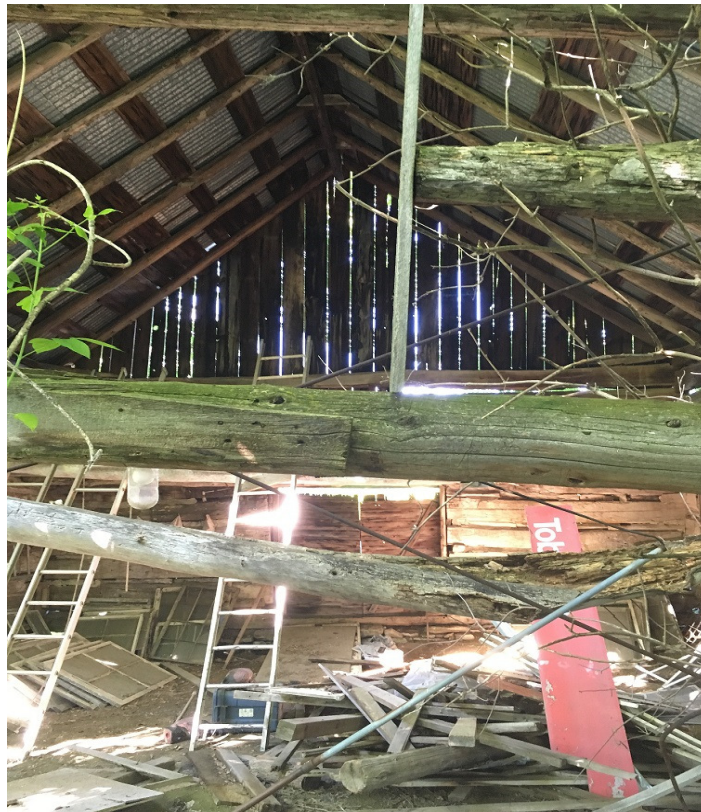
Photograph 4: Photograph illustrates former farm building southeast of residential dwelling, facing west.

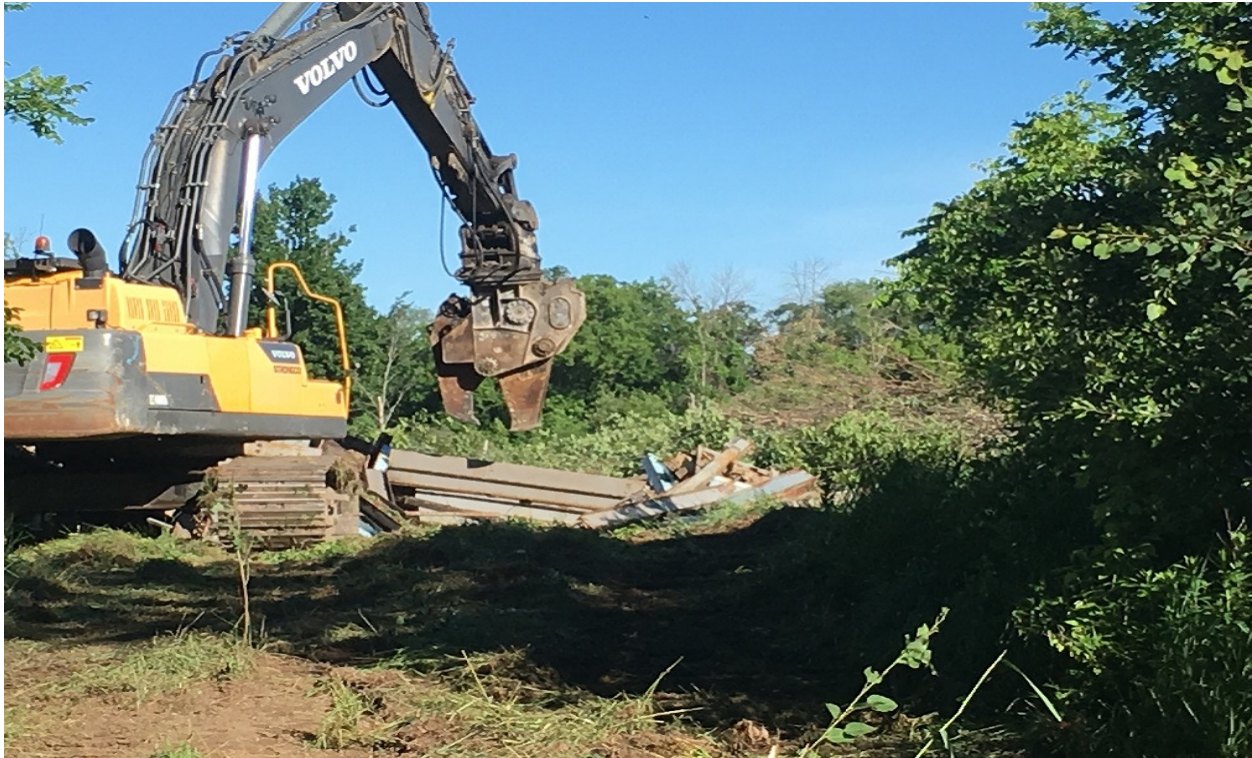
Other waste materials observed on site include defunct construction equipment, wooden job shacks and scrap metal. The aforementioned waste materials were stored further to the northeast and east of the residential dwelling and outbuildings. Fuller Construction was in the process of removing the waste at the time of the site visit. As noted in the aerial photograph review, a former barn structure was present further north of the residential dwelling. Stored items adjacent to the barn were unidentifiable from the photograph and considered to have included farm implements. The barn structure was no longer present at the time of the site visit and previously stored items appeared to have been removed based on soil disturbances noted at the time of the site visit.

Photograph 5: Photograph illustrates removal of scrap metal northeast of residential dwelling, facing north.

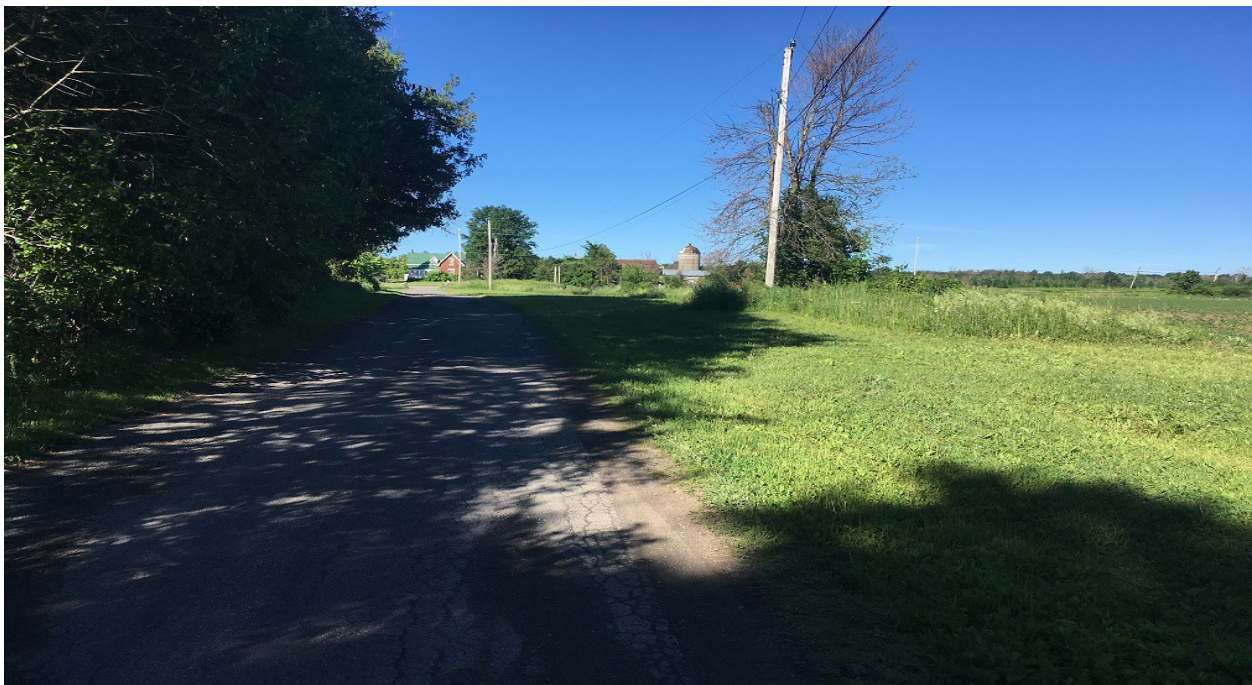
Photograph 6: View of western-central portion of Phase I Property, facing west. Photograph illustrates access laneway, soy fields and residential farmstead across March Road.

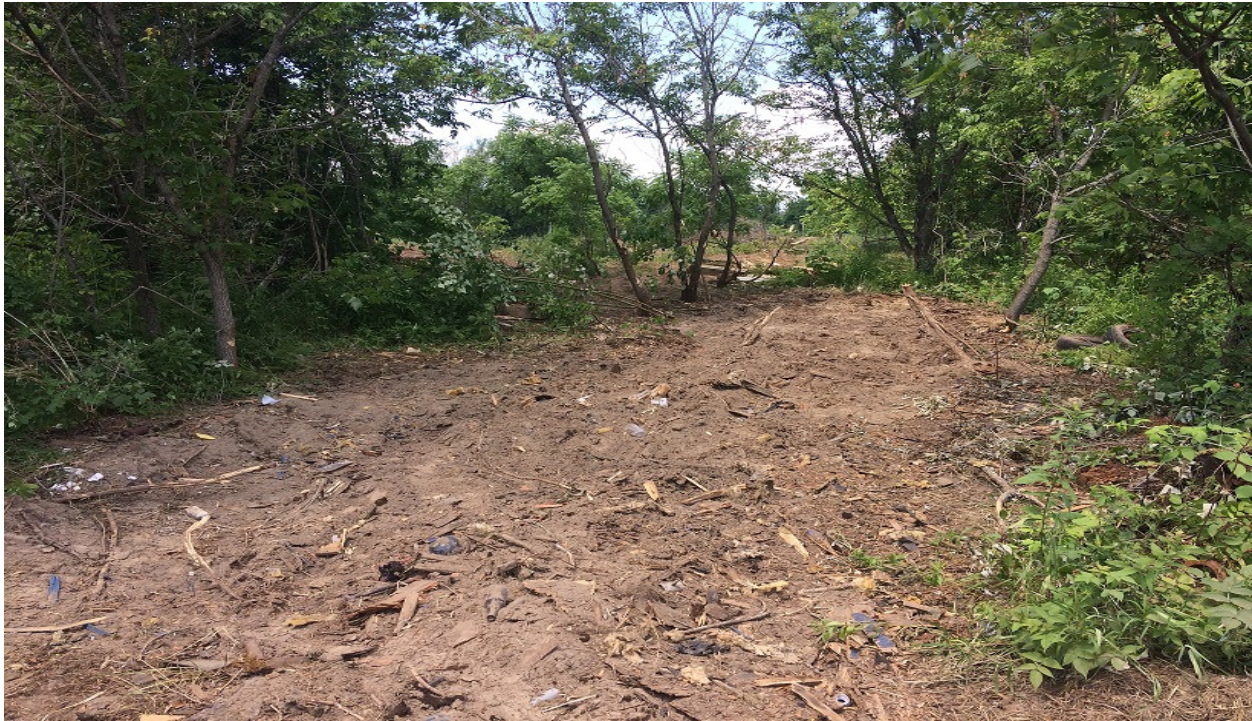
Photograph 7: Photo illustrates area of former stored scrap metal east of residential dwelling, facing north.

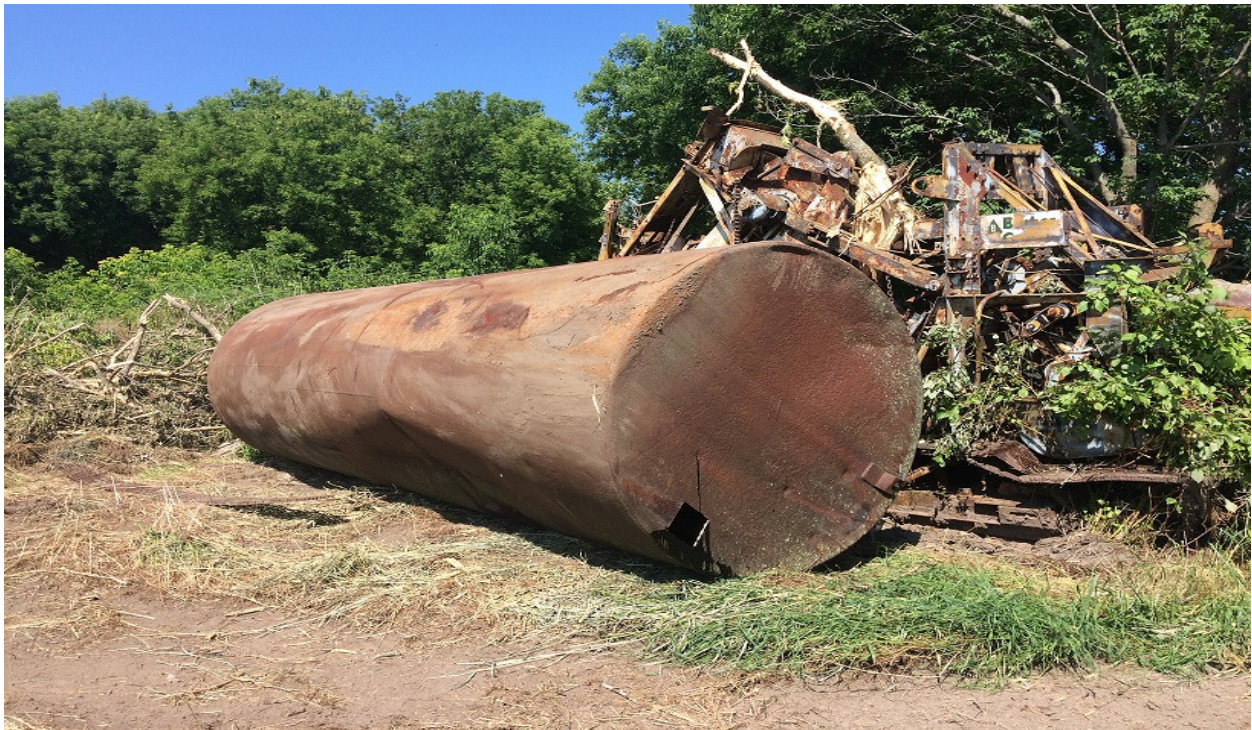
An empty aboveground fuel storage tank (AST) was observed to the further to the east of the residential dwelling at the time of the site assessment. No tag information was noted on the AST, which was approximately 5,000L in volume and in fair condition at the time of the site visit.

Based on the apparent age, condition and location of the AST, the tank is considered to have been empty when placed on the Phase I Property by Fuller Construction and not used on the Phase I Property for the storage of fuel. The tank appears to have been recently moved from a nearby grove of trees; a hole observed in the tank, is considered to have occurred during the moving of the AST. No signs of leakage or staining were noted on the AST or on the ground surface in the vicinity of the ASTs original or current location.

Photograph 8: Photograph illustrates unused AST and equipment southeast of residential dwelling, facing northwest.
