**Environmental Impact Statement  
3809 Borrisokane Rd.**

**Initial Report**

**December 21, 2018**

**KILGOUR & ASSOCIATES LTD.**  
www.kilgourassociates.com  
Project Number: CAIV836

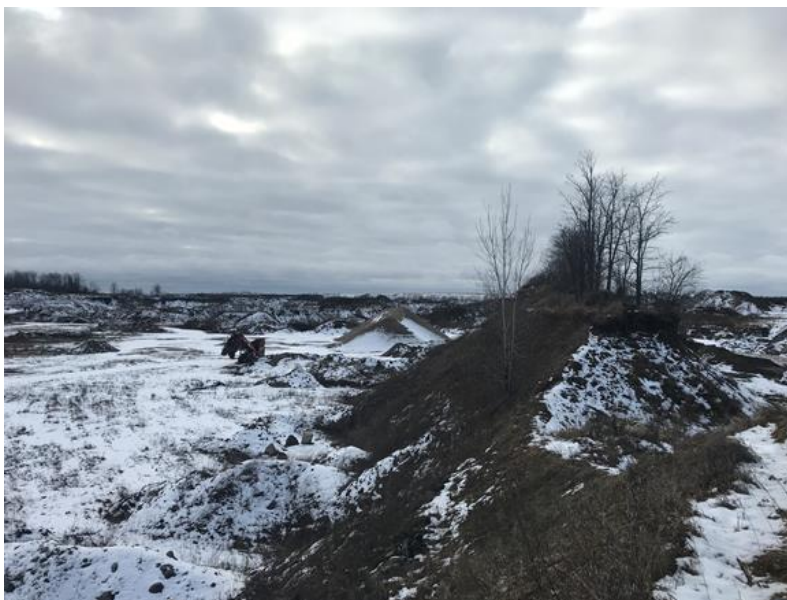
**Figure 1. Site on Nov. 29, 2018**

There are no surface water features on site. No ditches or other channelized water features cross the site or run along or near its perimeter. The 2017 air photo for the site suggests some water may have collected in low lying areas of the property in the past, though subsequent site(re) grading appears to have eliminated any potential wet pockets. There was no evidence of water collecting on site during a site visit by KAL biologist Rob Hallett on November 29, 2018 despite significant rainfall in the preceding days (Figure 1).

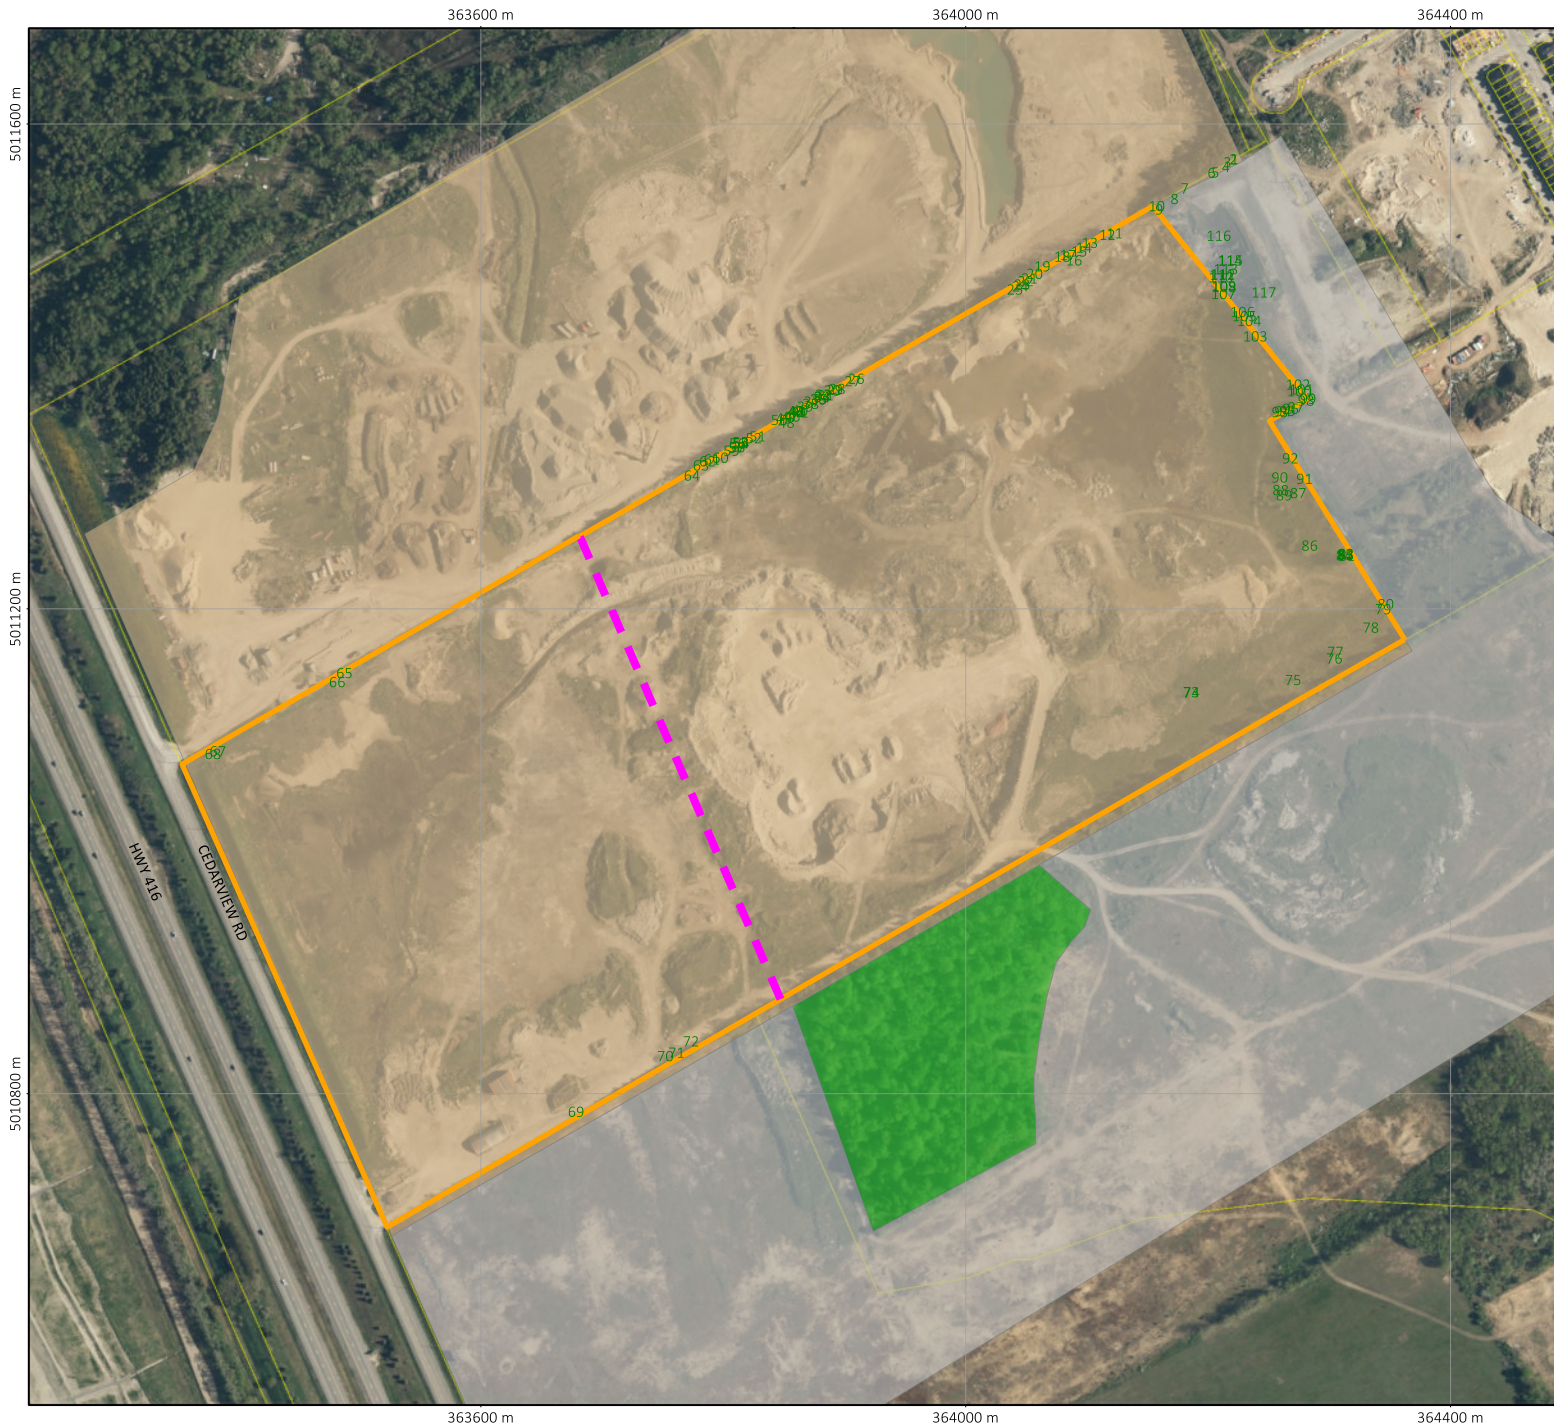
**Figure 2** Existing site conditions

Site land cover is mapped in Figure 2. The entire site has been excavated, leaving only narrow bands of trees along the site periphery. These hedgerows were generally left perched on tall ridges of leftover material. The site originally consisted of sand and gravel soils - Uplands and Mille-Isles formations in the west (strongly acid fine to coarse sand with limited fine gravel), to a Kars formation in the east (slightly acid to neutral, gravelly and cobbly coarse to moderately coarse textures glaciofluvial materials with a surface generally worked into beach deposits) (Marshall et al. 1979). Remnant piles of this material are scattered about the site. The site was active until recently. As such these piles are considered very unlikely to have had time to have become useful as habitat features.

The deciduous woodlot to the south of the site a 3.8 ha Dry – Fresh Sugar Maple Forest (FOD5). Large Sugar Maples with diameters of 45cm or larger dominate the upper canopy cover although they are fairly spaced out within the lot. The understory is almost entirely sugar maples smaller than 10cm DBH though some small basswoods occur near the edges of the feature. It appears as if this woodlot was previously managed as a maple sugar bush with trees being removed to facilitate the growth of the larger sugar maples. The larger maples show some signs of crown and branch dieback and many of them have significant cavities as a result.

Trees located along the north and south side of the property are perched somewhat precariously along the raised edges of the site. Many tree previously occurring there have already toppled over into the former pit area. While remaining individual trees provide some shading and possible nesting space for local fauna, this functionality is likely very limited. As a row, they do not lead to any other natural features cannot provide service as a corridor. All trees on site will be removed as the area is rehabilitated

As per standard tree protection measures indicated in Section 6.2, construction fencing should be run along the south edge of the site between planned construction work and the FOD5 woodlot (outside of the CRZ of trees therein) during the development period to prevent intrusion into that feature. As no other significant natural features occur on site or within 120 m of the site, no other specific mitigations are required.
