**Environmental Impact Statement
3809 Borrisokane Rd.**

Full Report

August 1, 2019

KILGOUR & ASSOCIATES LTD.
www.kilgourassociates.com
Project Number: CAIV836

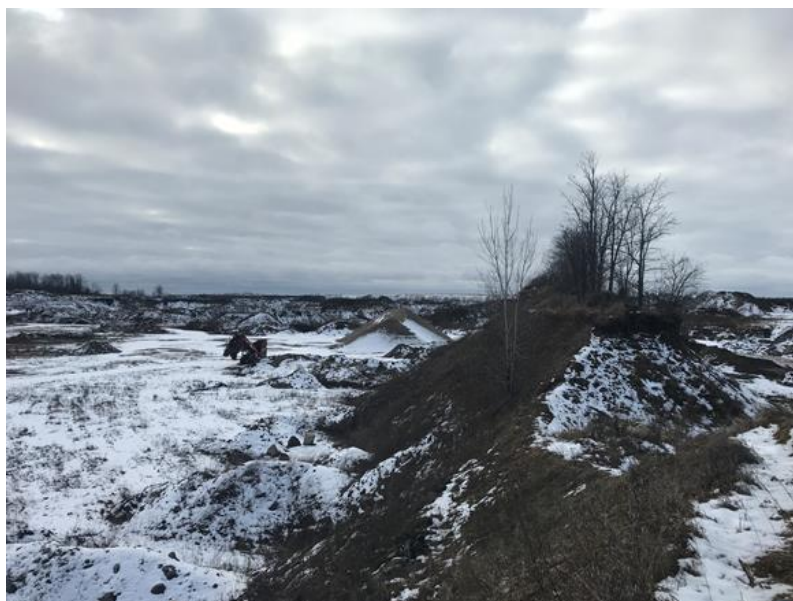
Figure 1. Proposed development area on Nov. 29, 2018

There are no surface water features on the site. No ditches or other channelized water features cross the site or run along or near its perimeter. The 2017 air photo for the site suggests some water may have collected in low lying areas of the property in the past, though subsequent site (re)grading appears to have eliminated any potential wet pockets. There was no evidence of water collecting on site during a site visit by KAL Biologist, Rob Hallett, on November 29, 2018 despite significant rainfall in the preceding days (Figure 1). Similarly, no water features were observed on site during any of the bird surveys conducted in June and July of 2019.

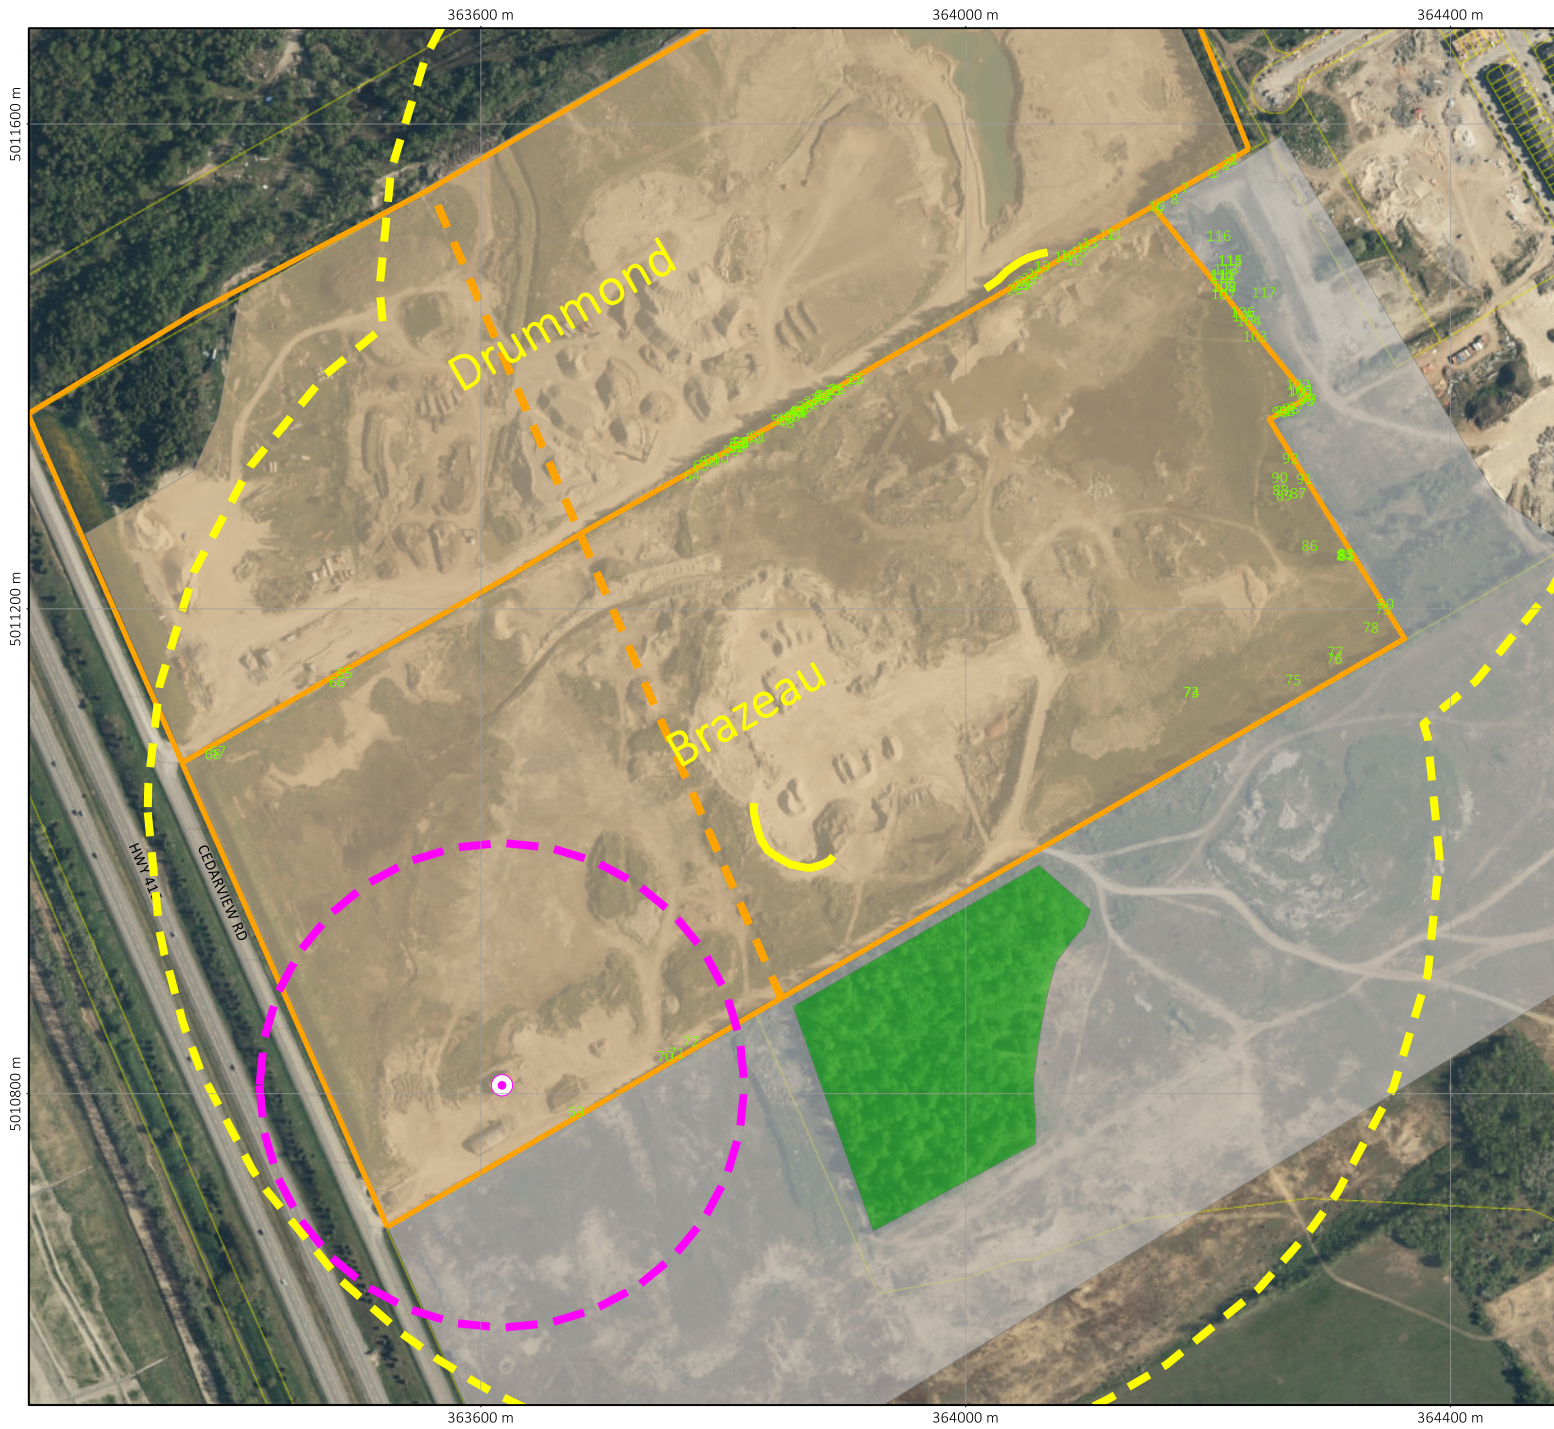
Figure 2 Existing site conditions

Area land cover is mapped in Figure 2. The entire Brazeau property has been worked over the years, leaving only narrow bands of trees along property periphery. These hedgerows were generally left perched on tall ridges of “leftover” material. The entire area originally consisted of sand and gravel soils - Uplands and Mille-Isles formations in the west (strongly acid fine to coarse sand with limited fine gravel), to a Kars formation in the east (slightly acid to neutral, gravelly and cobbly coarse to moderately coarse textures glaciofluvial materials with a surface generally worked into beach deposits; Marshall et al. 1979). Remnant piles of this material are scattered about the site. These piles are considered very unlikely to have had time to become useful as habitat features (particularly for cliff or bank-nesting bird species); the slopes generally have less than 70% grades. Several vertically cut sand faces do occur in the central portion of the site, however, and these provide some suitability for cliff and/or bank-nesting bird species. The entire site is covered in a combination of bare sand/gravel with sparse patches of grasses and common forbs.

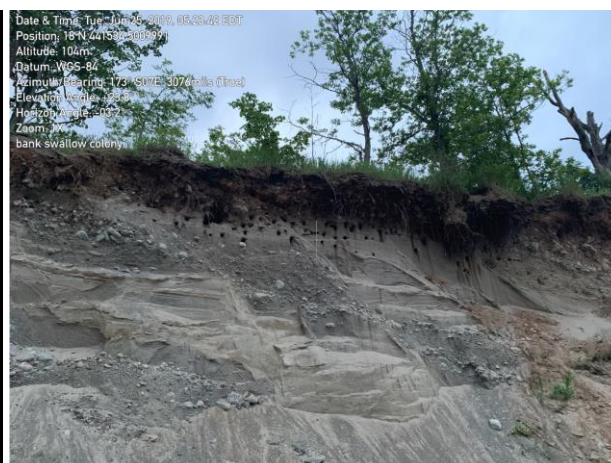
Figure 4. Bank Swallow nesting site.

Two Bank Swallows (listed as Threatened under the ESA) were noted flying over the site during the first survey, though neither appeared to be using the Brazeau property. From the ridge along the north side, however, more Bank Swallows were observed above the Drummond Sandpit. CBDC obtained permission for KAL Biologists to access the Drummond site on the second survey. During the second survey on June 25th, Rob Hallett found a Bank Swallow colony in a vertical sandbank on that site, near the property line with the Brazeau site (Figure 2). The colony (Figure 4) is not located on the Brazeau site though the associated feeding habitat for the species, which is considered to be the area extending out 500 m from a nest colony, does include the subject property. By the time of the third survey, Bank Swallows had established a secondary colony on a vertical sand face in the center of the Brazeau site.

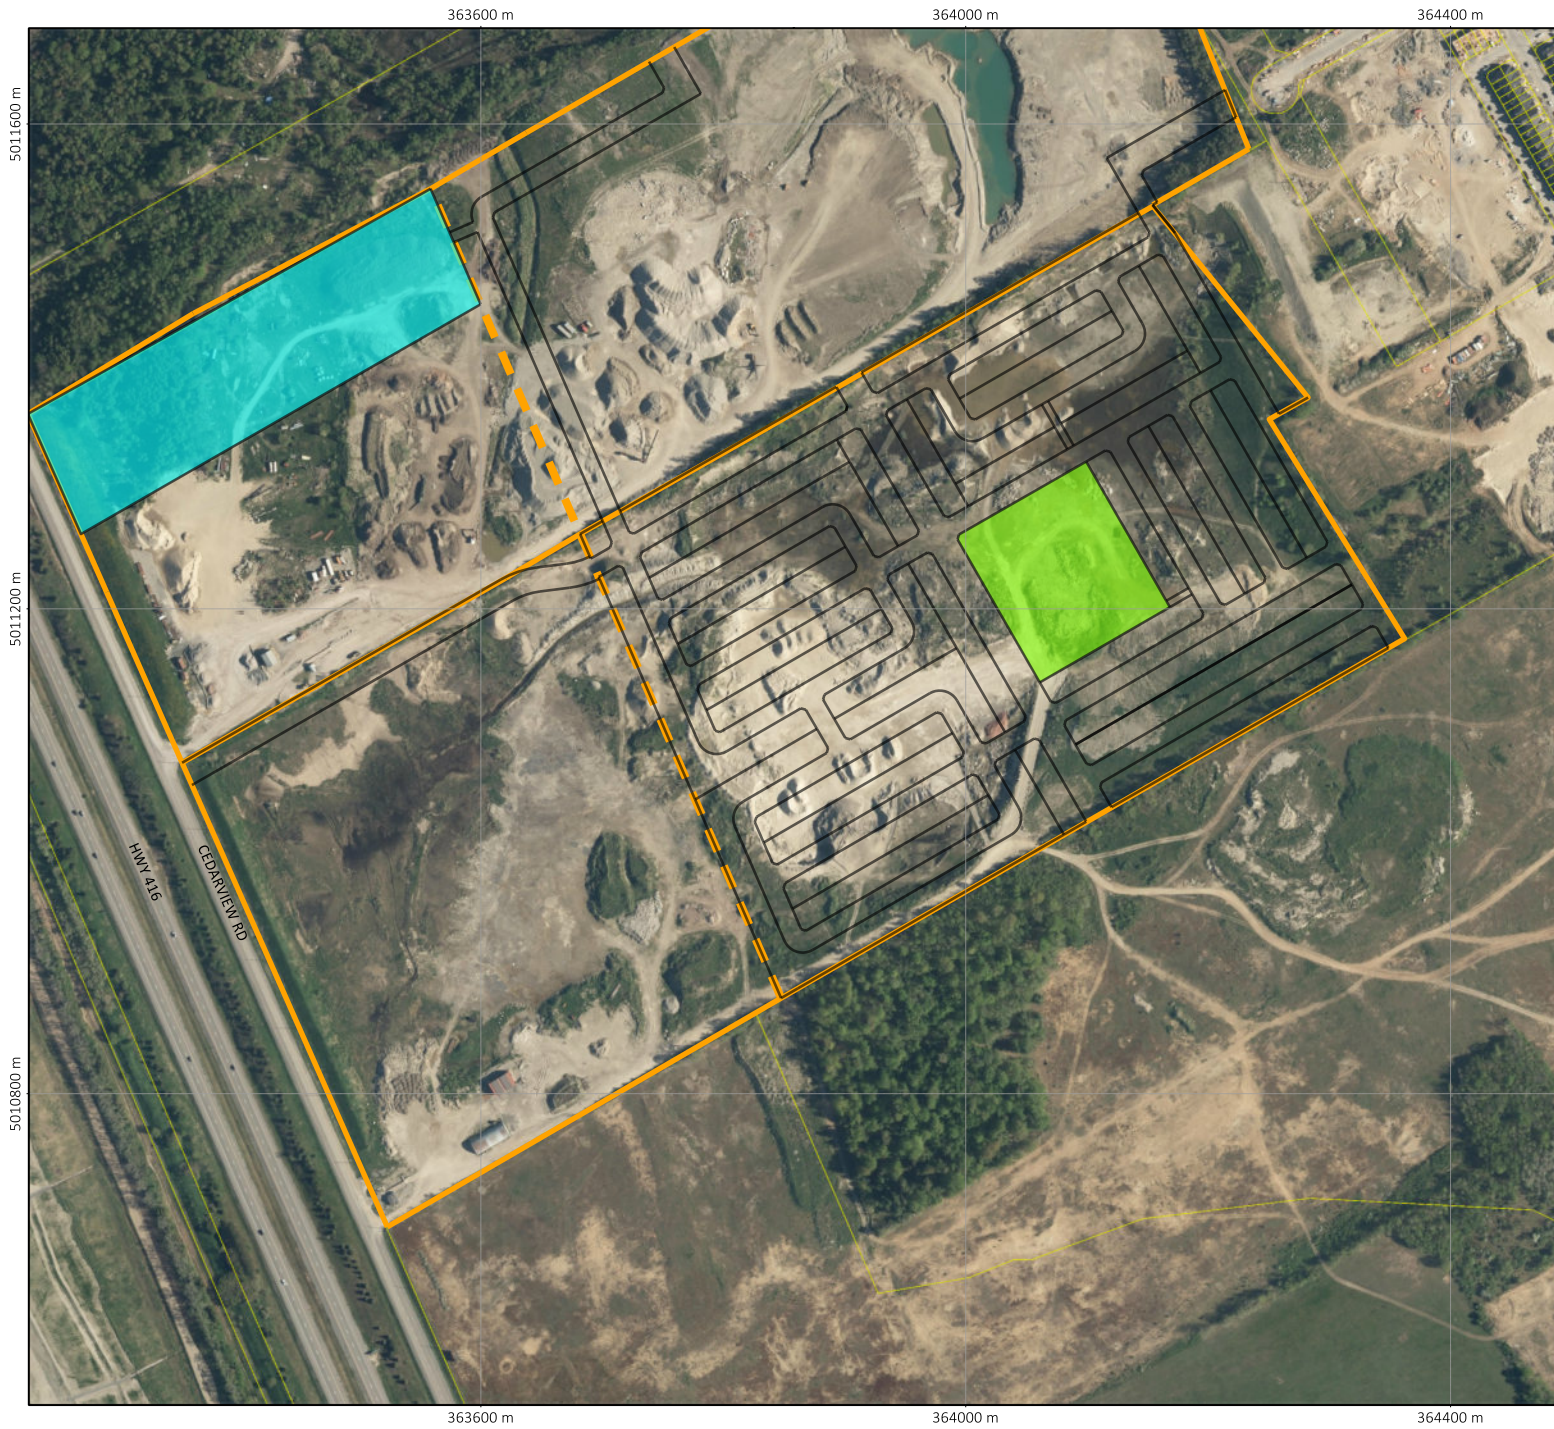
Figure 5 Proposed development

The project addressed by this EIS is a proposed residential community on the eastern half of the Brazeau property and the SWM pond area on the northwest corner of the Drummond property (Figure 5). The community will include a mix of single and town homes with a 1.72 ha neighbourhood park in the middle of the residential development.

The western half of the Brazeau property and the remainder of the Drummond property (i.e. outside of the SWM pond area) will be reserved for future development. Main access to the proposed community will be from Borrisokane Road to the west. The community will be designed to allow for street access to the future residential community to the east. Servicing will be in accordance with the Functional Servicing Report prepared by DSEL. The stormwater management area for the development will be located within the northwest corner of the property. The pond will outlet to a pipe which goes down Borrisokane to Cambrian where it outlets into a roadside ditch and eventually into the Jock River.
