Geotechnical Investigation

Proposed Residential Development
Riverside South - Phase 12
750 River Road
Ottawa, Ontario

January 14, 2021

Report: PG3320-3

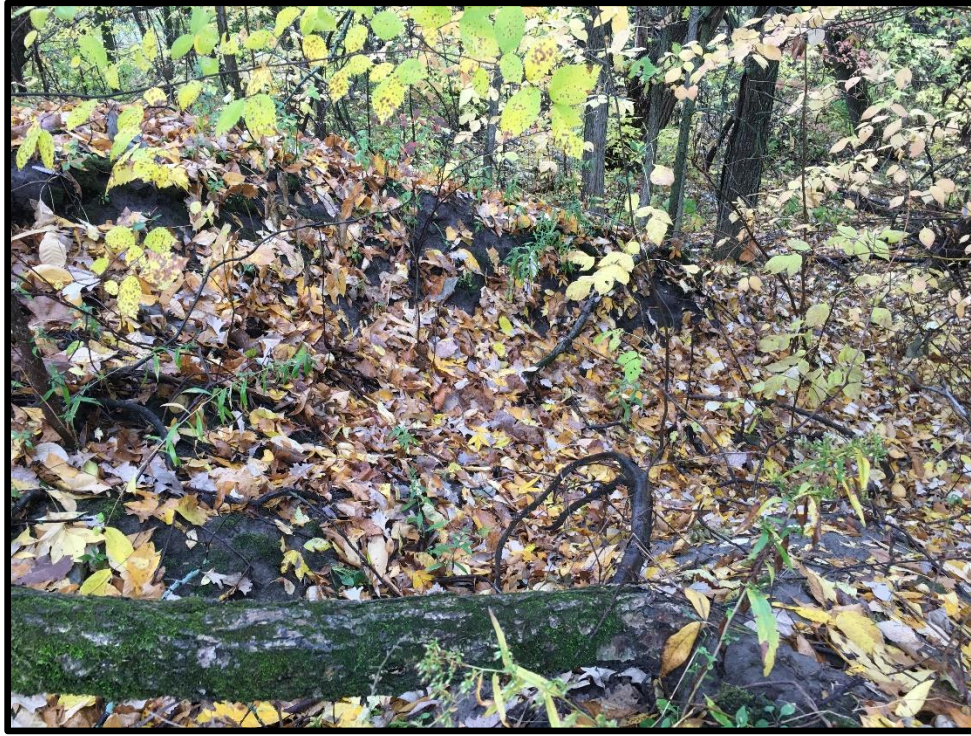
Photo 1: Existing conditions of western slope face, looking downslope, facing west. (October 16, 2020)

Signs of erosion were noted along the slope face that confines the Rideau River located along the western boundary of the subject site. Some minor sloughing failures were noted in the lower portion of the slope, leaving some exposed tree roots.

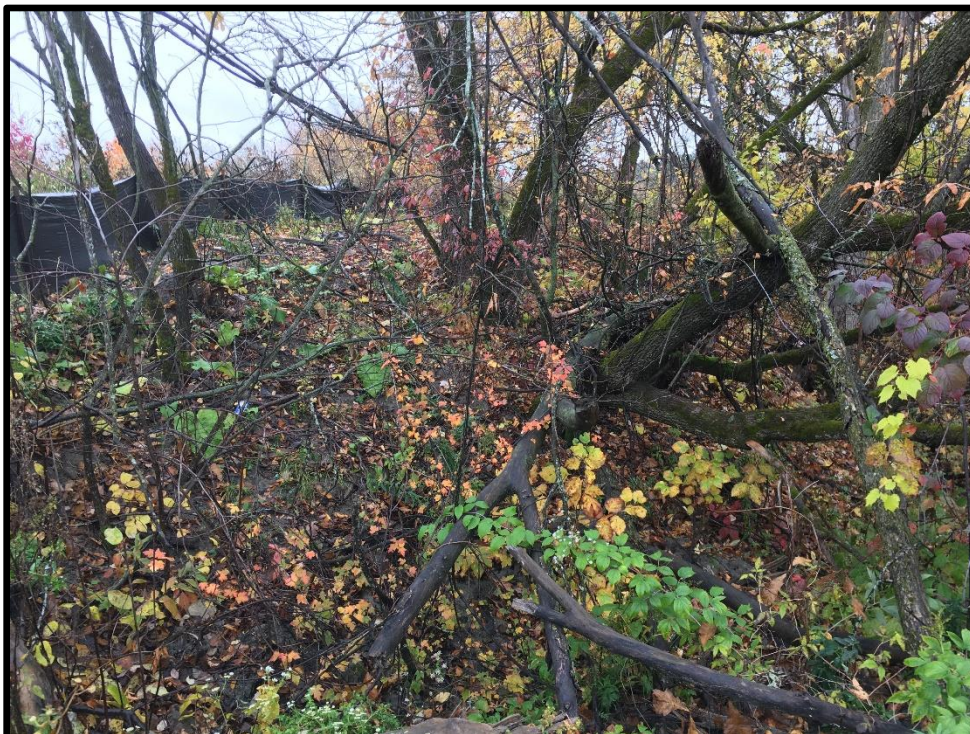
Photo 2: Existing conditions of western slope face, looking upslope, facing east. (October 16, 2020)

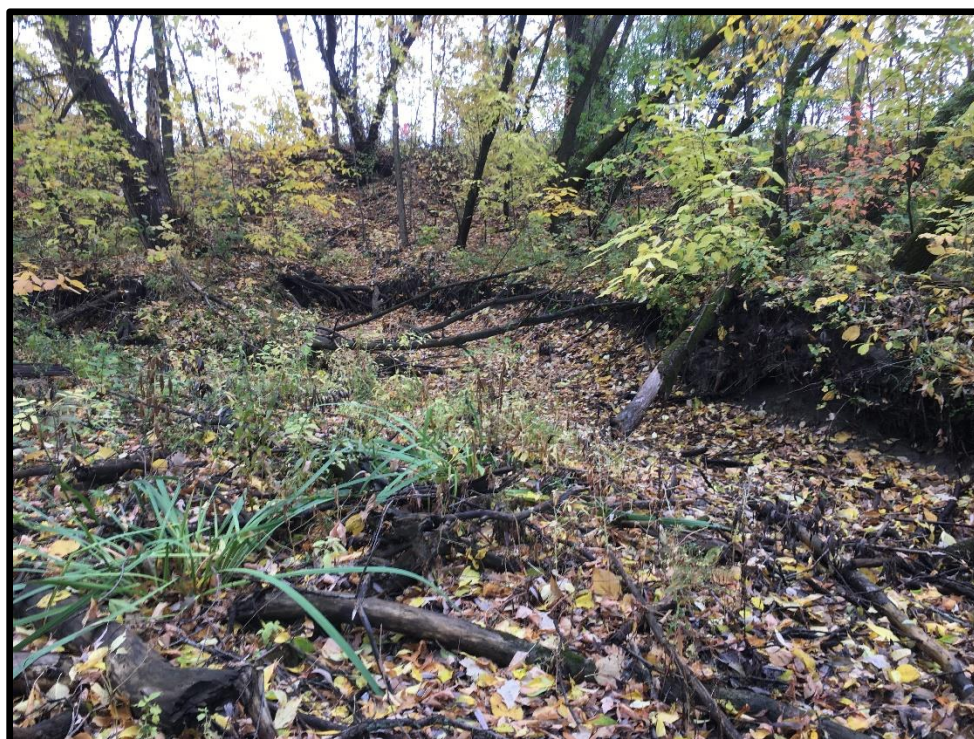
Photo 8: Existing conditions of northern ravine at the western portion of the subject site, facing east. (October 16, 2020)
