Supplemental Geotechnical Investigation

Proposed Residential Development
Riverside South - Phase 12
708 & 720 River Road
Ottawa, Ontario

November 20, 2020

Report PG3320-2 Revision 1

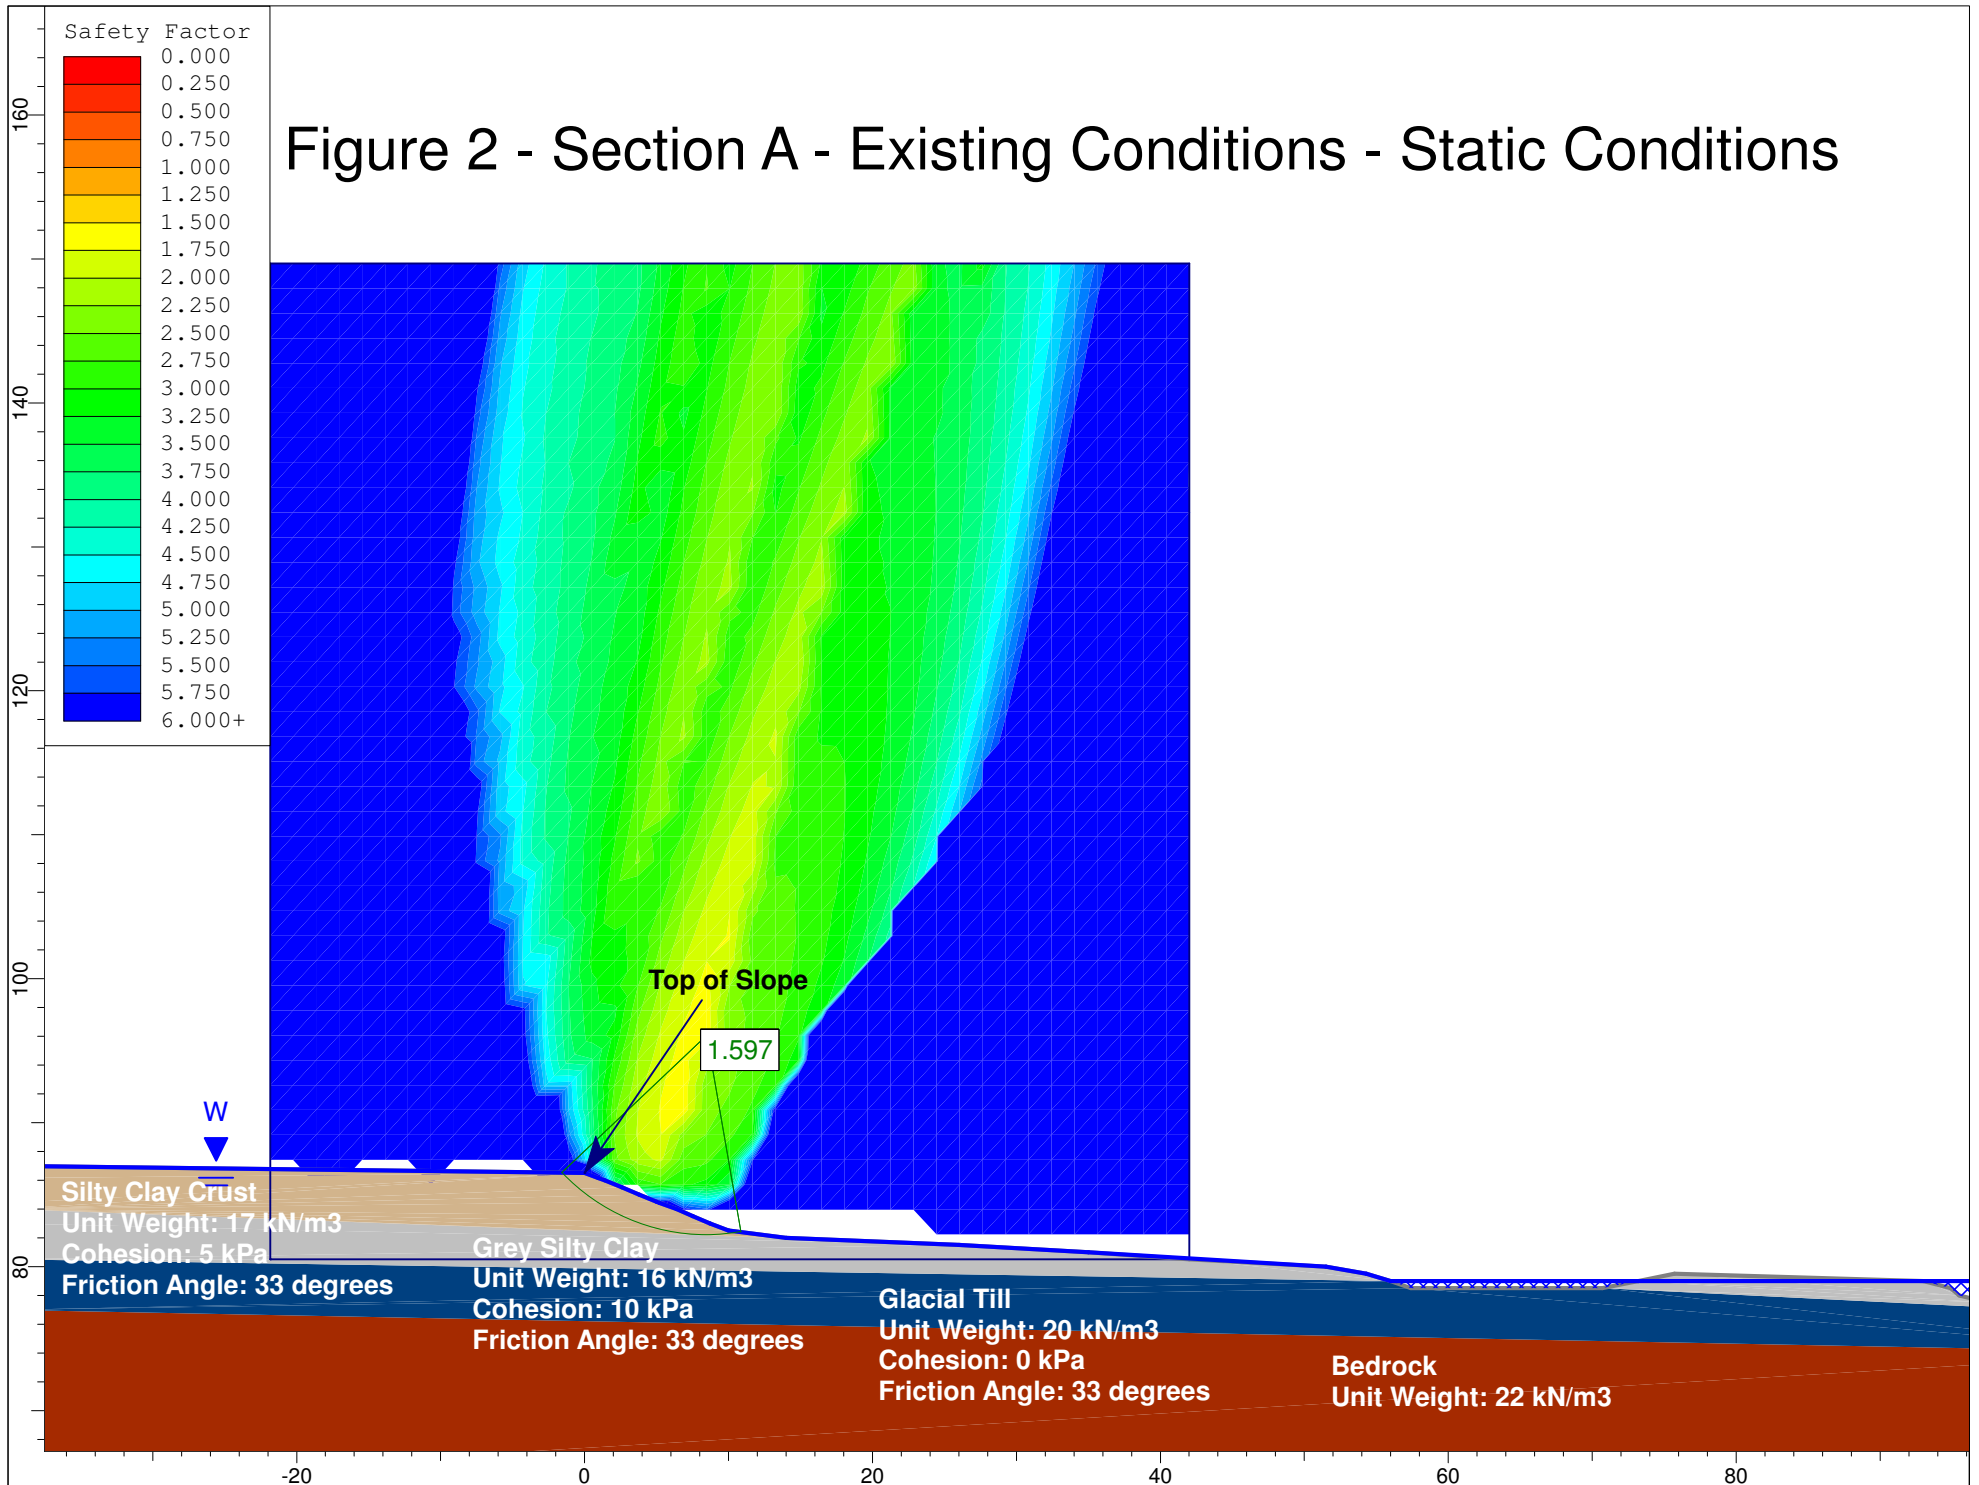
Figure 2 - Section A - Existing Conditions - Static Conditions

The results for the existing slope conditions under static loading at Sections A, B, C, D and E are shown in Figures 2, 4, 6, 8 and 10 respectively, presented in Appendix 2. The factor of safety was found to be greater than 1.5 at all sections.

The analysis of the stability of the slope was carried out using SLIDE, a computer program which permits a two-dimensional slope stability analysis using several methods including the Bishop's method, which is a widely used and accepted analysis method. The program calculates a factor of safety, which represents the ratio of the forces resisting failure to those favoring failure. Theoretically, a factor of safety of 1.0 represents a condition where the slope is stable. However, due to intrinsic limitations of the calculation methods and the variability of the subsoil and groundwater conditions, a factor of safety greater than one is usually required to ascertain the risks of failure are acceptable. A minimum factor of safety of 1.5 is generally recommended for conditions where the failure of the slope would endanger permanent structures.

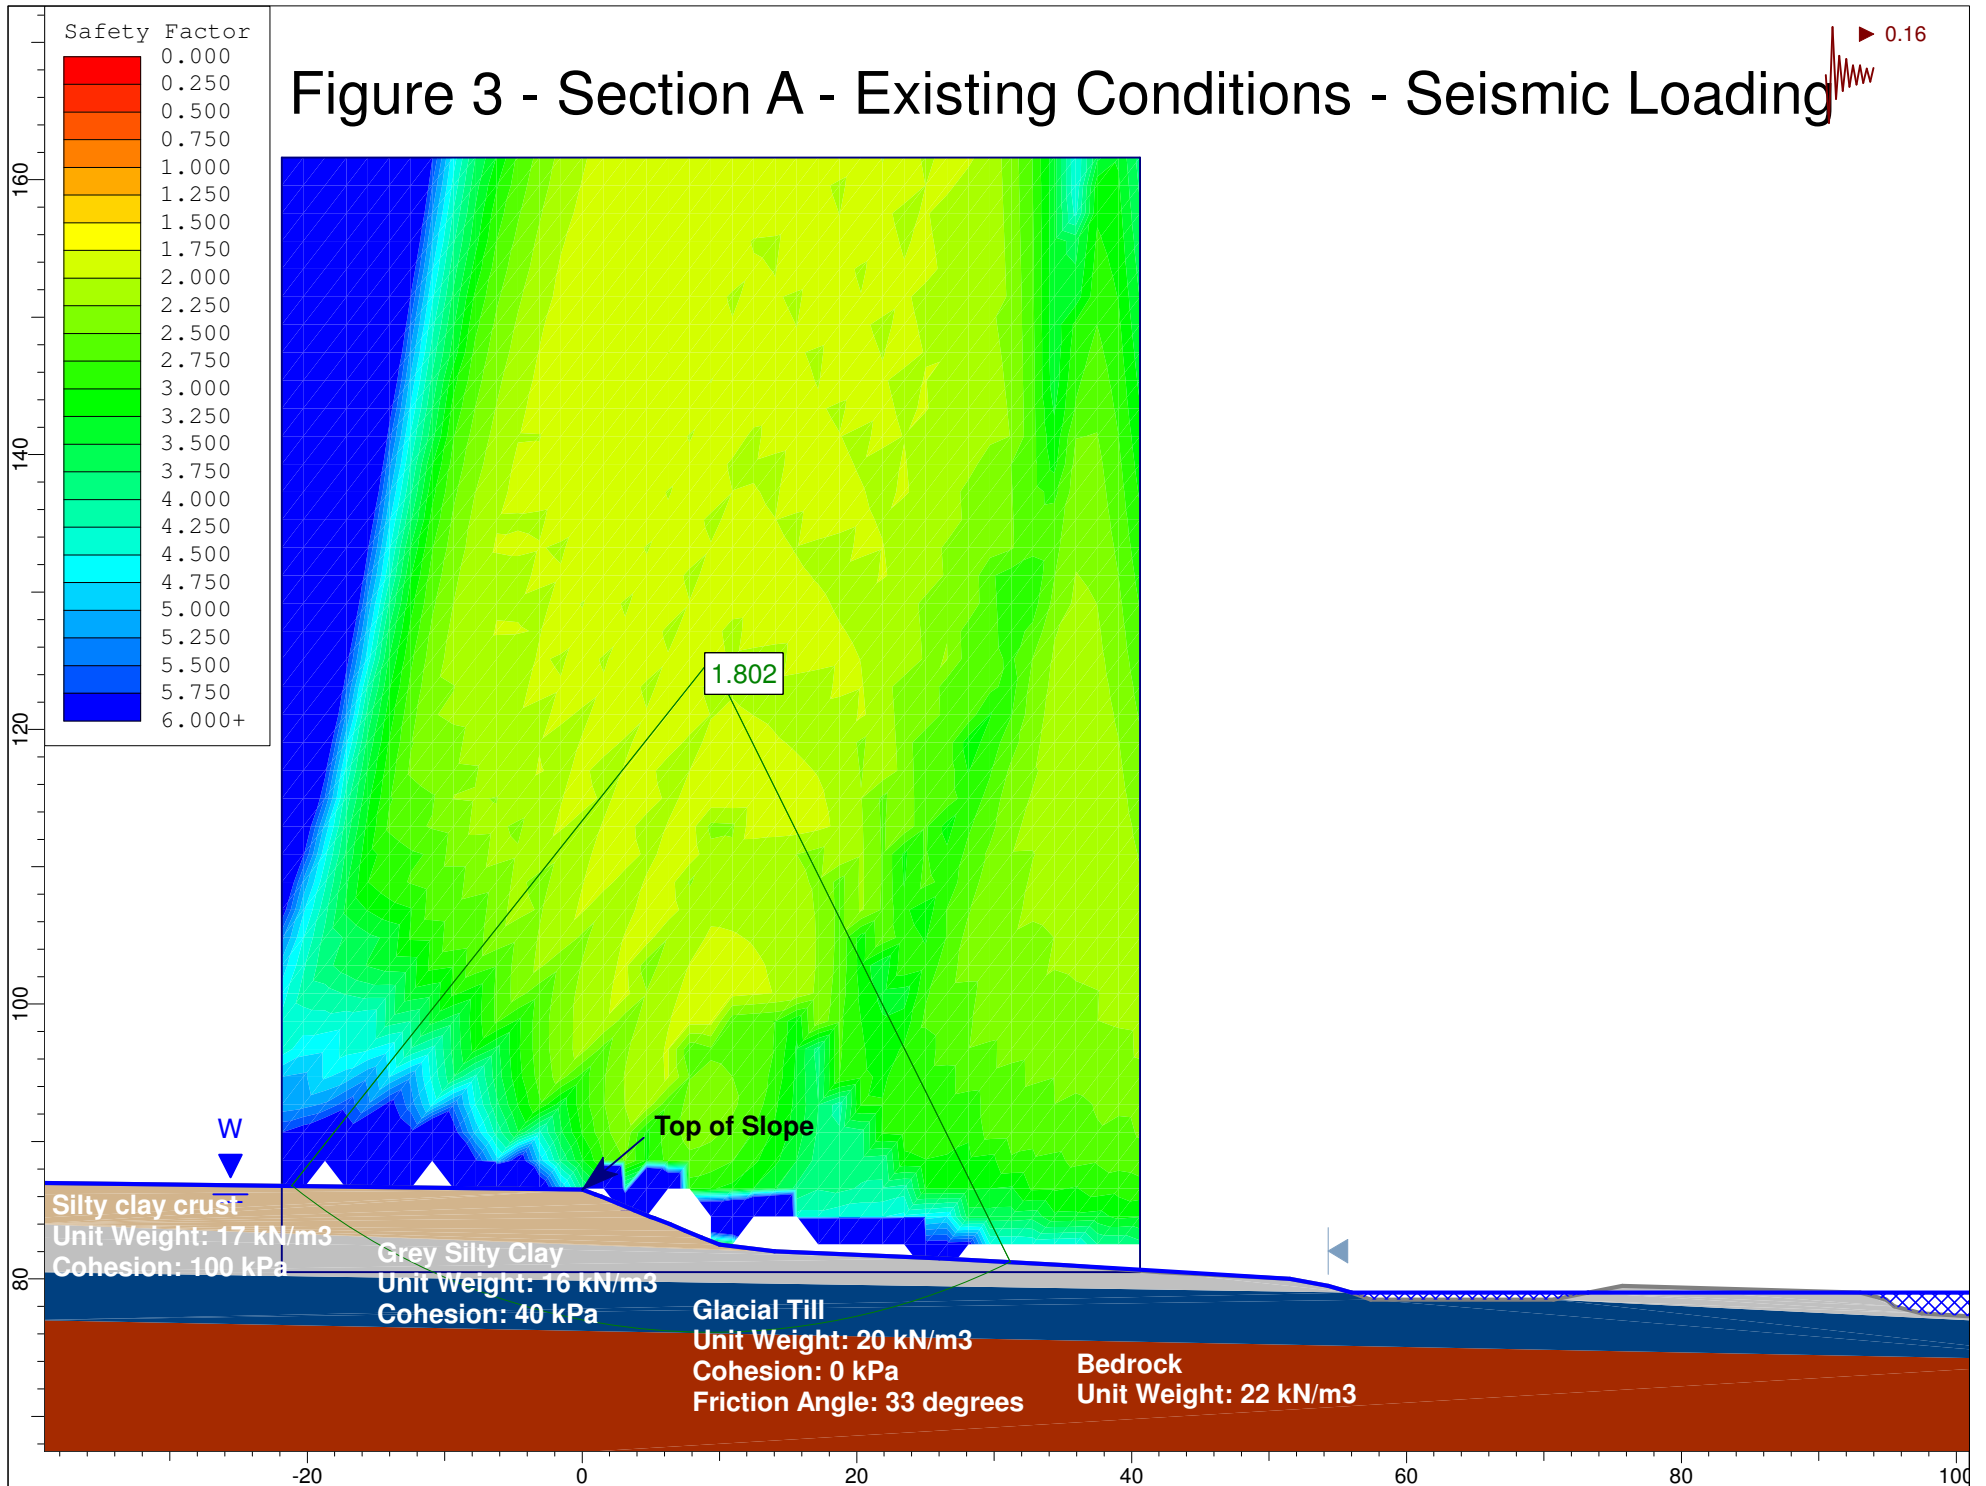
Figure 3 - Section A - Existing Conditions - Seismic Loading

The results of the analyses including seismic loading are shown in Figures 3, 5, 7, 9 and 11 for the slope sections. The results indicate that the factors of safety are greater than 1.1 under seismic conditions. Based on these results, the slopes are considered to be stable under seismic loading. Therefore, when considering seismic loading, no geotechnical setback from the top of the slope is required to achieve a factor of safety of 1.1 for the limit of hazard lands.
