Phase I-Environmental Site Assessment

Vacant Land
4725 Spratt Road
Ottawa, Ontario

October 23, 2018

Report: PE4468-1

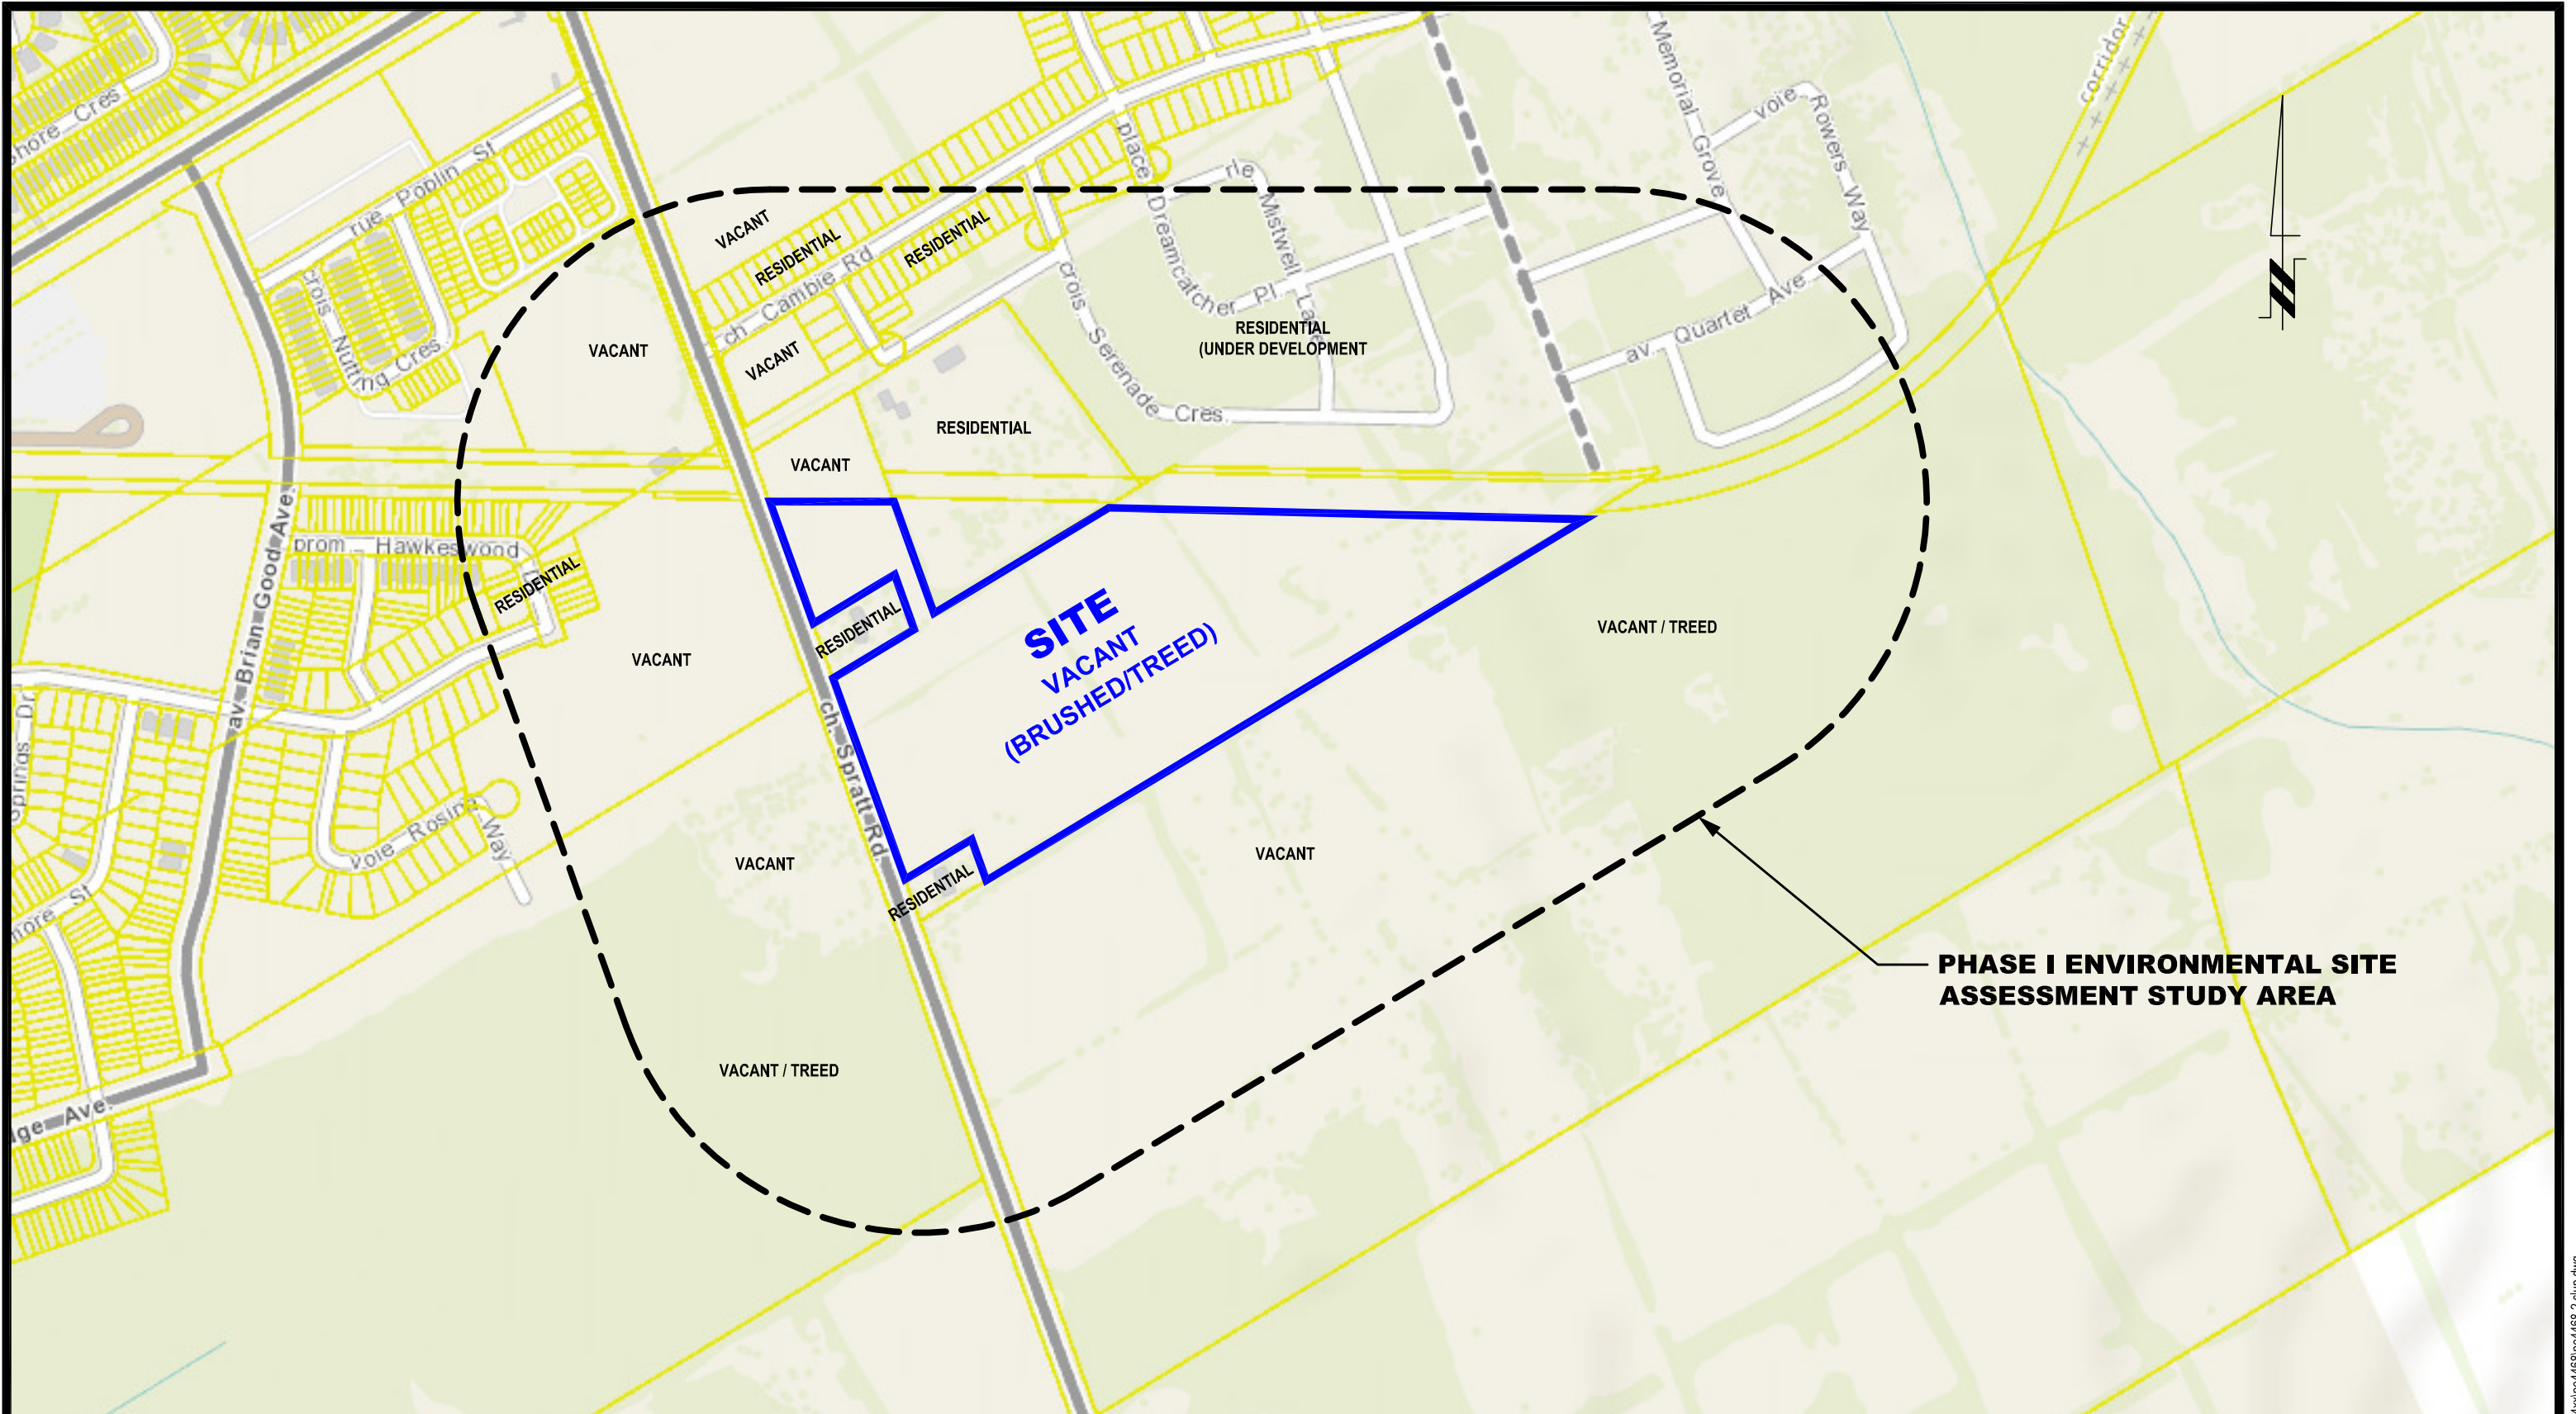
DRAWING PE4468-2 – SURROUNDING LAND USE PLAN

- North - Vacant land, followed by a residential development;
- South - Residential dwelling and vacant and undeveloped land;
- East - Vacant land and a residential subdivision;
- West - Spratt Road, followed by vacant land.

The current use of the immediately adjacent properties is not considered to pose an environmental concern to the subject site. No properties within the Phase I study area are occupied by potentially contaminating activities. Current land use in the Phase I Study area is illustrated on Drawing PE4468-2 – Surrounding Land Use Plan in the Figures section of this report.

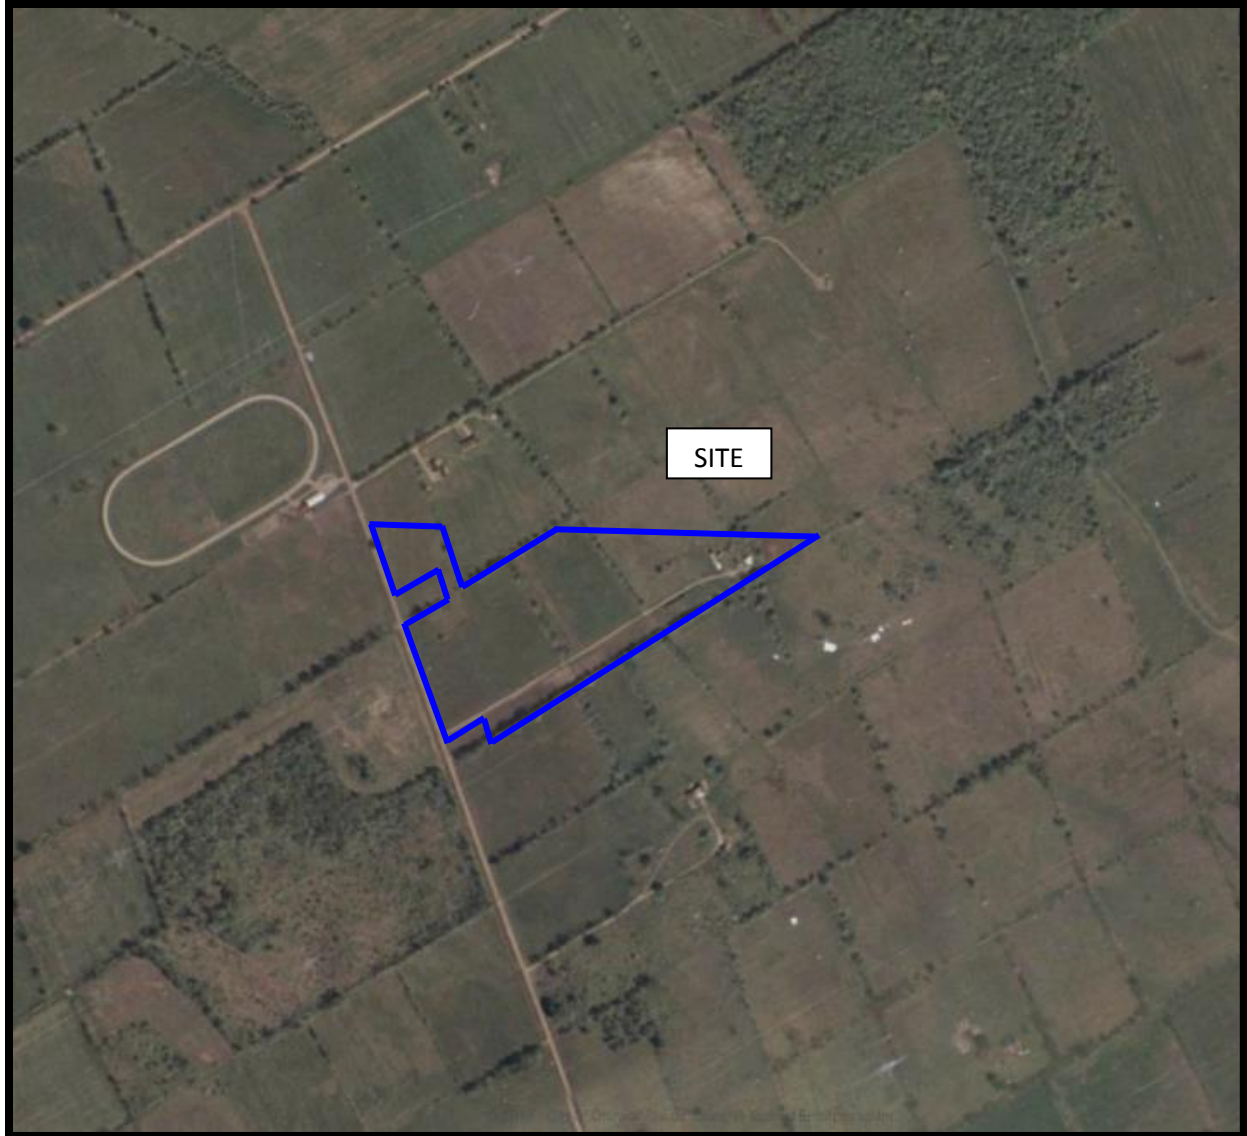
AERIAL PHOTOGRAPH
1976

| 1976 | The subject site appears as agricultural fields occupied by a farmstead on the southeast corner. The neighbouring lands are occupied with some farmsteads and agricultural fields. |

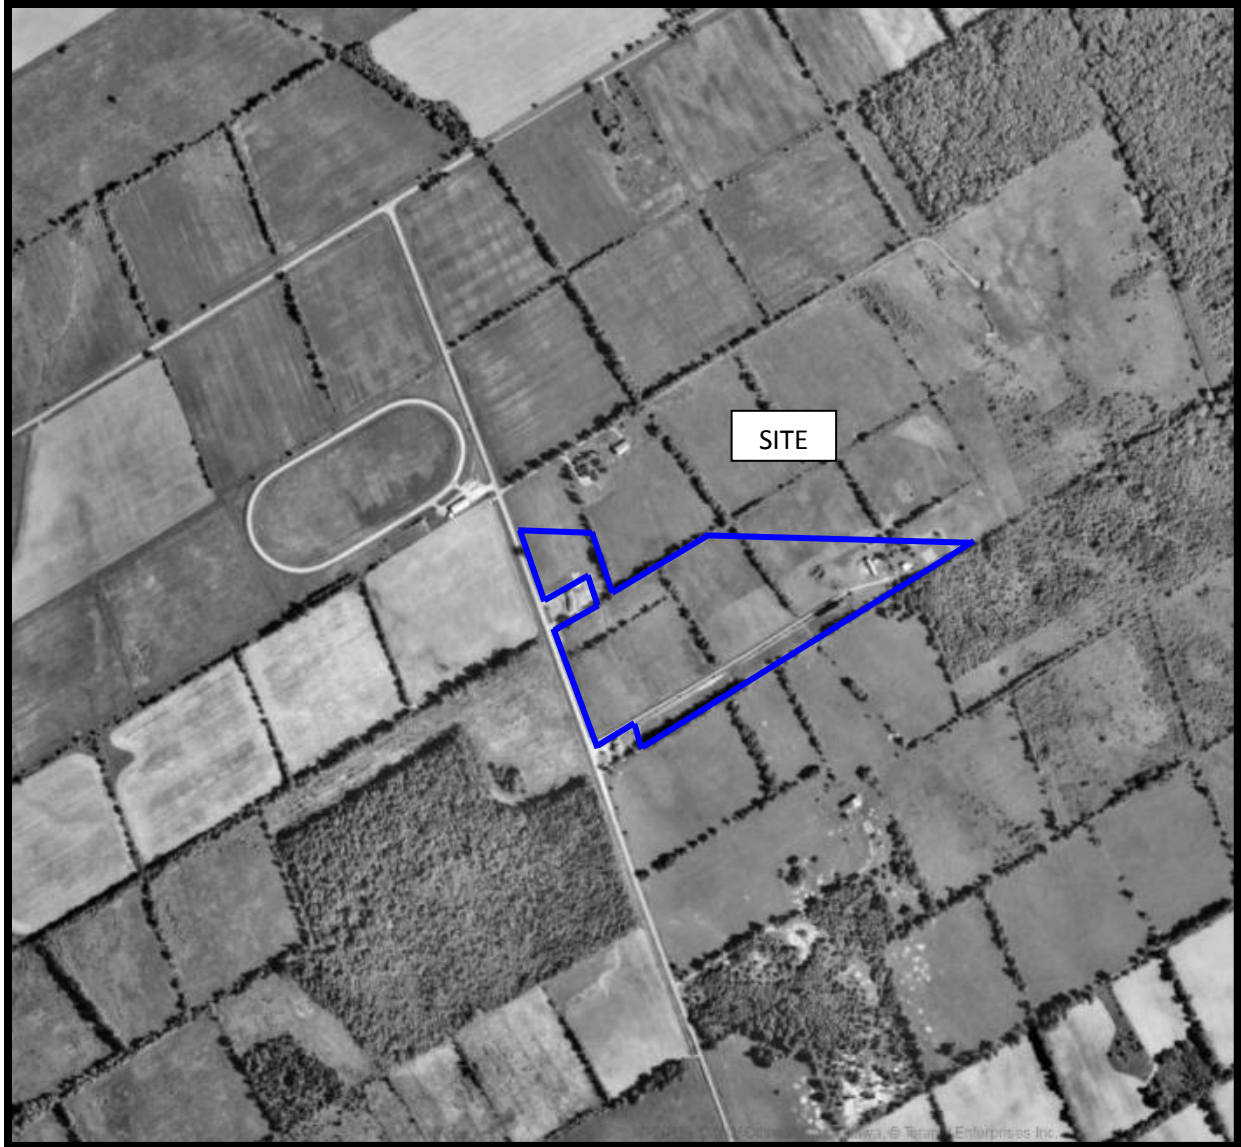
AERIAL PHOTOGRAPH
1991

| 1991 | The subject site appears unchanged from the previous photograph. The adjacent lands are the same except for two (2) residential dwellings located to the south and west of the site. |

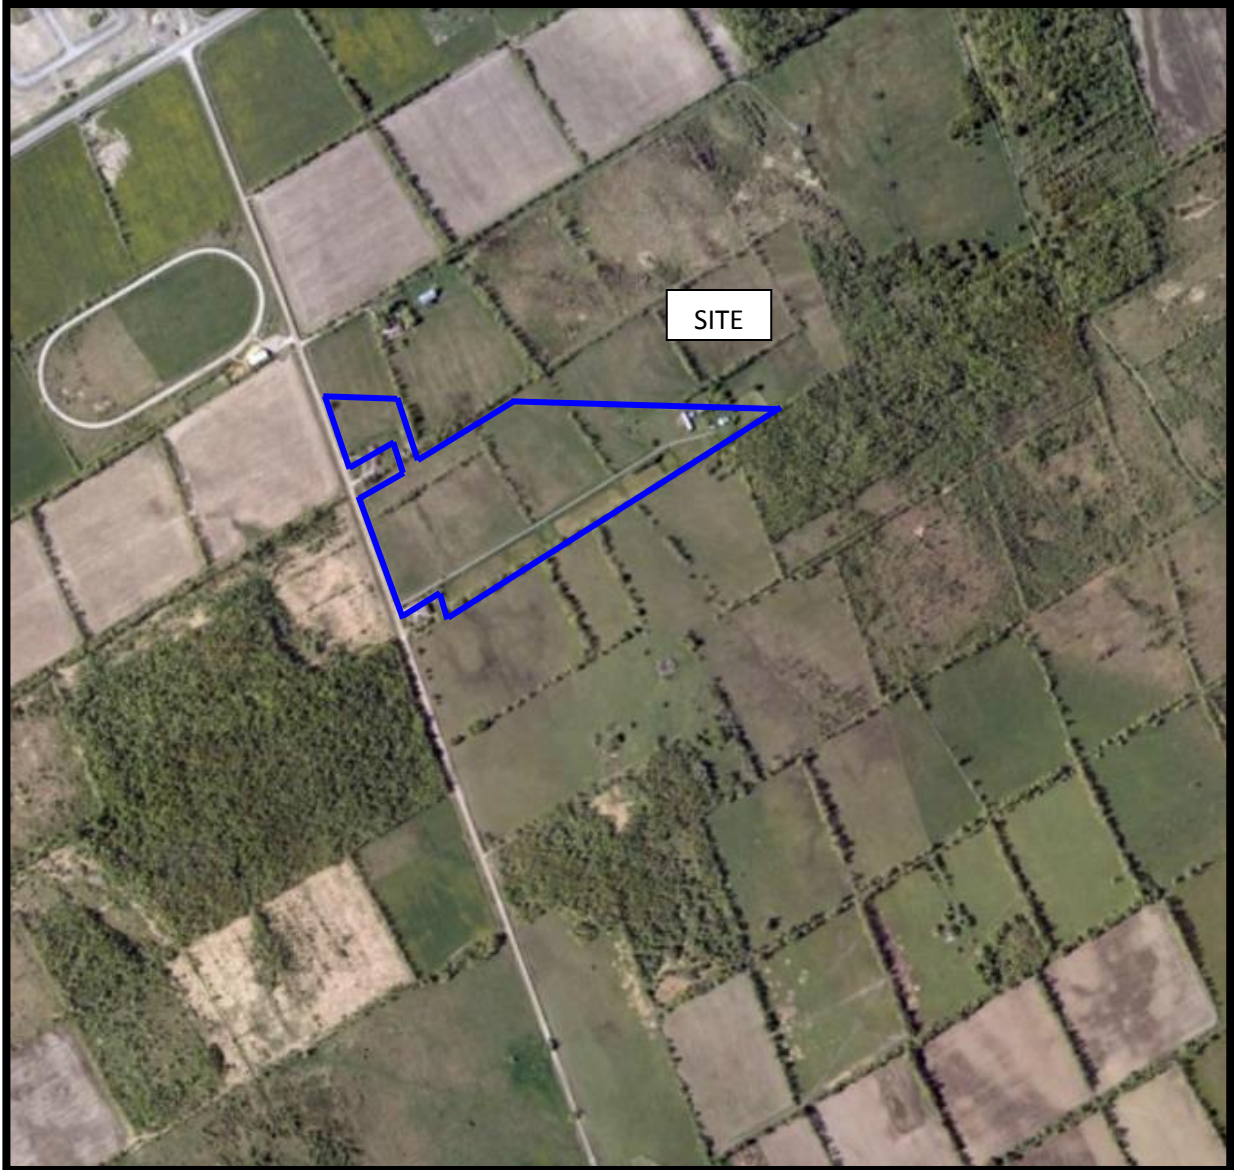
AERIAL PHOTOGRAPH
2002

| 2002 | No significant changes have been made to the subject site or surrounding properties. A residential subdivision development is beginning to occur further to the northwest, on the north side of Earl Armstrong Road. |

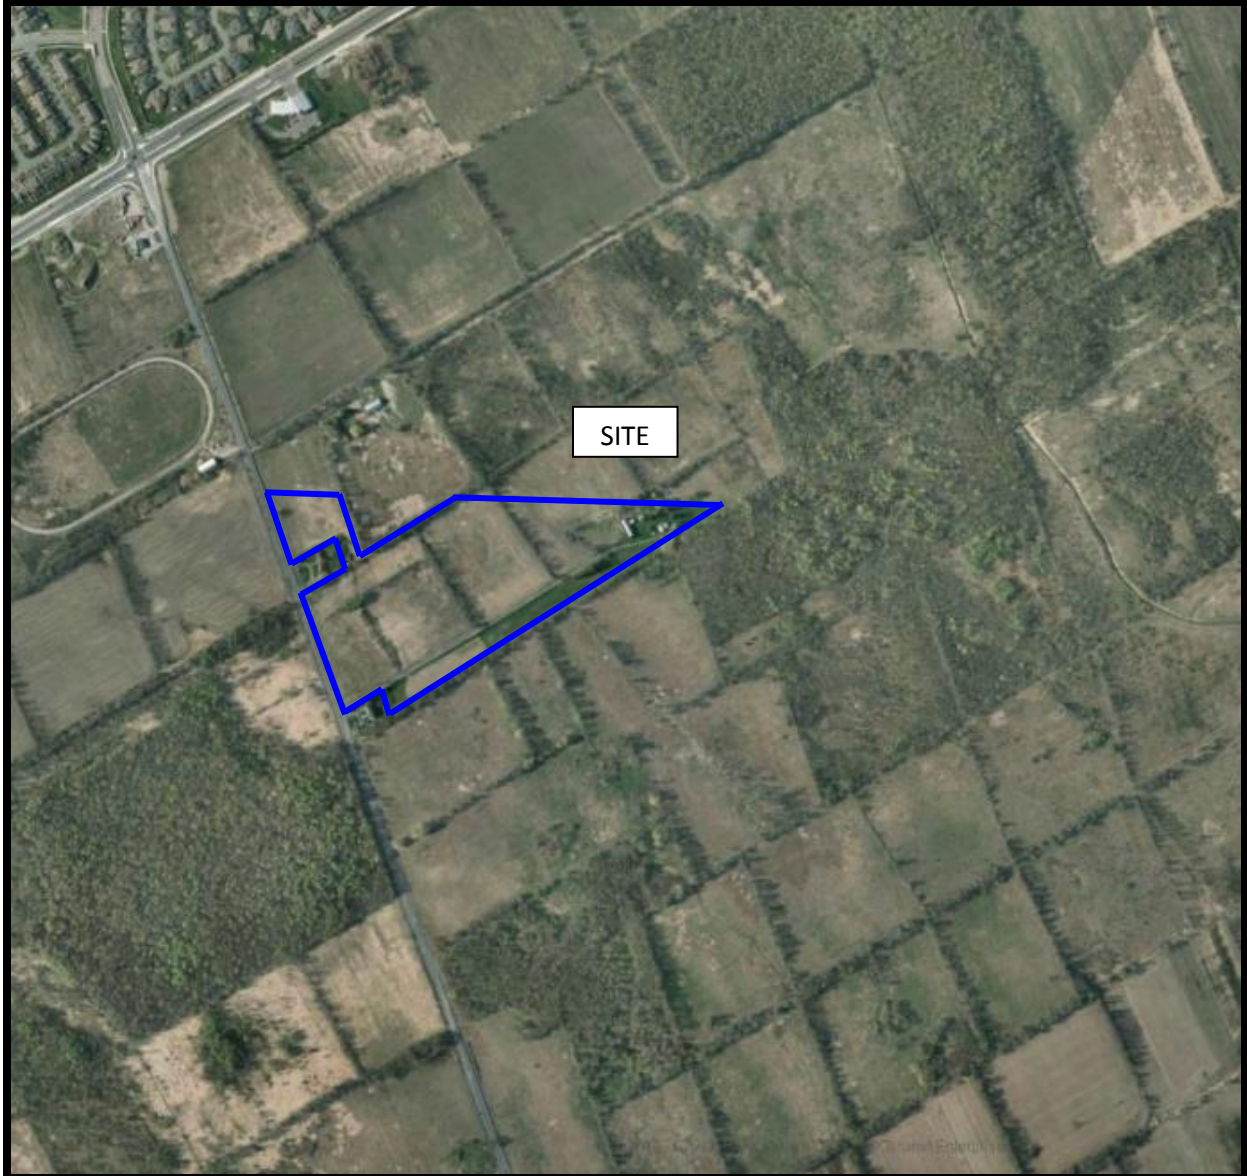
AERIAL PHOTOGRAPH
2011

| 2011 | No significant changes have been made to the subject site or surrounding properties. More residential development is noticeable further to the north. |

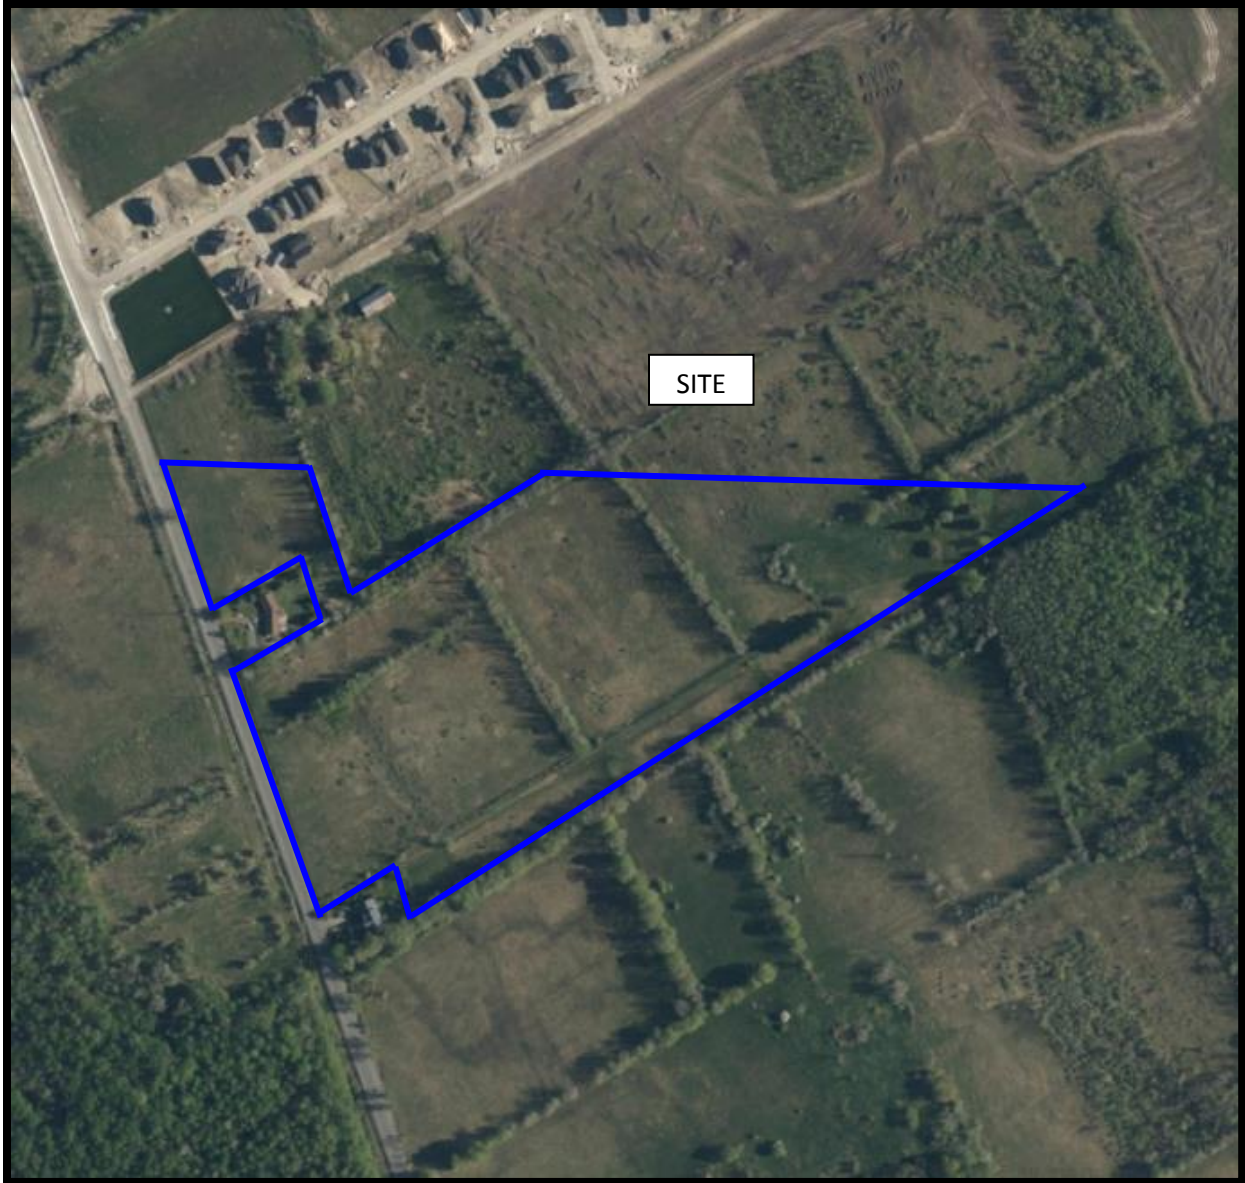
AERIAL PHOTOGRAPH
2017

| 2017 | The subject site appears vacant. The farmstead that was located on the southeast corner of the subject site no longer exists at this time. More residential development is occurring to the west, northwest and north, while the remaining lands are vacant and/or undeveloped in the east, south and southwest. |

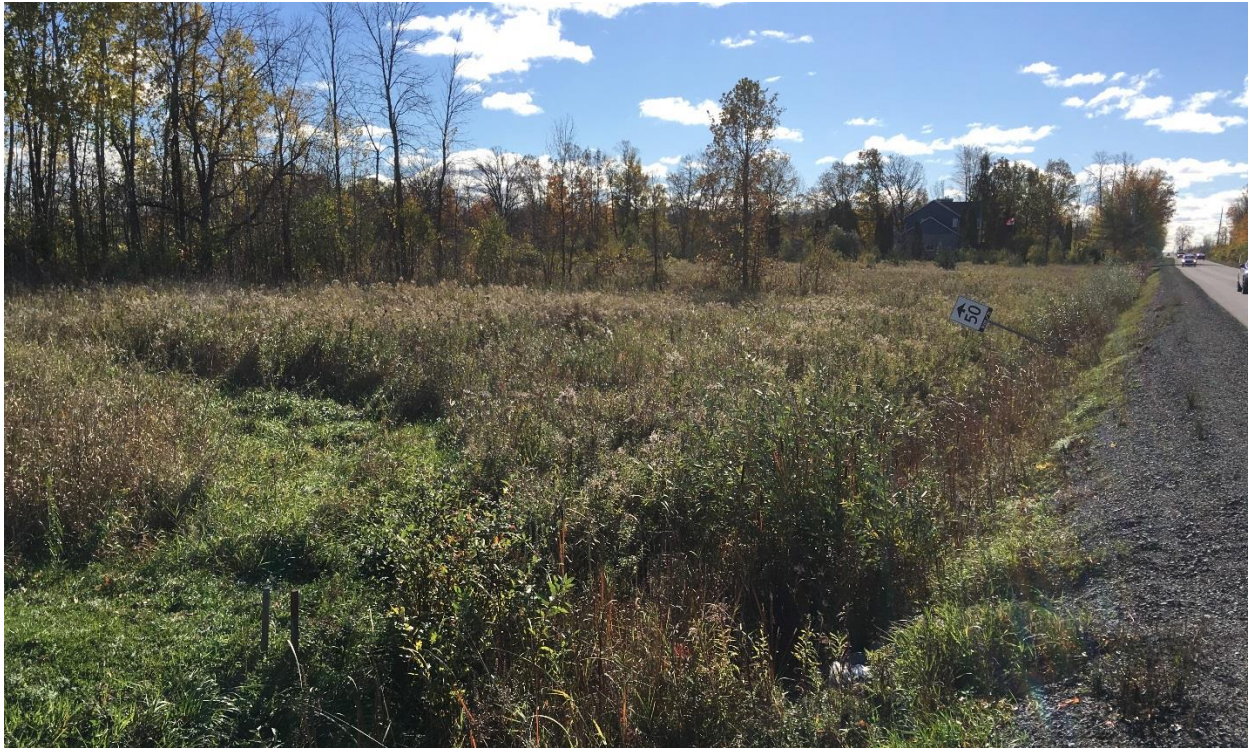
Photograph 1: View of the southwest side of the subject property, taken from Spratt Road looking south.

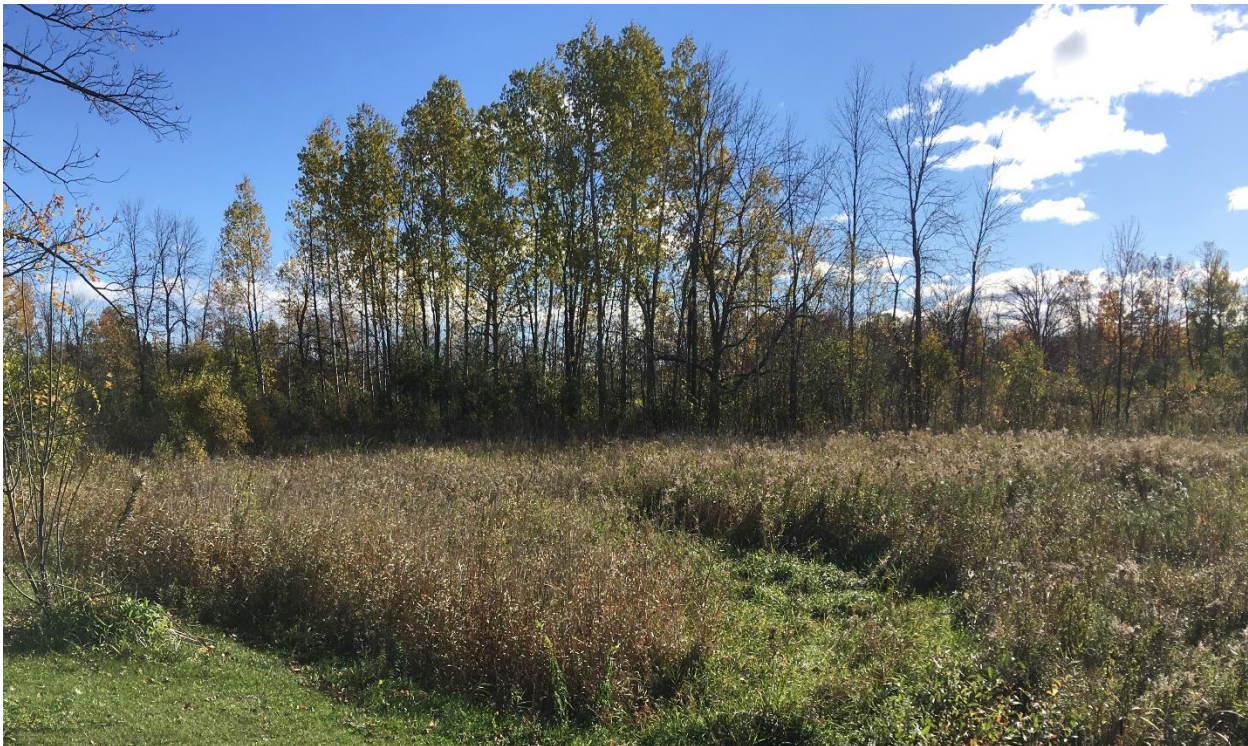
Photograph 2: Central view of the subject site, looking southeast.

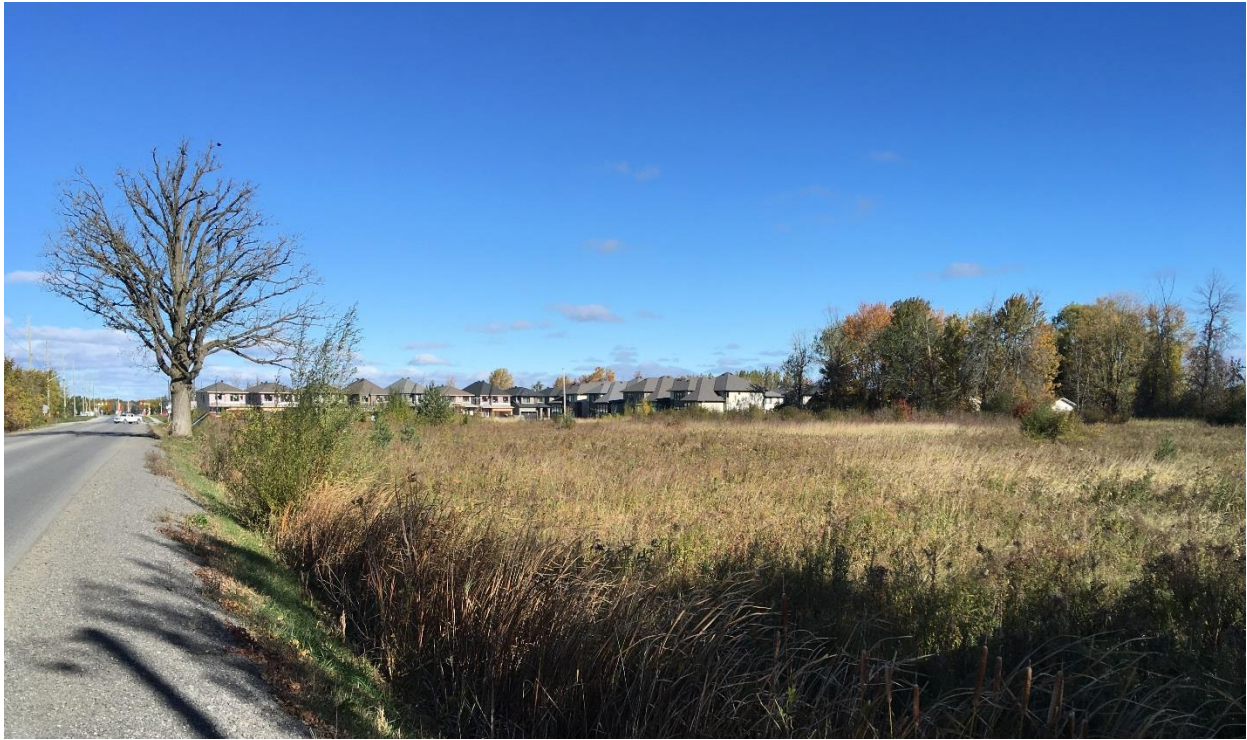
Photograph 3: View of the northwest side of the subject site, looking north onto Spratt Road.

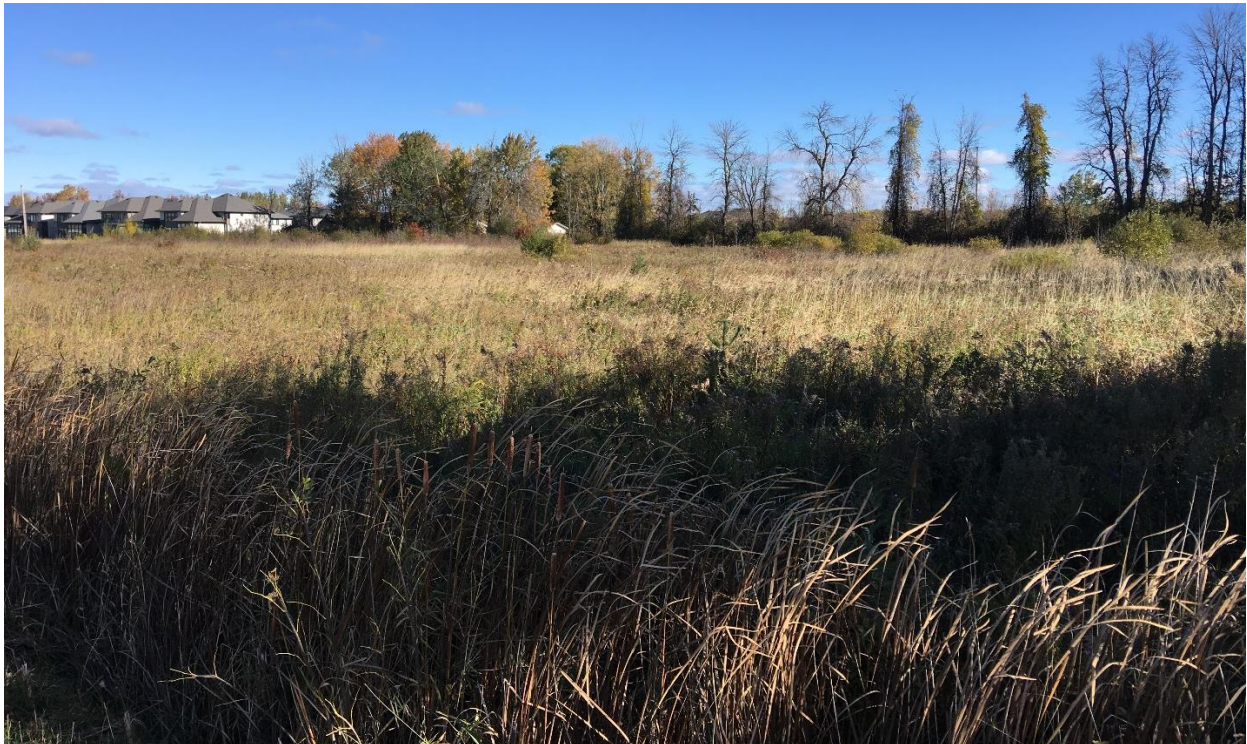
Photograph 4: Northeast view of the subject site, taken from the northwest side of the site (on Spratt Road).
