# PHASE ONE ENVIRONMENTAL SITE ASSESSMENT UPDATE

PART OF LOT 4, CONCESSION 3,  
PARTS 1, 2, 3, 4 AND 5,  
GLOUCESTER, ONTARIO  
(3646, 3636 AND 3604 INNES ROAD,  
OTTAWA, ONTARIO)

JUNE 27, 2016

Project no: 161-06382-00

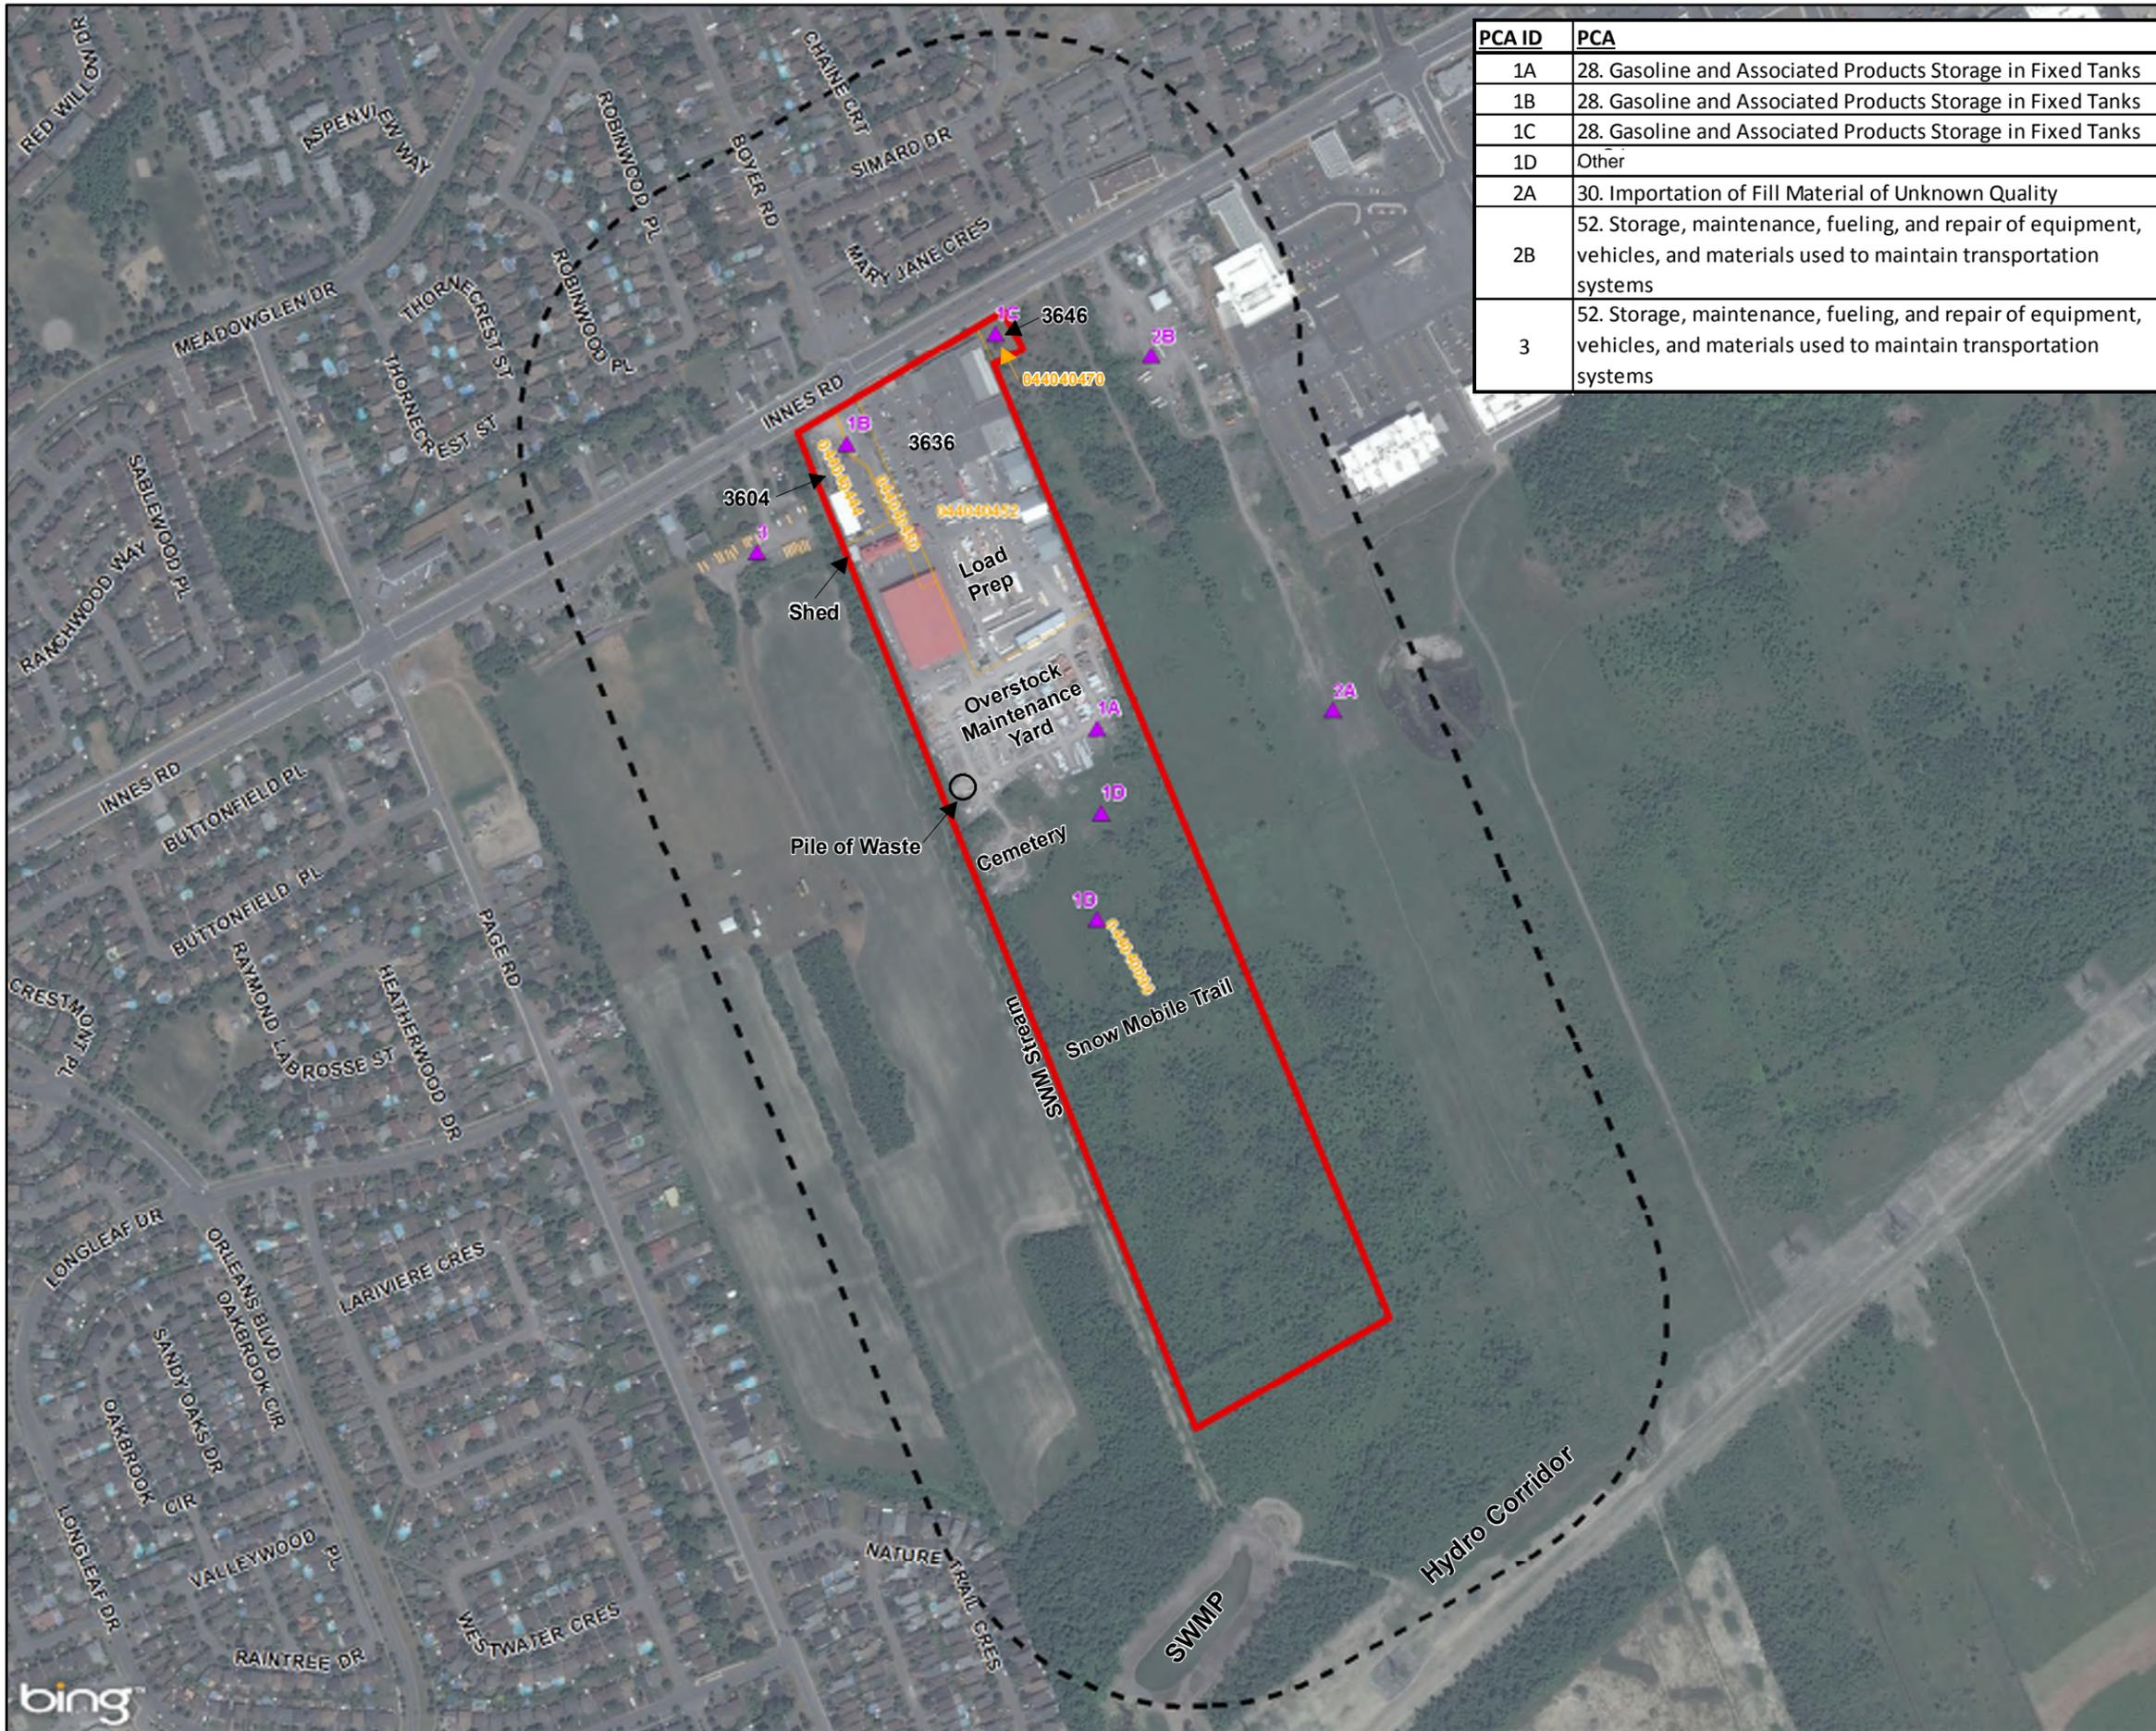
**FIGURE 3**

During the Phase One ESA, four (4) PCAs were identified at three (3) properties in the Phase One Study Area, as summarized in Table 11 and shown in Figure 3.

PCA ID	PCA
1A	28. Gasoline and Associated Products Storage in Fixed Tanks
1B	28. Gasoline and Associated Products Storage in Fixed Tanks
1C	28. Gasoline and Associated Products Storage in Fixed Tanks
1D	Other
2A	30. Importation of Fill Material of Unknown Quality
2B	52. Storage, maintenance, fueling, and repair of equipment, vehicles, and materials used to maintain transportation systems
3	52. Storage, maintenance, fueling, and repair of equipment, vehicles, and materials used to maintain transportation systems

TITLE  
**POTENTIALLY CONTAMINATING ACTIVITIES**

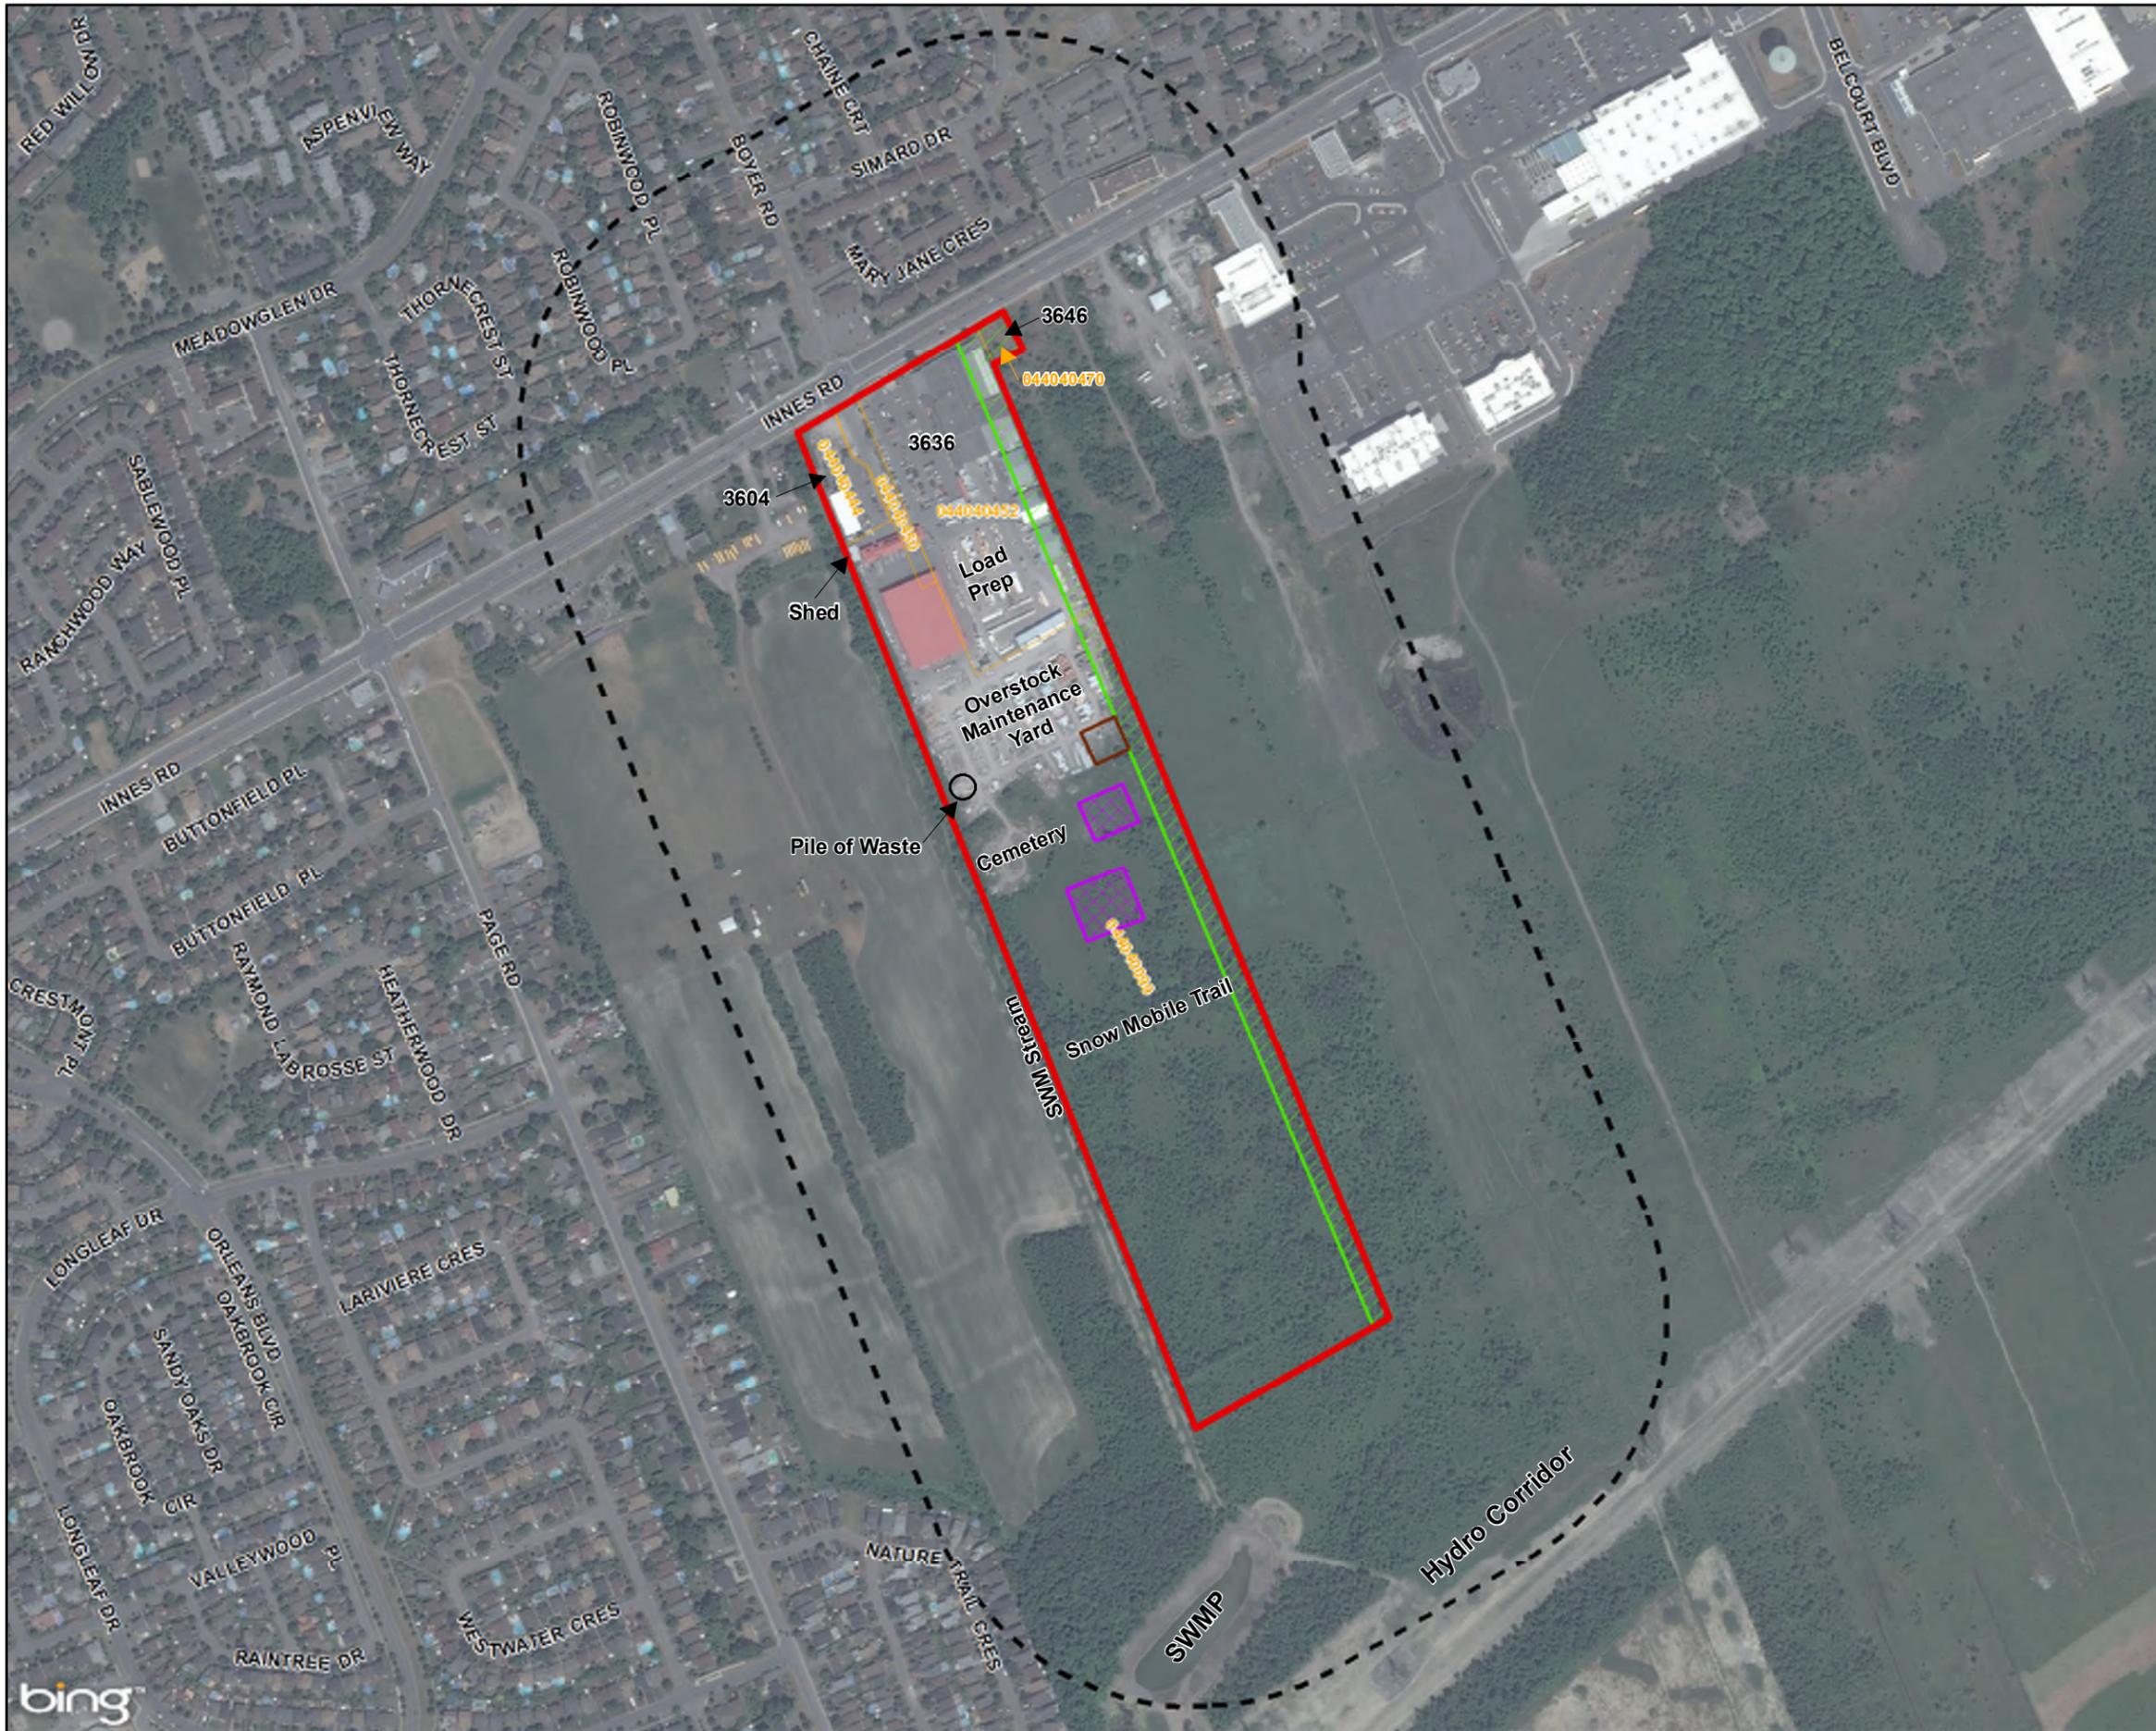
FIGURE 4

WSP has identified two APEC's at the Site resulting from two on site PCAs, and one APEC that can be attributed to one off-site PCAs with the potential to result in an APEC at the Site from contaminant migration through groundwater movement, as summarized in Table 12 and Figure 4.

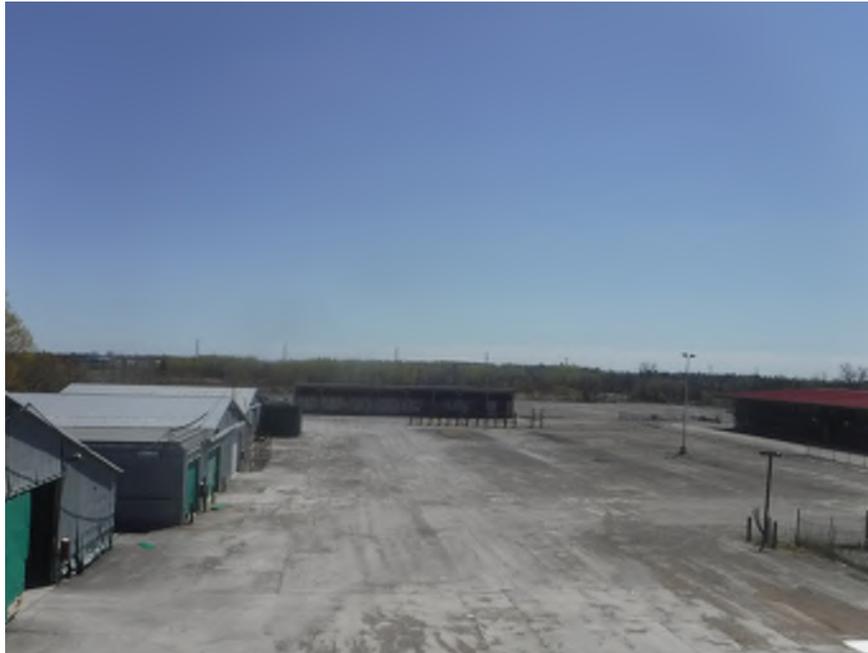
- Observations of the exterior of the property included the following:
  - The exterior of the Site was an asphalt surface on the north half, where the parking for the main building was with a gravel surface in the loading zone located south of the main building where the buildings #1, #2, #3 and #4 were located. This is referred to as the 'load prep' area (Photo 3).

**Photo 3. Sheds #1 (front left) #2 (second left), #3 (third left), #4 (straight ahead) and #6 (right) facing south from the south part of the roof of building #5.**

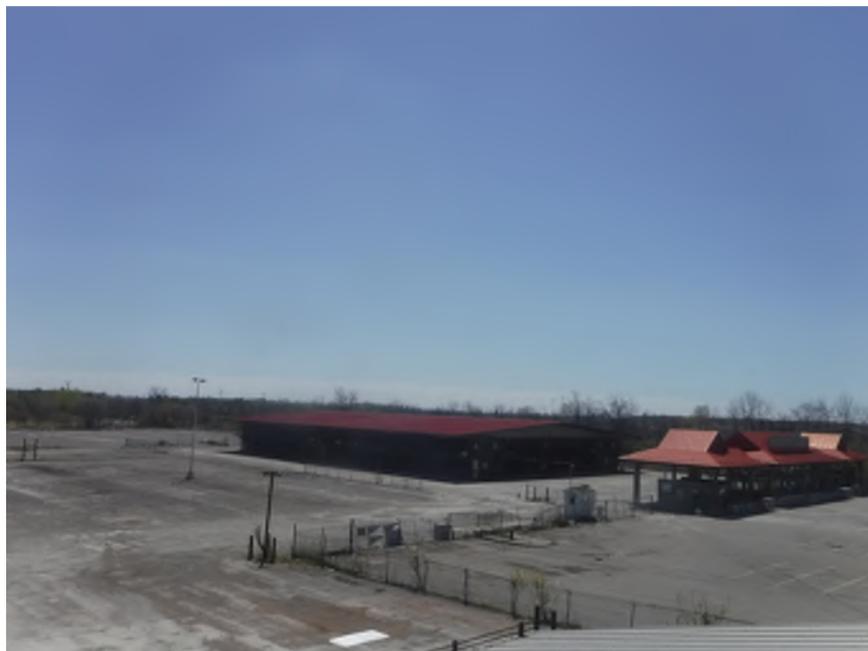
- The northwest portion of this property contains three of the eight buildings: partially open self-serve retail shelter (building #6), cashier shelter with four individual kiosks (building #7) and a shed which formerly contained a large circular saw (building #8) are located on the north portion of this property, with the 'overstock storage yard' located south (Photo 4).

**Photo 4. Buildings #6 (left) and #7 (right) facing southwest from the southwest portion of the roof of building #5.**

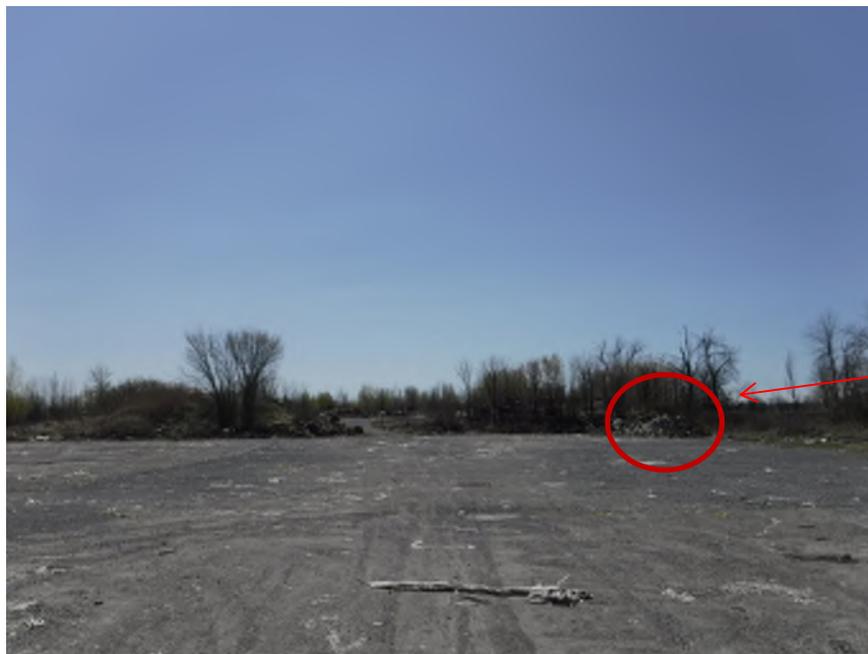
Pile of construction debris

- Mr. Laplante indicated that the pile of topsoil located on the southwest side of the overstock storage yard was used to dispose of old bricks that were not in good enough condition to sell. He referred to this area as the 'cemetery'. Materials were reportedly just placed on top of the pile, and not buried.

**Photo 6. The 'Overstock Storage Yard', cemetery (ahead) and pile of construction debris (right) facing south from building #6.**

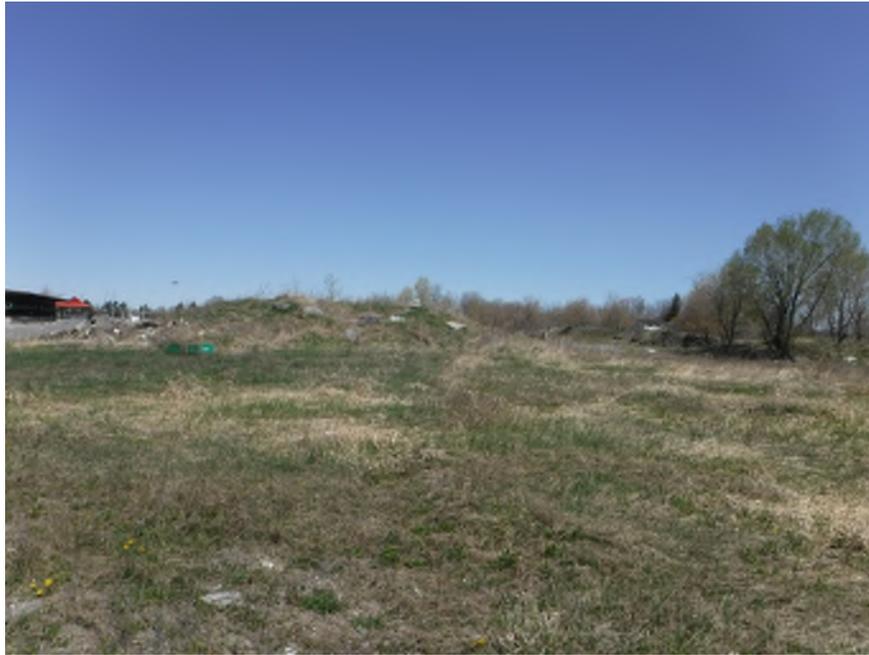
- Large piles of soil that are grassy with small shrubs and trees are located south of the gravel area with some pieces of miscellaneous construction debris including wood, plastic and drywall are located on the surface of the soil piles (Photo 7).

- A grassy area with small shrubs is located south of the piles of top soil, and a fence/gate that runs east-west is located approximately 20 m south of that. Pieces of plastic, wood, drywall and miscellaneous building materials are scattered in this area (Photo 7).

**Photo 7. Representative photograph of the former snow storage yard identified on the Phase I ESA and piles of 'top soil' located south of the 'overstock storage yard' facing north from the south fence.**

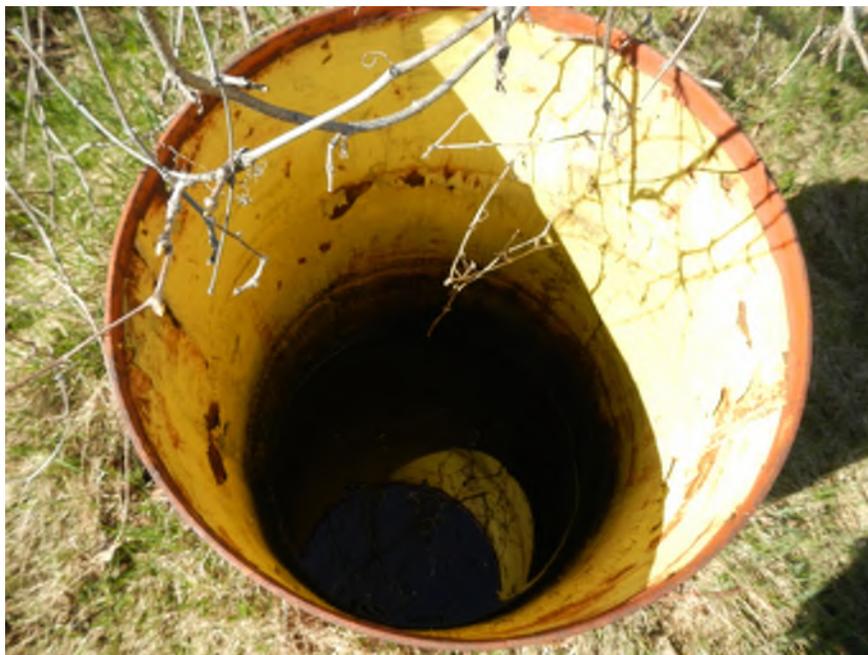
- This property was vacant during the time of the Site visit with a grassy area on the north half and exposed weathered bedrock on the south half with scattered trees and brush (Photo 18).
- An open 205 litre drum was observed in the middle of the property with about 1" of wet sediment in the bottom (Photo 19 and Photo 20).
- Garbage (plastic, wood, shingles and construction debris) was observed to be scattered over the developed north portion of the Site and along the east property fence line (Photo 21).
- A hydro pole with three transformers was observed on the northwest corner of the Site along Innes Road. HydroOttawa has previously confirmed that pcb-containing transformers have been removed from service within the City of Ottawa (Photo 5).

**Photo 20. Interior of drum located at 3646 Innes Road.**

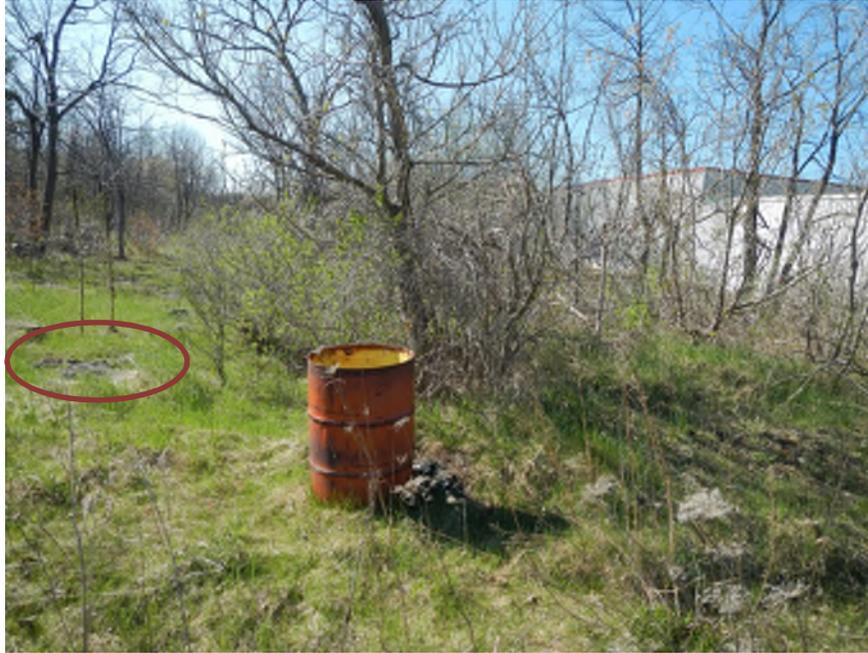
Roof Shingles

**Photo 21. Pile of roof shingles and drum located on 3646 Innes Road (facing southwest from the centre of the 3646 Innes Road).**

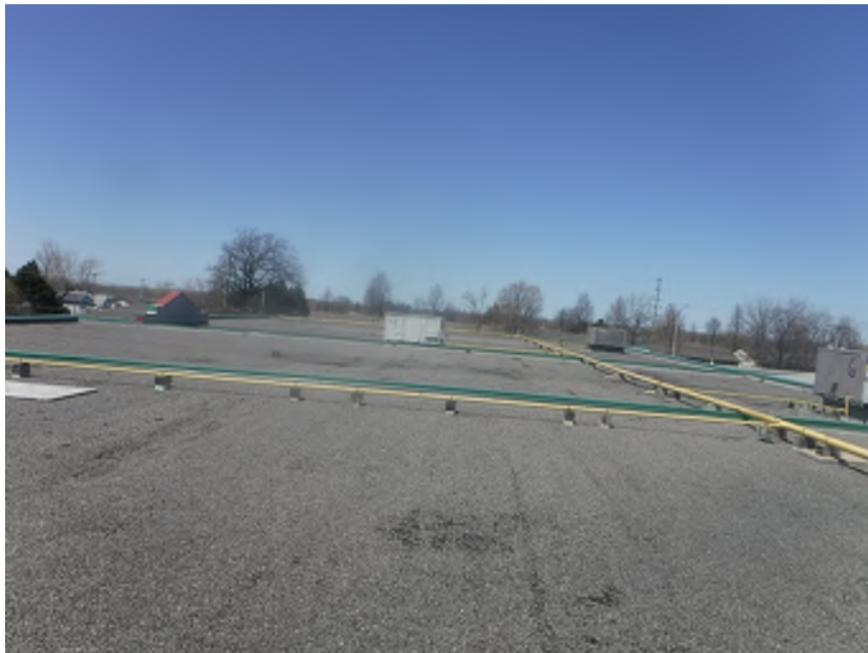
**Photo 22. Representative photograph of HVAC units located on the roof of building #5 facing north from the south side of building #5.**

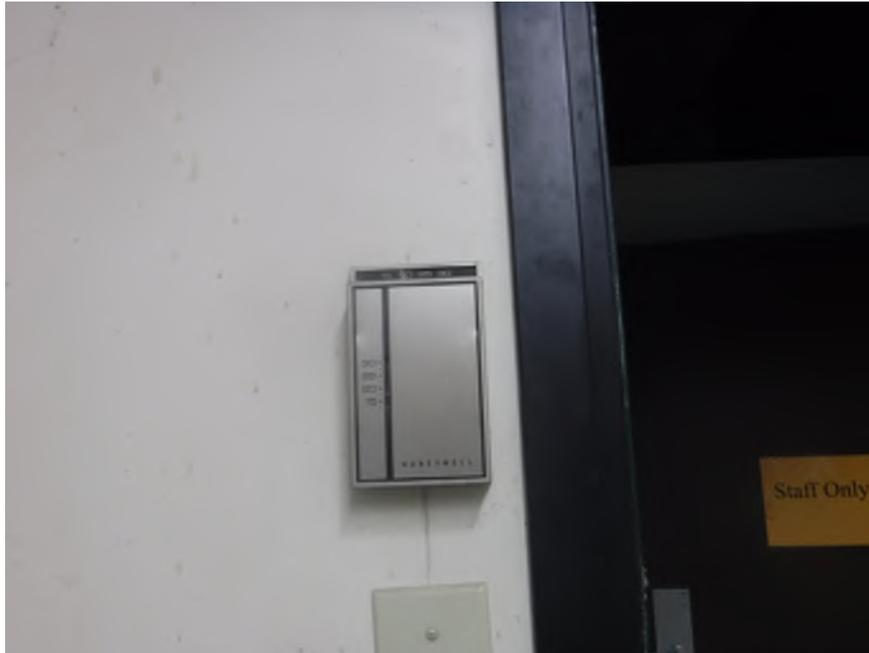
- During the Site visit, 10 suspected mercury containing thermostats were observed throughout the building (Photo 23).
  - Fire extinguishers (at least 20) were observed throughout the building.

**Photo 23. Representative photograph of suspect mercury-containing thermostats located throughout the building #5.**

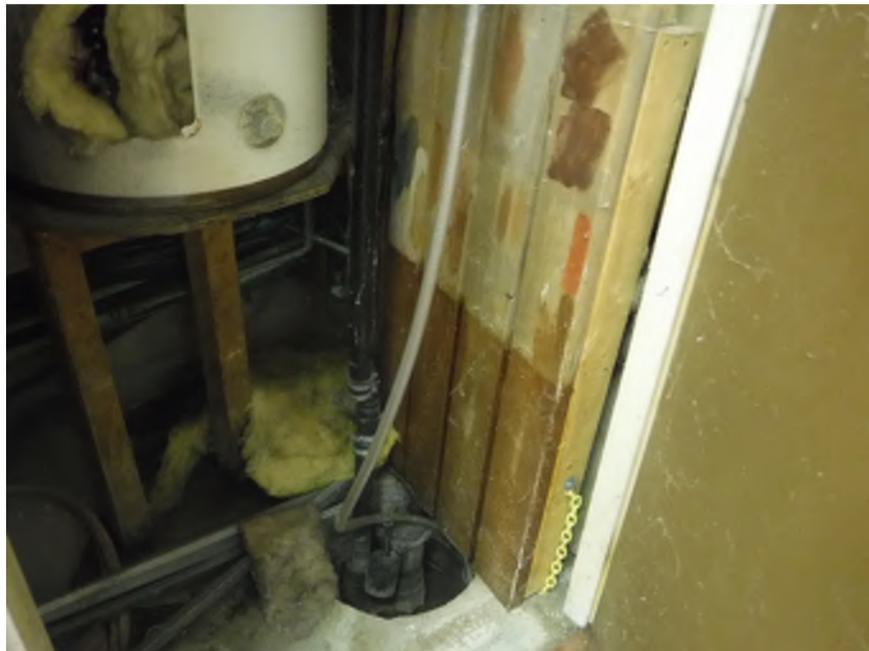
- Four (4) transformers were observed within the buildings interior. These were observed to be 3 phase dry-type transformers.
  - One sump pump (not operational) was located in a closet located on the east side of the building. It was not determined where the sump pump discharges to at the time of the Site visit, however, it is likely into the local storm/sanitary sewer (Photo 24).

**Photo 24. Sump pump located in a closet in the east side of building #5.**

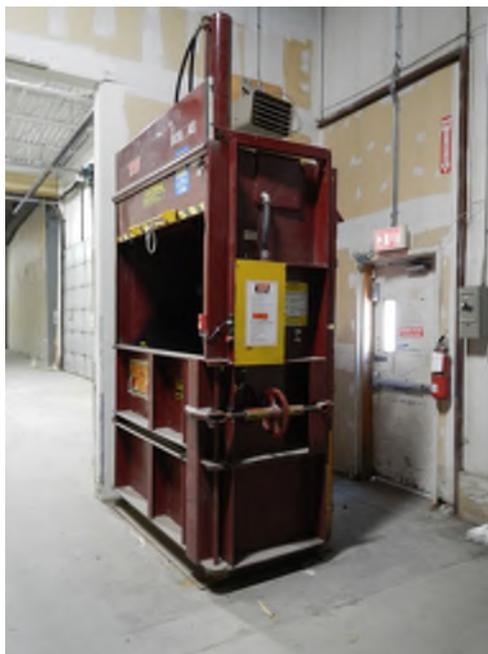
**Photo 25. Garbage compactor located on the southwest corner of building #5.**

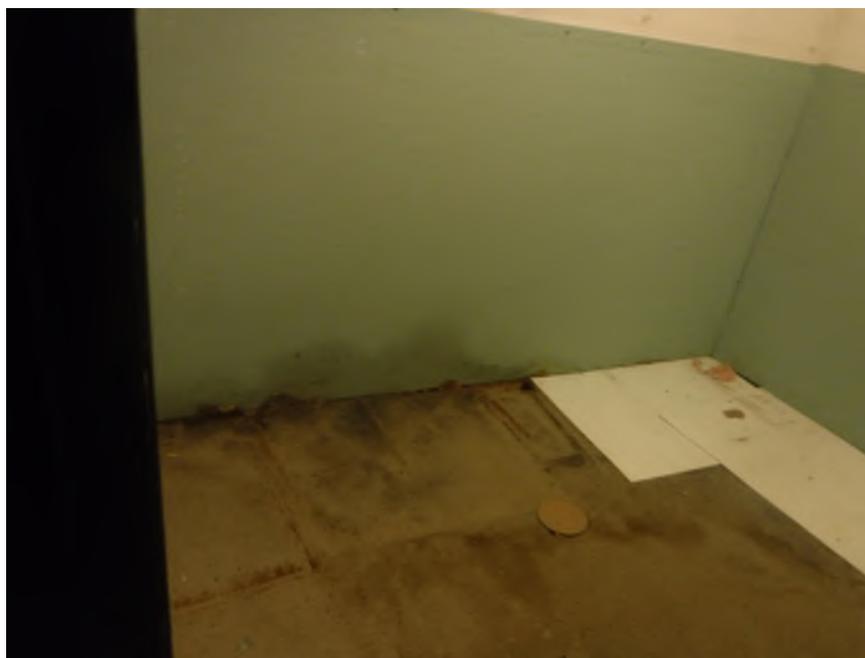
- A large garbage compactor was located in the southeast corner of building #5 (Photo 25).
  - Suspect mould and water staining was observed along the base of the drywall in a room located in the northeast corner of building #5 (Photo 26).

**Photo 26. Suspect mould and water damage located in a room located in the northeast corner of building #5.**

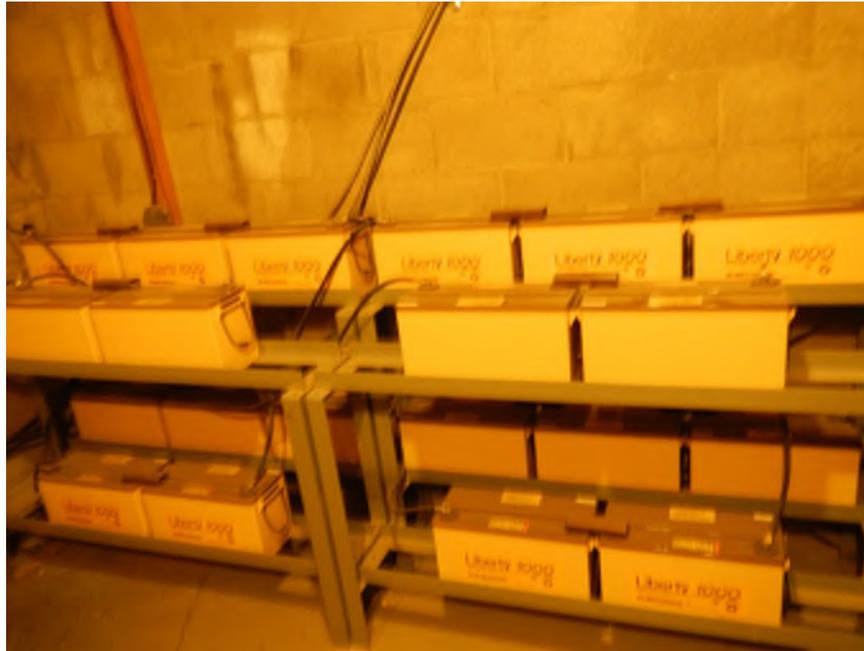
- Water staining around a garage door also observed in the warehouse area located in the south side of building #5.
  - 20 batteries (labelled as 'Liberty 1000') were observed in a room located on the west side of the building. Evidence of leaking from the batteries was not observed at the time of the Site visit (Photo 27).

**Photo 27. Batteries located in a room within the northeast corner of building #5.**

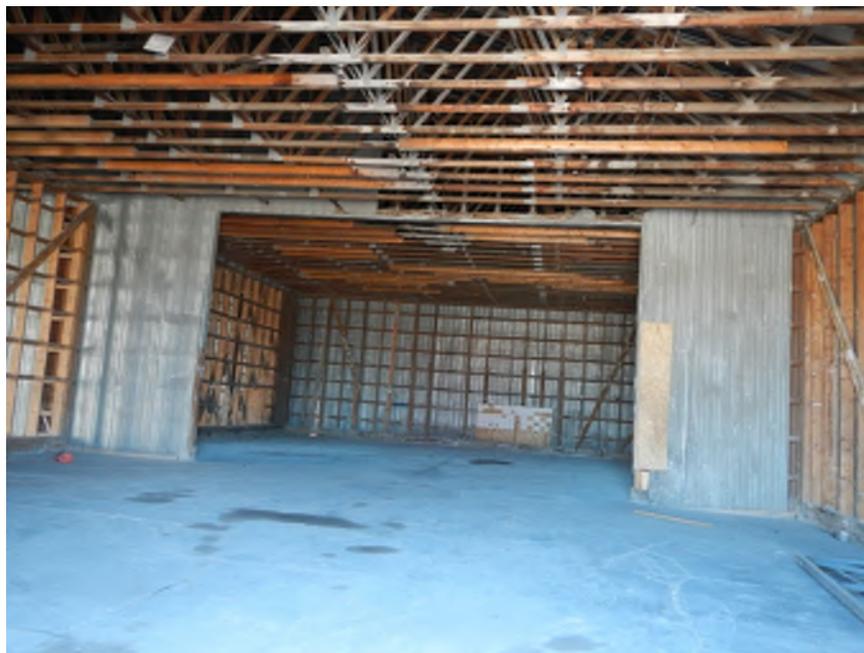
- The building was vacant, and had some light oil staining on the concrete surface of the south side of the building (Photo 28).
- Observations of building #2 during the Site visit include the following:

**Photo 28. Interior of the north shed (shed # 1) located south of building #5 facing east.**

- It was recommended that observed wood debris, bricks, plastics, used tires located on the southwest corner of the Site be disposed of.
- It was also recommended that the floor of Storage building No. 2 be cleaned as a result of some leaking from barrels of hydraulic oil that were stored in the vicinity.

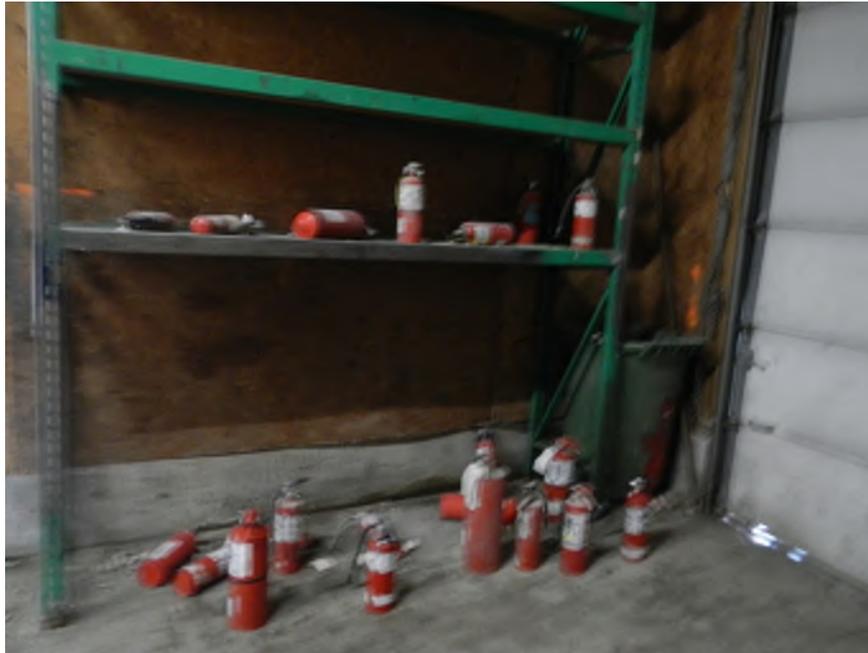
**Photo 29. Fire extinguishers located inside Shed #2.**

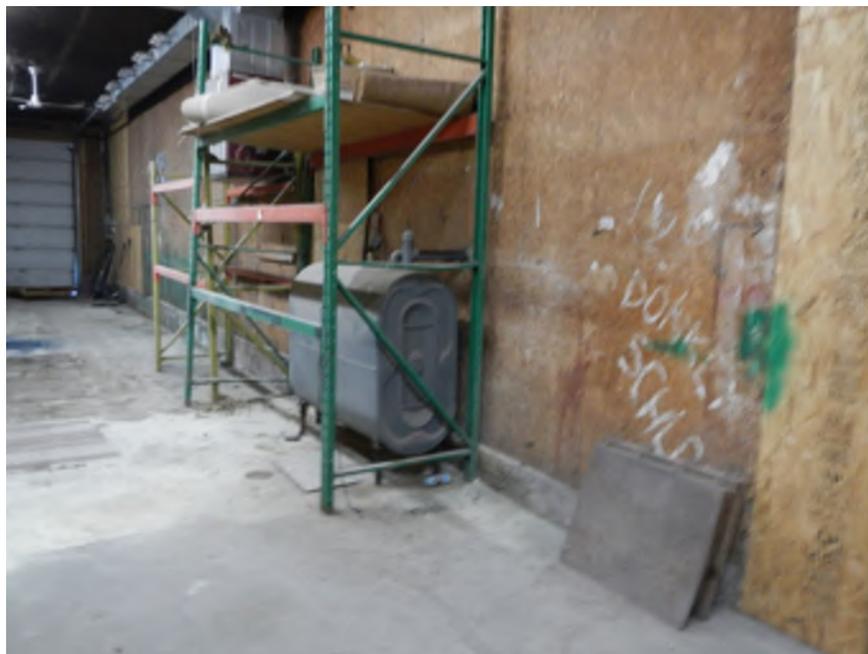
- A heating oil tank (approximately 1000 litres) is located on the north side of the building interior. Evidence of staining or leaking on the concrete slab surrounding the tank was not observed (Photo 30).

**Photo 30. Heating oil tank located in the north side of Shed #2 facing northwest from the east side of the shed.**

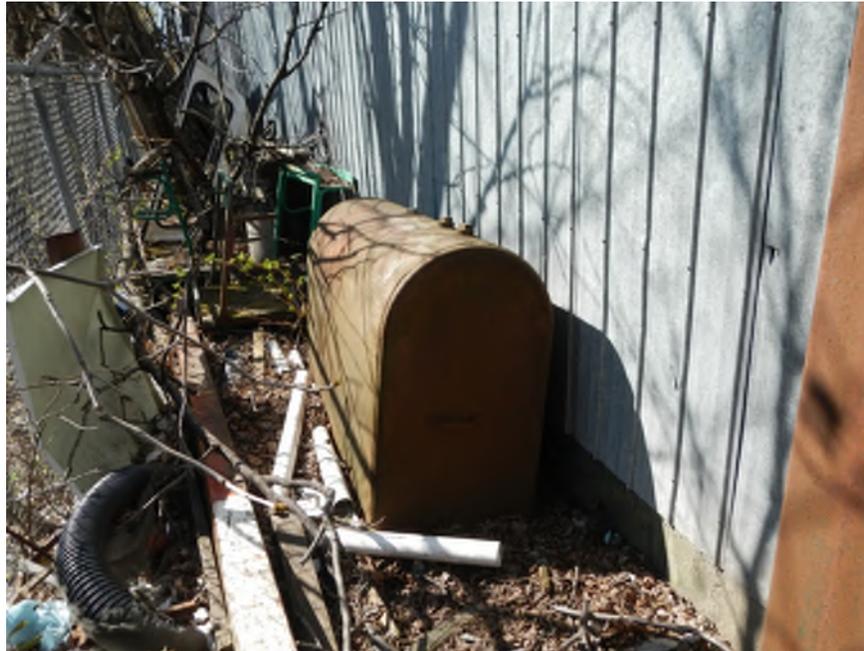
- A heating oil tank (approximately 1000 litres) is also located on the northeast exterior of the building. Odours and evidence of leaking surrounding the tank was not observed (Photo 31).

**Photo 31. Heating oil tank located on the east side of shed #2 (along the east property line) facing south from the northeast corner of the shed #2.**

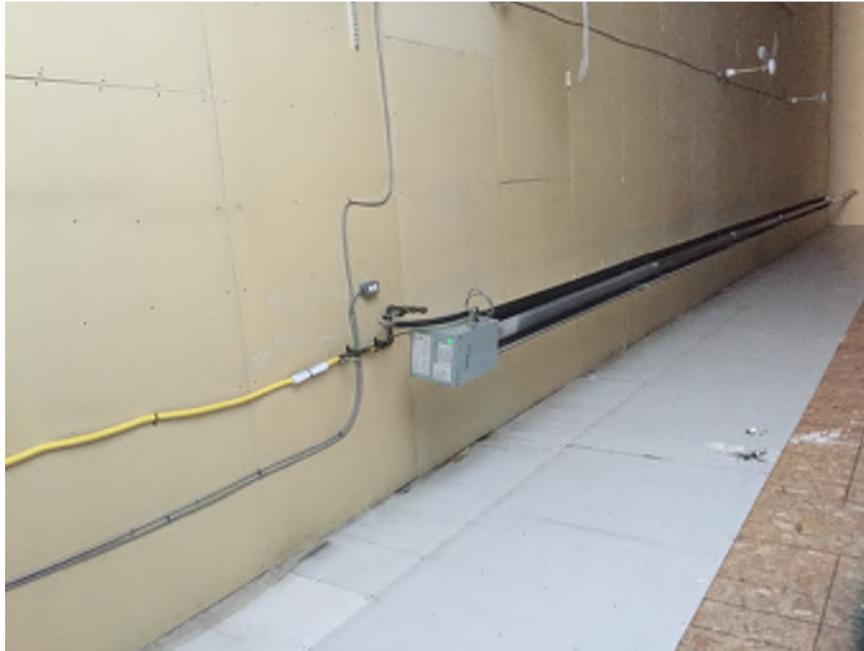
**Photo 32. Natural gas heater located on the south side of shed #2.**

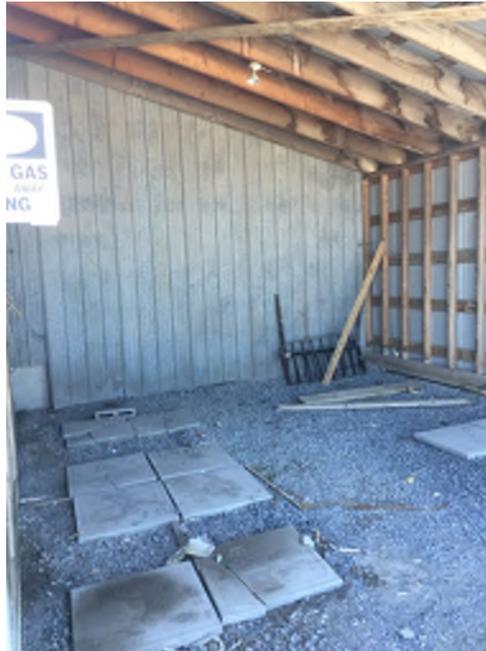
- A small sheltered area was located on the southwest side of the building that formerly held 3 diesel tanks. Although the tanks have been removed, residual petroleum odour and visible staining were observed in this area (Photo 33).

**Photo 33. The southwest corner of Shed #3 (where diesel fuel tanks were historically located).**

A Phase Two ESA is recommended to investigate soil and groundwater quality in the vicinity of the APECs identified at the Site.

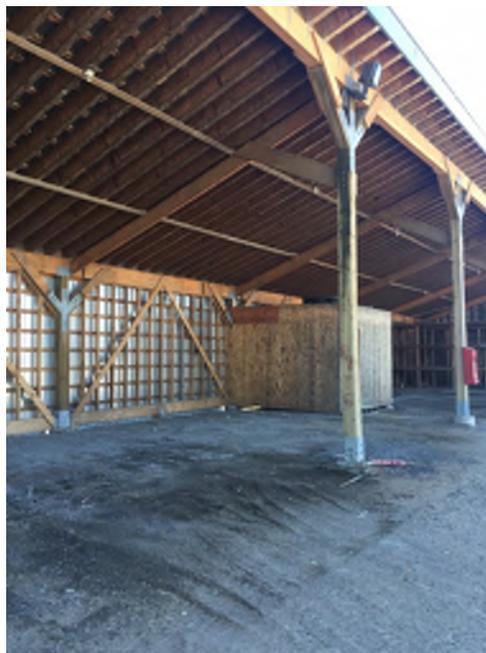
- Observations of building #4 during the Site visit include the following:
  - The construction of the building is concrete slab on-grade with a wood frame and sheet metal exterior on three sides (east, south and west). A small room was located in this shelter with a small electrical heater (Photo 34).

**Photo 34. Representative photograph of the interior of shed # 4.**

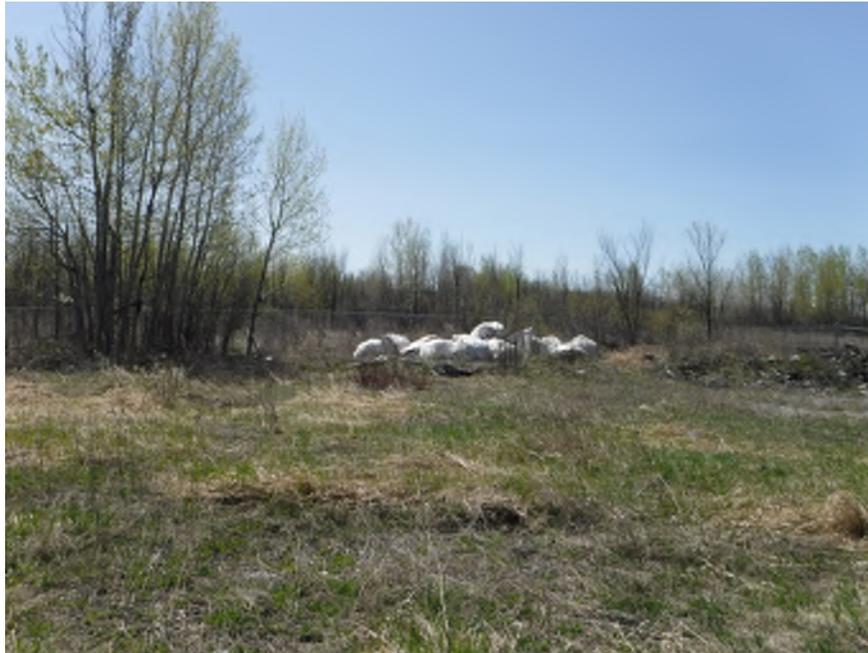
- Some wood, plastic, metal and construction debris was observed along the east property line. A fence is located in this area running north-south along the east property line as well (Photo 35).

**Photo 35. Pile of plastic and construction debris located south of the 'overstock storage yard', in the grassy area on the northeast corner of the fence.**

It is also recommended that the miscellaneous plastics, wood, drywall and construction debris located across the north section of the Site be disposed of.

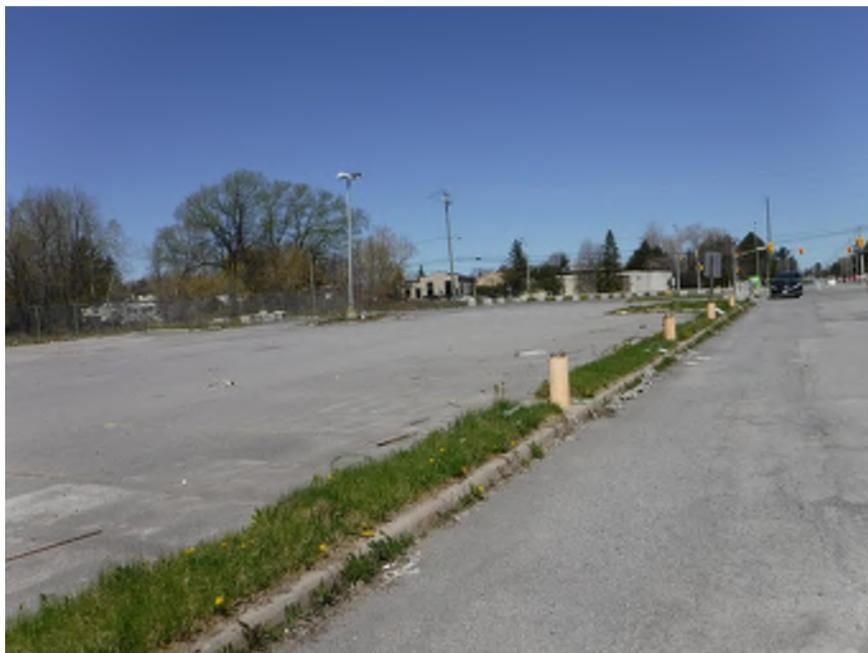
- This property was vacant at the time of the Site visit, with the south surface of the property gravel and asphalt on the north. A chain link fence followed by a treed area is located along the west property line. A chain link fence is also located across the centre of the property oriented east-west (Photo 36).
- An empty spray paint can was observed in the centre of the property.

**Photo 36. Northwest corner of the Site (3604 Innes Road) facing north from the south portion of the Site entrance.**

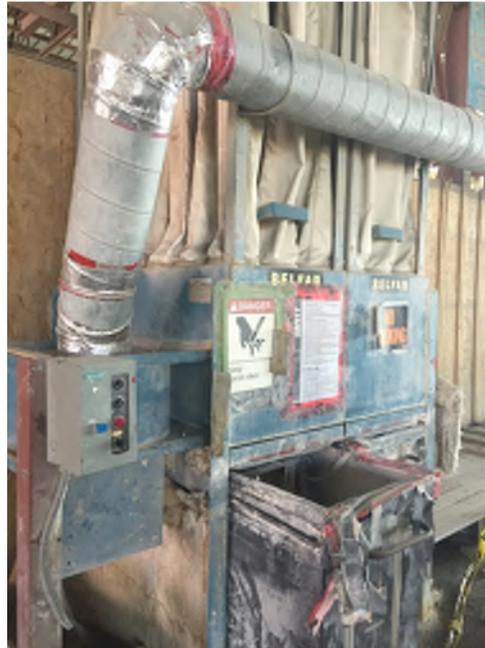
- Some miscellaneous garbage and discharged fire extinguishers were observed throughout the ground of the building.
  - A saw dust collection system is located in the centre of the building (Photo 38)

**Photo 38. Saw dust collector system located in building #6.**

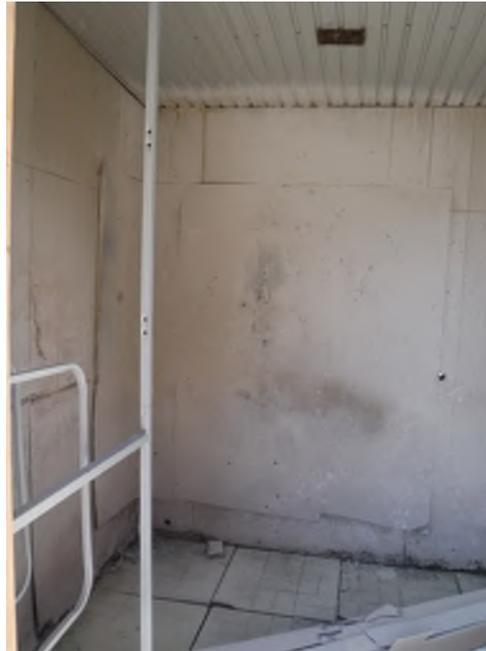
**Photo 39. Interior of circular saw shed (building #8) where fire extinguishers had been discharged.**
