Phase I Environmental Site Assessment

Vacant Land
Trim Road and Portobello Boulevard
Ottawa, Ontario

January 20, 2018

Report: PE4111-1

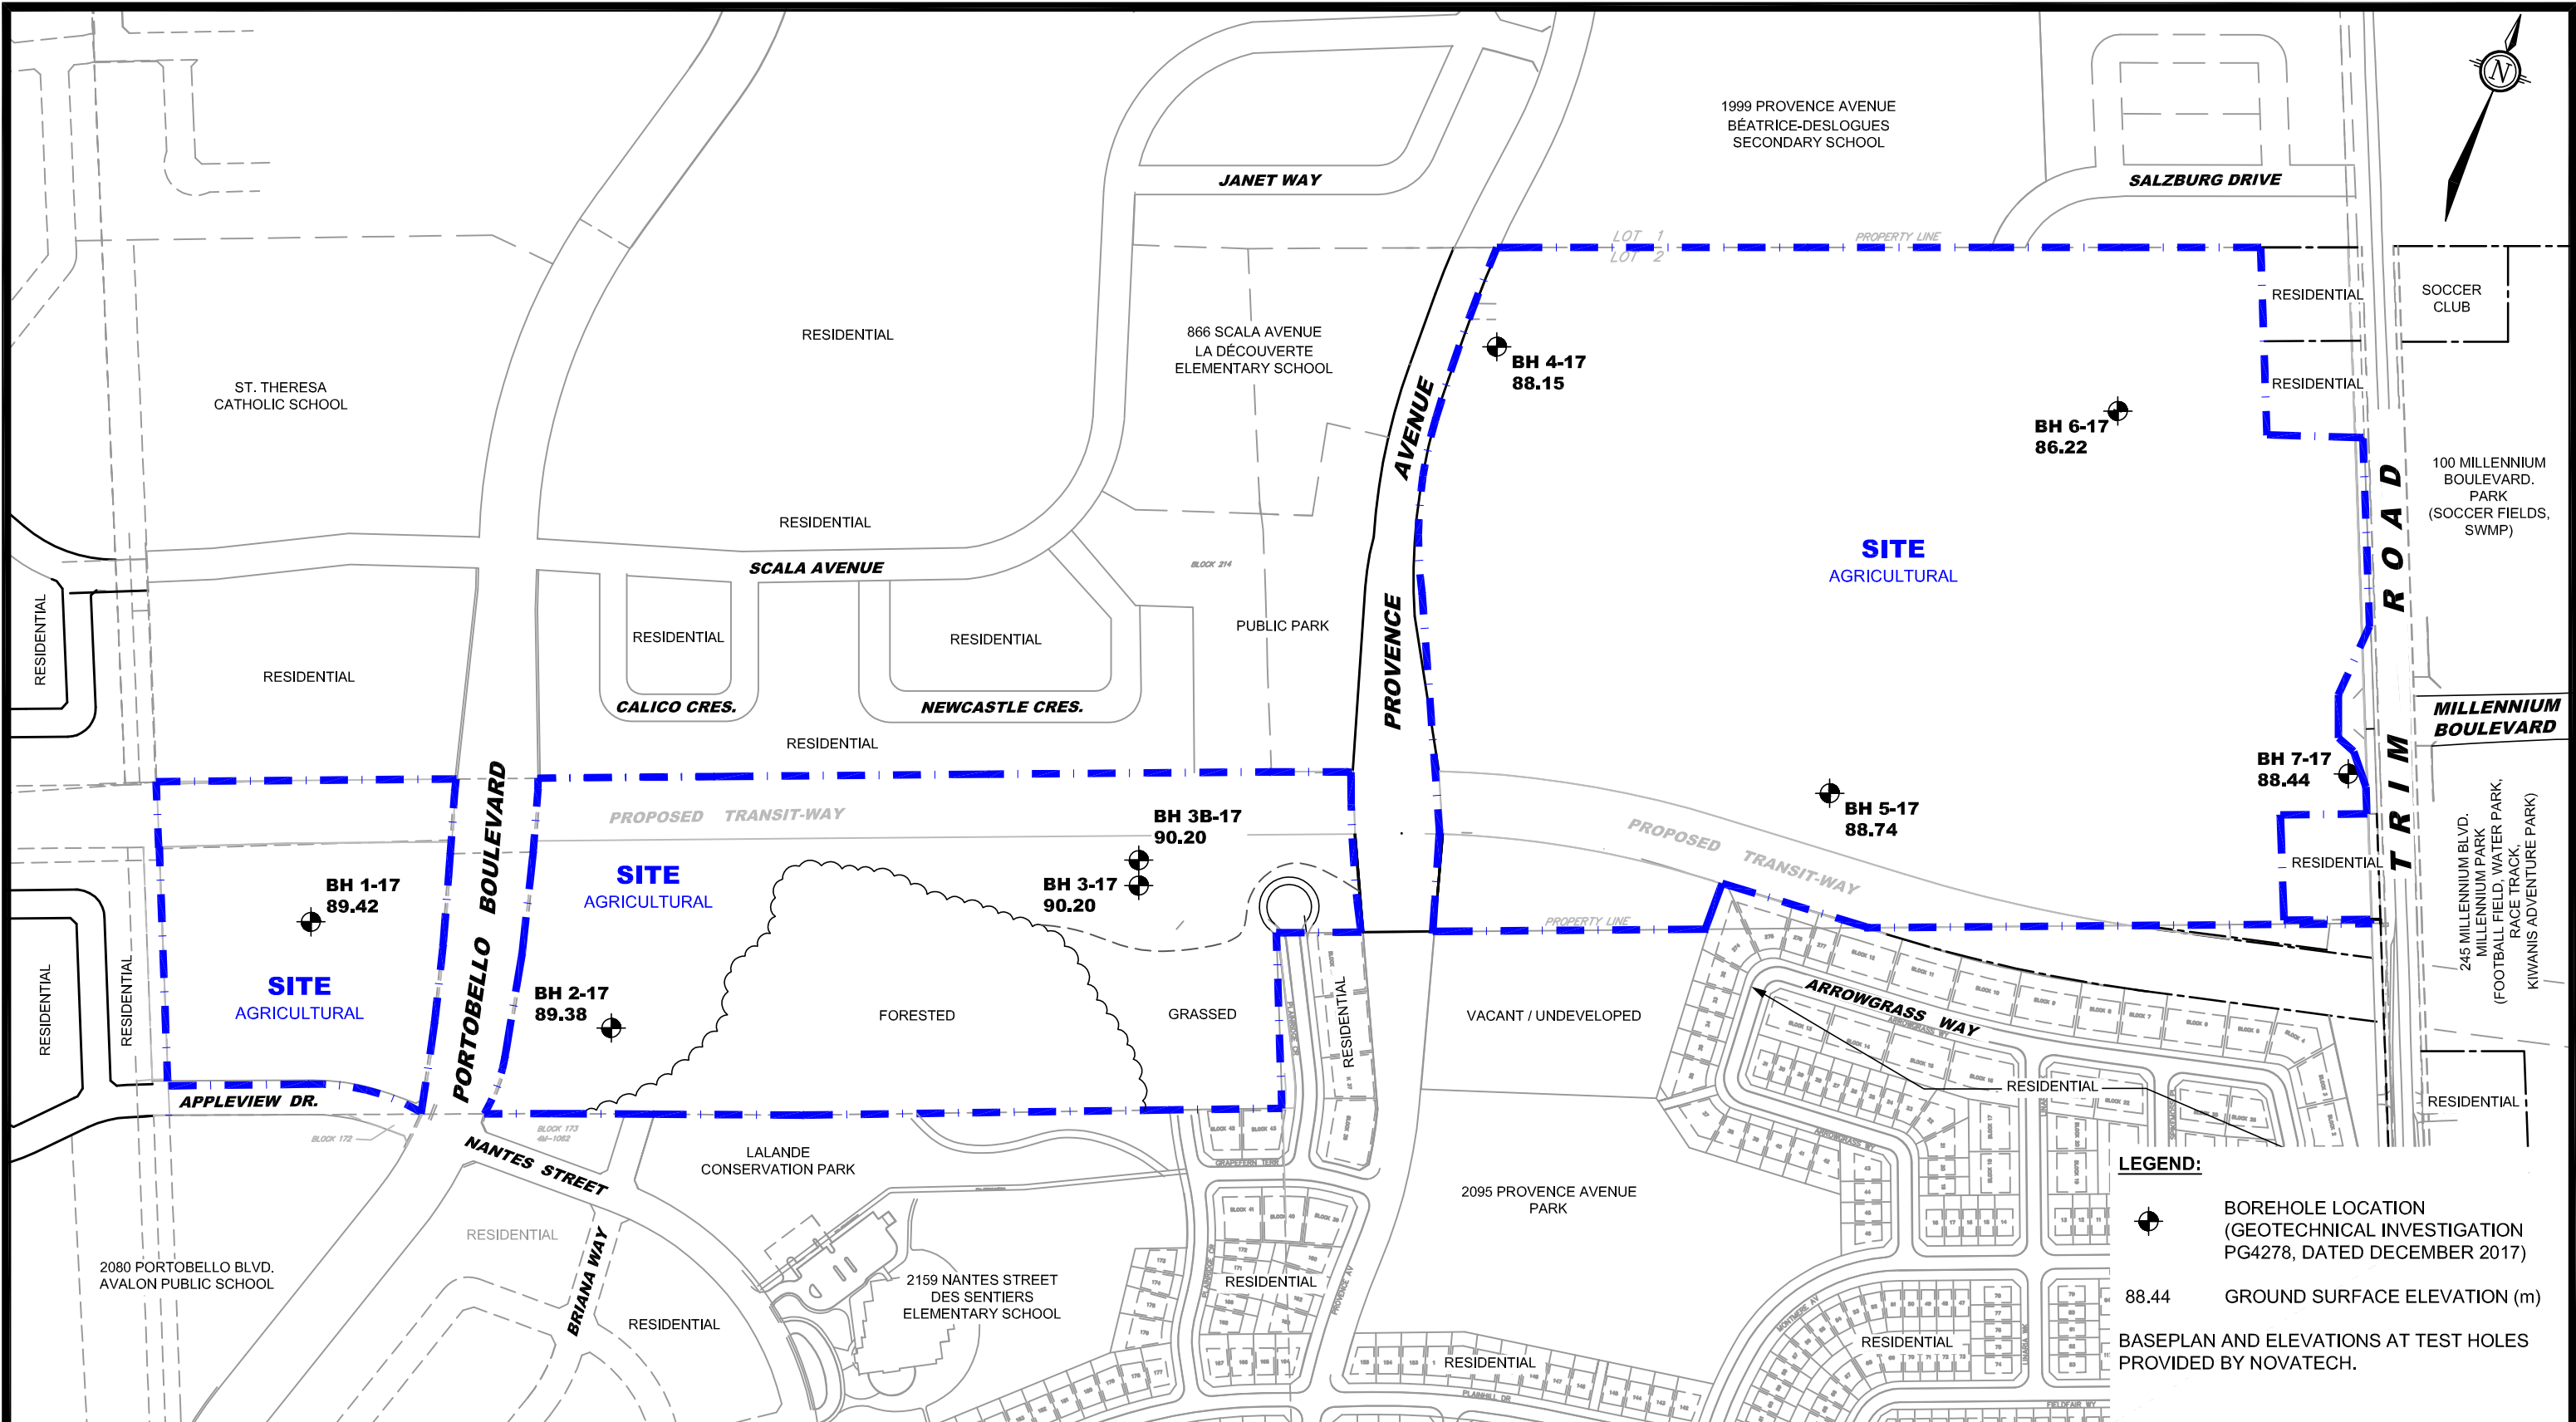
Scale:	1:4000	Date:	01/2018
Drawn by:	RCG	Report No.:	PE4111-1
Checked by:	MM	Dwg. No.:	PE4111-1
Approved by:	MSD	Revision No.:	0

borehole data collected as part of the 2017/18 geotechnical investigation conducted by Paterson, shallow bedrock (depth 0 to 3m) occurs on the southcentral portion of the site (near BH3 and BH3b on Drawing PE4111-1).

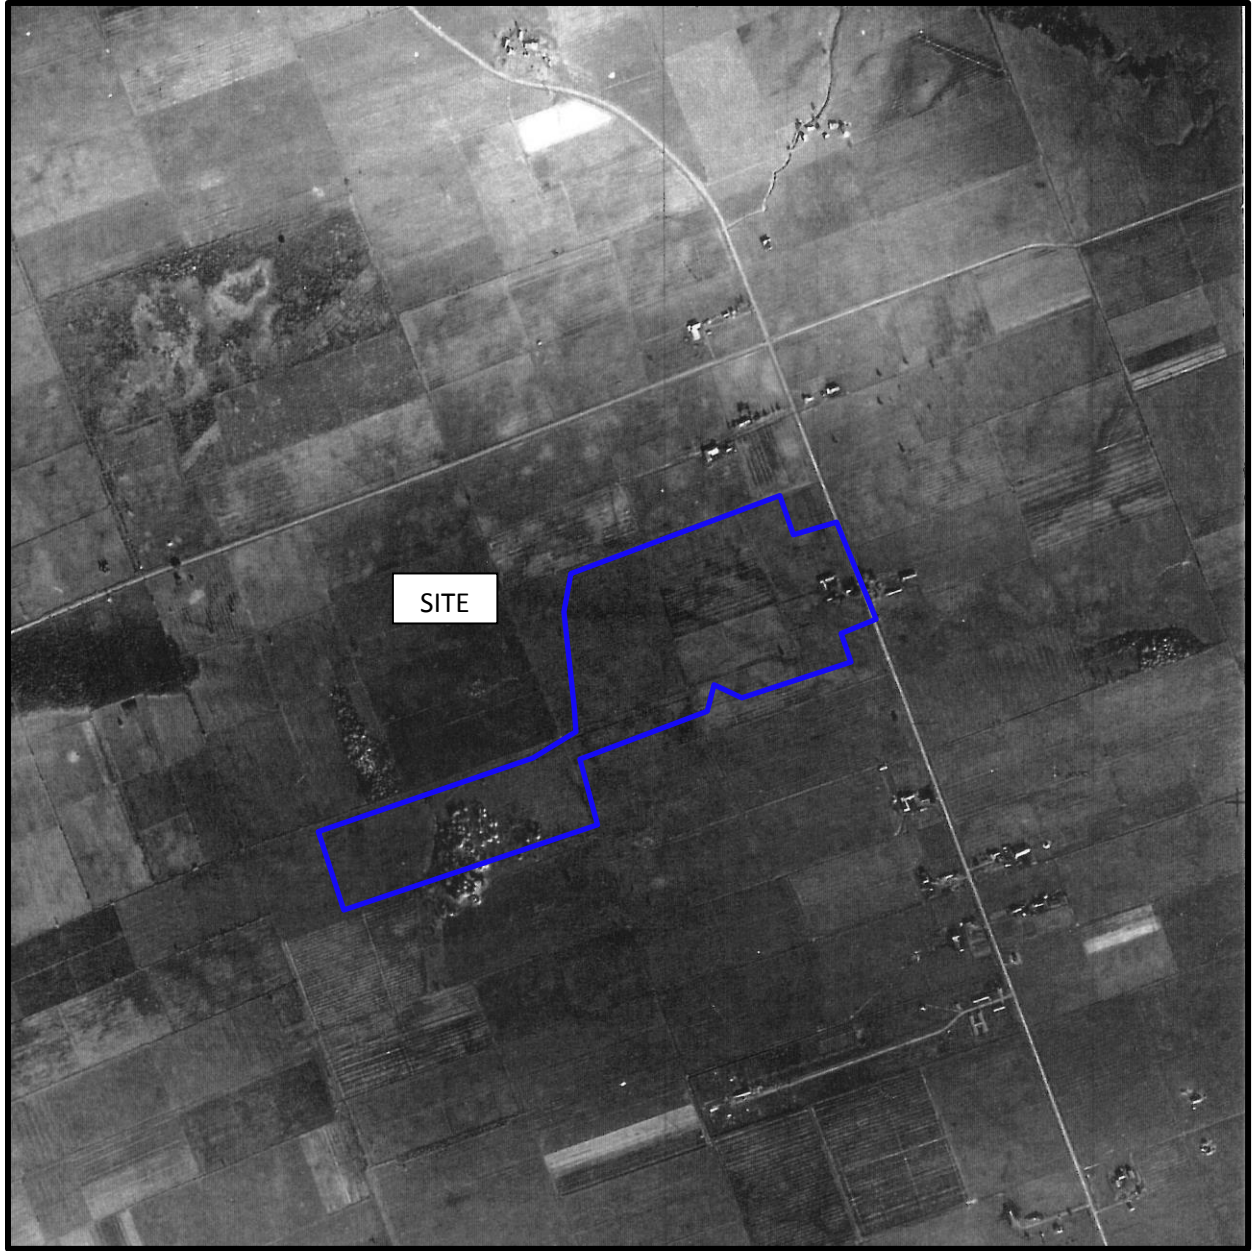
AERIAL PHOTOGRAPH
1945

| 1945 | The subject site appears mainly vacant or used for agricultural purposes. The eastern perimeter of the subject site is occupied by a farmstead, a barn and several small garages or sheds (adjacent to Trim Road). Agricultural lands surround the subject site and farmsteads are visible along Trim Road. A small forested area is visible in the southwest portion of the subject property. |

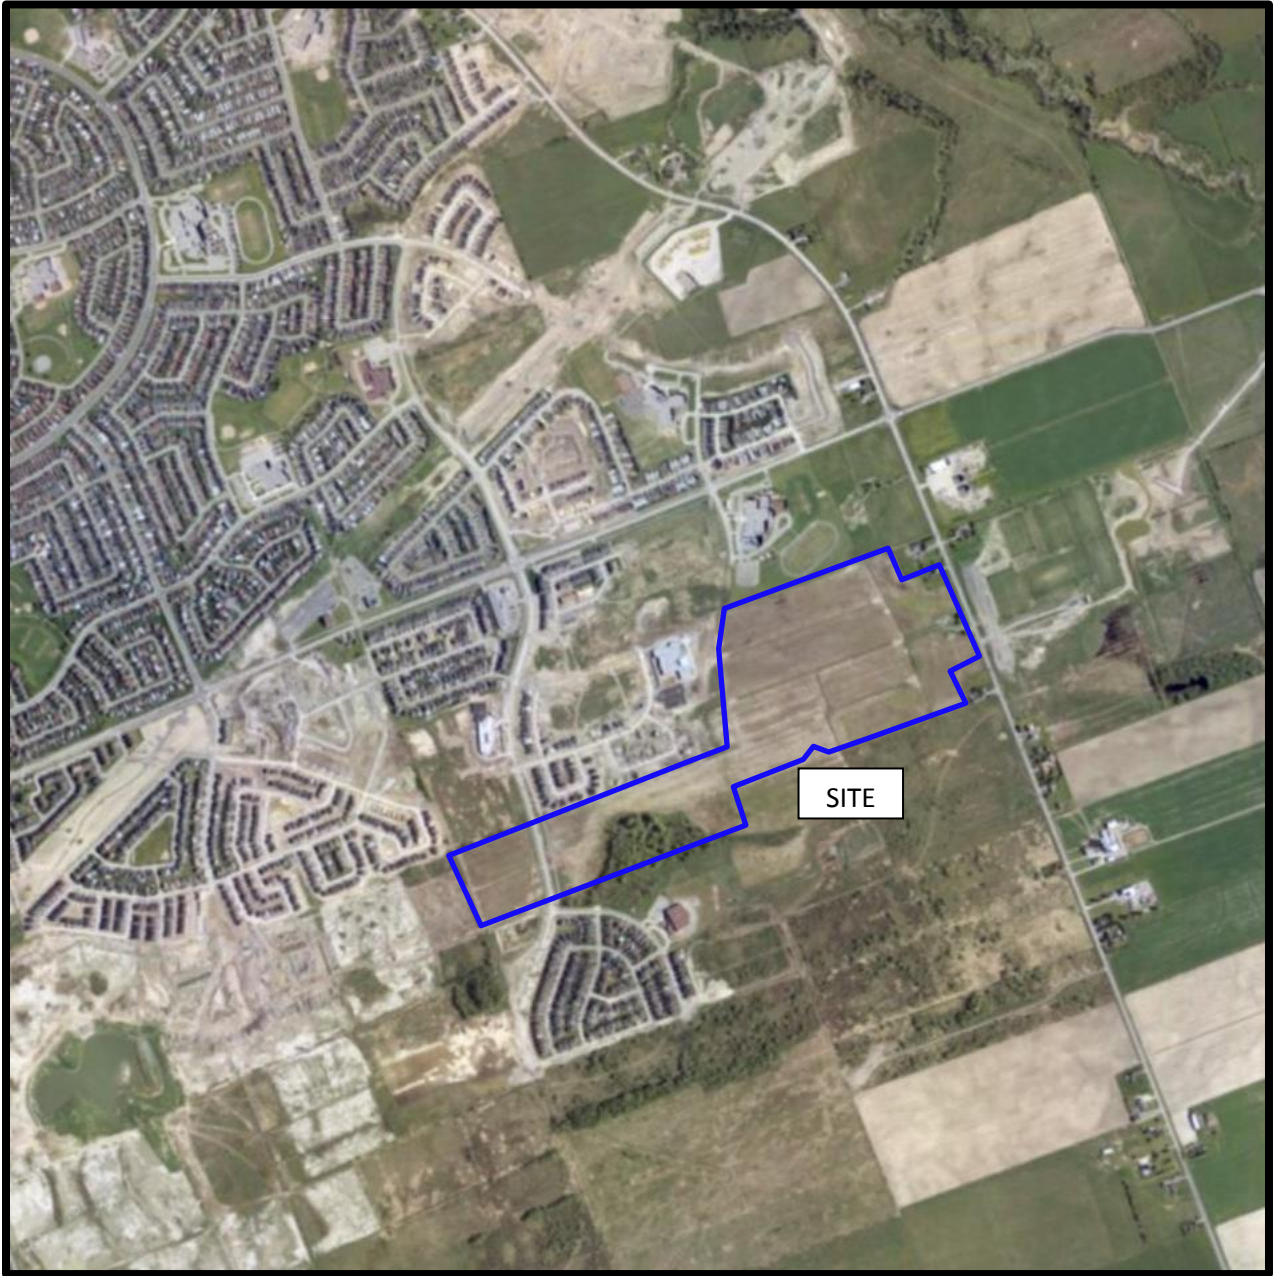
AERIAL PHOTOGRAPH
2002

| 2002 | (City of Ottawa website) The structures on the subject site have been demolished. A pile of rubble is visible on the subject site in the former location of the structures. Several residential developments have been constructed north and south of the subject site. Two (2) schools have been constructed north of the subject site. Soil grading (for soccer fields and additional developments) is visible north and west of the subject site, as well as on the east side of |

Trim Road. Additional residential dwellings are being constructed north of the subject site, along Portobello Boulevard and Scala Avenue.

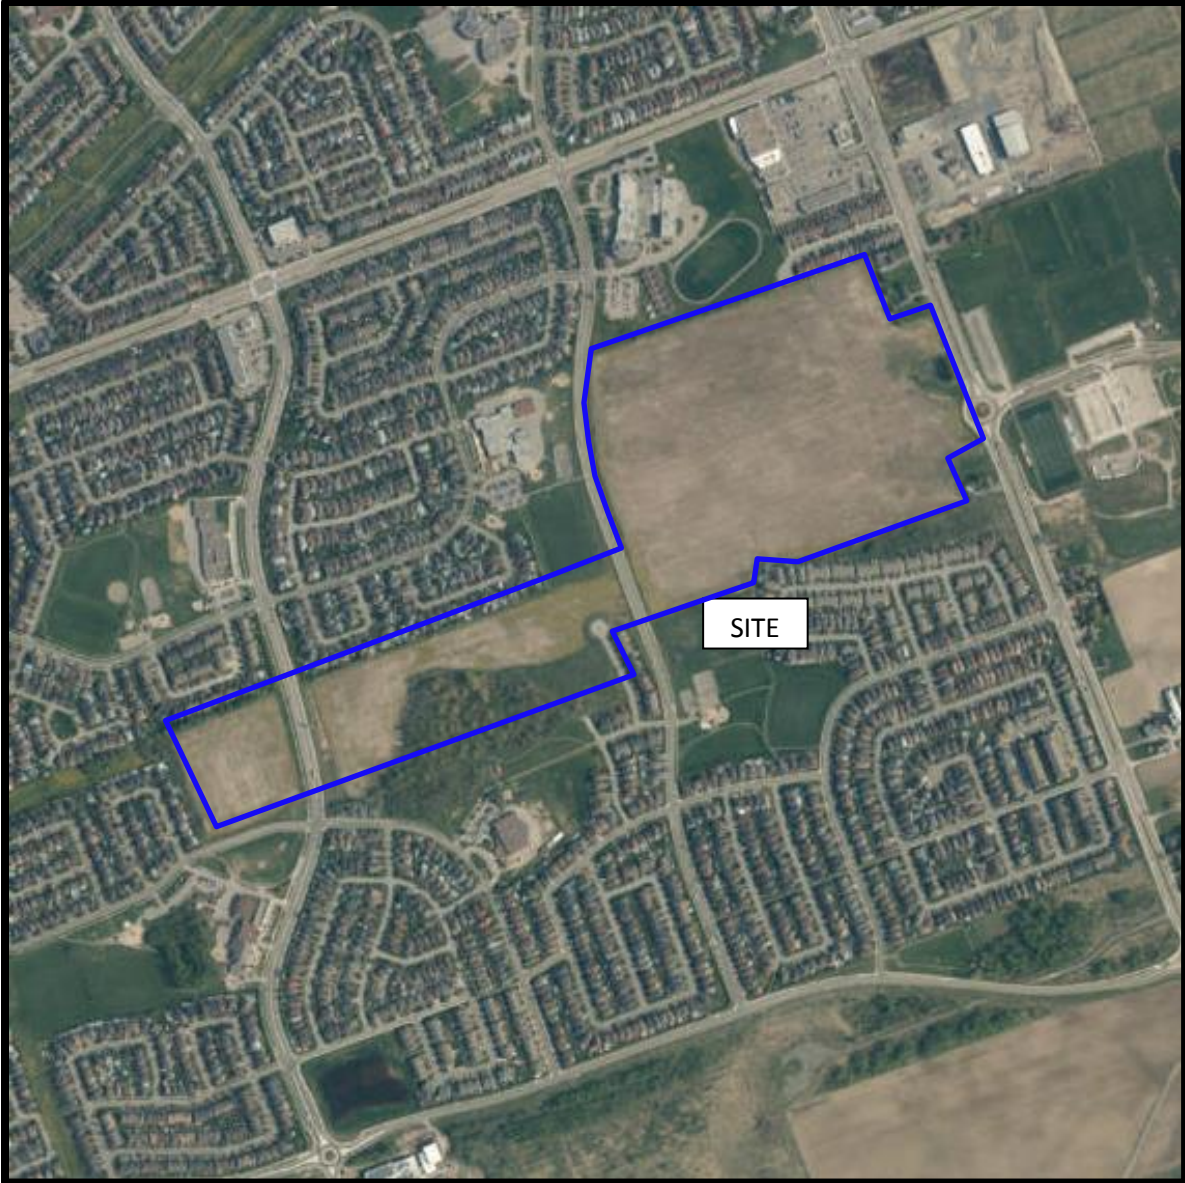
AERIAL PHOTOGRAPH
2017

2017 (City of Ottawa website) The subject site and neighbouring properties appear as they do today. Residential dwellings have been constructed south (north of Montmère Avenue and east of Provence Avenue) and north (along Scala Avenue) of the subject site. The City of Ottawa's Trim Road Garage Depot is visible further to the northeast, on the east side of Trim Road (2035 Trim Road and 5300 Innes Road).

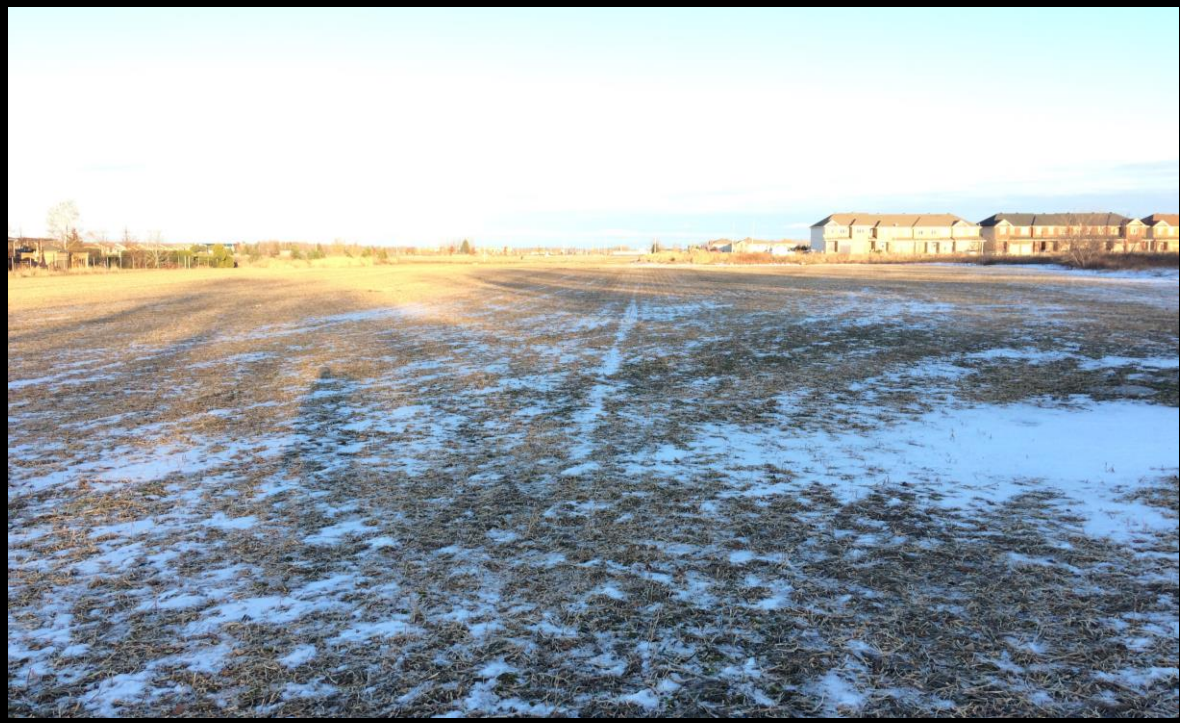
Photograph 3: View of the central portion of the subject site, facing southwest.

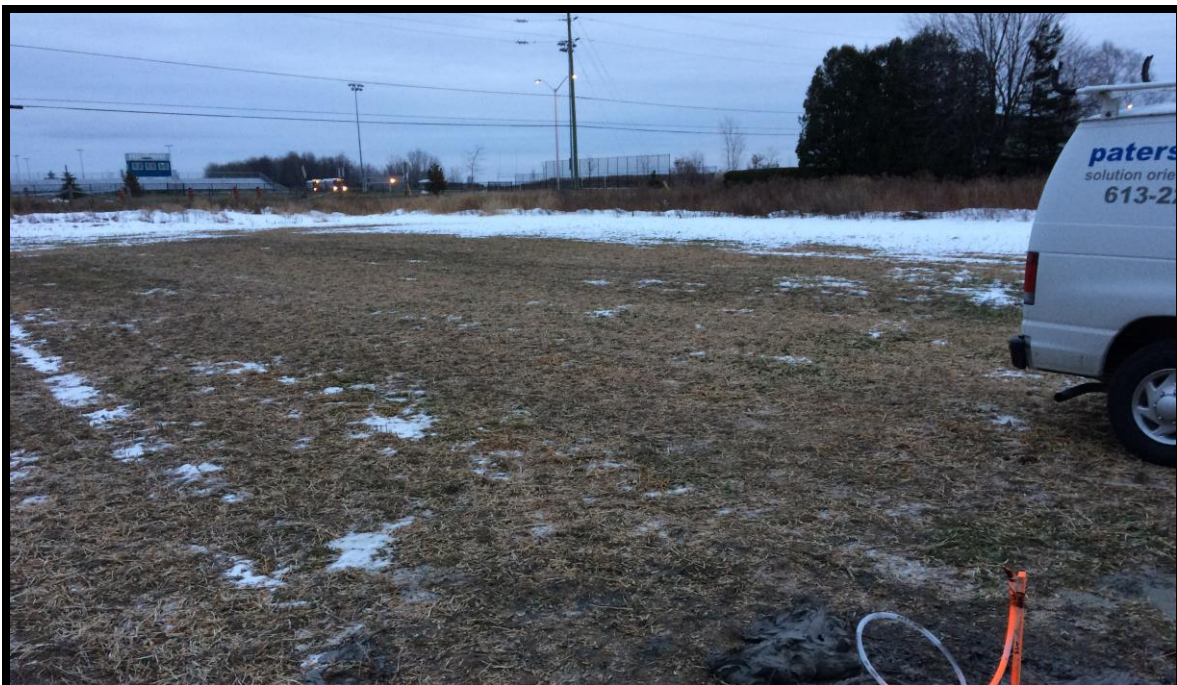
Photograph 4: View of eastern portion of the site, adjacent to Trim Road. Photograph taken facing northeast.
