## Phase I-Environmental Site Assessment

760 River Road  
Ottawa, Ontario

Claridge Homes

Report: PE4467-1

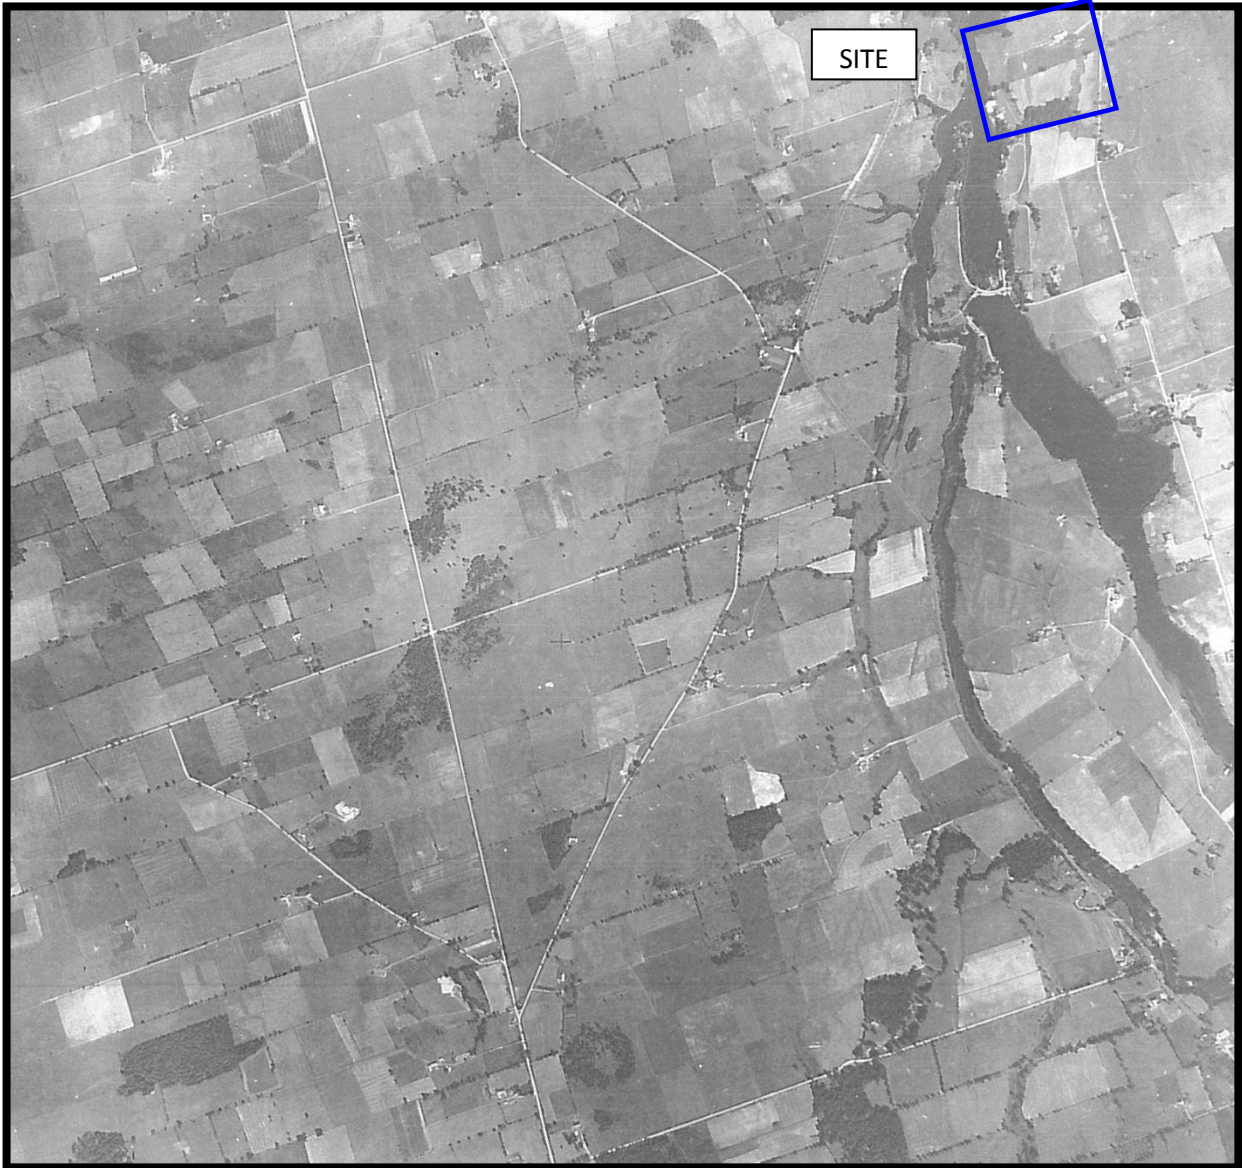
AERIAL PHOTOGRAPH  
1946

| 1946 | The subject site appears to be occupied by a couple of large barn-like structures, a private garage and residential dwelling. The majority of the subject land is agricultural fields. The surrounding lands appear as vacant agricultural land with occasional residential dwellings. The Rideau River is present to the west and River Road is present to the east. |

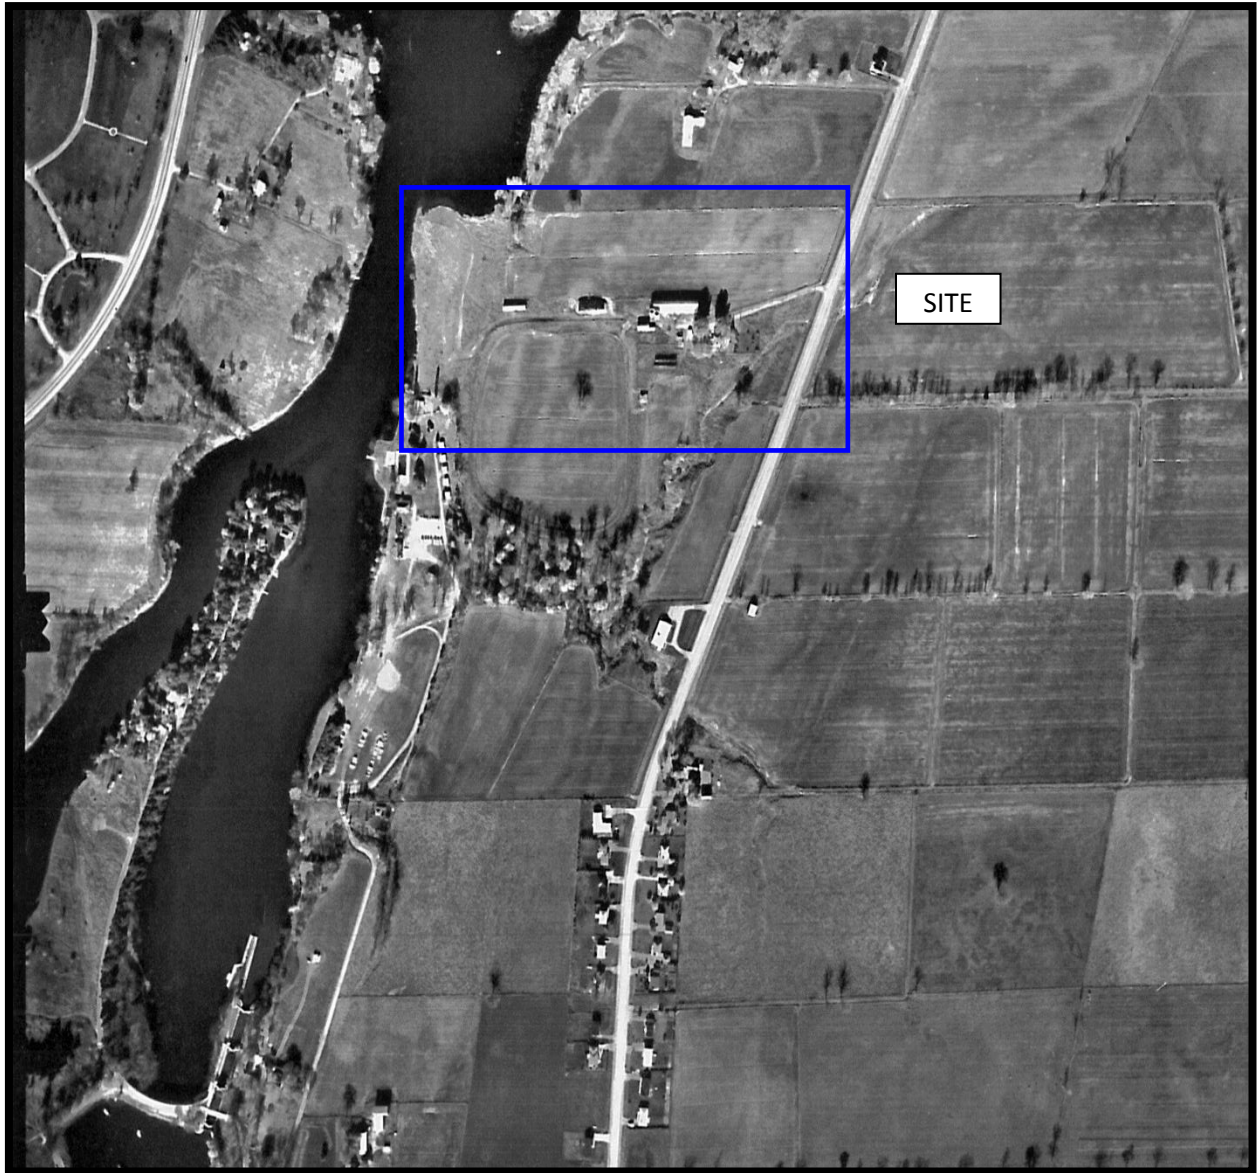
AERIAL PHOTOGRAPH  
1968

| 1968 | No significant changes are apparent to the subject site. The adjacent property to the north appears to be occupied by a farmstead as well. No significant changes have been made to the surrounding lands. |

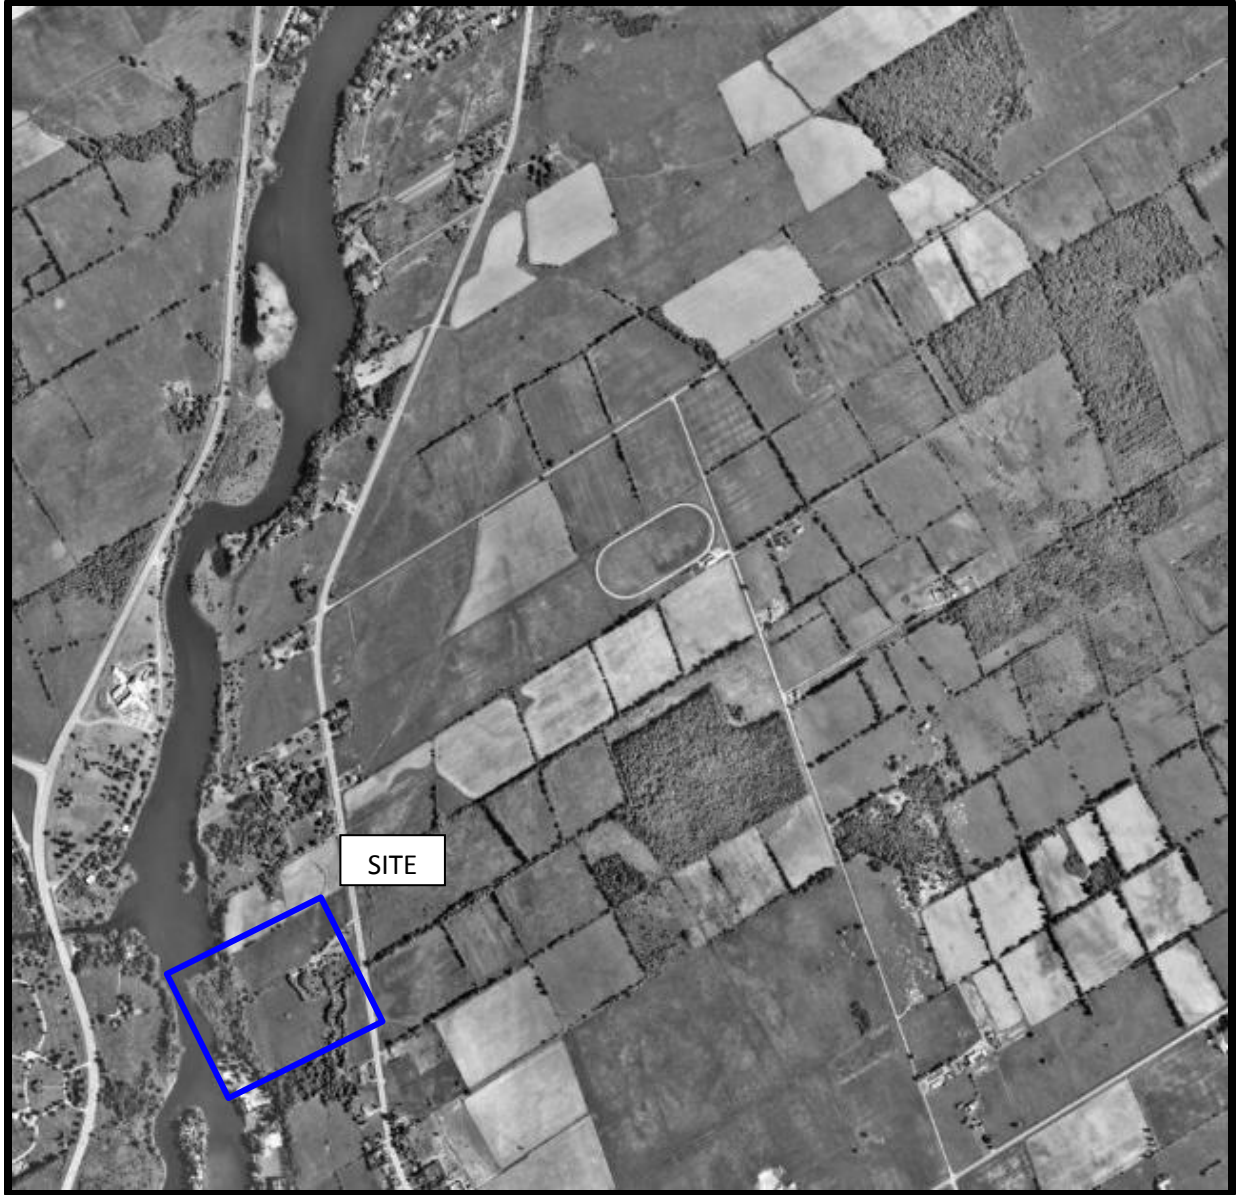
AERIAL PHOTOGRAPH  
1991

| 1991 | No significant changes are apparent to the subject site or surrounding area, with the exception of more tree coverage on the subject property. |

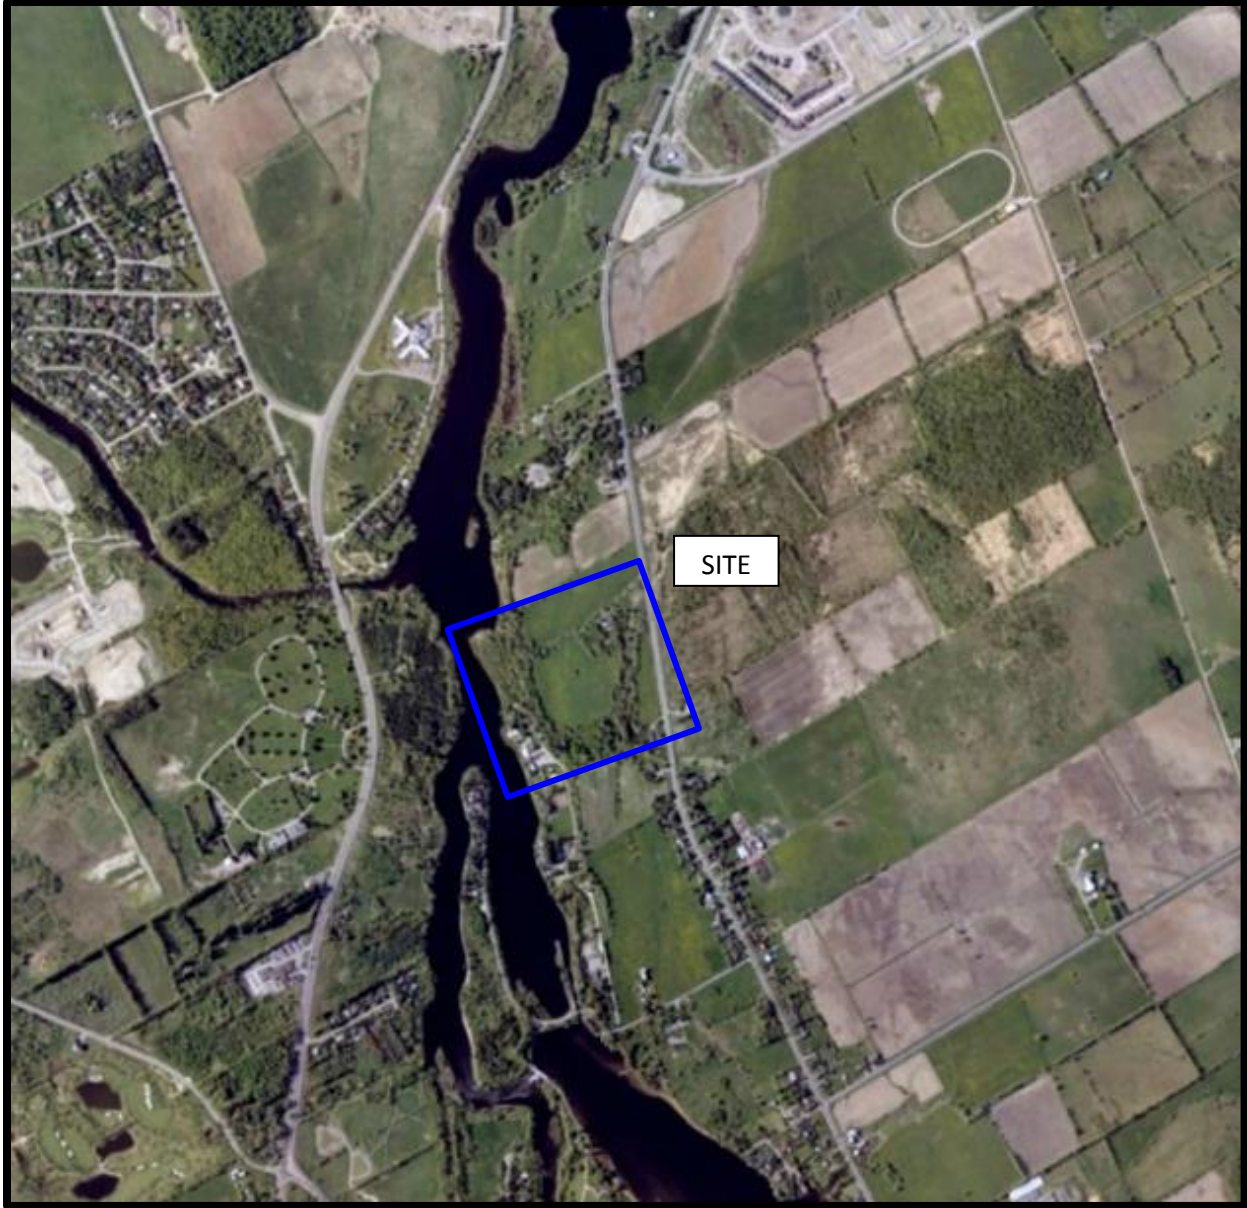
AERIAL PHOTOGRAPH  
2002

- 2002      No significant changes have been made to the subject site or surrounding properties. Residential development is beginning to occur further to the north.
- 2017      All of the previous structures on the subject site have been demolished and no longer exist at this time. The subject site and adjacent properties to the north, east, and south appear as vacant lands. The surrounding lands appear unchanged from the previous photograph, with the exception of further to the north, where there has been an increase in residential development.

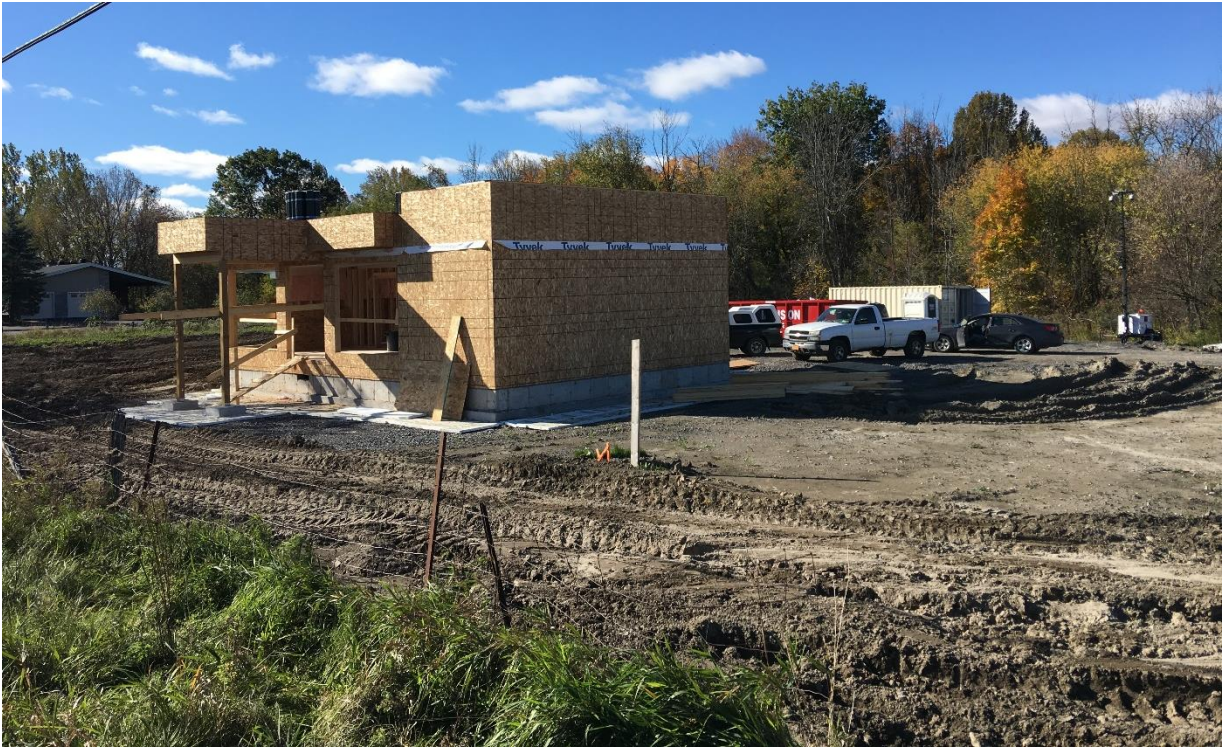
There is one structure currently under construction on the southeast corner of the subject site; a sales centre for the future residential development. No

Photograph 1: View of the southeast end of the subject property, looking onto a future sales office.

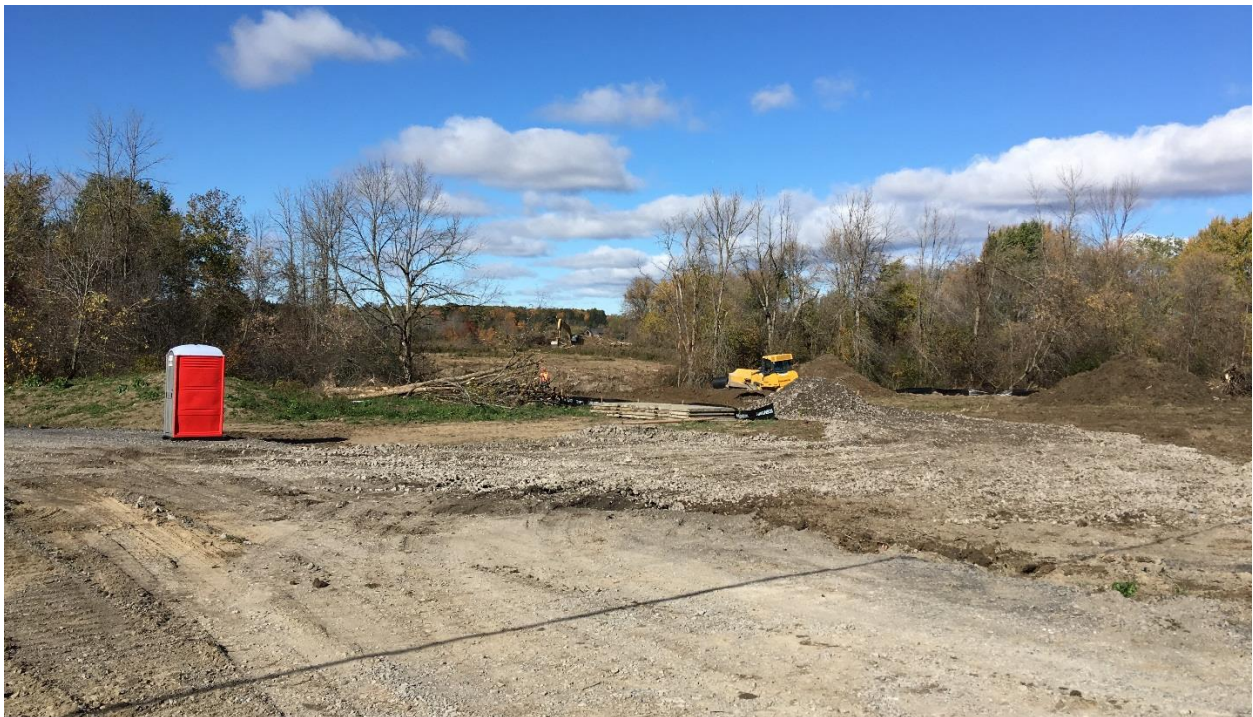
The site is vacant and in the initial grading stages for the proposed residential development. The site is covered by soil and some gravel along the eastern edge of the property, while the majority of the remaining land along the western and northern edges is grass, brush and tree covered.

Photograph 2: View of the central portion of the subject site, taken from River Road.

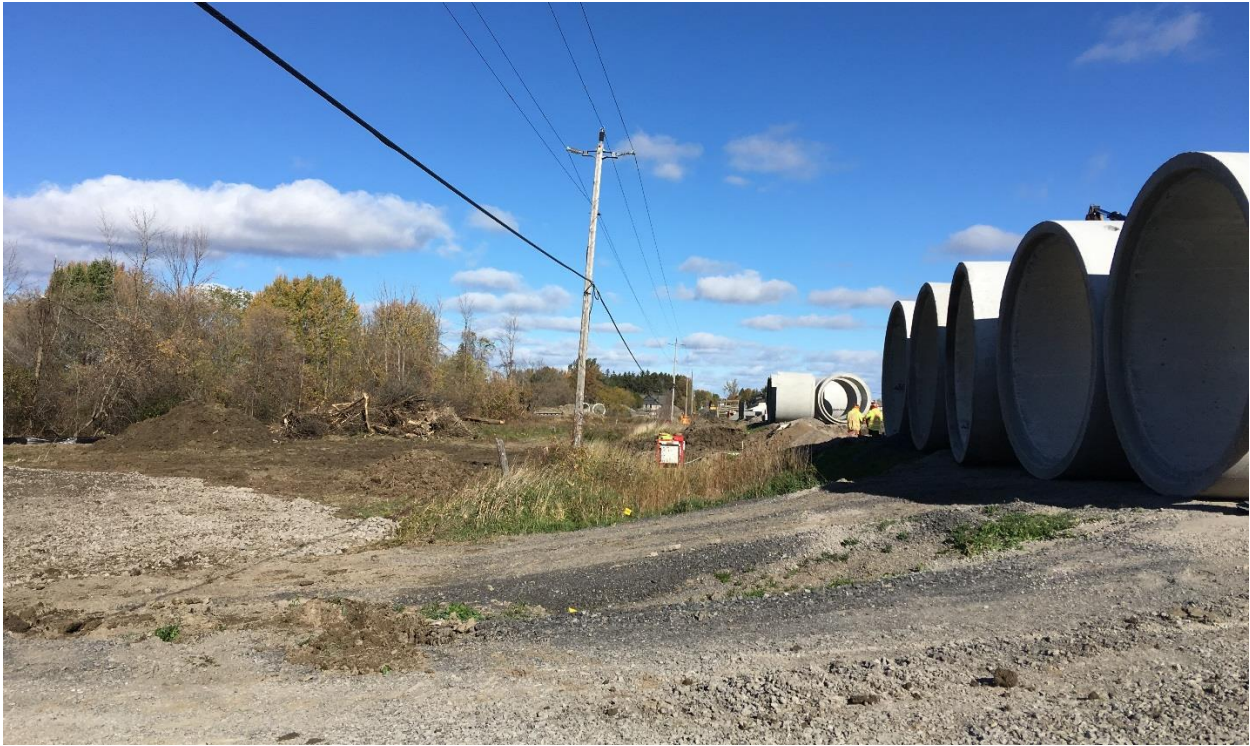
Evidence of some fill placement was observed on-site. The fill consisted of native soil that most likely originated from the subject site. Some gravel was also observed on site to create an access lane. The fill was not considered to be deleterious and does not pose an environmental issue.

Photograph 3: View of the northeast side of the subject site, along River Road, looking north.

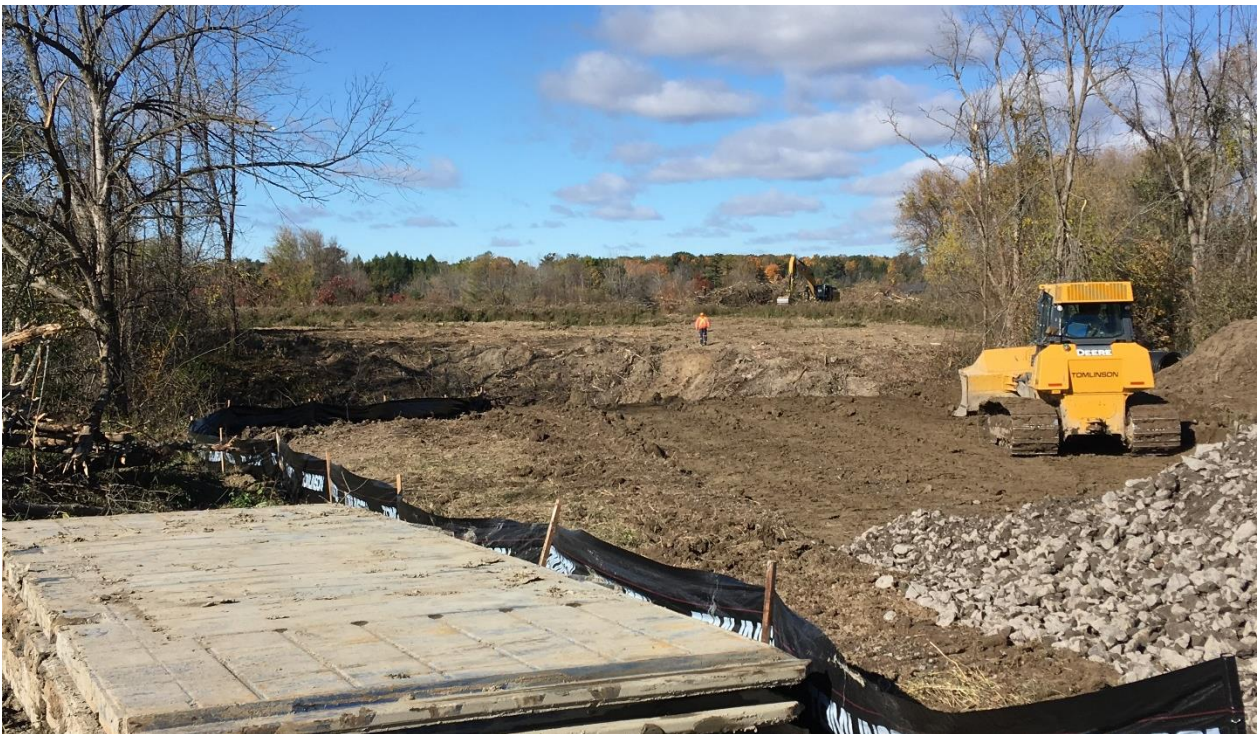
Photograph 4: View of the central portion of the subject site, looking west.
