CANADA LANDS COMPANY
REPORT NUMBER: 19M-00609-00-CLC

GEOTECHNICAL STUDY 530 TREMBLAY ROAD, OTTAWA, ON

NOVEMBER 2019

PROJECT NO.: 19M-00609-00-CLC
DATE: NOVEMBER 2019

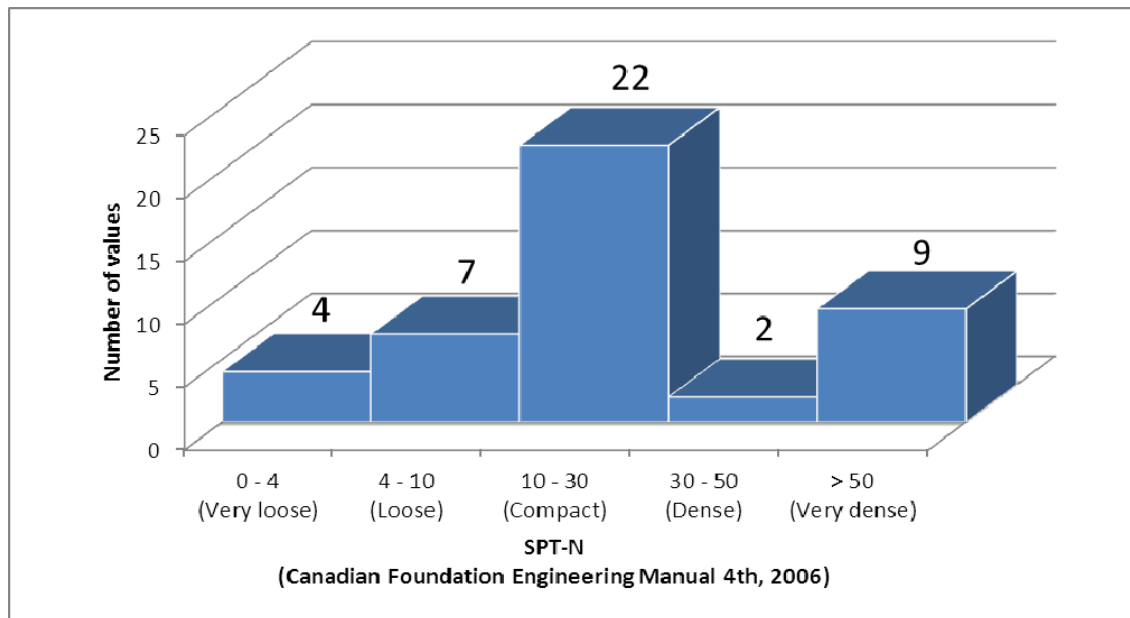
Figure 1: SPT-N Distribution

Standard penetration test N values near the surface were generally below 10, indicating that the density of the till is loose to very loose. N values were higher at lower elevation, until refusal was encountered within the till, fractured rock or bedrock. It is to be noted that water content was higher where density is lower.

Figure 1 presents SPT-N distribution obtained in till deposit.

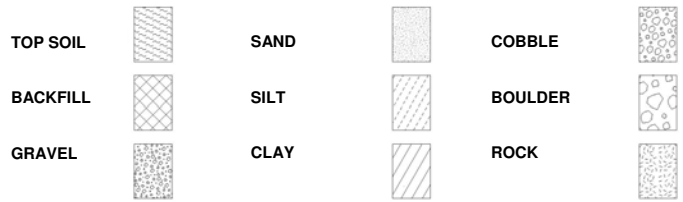
SYMBOLS

Description of the stratigraphic units: Every geological formation is detailed. The proportion of the different elements of the soil, defined according to the size of the particles, is given following the classification hereafter. The relative compactness of cohesionless soils is defined by the "N" index of the Standard Penetration Test. The consistency of cohesive soils is defined by their shear resistance.

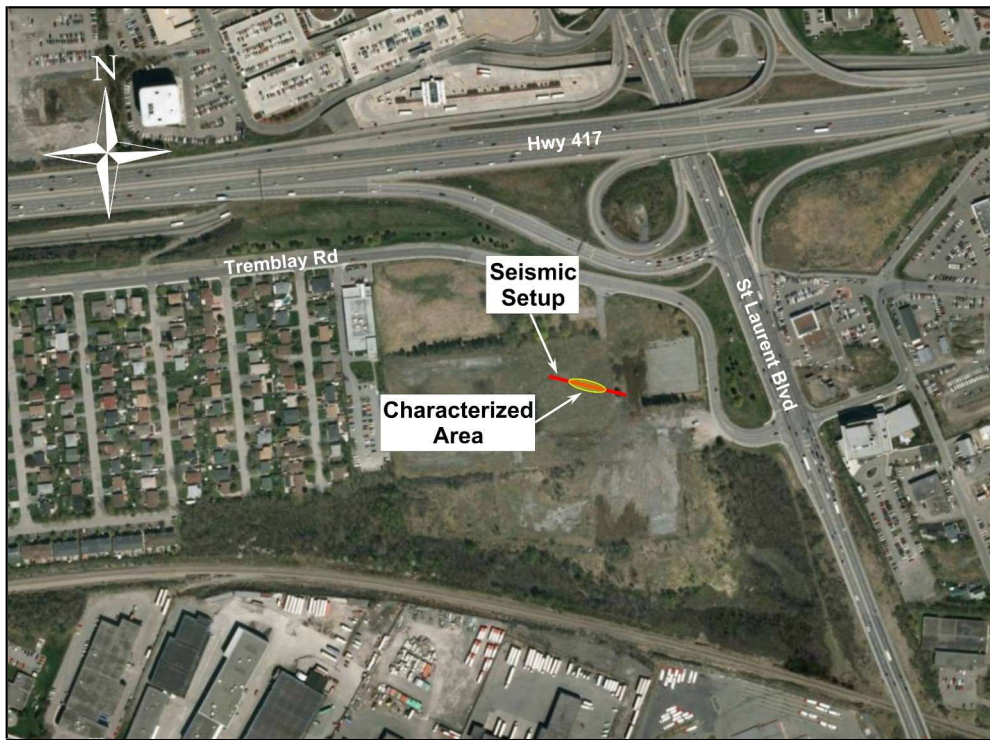
Figure 2: Location of the seismic spread
(source : geoOttawa)

The surveys were carried out on January 31st, by Mr. Charles Trottier, M.Sc. phys. and Mr. Nicolas Beaulieu, Jr Eng. Figure 1 shows the regional location of the site, and Figure 2 illustrates with more details the location of the seismic spread. Both figures are presented in the appendix.
