Phase Two Environmental Site Assessment

6171 Hazeldean Road, Ottawa, Ontario

OTT-00258780-C0

July 24, 2020

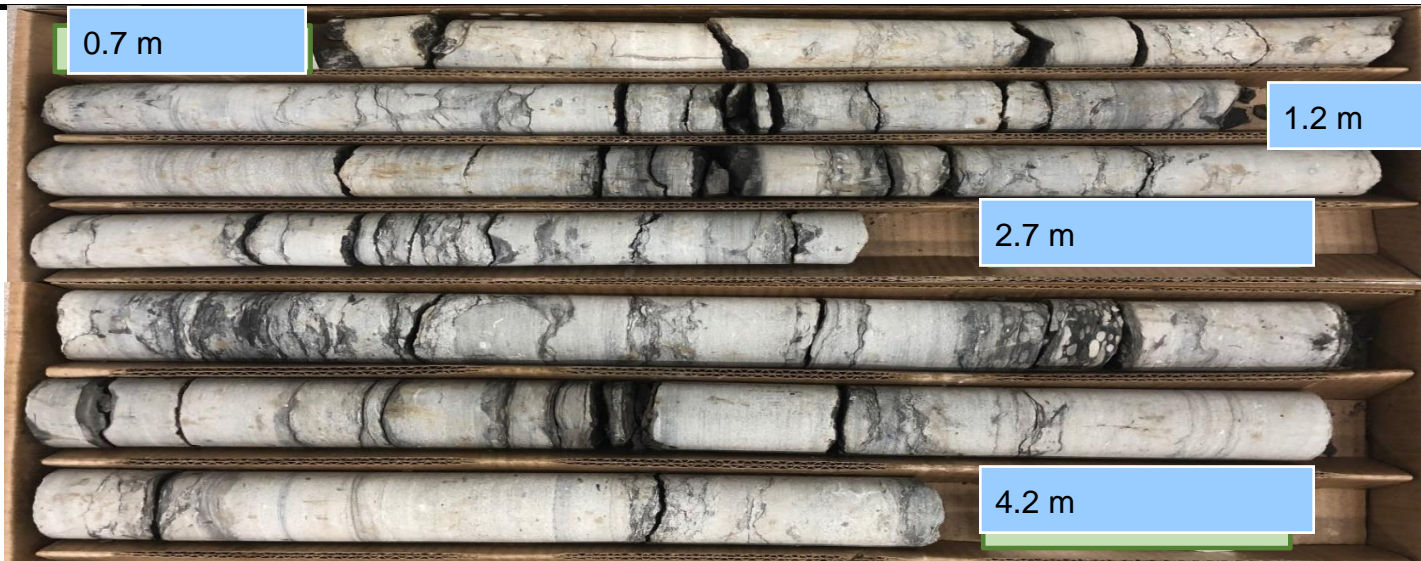
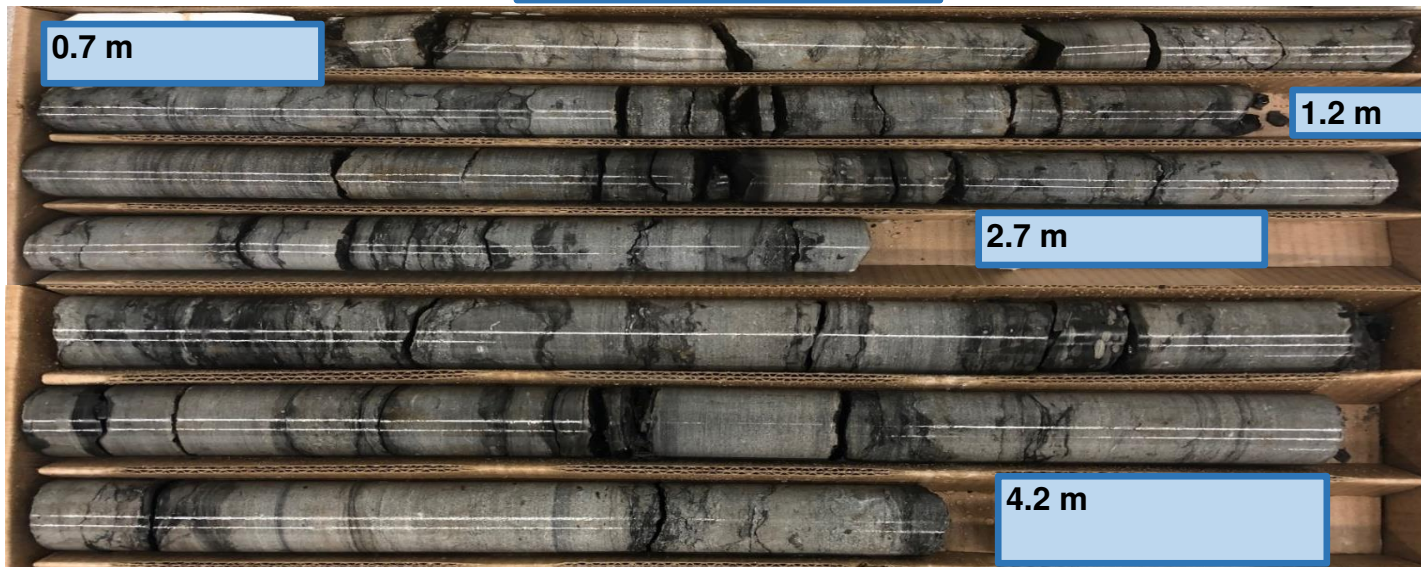
Borehole No. BH-1	Core Runs Run 1 : 0.7 - 1.2 m Run 2 : 1.2 - 2.7 m Run 3 > 2.7 - 4.2 m	Project Name: Proposed Residential Development. 6171 Hazeldean Road, Ottawa, ON	Project No: OTT-000258780-B0
		ROCK CORE PHOTOGRAPHS

DRY BEDROCK CORES

WET BEDROCK CORES
