**Phase One Environmental  
Site Assessment  
6171 Hazeldean Road  
Ottawa, Ontario**

OTT-00258780-C0

# Phase One Environmental Site Assessment 6171 Hazeldean Road, Ottawa, Ontario

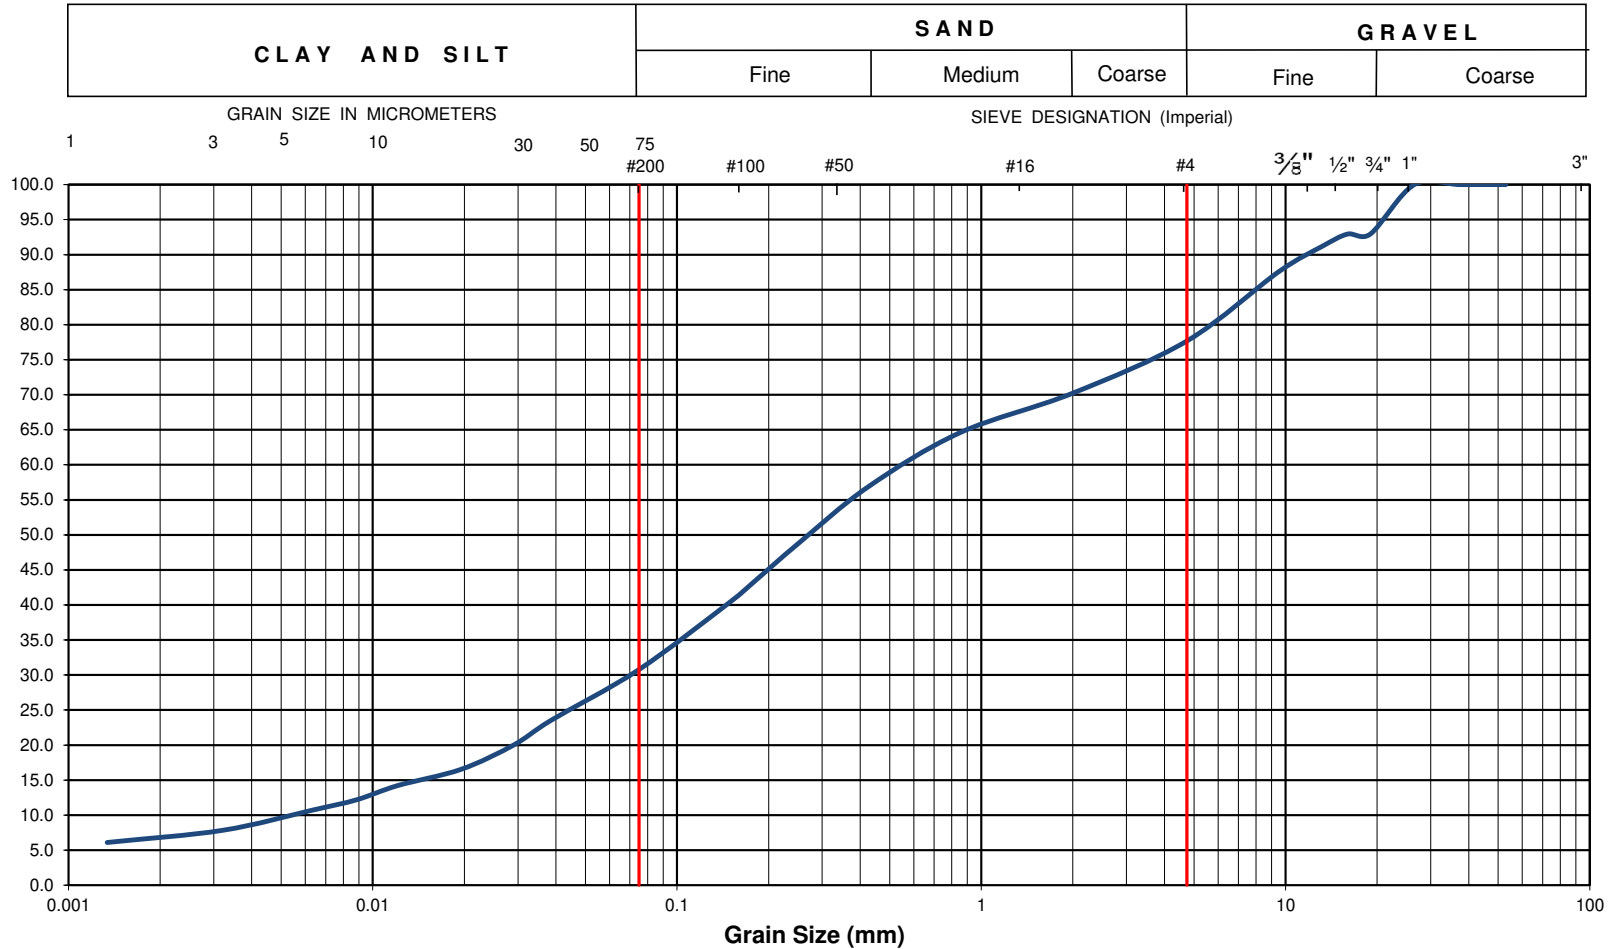
EXP Project No.:	OTT-00258780-B0	Project Name :	Geotechnical Investigation - Proposed Residential Development		
Client :	11654128 Canada Inc.	Project Location :	6171 Hazeldean Rd, Ottawa, ON		
Date Sampled :	March 24, 2020	Borehole No:	BH4	Sample No.: SS1	
Sample Description :	% Silt and Clay	31	% Sand	47	
Sample Description :	<b>Silty Gravelly Sand (SM)</b>			% Gravel	22
				Depth (m) :	0-0.6
				Figure :	27

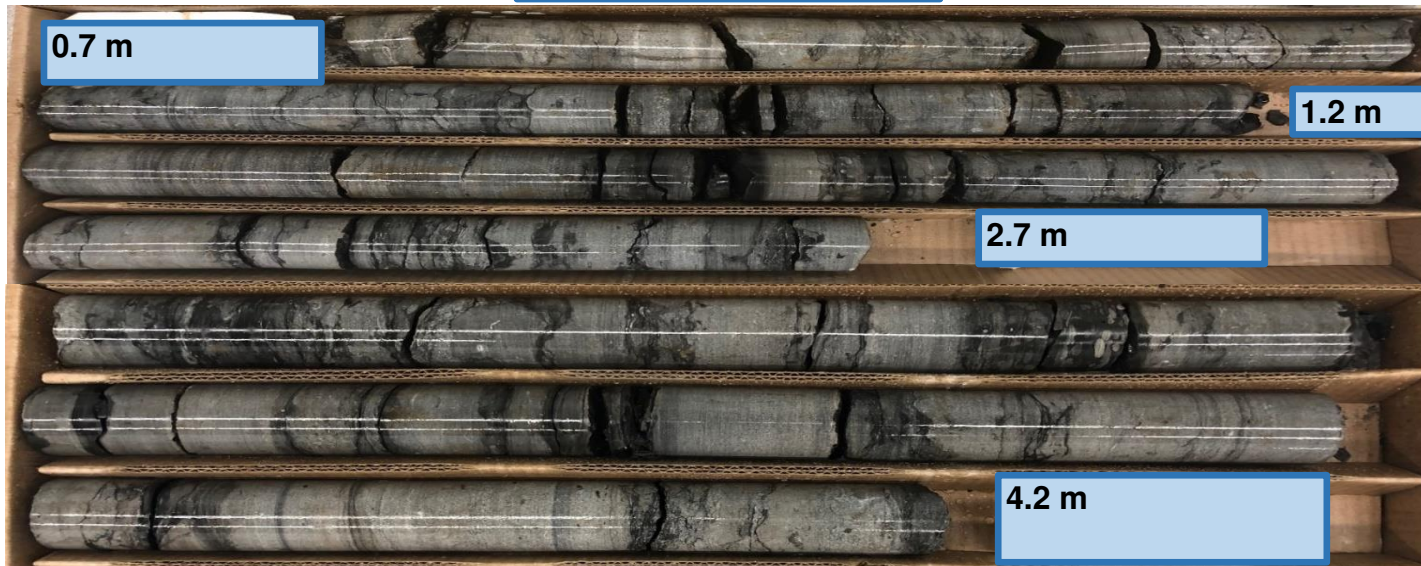
**DRY BEDROCK CORES**

Borehole No. <b>BH-1</b>	Core Runs Run 1 : 0.7 - 1.2 m Run 2 : 1.2 - 2.7 m Run 3 > 2.7 - 4.2 m	Project Name: <b>Proposed Residential Development. 6171          Hazeldean Road, Ottawa, ON</b>	Project No: <b>OTT-000258780-B0</b>
		<b>ROCK CORE PHOTOGRAPHS</b>	Figure No: <b>Fig 31</b>

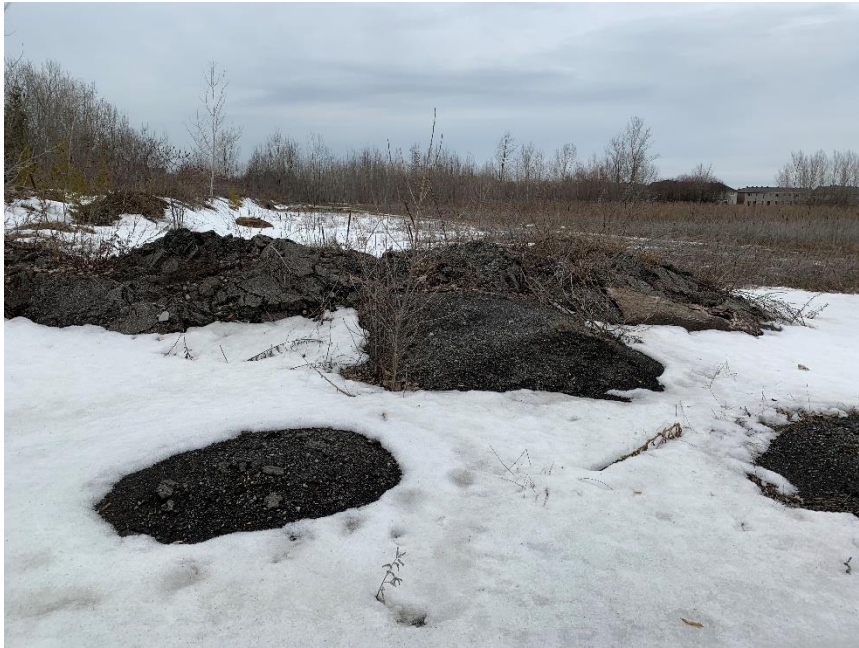
**Photograph No. 5**

Several stockpiles were noted along the western edge of the property. The stockpiles consisted mainly of re-work site material as well as some concrete and mixed asphalt/gravel.

View of fill piles along west property line

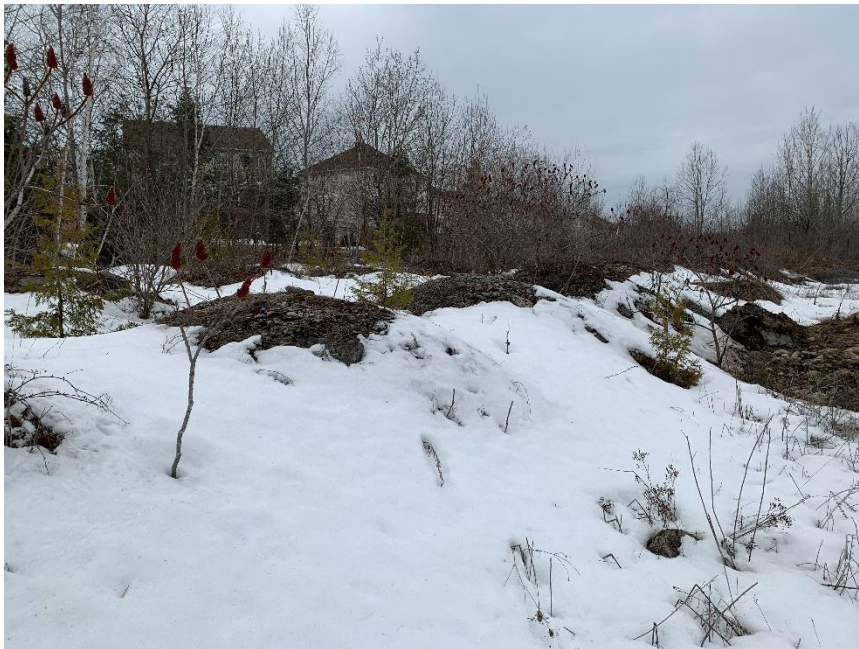
**Photograph No. 6**

View of fill piles along west property line
